H-25 HELICOPTER

DROP TEST

22 October 1960

TREC Technical Report 60-75

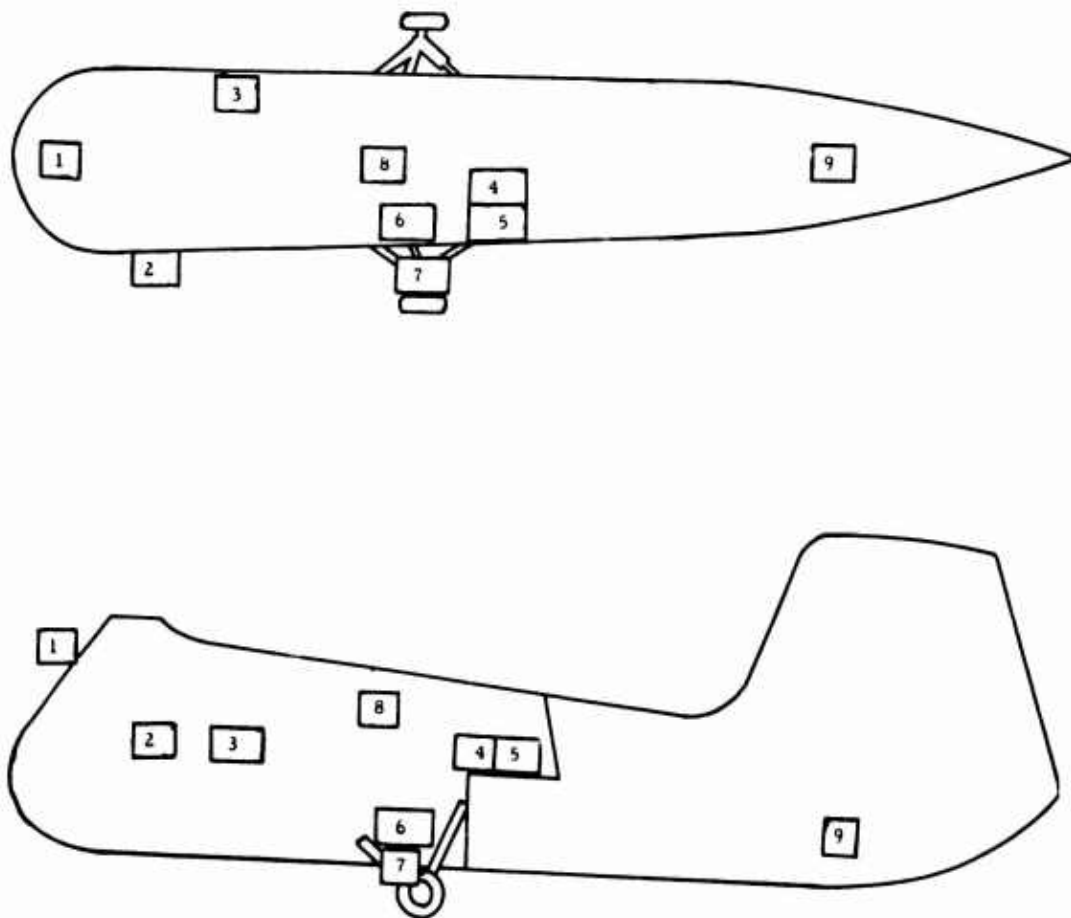
Figure 11. Instrumentation Recording Equipment Installations

A sketch showing location of airborne equipment is presented in Figure 11. A detailed description of the airborne recording system, including circuit diagrams, is presented in Appendix B. Photographs showing the airborne instrumentation package and camera installations are presented in Figures 12 through 15.

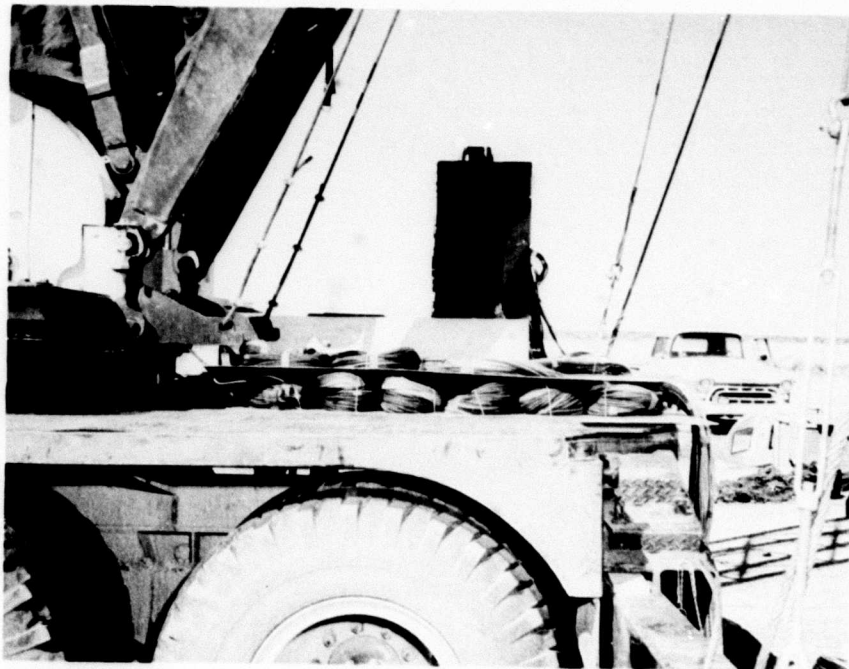
Figure 17. Umbilical Cable Pay-Off System

The umbilical cable installed between airborne instrumentation pickups and the ground recording system located on the crane deck had a maximum play-out length of 100 feet. A disconnect panel was provided should the distance between the helicopter and crane exceed the length. A photograph showing the cable in place on the drop crane is presented in Figure 17.

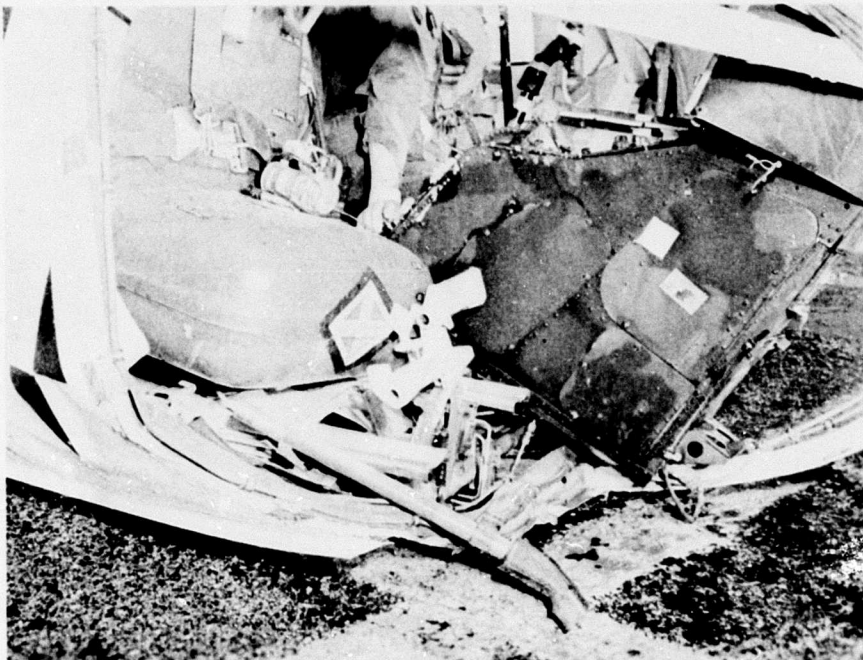
Photographs showing post-crash views of the pilot, passenger, range extender fuel tank, and helicopter structure are presented as Figures 32 through 37.

A post-crash examination was made to observe the extent of damage to the vehicle and injury to its occupants. The following observations were made:

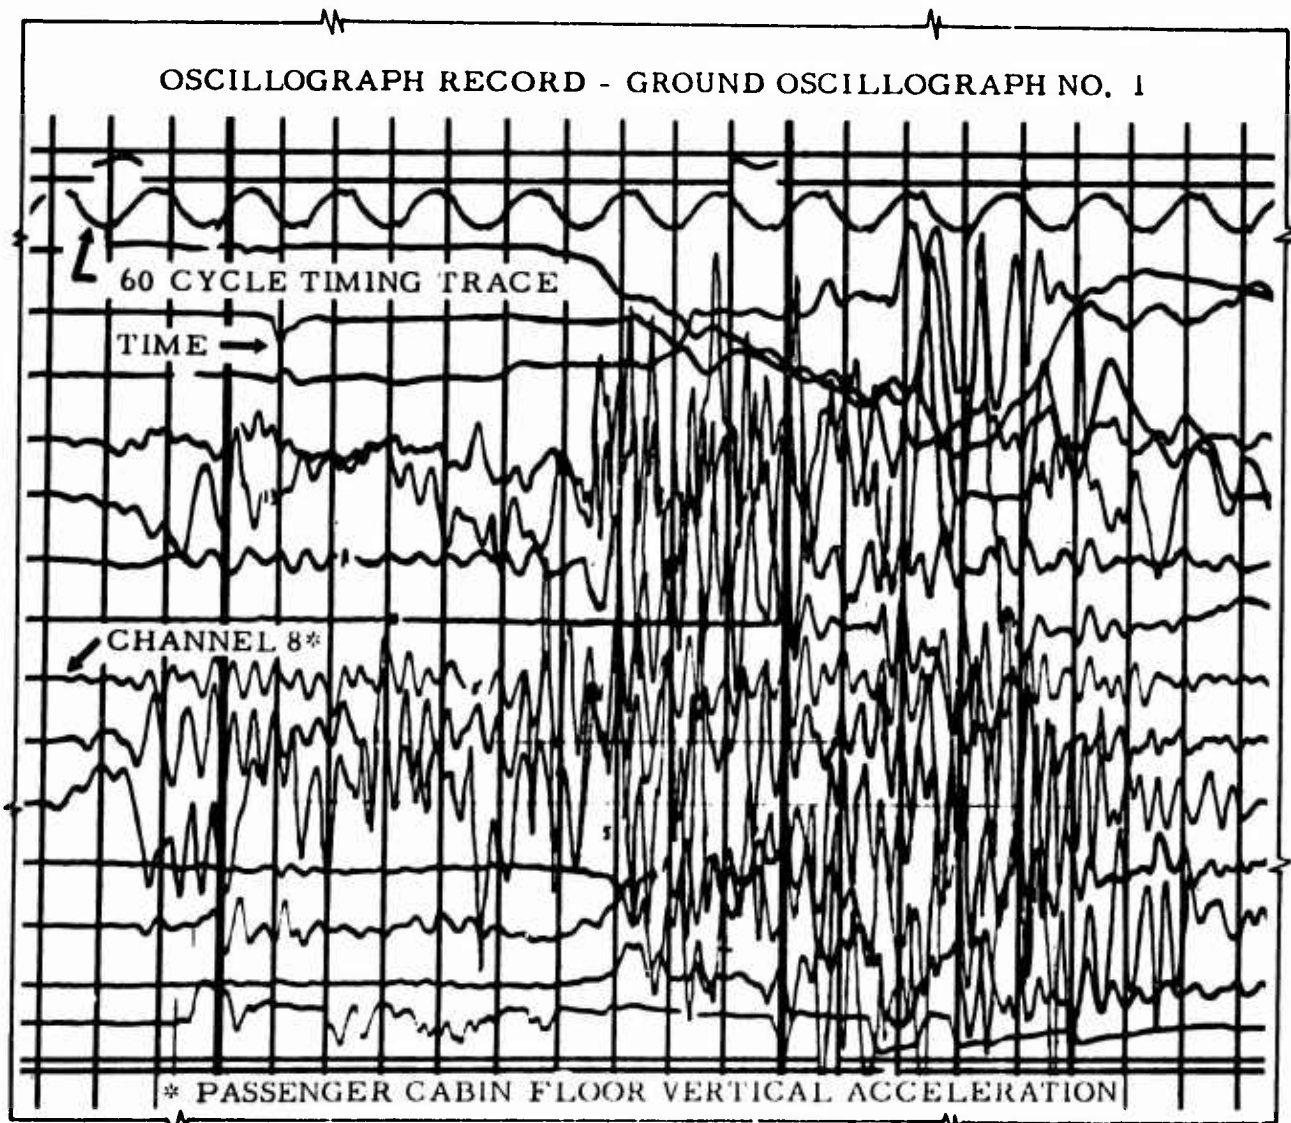
Figure 38. Oscillograph Record - Ground Oscillograph No. 1

The record taken from oscillograph No. 1 is shown in Figure 38 and is typical. The individual traces from these records have been separated and are being analyzed as discussed in a later section of this report. The sign conventions used for acceleration are shown in Figure 39. Acceleration sign conventions for the passenger dummy are referenced to the dummy and not to the airframe.
