CRASH INJURY EVALUATION

AC-1 DE HAVILLAND CARIBOU

21 January 1960

TREC Technical Report 60-62

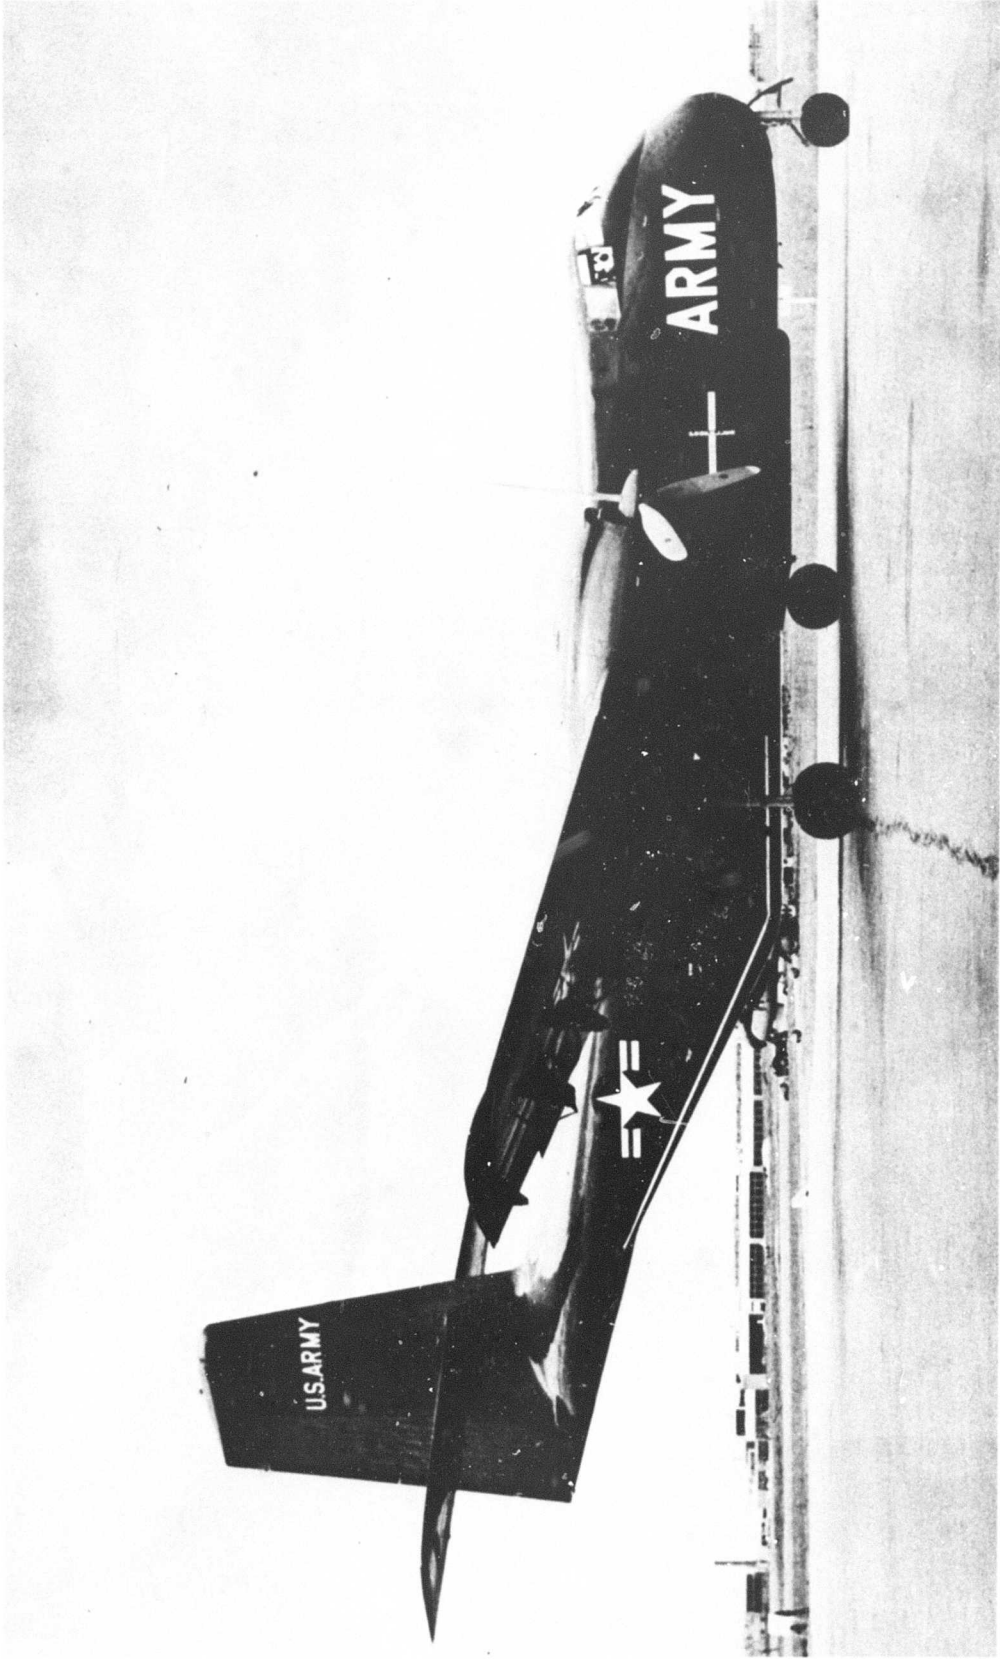
Figure 1. Front quarter view of the Caribou.

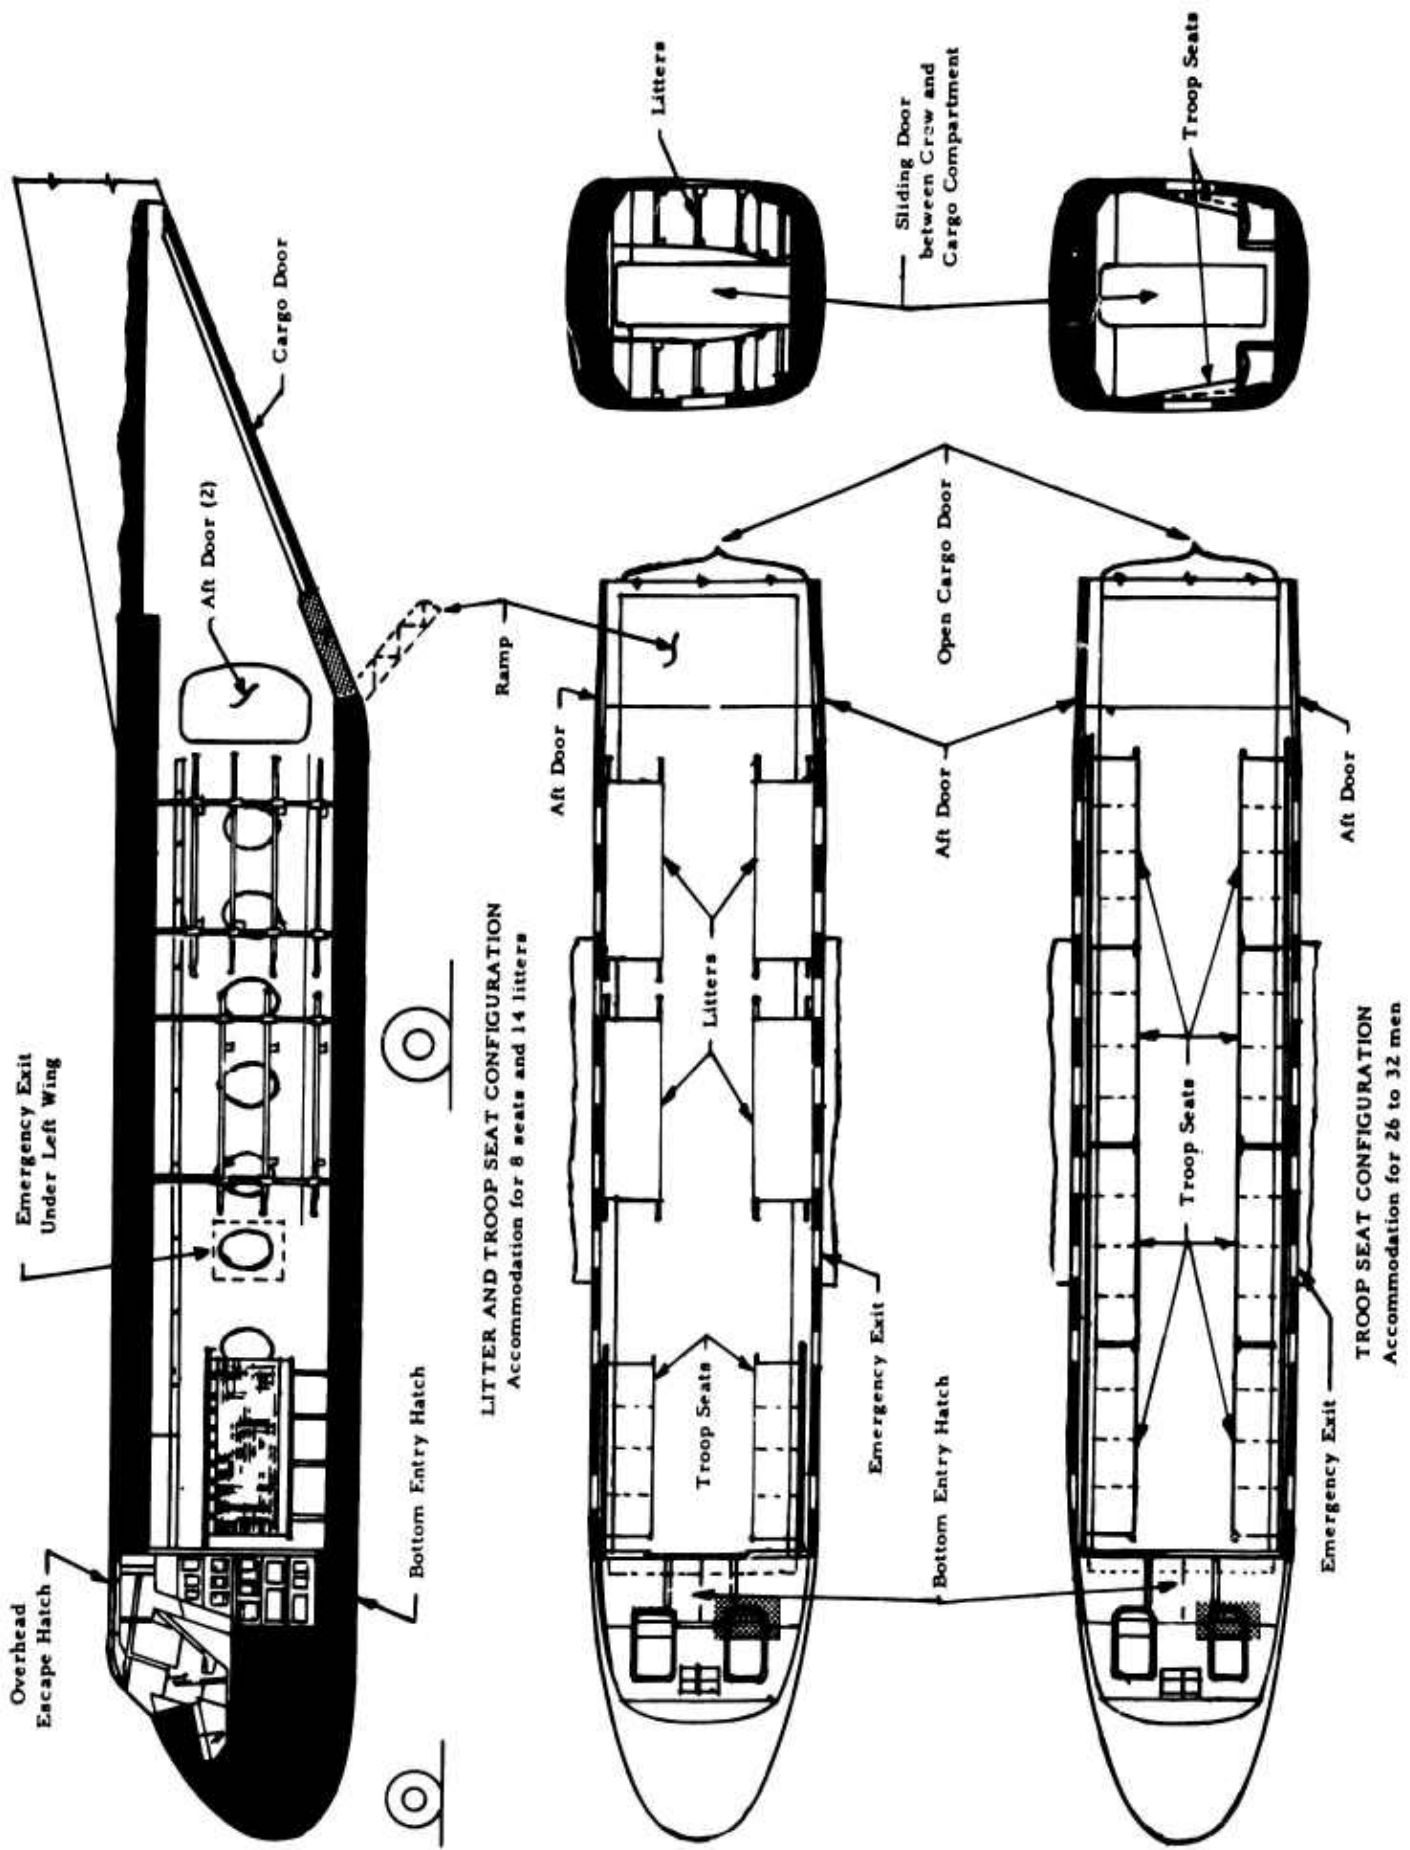
The cabin is equipped with an emergency exit on the left side of the fuselage under the left wing and two doors on opposite sides at the aft end of the cabin.

Figure 2. Cabin layout.

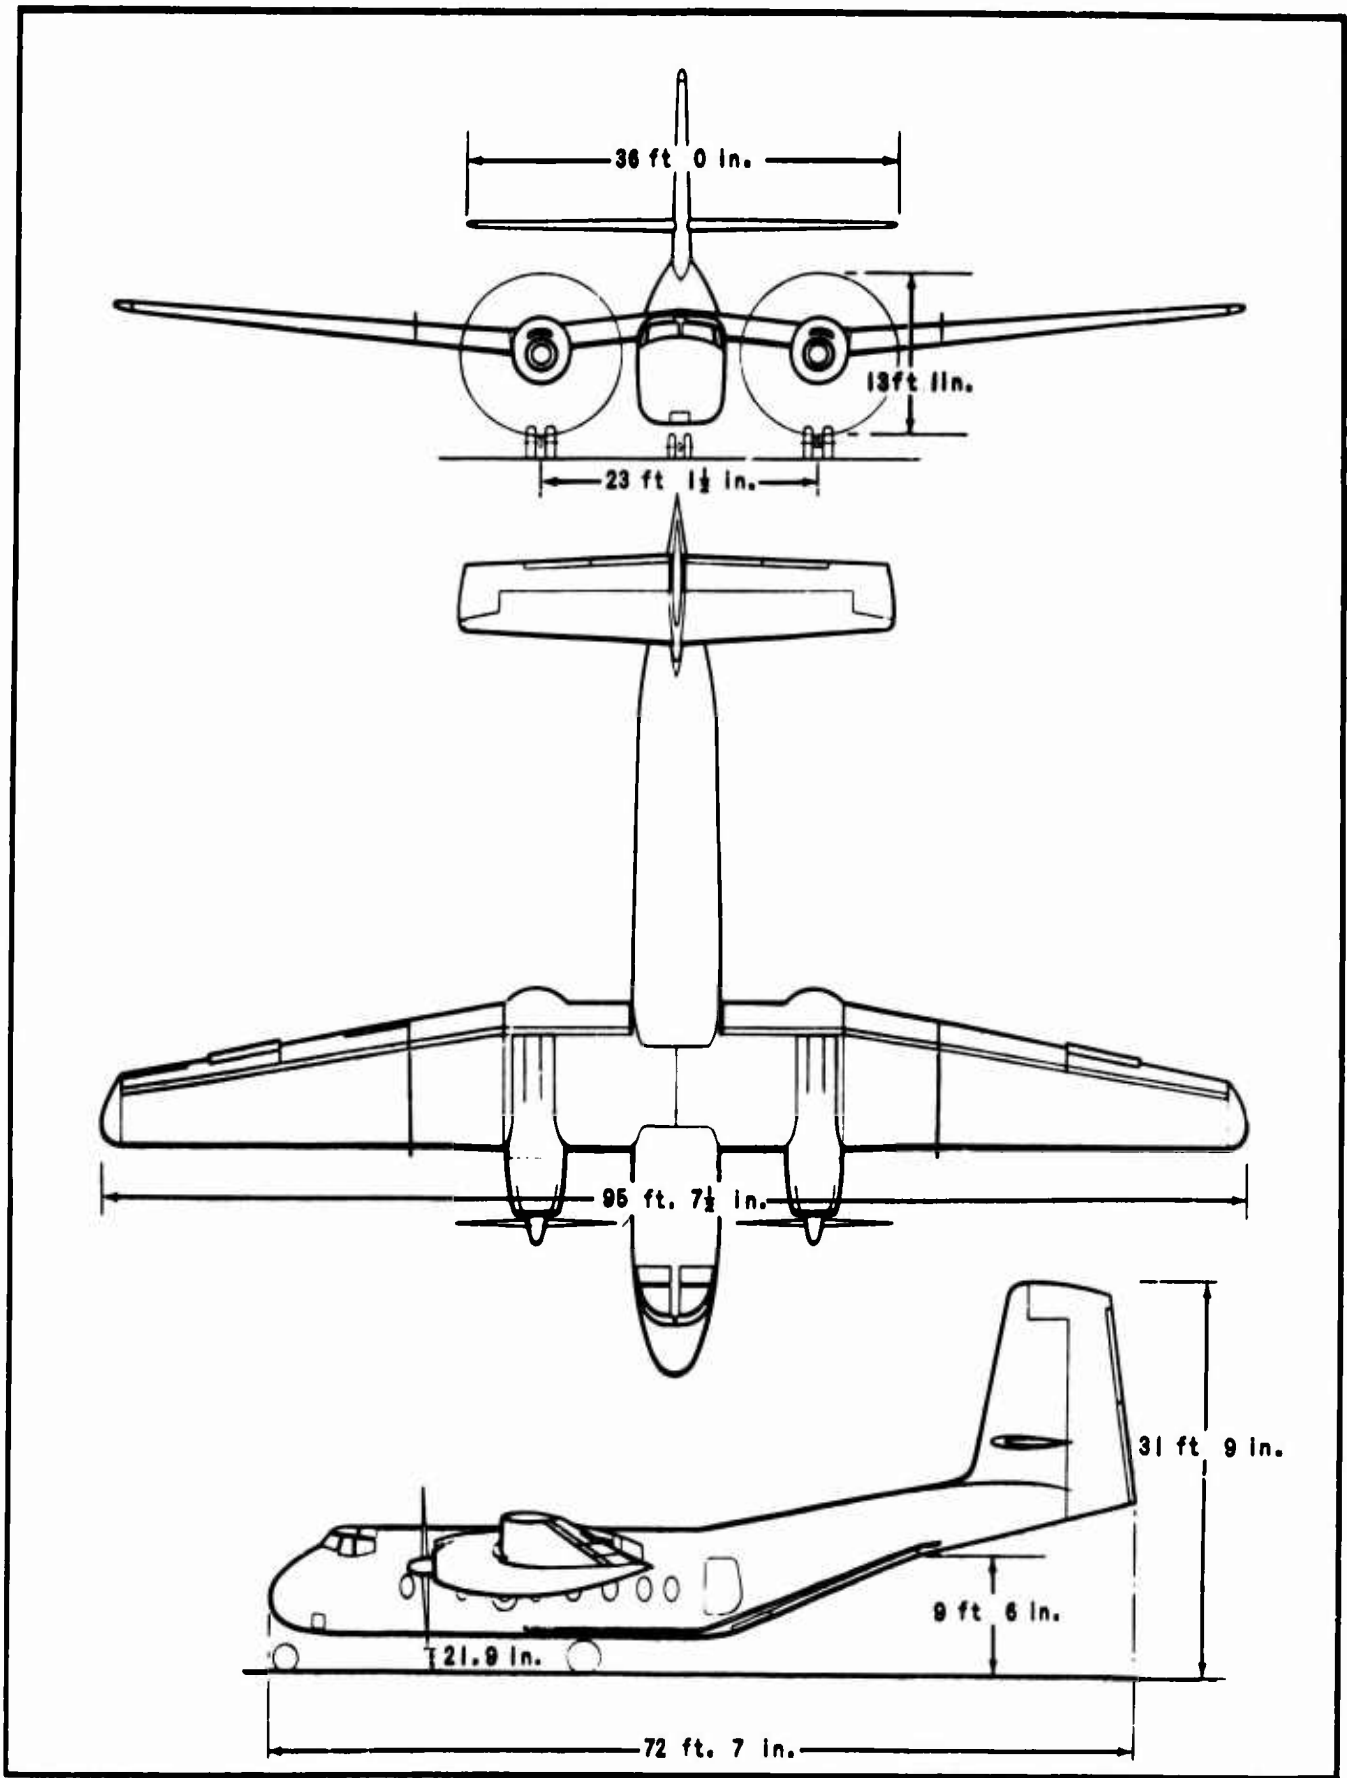
Figure 3. Three-dimensional view.

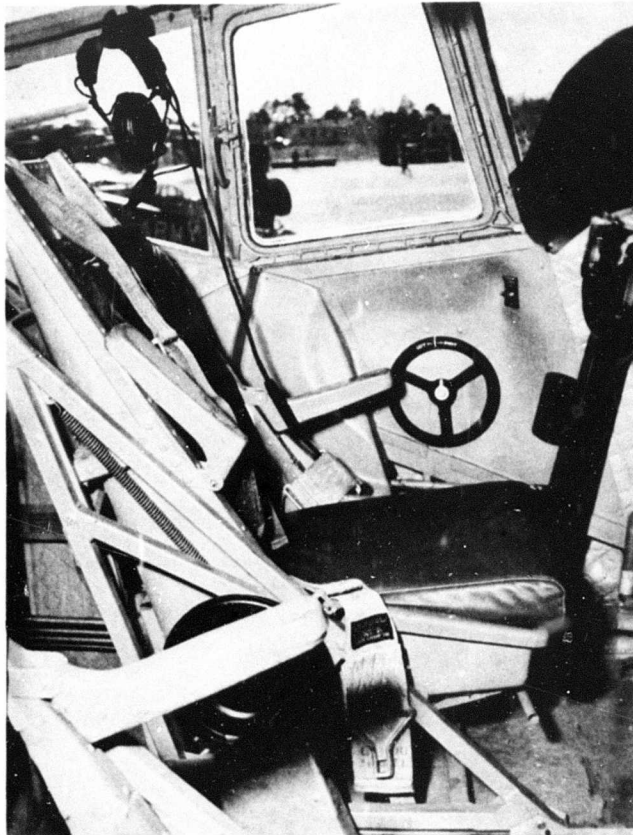
The pilot's and copilot's seats in this aircraft are attached to floor tracks in a side-by-side arrangement. The seats are adjustable in the fore and aft direction by means of a frame which slides over two floor tracks. They are vertically adjustable in this frame by means of levers and springs (Figure 5). The seats are equipped with seat belt (type MD-2), shoulder harness (type MB-2), and inertia reel (type MA-1), all attached to the seat. This arrangement is not desirable from the crash safety point of view since the occupant restraint effectiveness depends upon the seat tie-down strength.

Figure 5. Pilot's seat.

2. The width of the shoulder harness guide on top of the crew seat backs be reduced to increase lateral support during side load conditions.
3. The inertia reel in the Caribou be replaced by a model that ensures positive locking of the shoulder harness regardless of the direction of crash force.

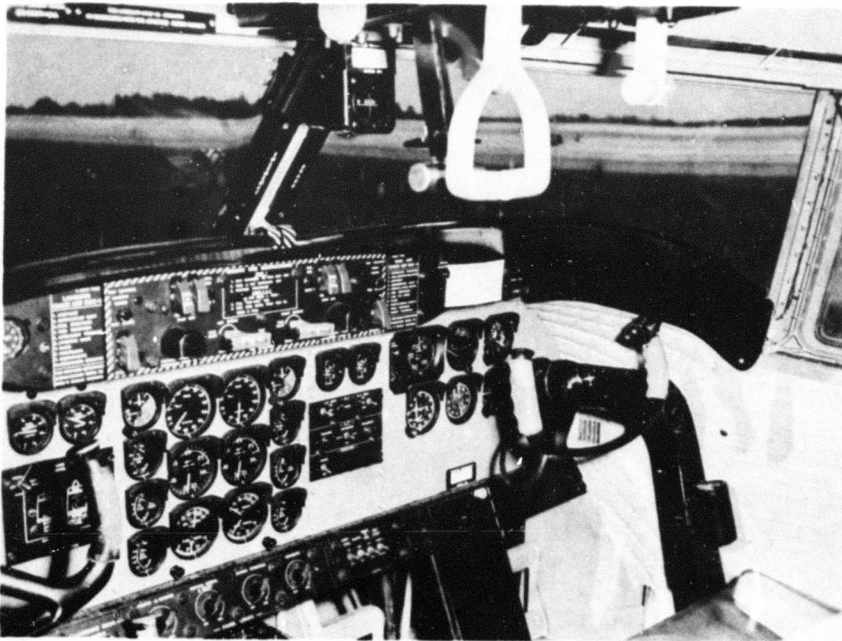
The cockpit gives an "uncluttered" impression which is mainly due to the overhead location of the engine controls (eliminating the conventional control pedestal) and the stowable radio equipment which is located on a console between the crew seats and slides forward into the instrument panel (Figures 6 and 7).

Figure 6. Right side of the cockpit, showing overhead location of engine controls.

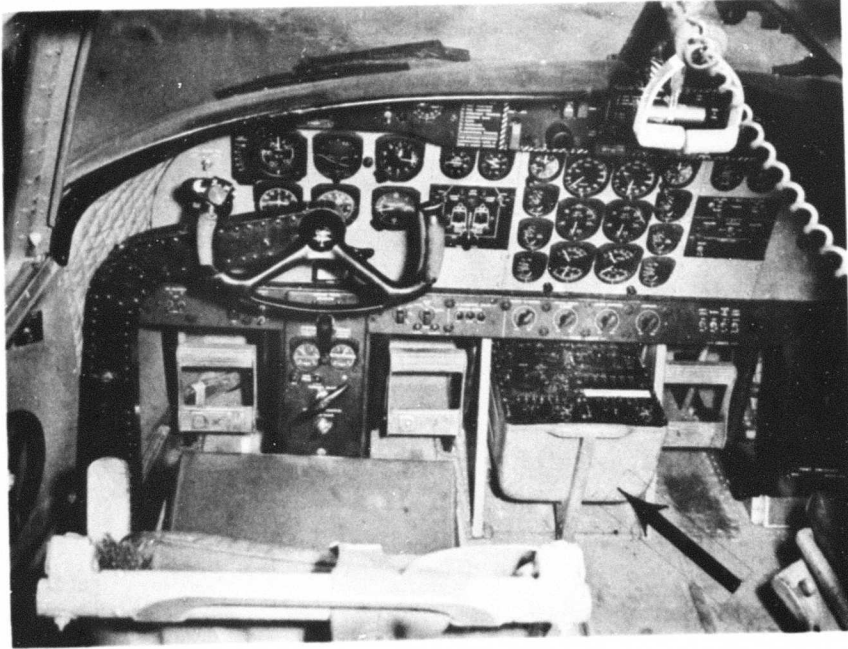
Although the tie-down strength of this console could not be accurately assessed, it can be stated that its resistance against abrupt decelerations should be at least equal to that of the crew seats to prevent it from becoming a dangerous projectile or imposing an additional load on the adjacent seat attachments.

Figure 7. Left side of the cockpit, showing the stowable radio console between the pilot's and copilot's rudder pedals (arrow).

1. The cockpit has several desirable features which reduce the number of objects within striking range of the crew.
2. The stowable radio console would constitute a serious hazard if it became dislodged.

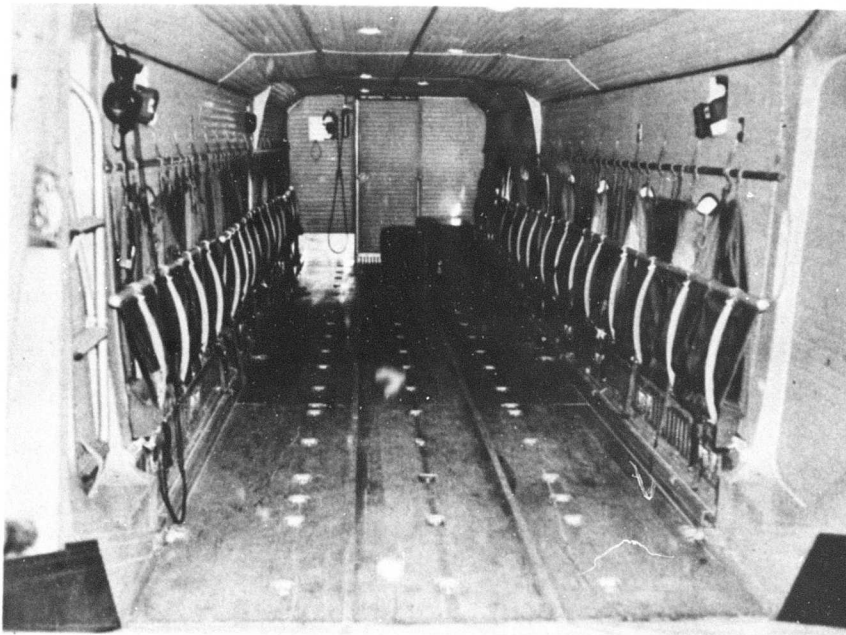
Figure 8. Forward view into the cabin/cargo compartment. The sliding door between cockpit and cabin is closed.

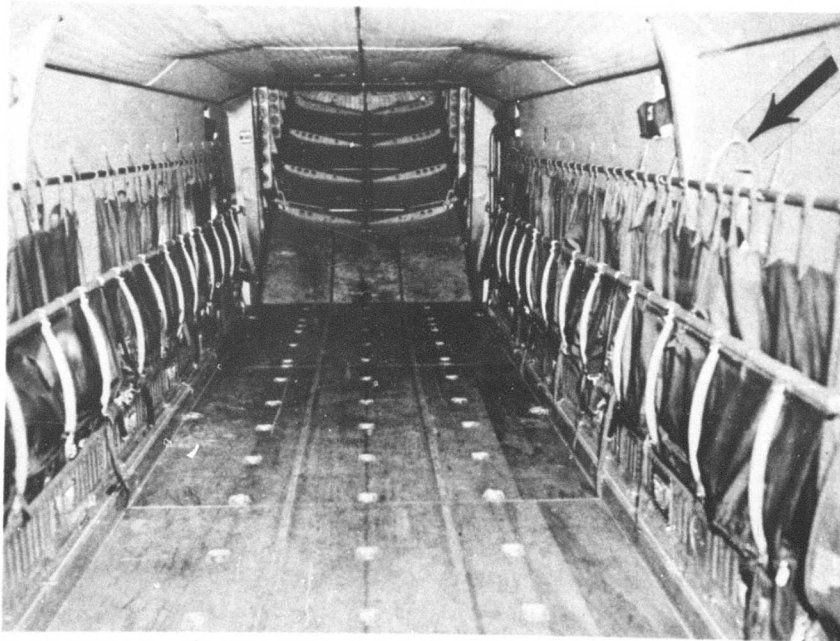
The cargo compartment is equipped with a large rear cargo door (Figure 9). The lower section of this door serves as a short ramp which can be adjusted to match truck bed height.

The upper section of the cargo door retracts into the roof, permitting a truck to back into the opening. This upper section, which can be operated electrically or manually, is jettisonable.

Figure 9. Aft view into the cabin/cargo compartment. The cargo door is closed. The arrow indicates the forward emergency exit.

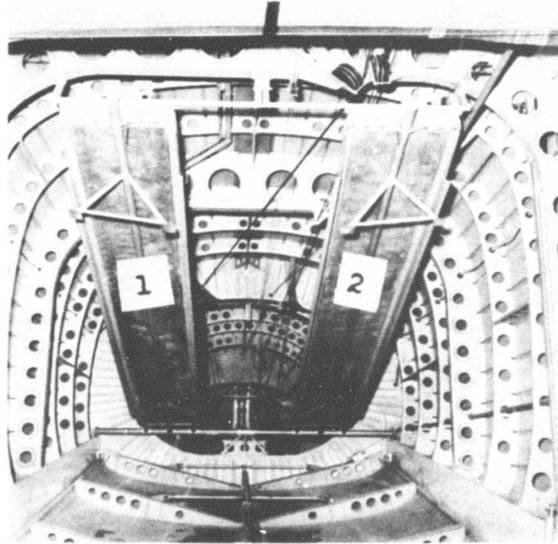
Two auxiliary ramps, to facilitate loading wheeled vehicles, are stowed against the ceiling in the aft fuselage above the cargo door (Figure 10). It is impossible to make an analysis of the tie-down strength of this installation based upon the available data. It can only be stated that these ramps would create a serious hazard for the cabin occupants if they became dislodged as a result of impact forces or distortion of the aft fuselage.

Figure 10. The two auxiliary ramps (1 and 2) are stowed against the ceiling in the aft fuselage above the cargo door.

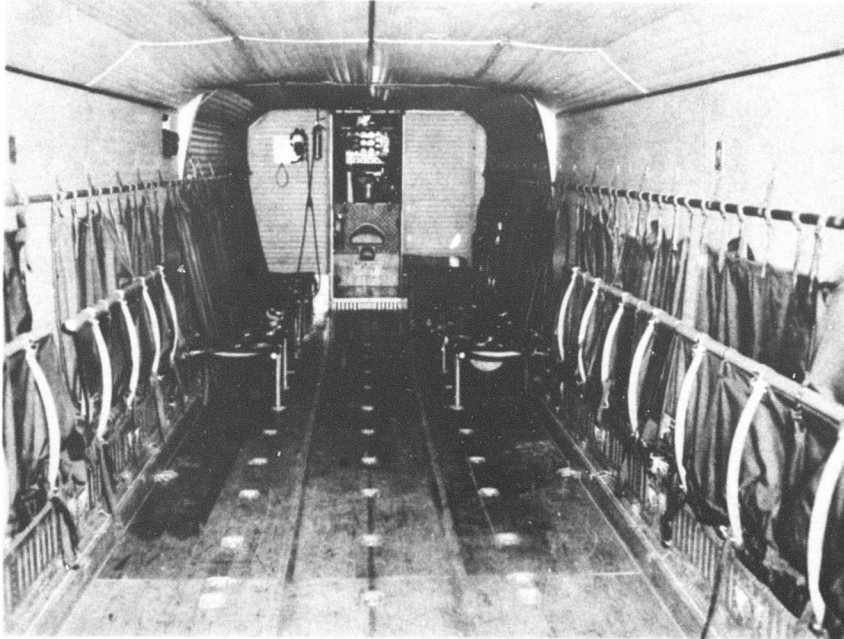
The seat frame consists of upper, rear, and front support tubes to which is attached the seat back and seat bottom material (nylon). The seat legs are attached to the front support tube. Spreaders maintain the distance between rear and front support tubes.

Figure 11. Forward view into the cabin showing the four-man troop seats in folded and unfolded position.

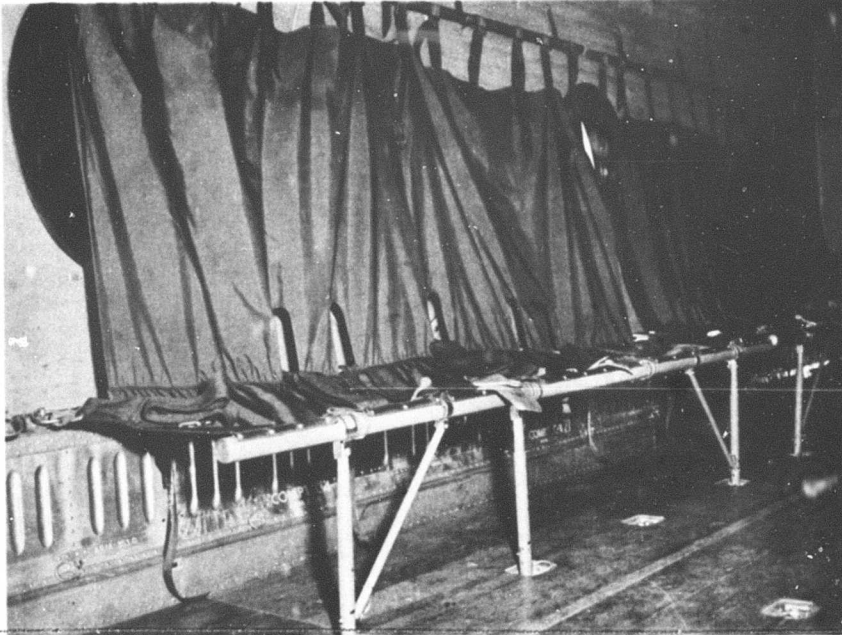
Although the Military Specification specifies tape (webbing) material for the seat back, the seat backs in the Caribou consist of one piece (nylon). This will undoubtedly help to prevent snagging of the equipment carried by paratroopers (Figure 12).

Figure 12. Close-up of a four-man seat. Notice the three legs and their attachment to the floor. The spacing of the holes in the seat back indicates the manner in which variation in seat belt anchorage makes this a variable width seat.

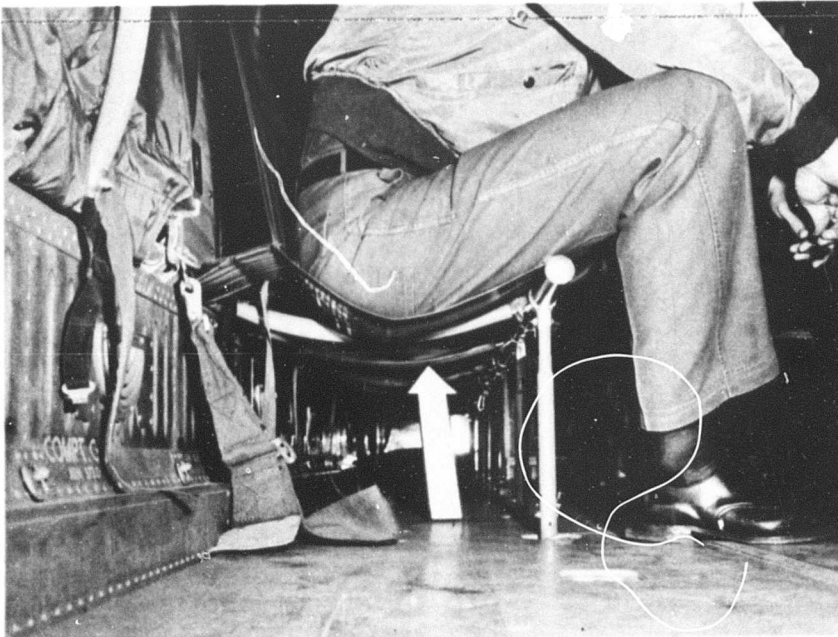
The strength requirements in both specifications are similar, with the exception of the seat bottom (11 G vs. 10 G). The load on the seat bottom may be considered equally distributed over the rear and front support tubes (Figure 13). This leads to some interesting speculations on the loading of the seat legs. According to the specification, the load carrying capacity of these legs is 1,000 pounds each. Making the conservative assumption that not more than half the occupant's weight is supported by the seat legs this would give the legs a 10 G strength. However, for a three-man seat the center leg is optional which implies that the resistance against vertical loads would be reduced to about 6.5 G ($\frac{2,000}{300}$). In the same manner the strength of a four-man seat with three legs, as used in the Caribou, would be reduced to 7.5 G.

Figure 13. Close-up showing the load distribution over the front and rear support tubes and seat back. The arrow indicates where the occupant straddles the spreader.

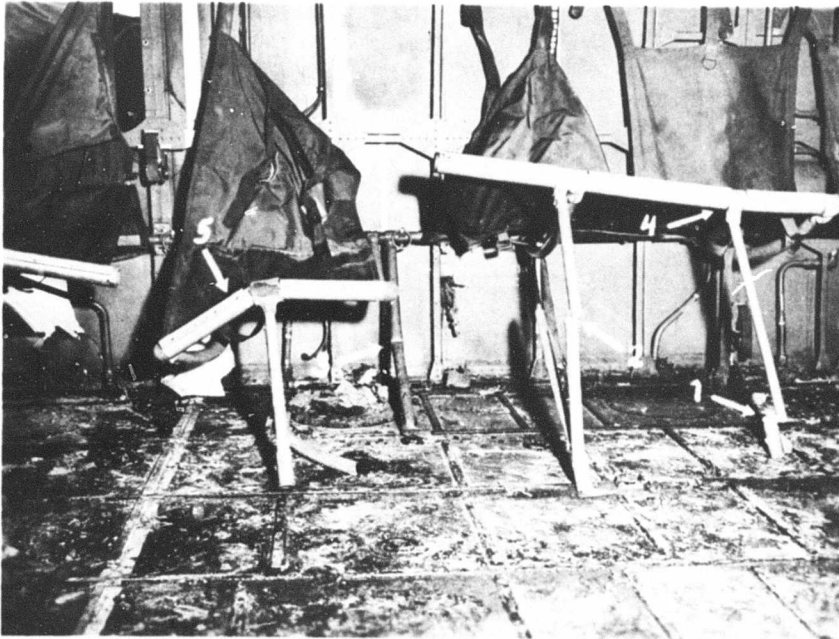
The effect of moderate crash forces on seats of similar design is shown in Figure 14. The seat legs and the front support tube failed in a manner that exposed the occupants to serious injury.

The side load strength requirement for this seat forms the main point of controversy concerning the adequacy of design. The seat is required to withstand an ultimate sideload of 225 pounds (1.1 G) applied in line with the center line of the front support tube. Since the seats are installed alongside the cabin walls (facing inboard), this load is applied parallel to the longitudinal axis of the aircraft and can actually be considered a forward load. In fixed wing aircraft this is often the direction in which a component of the main crash force is applied and for this reason most seats have their greatest strength in the forward direction. The foregoing should make it clear that in the case of the troop seat design requirements the situation is exactly reverse, that is, the seat has its lowest strength in the forward direction.

Figure 14. Post-crash appearance of seats built in accordance with the same Military Specifications, installed in another aircraft, after a moderate impact. The arrows indicate failures.

5. The design requirements for troop seats as specified in MIL-S-5804B and MIL-S-27174 offer the occupants inadequate crash protection, particularly when the seats are subject to side loads. Past accident experience underlines this deficiency.

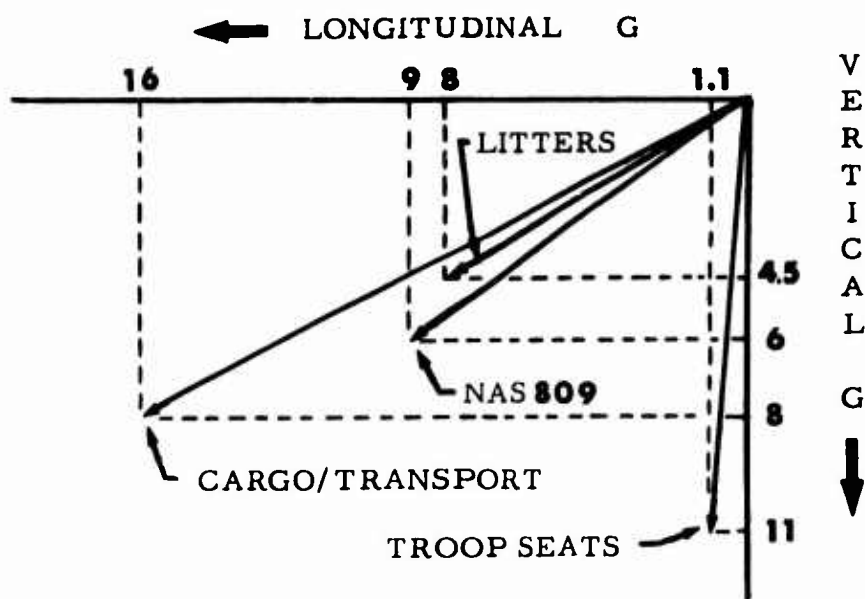
By making the favorable assumption that the static loads, which these structures must be able to withstand when applied separately, can also be sustained without failure when applied simultaneously, a more realistic approach to actual seat strength can be made. (See Figure 15.)

Figure 15. Static ultimate load requirements for seats, structures, and litters.

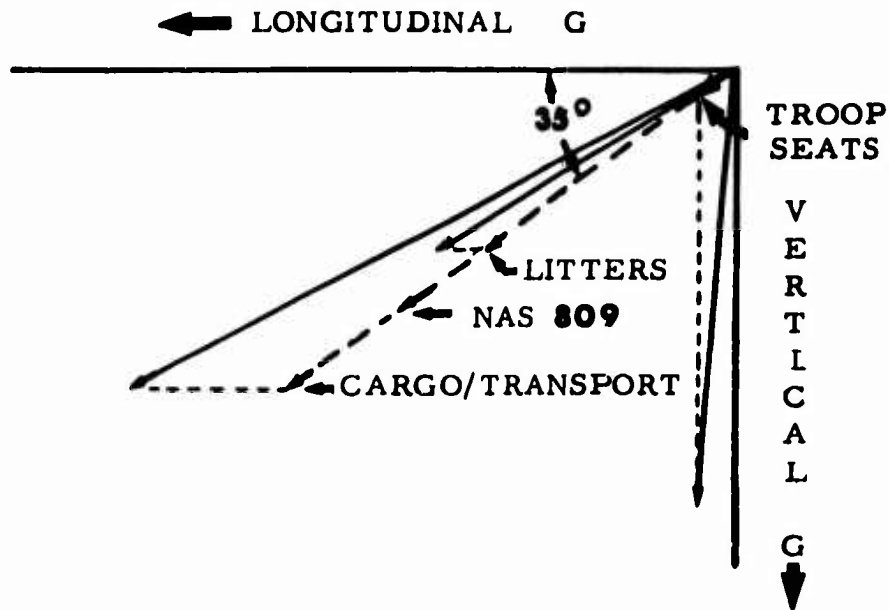
To make these data more meaningful the various ultimate load characteristics should be compared under identical conditions of crash force angle. This has been done in Figure 16.

Figure 16. Ultimate load characteristics for seats, structures, and litters at 35° crash force angle.

The resultant ultimate load characteristics of cargo/transport structure, litters, and troop seats have been transposed to a 35° vector, which coincides with the resultant of the NAS 809 passenger seat requirements. This angle was chosen because accident experience seems to indicate that this is an acceptable mathematical average of the directions of crash force application in survivable accidents. The results of this transposition can be summarized as follows: At a crash force angle of 35° the theoretical ultimate load strength of the subject structures is shown in Table 4.

Table 4 indicates clearly that the crash resistance of the troop seats under anticipated survivable impact conditions is inadequate.

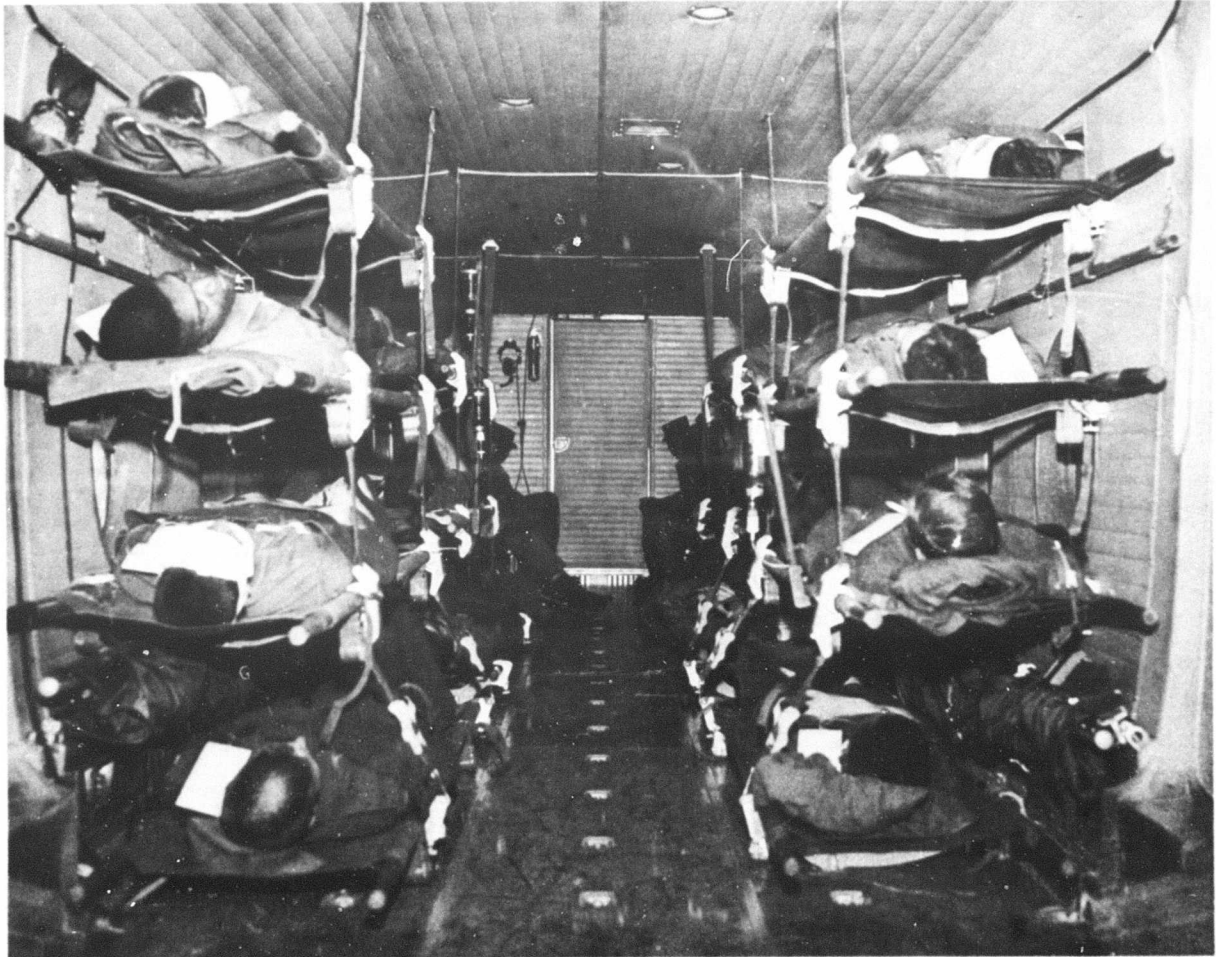
Figure 18. Litter and troop seat installations.

4. The standard litter installation in Army aircraft, as used in the Caribou, be subjected to static or dynamic tests to (a) determine its ultimate load-carrying capacity in relation to the requirements in MILS-5705; and (b) the adequacy of these requirements in relation to survivable crash force conditions.

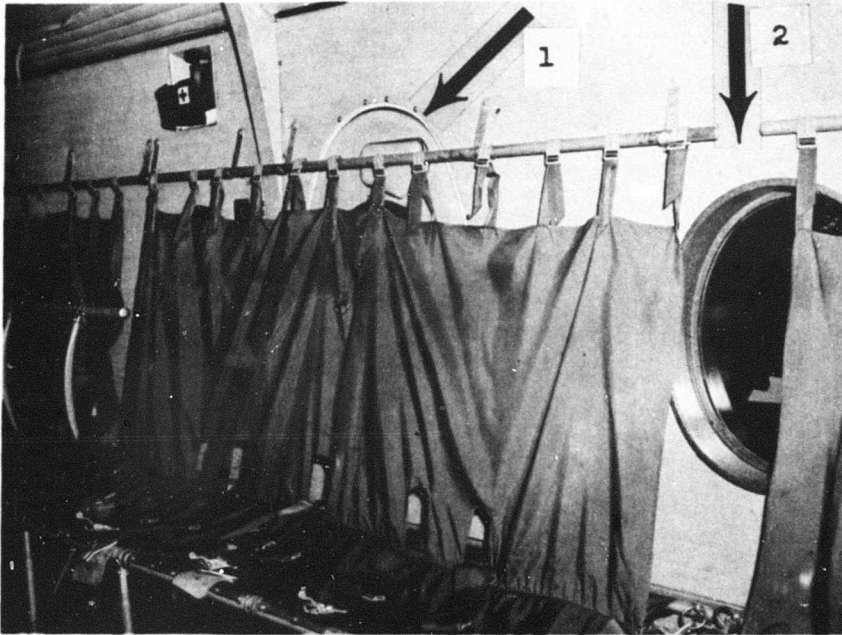
The effectiveness of this emergency exit and the ease of operation would be greatly increased if the open space between adjoining seats had been utilized (Figure 21). In addition, if the location of the exit release handle and guard were slightly changed (up or down) with respect to the upper seat support tube, this exit could be used without removal of seat structure.

Figure 21. The present emergency exit location in the cabin (arrow 1) necessitates removal of the upper seat structure before it can be used. Location of the exit between two adjoining seats (arrow 2) would simplify evacuation.

5. An extra emergency exit be added to the right cabin wall and that its location and design be governed by Recommendation 4.

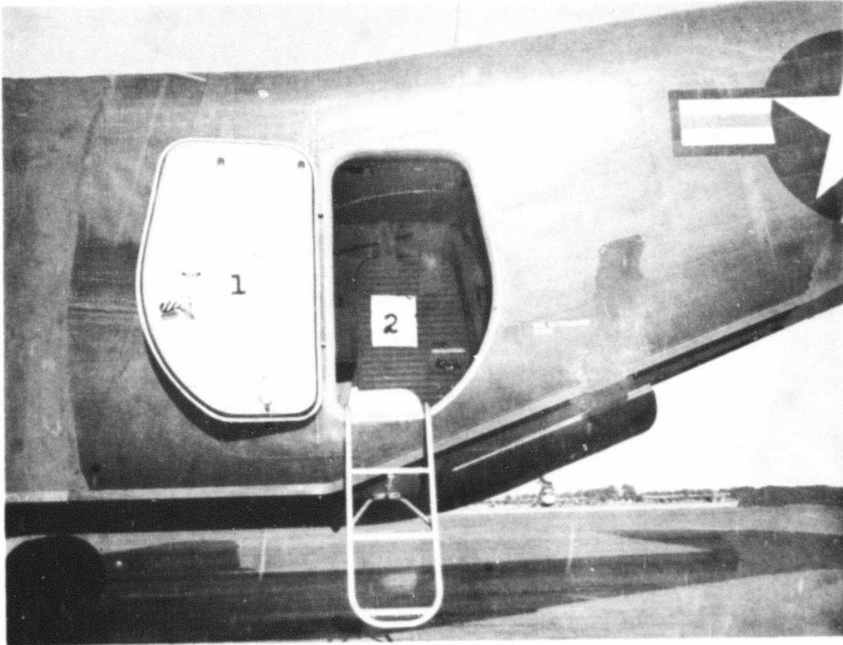
There are two doors (30 x 50 inches) on opposite sides at the aft end of the cabin (Figure 22). Although the one on the right is jettisonable according to the Model Specification, this was not the case in the model that was examined.

If the aircraft came to rest on its left side, two cabin exits might be rendered useless. This, in combination with possible jamming of the cargo door, would leave the cabin passengers with one exit only. The need for an extra emergency exit in the right cabin wall is also indicated in the following extract from the Handbook of Instructions for Aircraft Designers (HIAD - ARDCM 80-1):

Figure 22. The two doors on opposite sides at the aft end of the cabin (1 and 2) are not jettisonable.

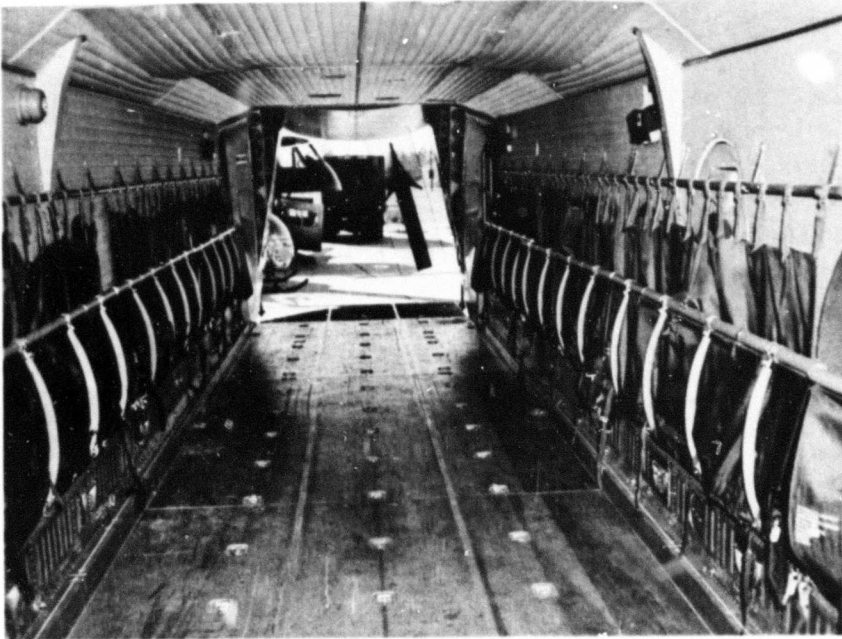
The rear cargo door provides a fourth emergency exit from the cabin compartment (Figure 23). The upper section of this door is jettisonable. The large size of this section and the manner in which it fits in the aft fuselage when in closed position make it very likely that this door will be jammed, when this part of the fuselage is distorted during a crash. Therefore, this door should not be depended upon as an emergency exit unless it is opened or jettisoned before impact. This further indicates the necessity of making both aft exits jettisonable.

Figure 23. The rear cargo door retracts in the roof structure of the aft fuselage (arrow). It can also be jettisoned.
