# SEQUENTIAL STUDY OF DESERT FLOODING IN THE WHITE MOUNTAINS OF CALIFORNIA AND NEVADA

Choster B. Beaty

January 1968

TECHNICAL REPORT  
68-31-ES

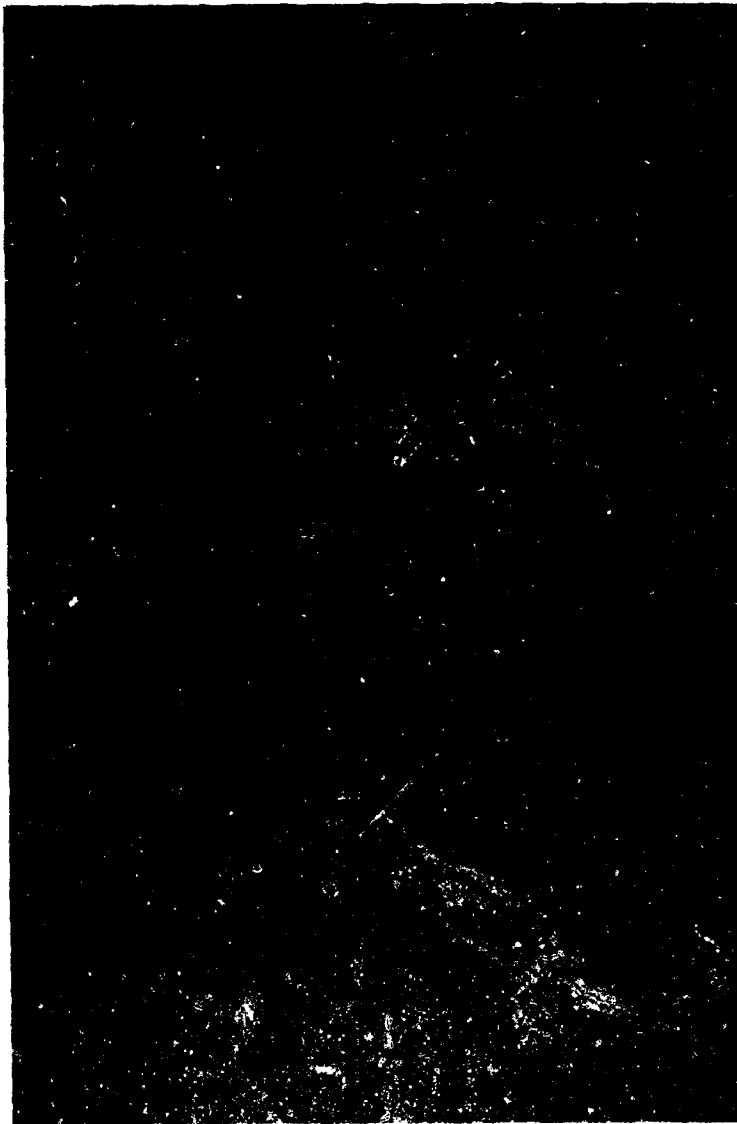
Figure 9. Aerial view of narrow debris flow on Willow Creek alluvial fan, assumed to have occurred in 1958.

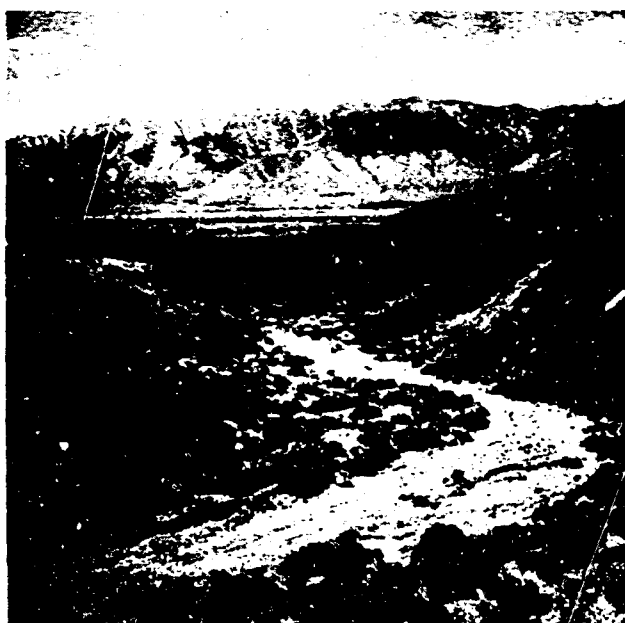
Figure 30. Part of lower Poleta Canyon as it looked in 1956 (A), and as it appeared after the heavy rains of December 1966 (B).

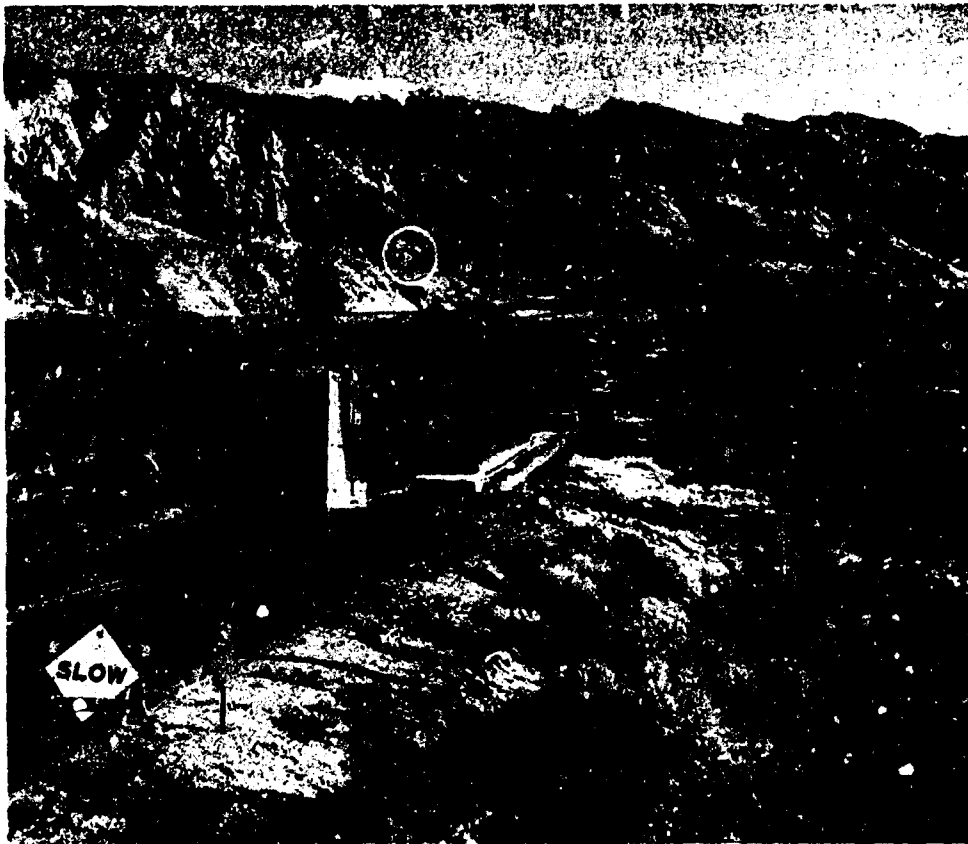
Figure 38. Owens River out of its banks and over California State Highway 135 about 3 miles southeast of Lone Pine, 8 December 1966.

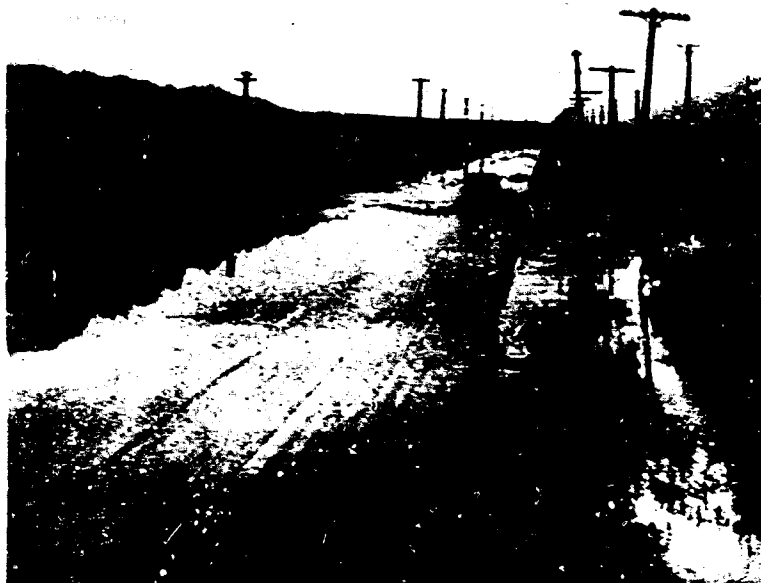
Figure 47. Runoff from Lone Tree Creek across U.S. Highway 6 in Upper Owens Valley, early morning of 13 July 1967. Minor flooding was produced by heavy rains on evening of 12 July 1967.

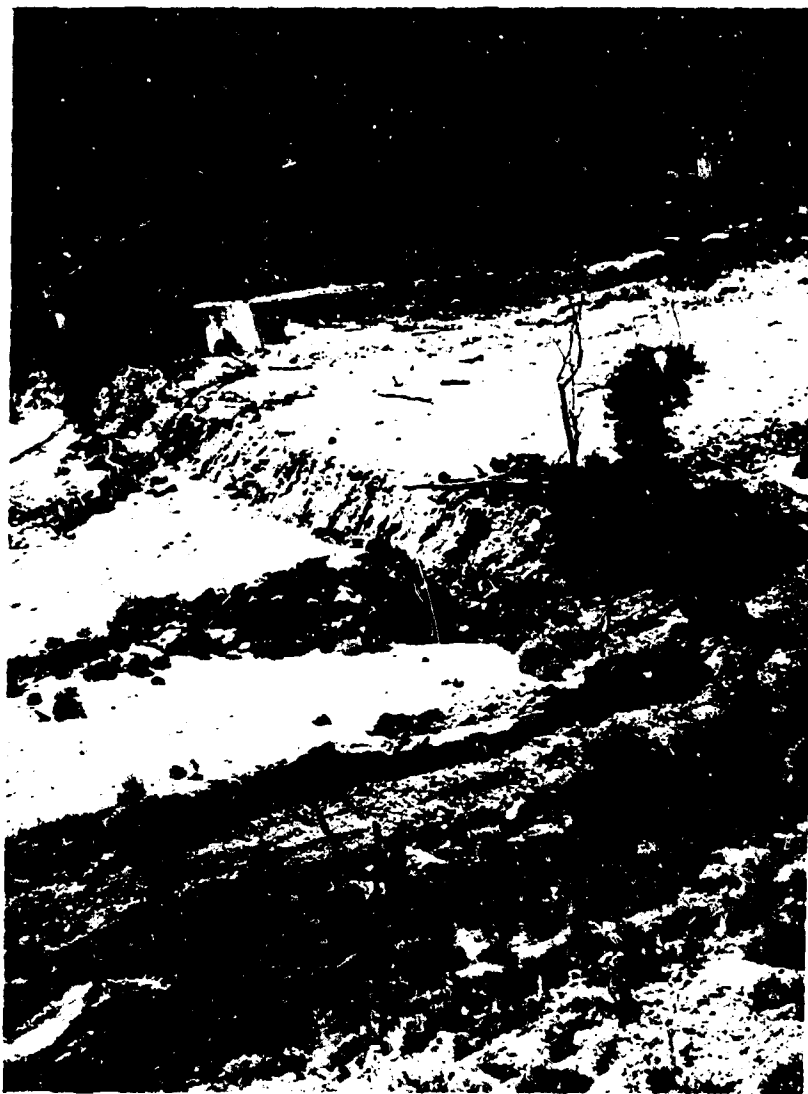
Figure 54. Pipeline intake reservoir in lower Leidy Creek Canyon filled and partly destroyed by flood of July 1967.
