Microporosity in Lead-Antimony Grid Alloys

A. C. SIMON

*Electrochemistry Branch
Chemistry Division*

June 18, 1968

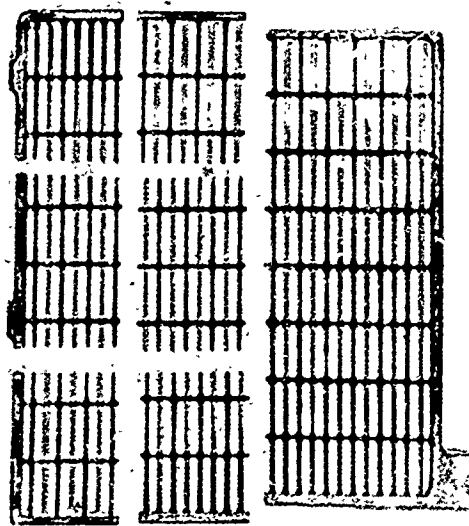
Fig. 1 - Sectioning of storage battery plates to obtain samples for microscopic examination. The active material which would normally fill the spaces between, and partially cover, these grids has been eliminated here for the sake of clarity. Photographed grid is also somewhat less than natural size.

Strips were then cut from the carefully supported and clamped plate. These strips were taken from the plate with the long dimension parallel to the smaller grid bars, which are usually horizontally placed in the battery cell (Fig. 1). Such strips could be cut from the battery plate with very little distortion of the grid members, dislodgment of active material, or other damage, if an X-acto razor saw was used. Four or more strips, each approximately 1-1/4 in. wide by 1-3/4 in. long, from the same plate were usually placed together in one mold cavity, which was 1-1/2 in. diameter by 1-3/4 in. high.

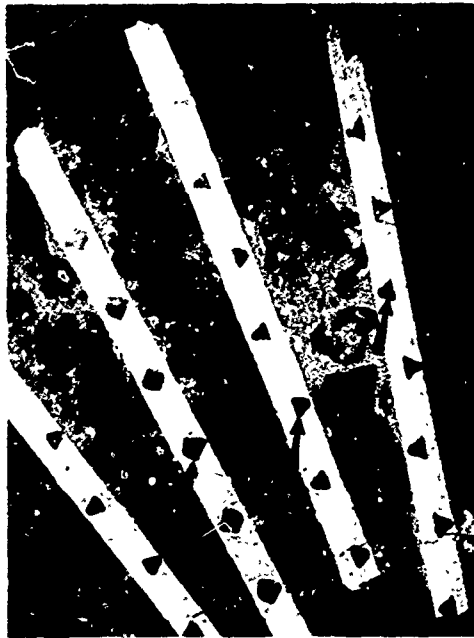
Fig. 2 - Appearance of samples, cut from the plate as in Fig. 1, after they had been impregnated with plastic, mounted, sectioned, and polished. The four slender, light-appearing, rectangular sections are cross sections through a cured but unformed plate. They are embedded in a cylindrical plastic casting, of which a portion of the perimeter can be seen at the top of the photograph. The arrows point to cross sections of the grid, as seen within the plate sections. The origination magnification was 3.2X.

This random sectioning usually resulted in sections where the smaller, staggered grids were seen in cross section, surrounded by the active material that made up the greater portion of the plate and cross section (Fig. 2). In the common starting, lighting, and ignition type battery the above preparation of a single cylindrical sample may present 20 to 30 individual grid cross sections for examination.

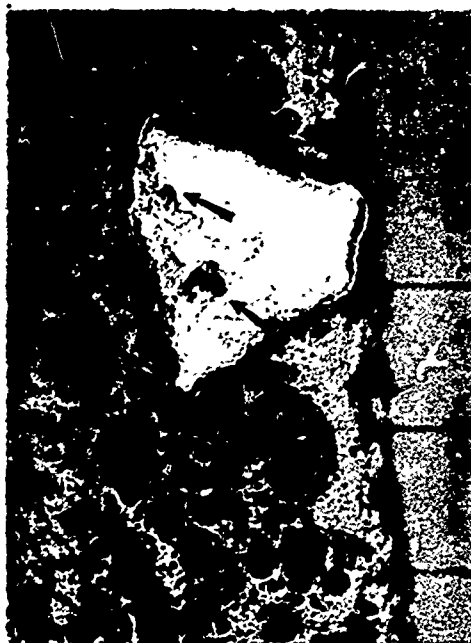
Fig. 3 - Magnified area of a grid section, similar to those seen in Fig. 2. The arrows point to dark, sunken areas in the grid that indicate porous areas. The original magnification was 45X. The superimposed line spacing represents 528 microns between lines.

Figure 3 illustrates the appearance of a grid cross section at the low magnification (45X) used in scanning for porosity. The bright portion is the grid, as seen when sectioned. The dark areas indicated by the arrows are locations of rather extensive porosity. The black area is not caused by a hole of equal size but is the result of a slightly concave surface at that point and of the effect that this produces on reflection from the surface. The slightly concave surface results when a fairly extensive area of micro-porosity occurs and is probably the result of the metal being removed somewhat faster during polishing in this area which is deficient in the harder antimony particles.
