TECHNICAL REPORT  
69-49-CE

A STUDY OF FORCES CAUSED BY HEAD IMPACT ON  
AIRCREW PERSONNEL ARMOR UNDER SIMULATED  
CRASH CONDITIONS

Dynamic Science  
A Division of Marshall Industries  
Phoenix, Arizona

November 1968

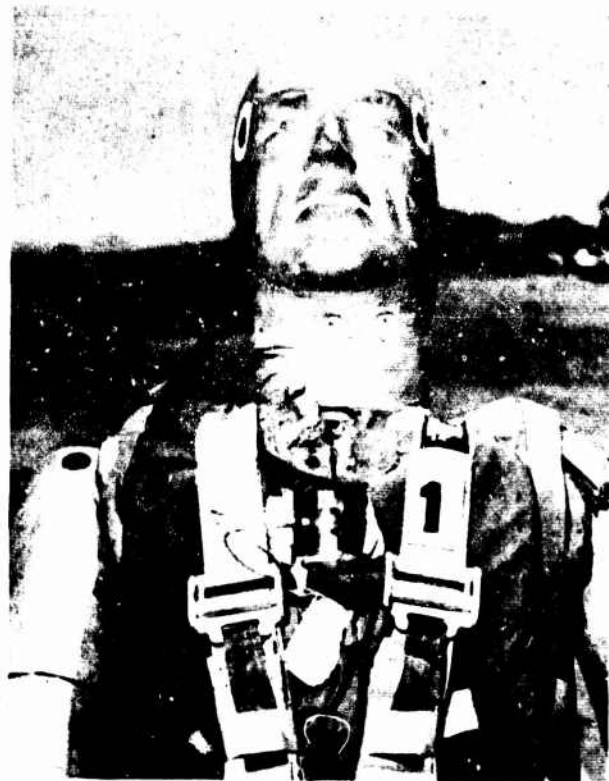
Figure 19. Dummy Fitted With Standard Aircrew Protective Armor for Tests 1 Through 4.

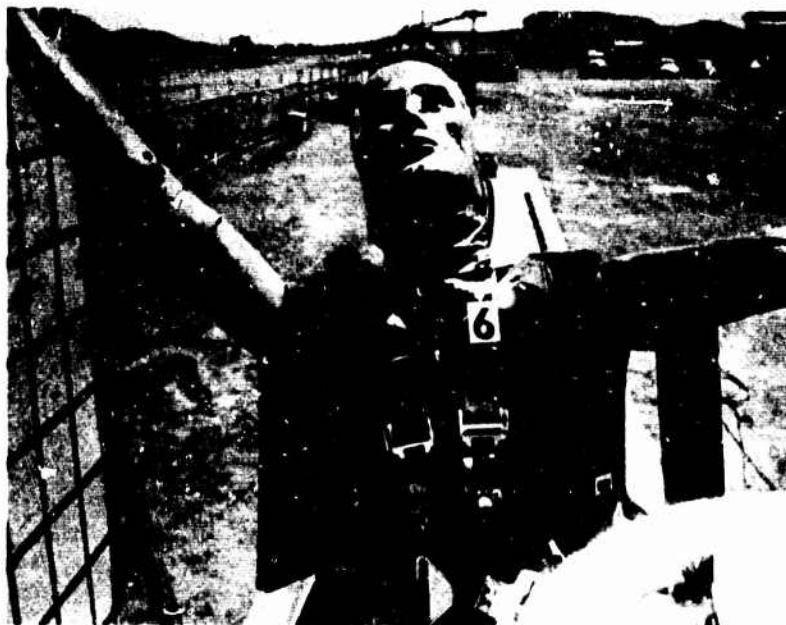
Figure 24. Posttest View - Test 6.  
(Black mark on chin is contact point.)

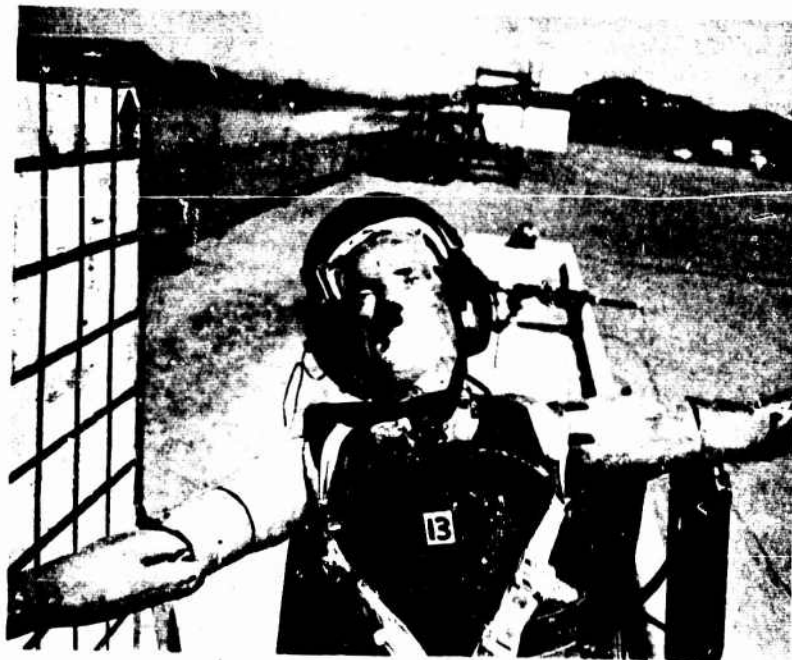
Figure 79. Posttest Front View - Test 13.

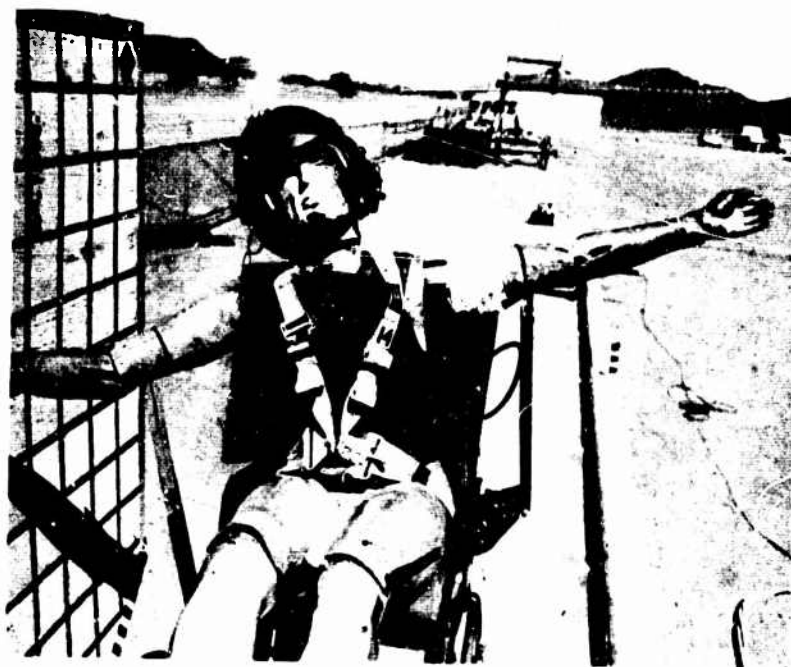
Figure 80. Posttest Front View - Test 14.
