Technical Note N-1018

SITE SURVEY OF THE SOUTHERN PORTION OF THE SAN JUAN SEAMOUNT

NAVAL CIVIL ENGINEERING LABORATORY  
Port Hueneme, California 93041

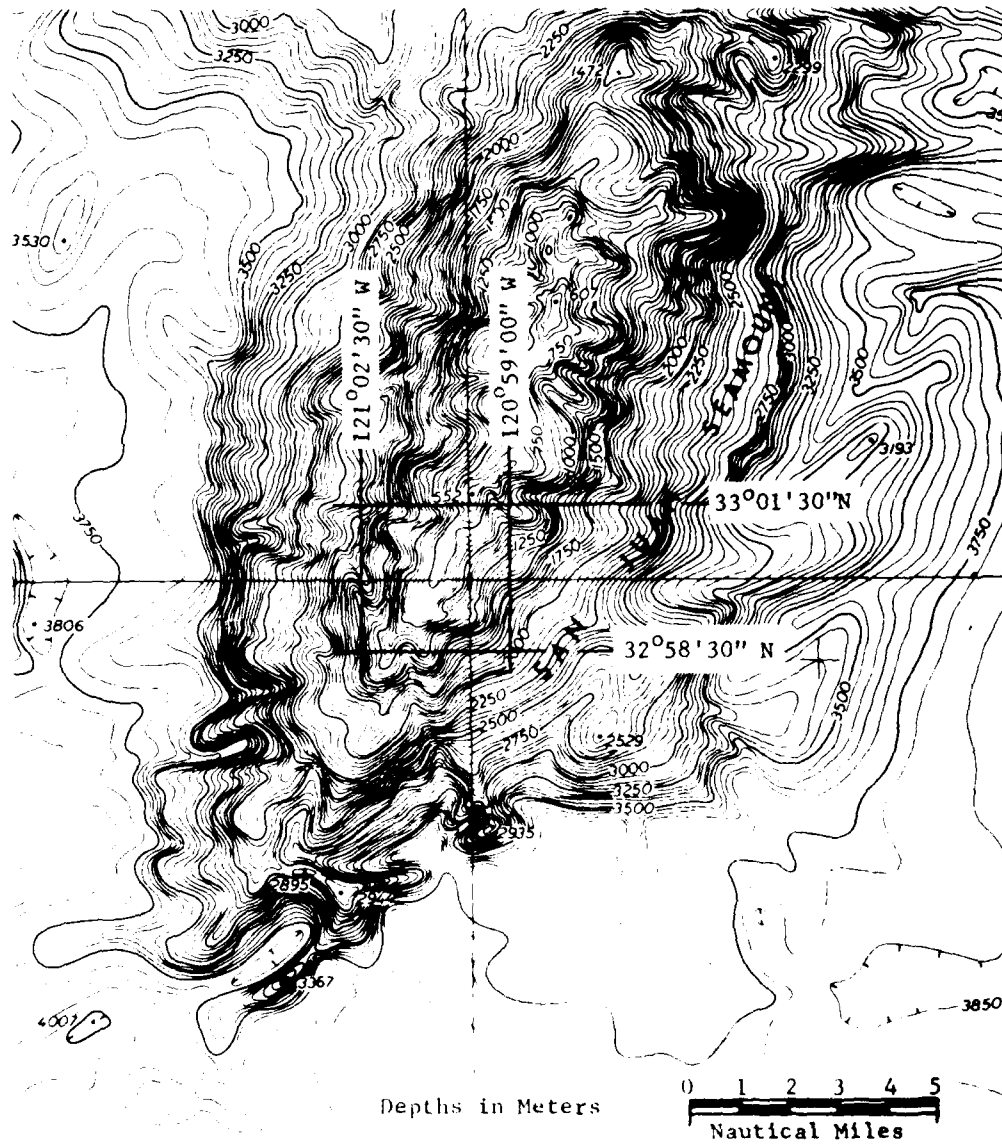
Figure 1 shows the location of the San Juan Seamount relative to the Southern California Coast. It is situated approximately 25-30 miles west of the generally accepted shelf break, on the continental slope. Figure 2 is taken from a currently used chart (C&GS 1306N19) compiled by the Coast and Geodetic Survey, from data taken prior to 1937.<sup>1</sup> This chart shows the general SW-NE trend of the Seamount topography and the relatively steep slopes. The area covered by the NCEL Site Survey is outlined in Figure 2.

San Juan Seamount from Coast and Geodetic Survey

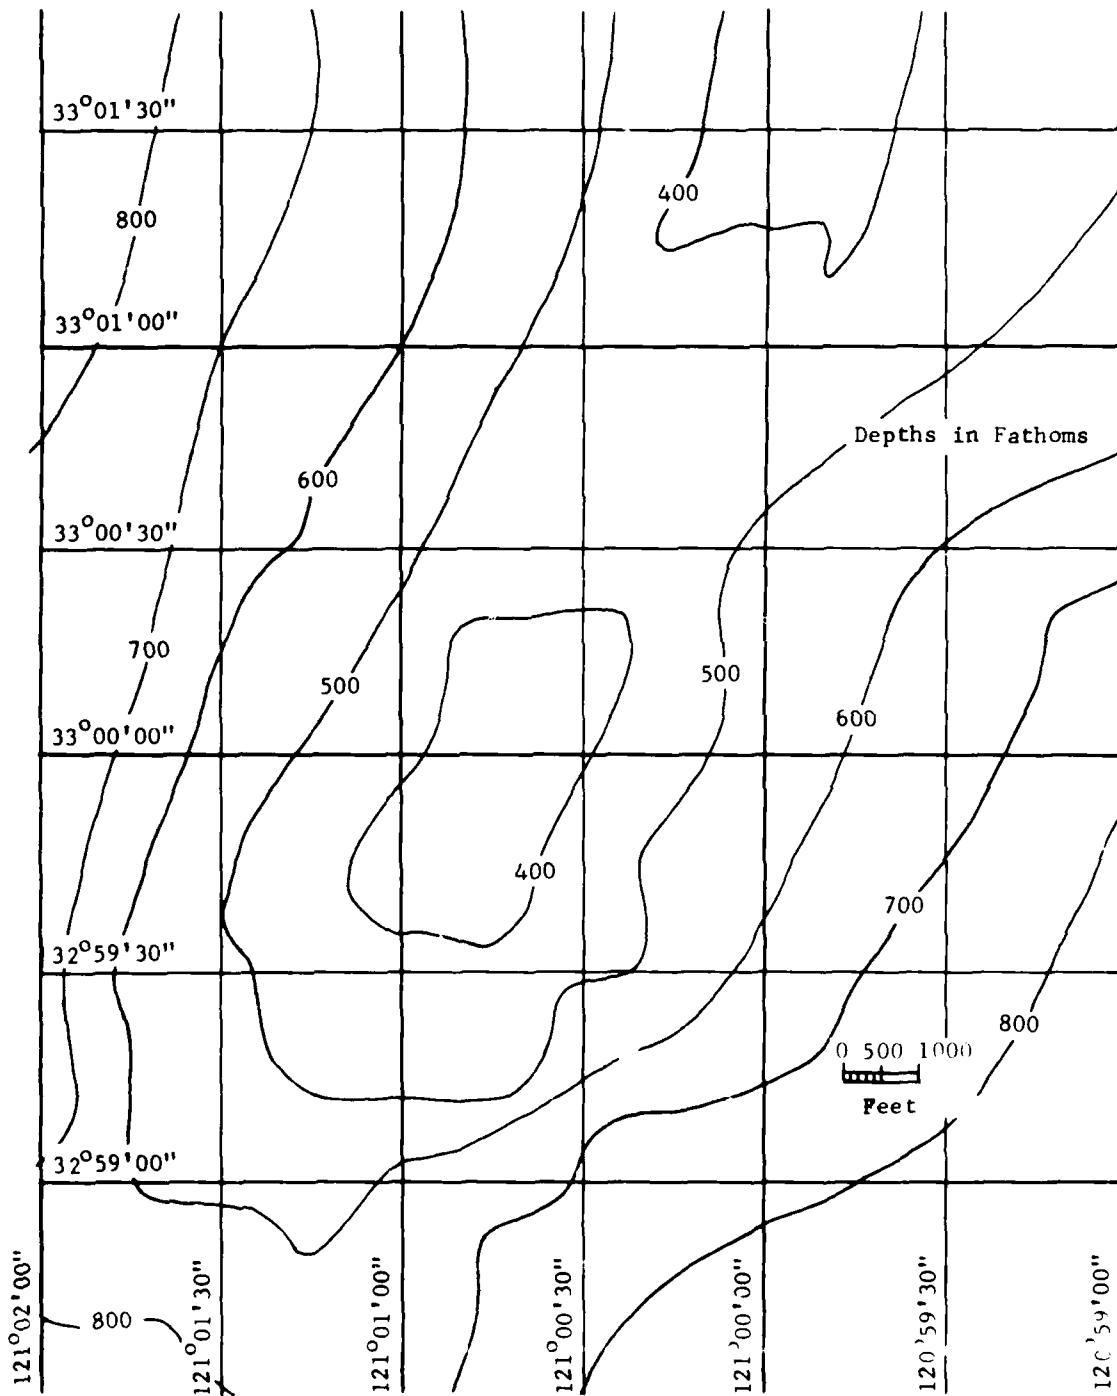
Until only recently, most of the work at the San Juan Seamount had been done by Emery and Shepard. Figure 3 shows the bottom contours

established by a topographic survey conducted aboard the vessel E. W. SCRIPPS by these men.<sup>2</sup> The San Juan Seamount was found to be a ridge containing a series of sharp summits. Small samples of material laboriously dredged from the southeast side of the seamount were described as basaltic rock.

San Juan Seamount, Southern Portion, from Shepard and Emery

The Shepard and Emery chart checks very well at the crest, but the notable peak at 33°00'30"N, 121°00'45"W was not portrayed. The lower contours on this 1941 chart appear directly to the east (occasionally as much as 2,000 feet east) of those on the new chart. However, the general shape of the seamount as presented in the Shepard and Emery chart and in the NCEL chart agree surprisingly well.

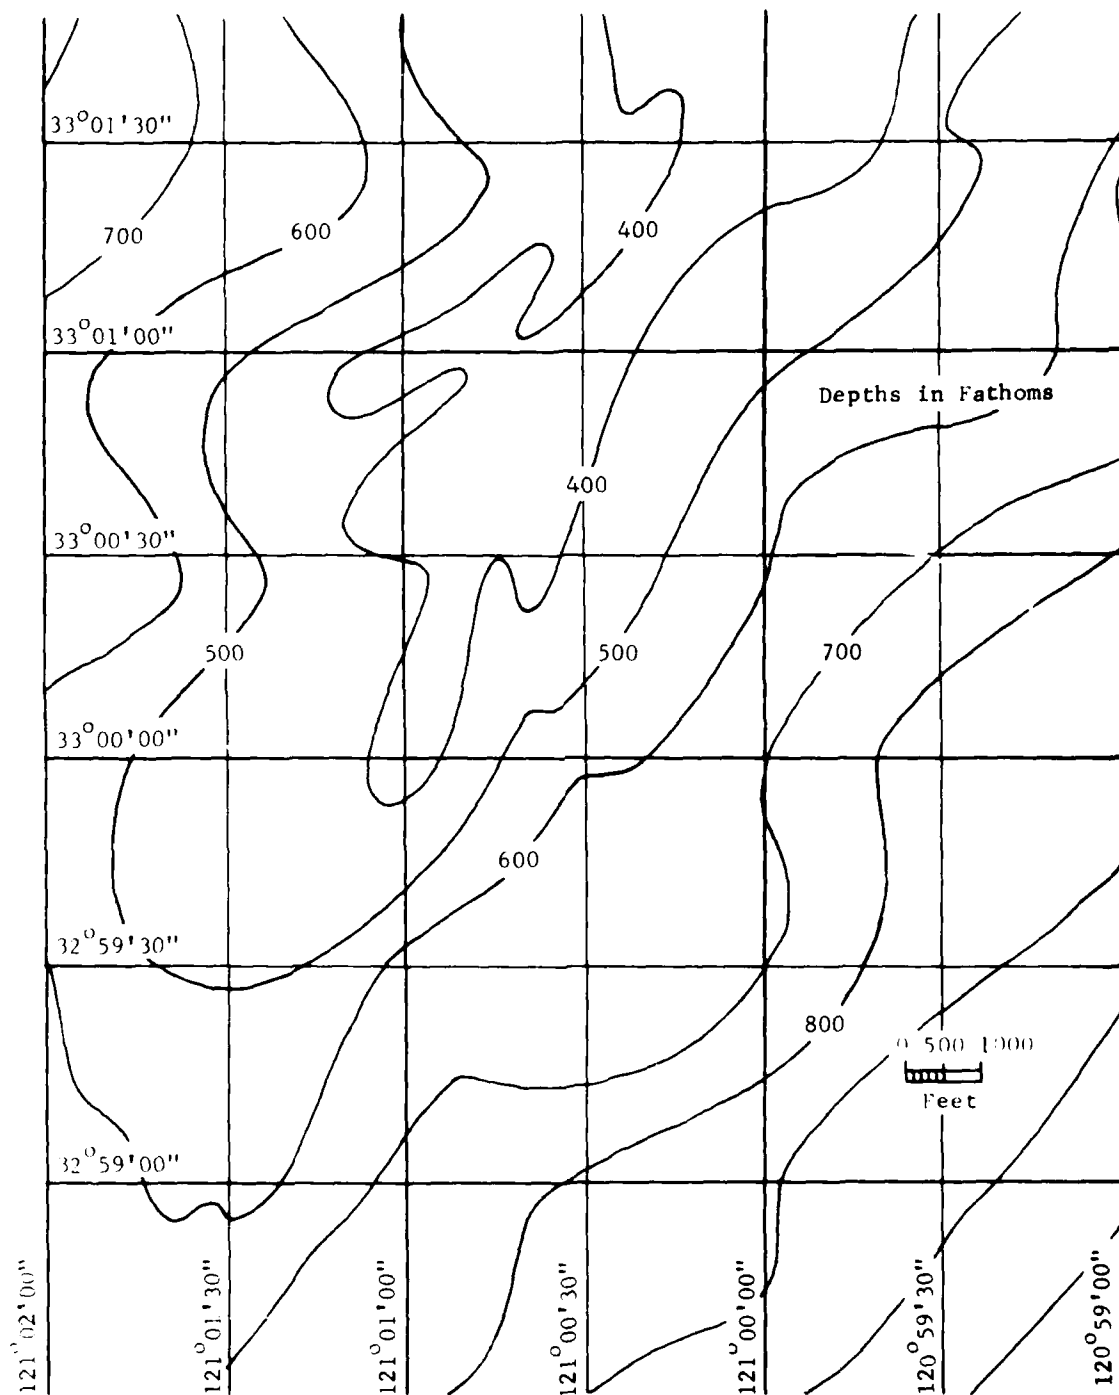
Emery in 1960 once again alluded to the volcanic appearance of the San Juan Seamount.<sup>4</sup> Additional evidence of the volcanic origins of the seamount were obtained in 1967 when the Naval Oceanographic Office conducted a bathymetric and magnetic field investigation of the southern portion of the San Juan Seamount.<sup>5</sup> Magnetic intensity measurements indicate a basaltic mass runs from the seamount eastward under the continental shelf. This NAVOCEANO investigation was a preliminary step of the planned interseamount acoustic range which prompted the work of this report. Figure 4 is taken from the report of the NAVOCEANO investigation.<sup>5</sup>

San Juan Seamount, Southern Portion, from Thomas

A comparison of the shapes of the seamount as depicted by Thomas (NAVOCEANO) and by this survey shows that they are very similar. Thomas also detected the rise that Shepard and Emery missed. However, the entire NAVOCEANO chart appears north, northwest of the new chart.

Occasionally there is as much as 3,000 feet of lateral separation between the contours of the chart by Thomas and those of the chart of this site survey.

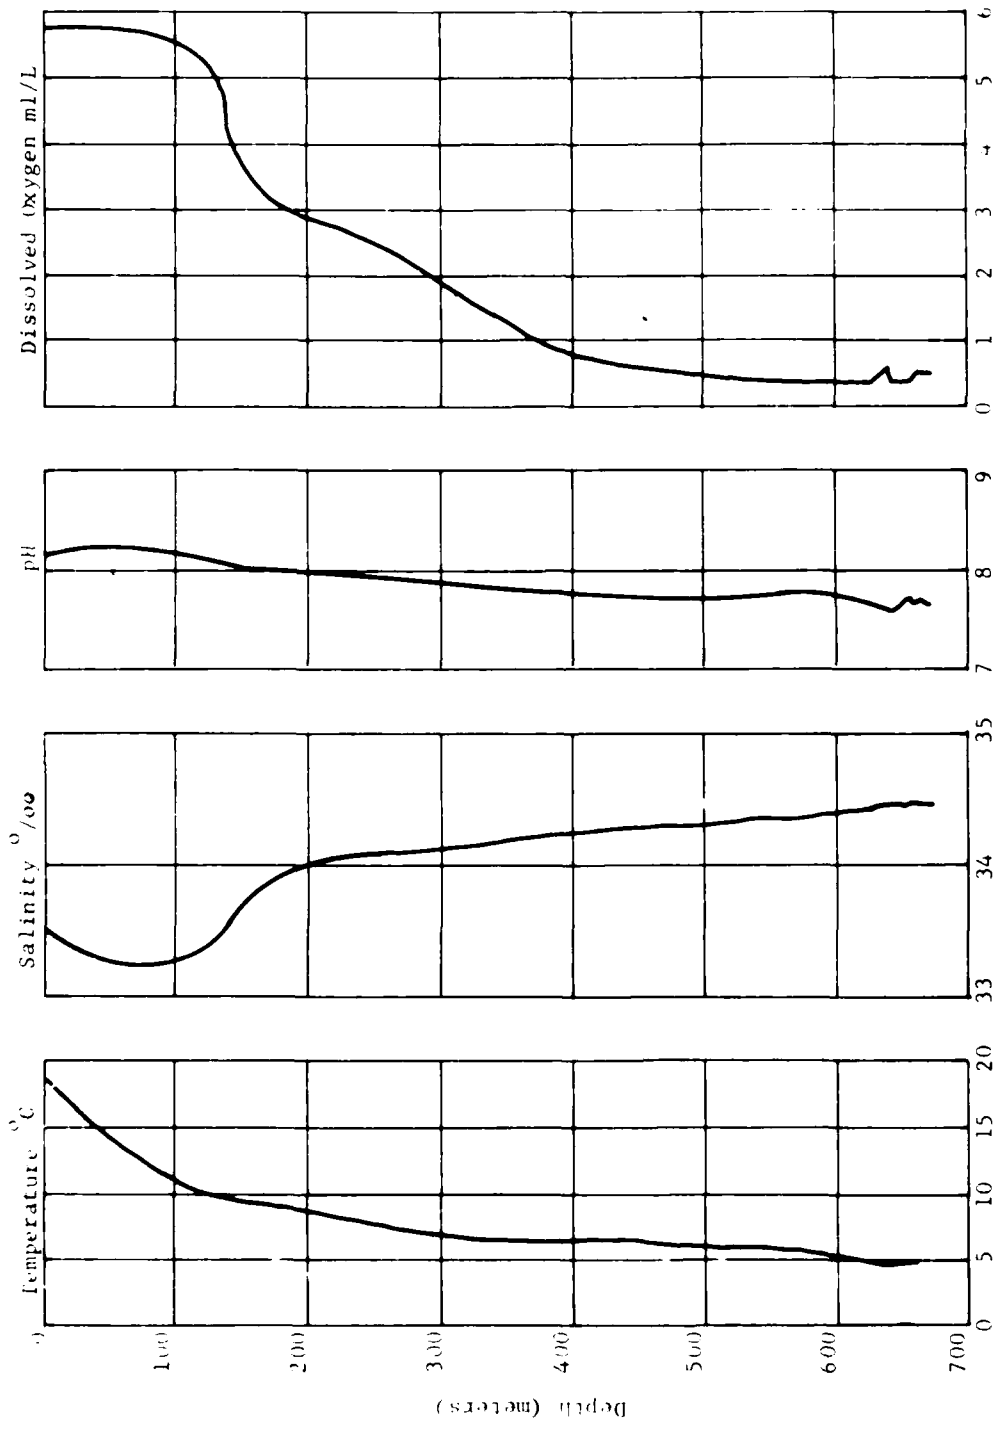
Table 1 and Figure 13 give the results of the water analysis.

Figure 13. Results of Water Sample Analysis

The low oxygen content and moderate salinity shown by the water data is an advantage with respect to the corrosion of the equipment
