# AIR FORCE MISSILE DEVELOPMENT CENTER TECHNICAL REPORT

DEVELOPMENT OF A NINE INCH DIAMETER,  
MACH 5.5, MONORAIL, ROCKET SLED

June 1969

**HOLLOMAN AIR FORCE BASE  
NEW MEXICO**

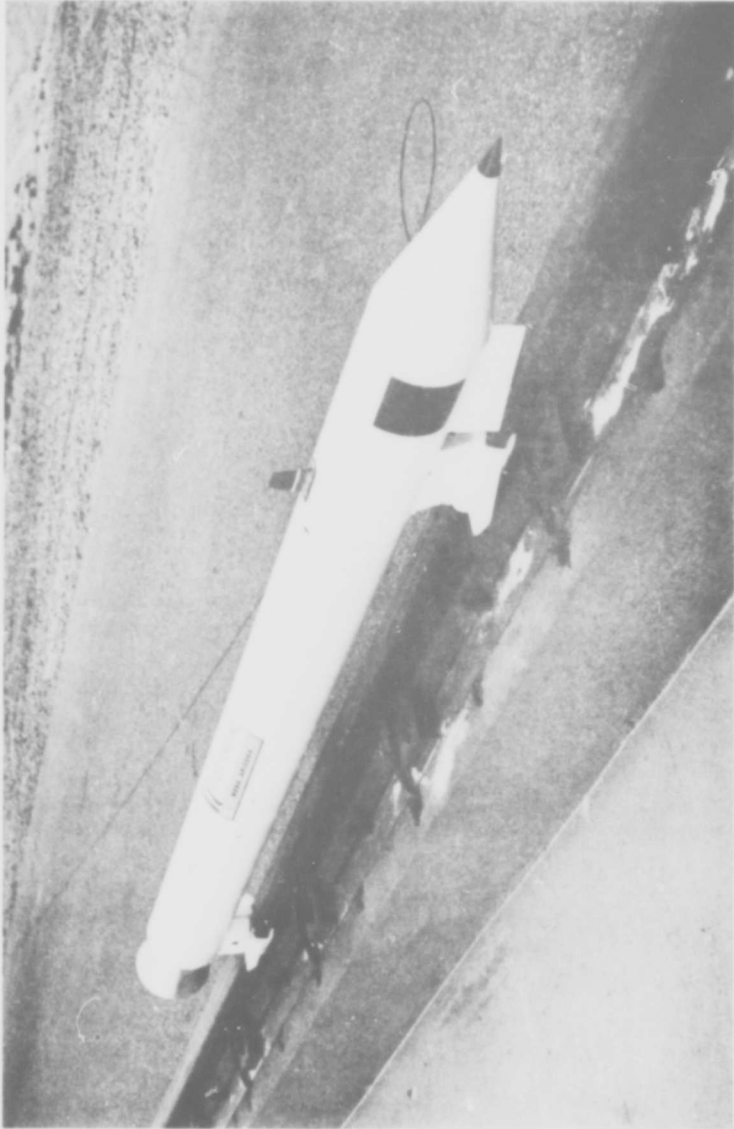
FIGURE I 49X TEST SERIES MONORAIL SLED

The vehicle used in this test series is shown in Figures 1 and 2. The following is a list of dimensions and weights.

Overall length	114.88 in
Cone half angle	14°
Cone base diameter	9.0 in
Centerline Height above rail	7.65 in
Distance between leading edge of forward and aft slipper	100.74 in

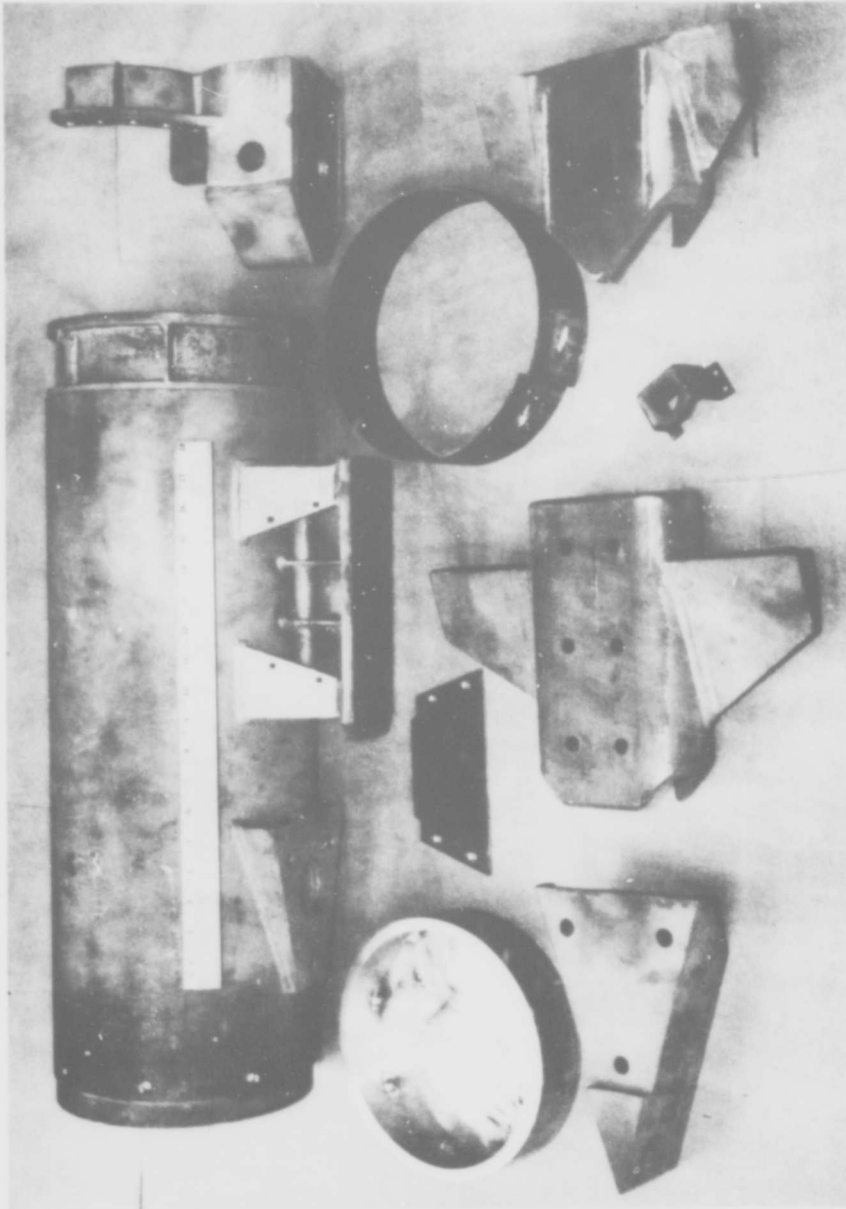
FIGURE 2 49 X SERIES MONORAIL SLED COMPONENTS

The sled design was to be of a modular construction consisting of a forward wedge, slippers, nose cone and body. A solid fuel rocket motor was to be used as a part of the operational sled structure.

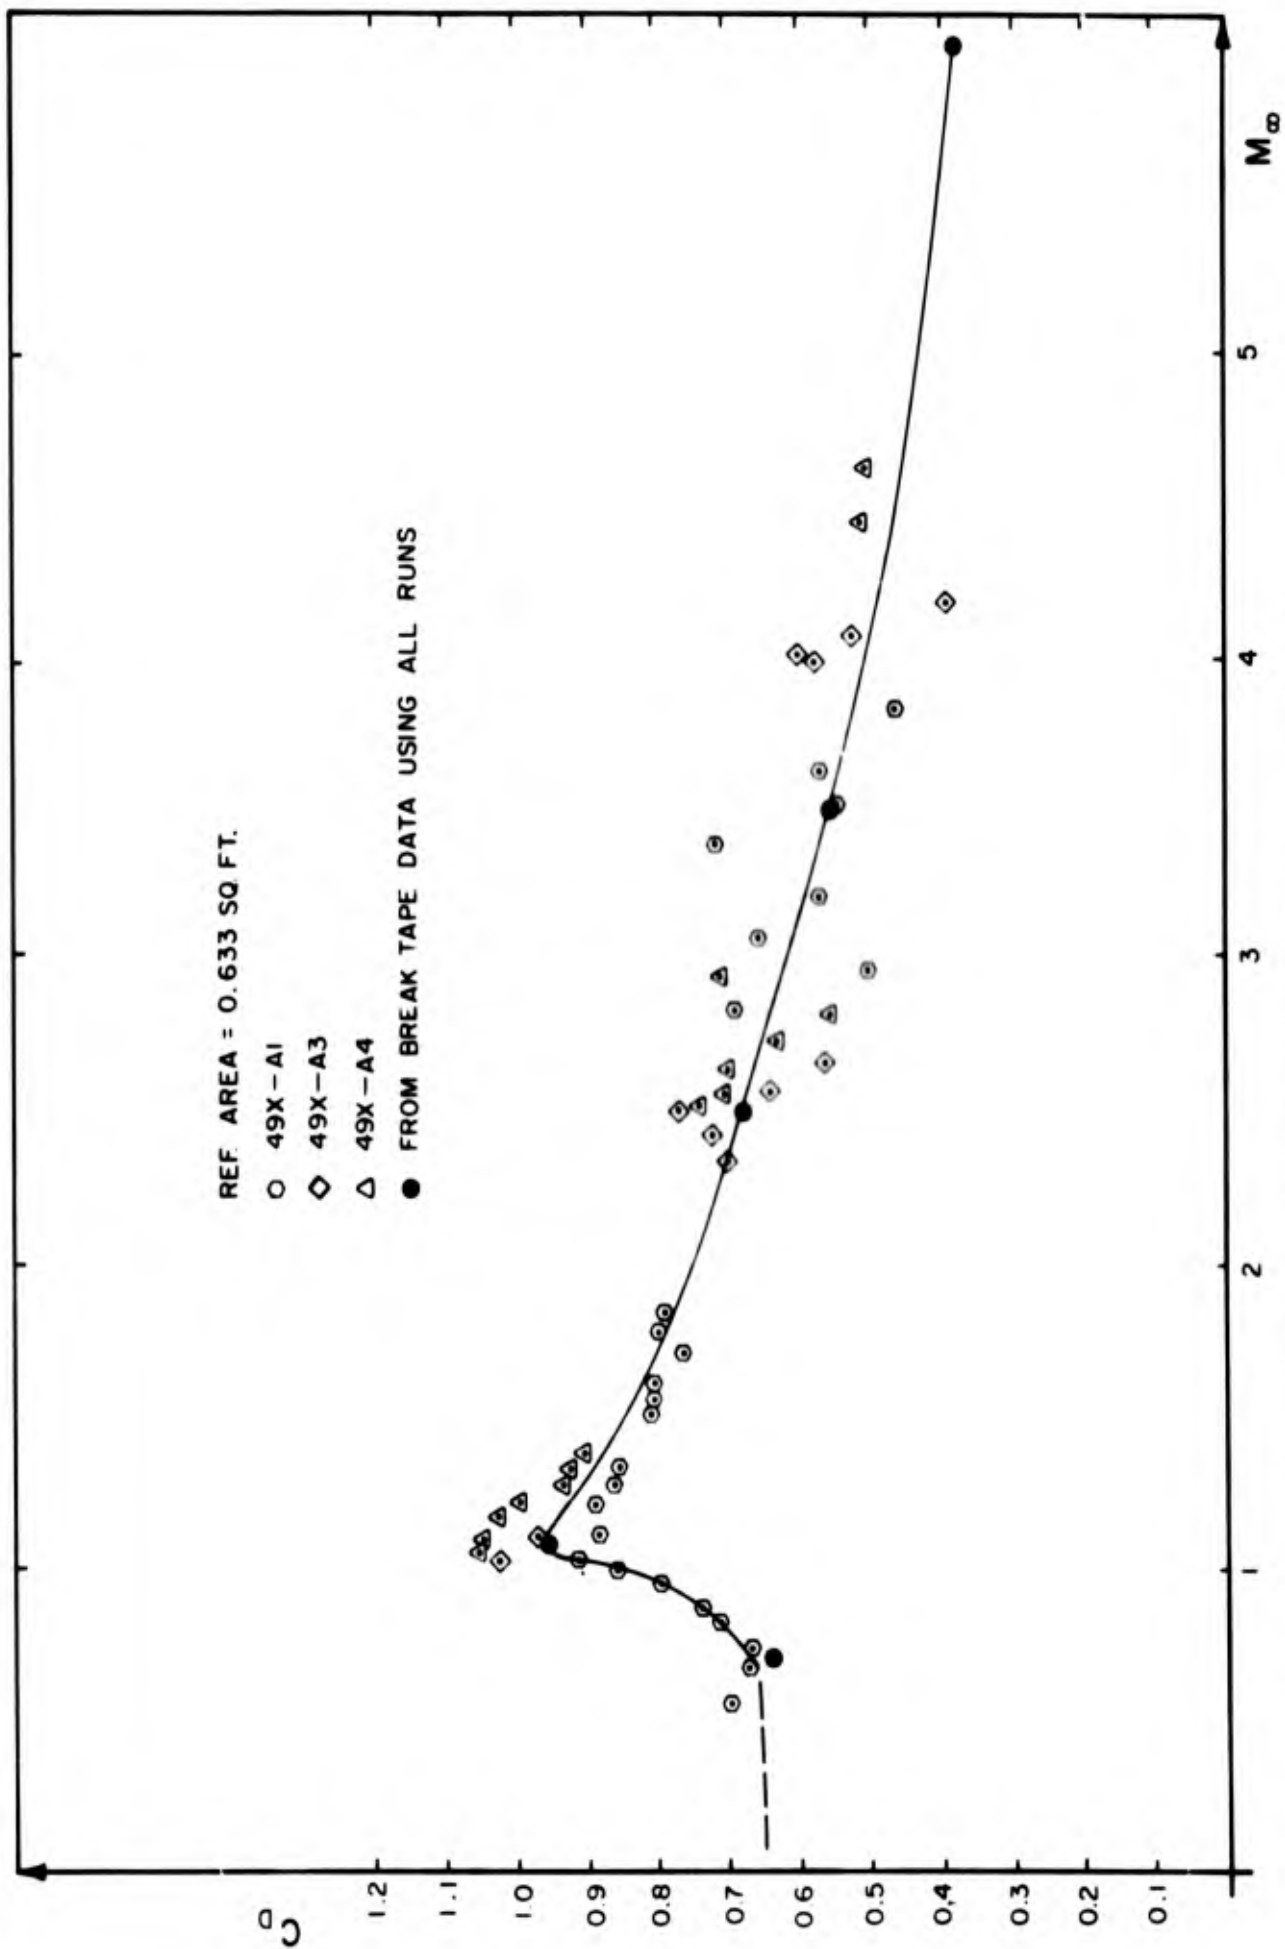
FIGURE 3 DRAG COEFFICIENT AS A FUNCTION OF MACH NUMBER

Figure 3 presents the drag coefficient as a function of Mach number. The data are the result of the evaluation of time and distance information obtained by two different techniques. One technique is the use of an electro-optical (ribbon frame camera) system for space-time measurements. These measurements were then reduced to velocity, time and distance by a contractor (Computing and Software Incorporated), and returned to the Track organization for analysis and evaluation. Data obtained are then analyzed to give drag coefficients by averaging the time and distances over velocity increments in the order of approximately 200 feet per second. Another technique was the use of spot velocity information. Spot velocity information gives the time history of the sled run at fixed track station locations. The average velocity between two track stations not more than 200 feet apart, is calculated. This velocity and distance profile was compared with the computer estimate, which is based on assumed drag coefficients. The drag coefficients are reevaluated until the computed and actual velocity and distance profiles match.

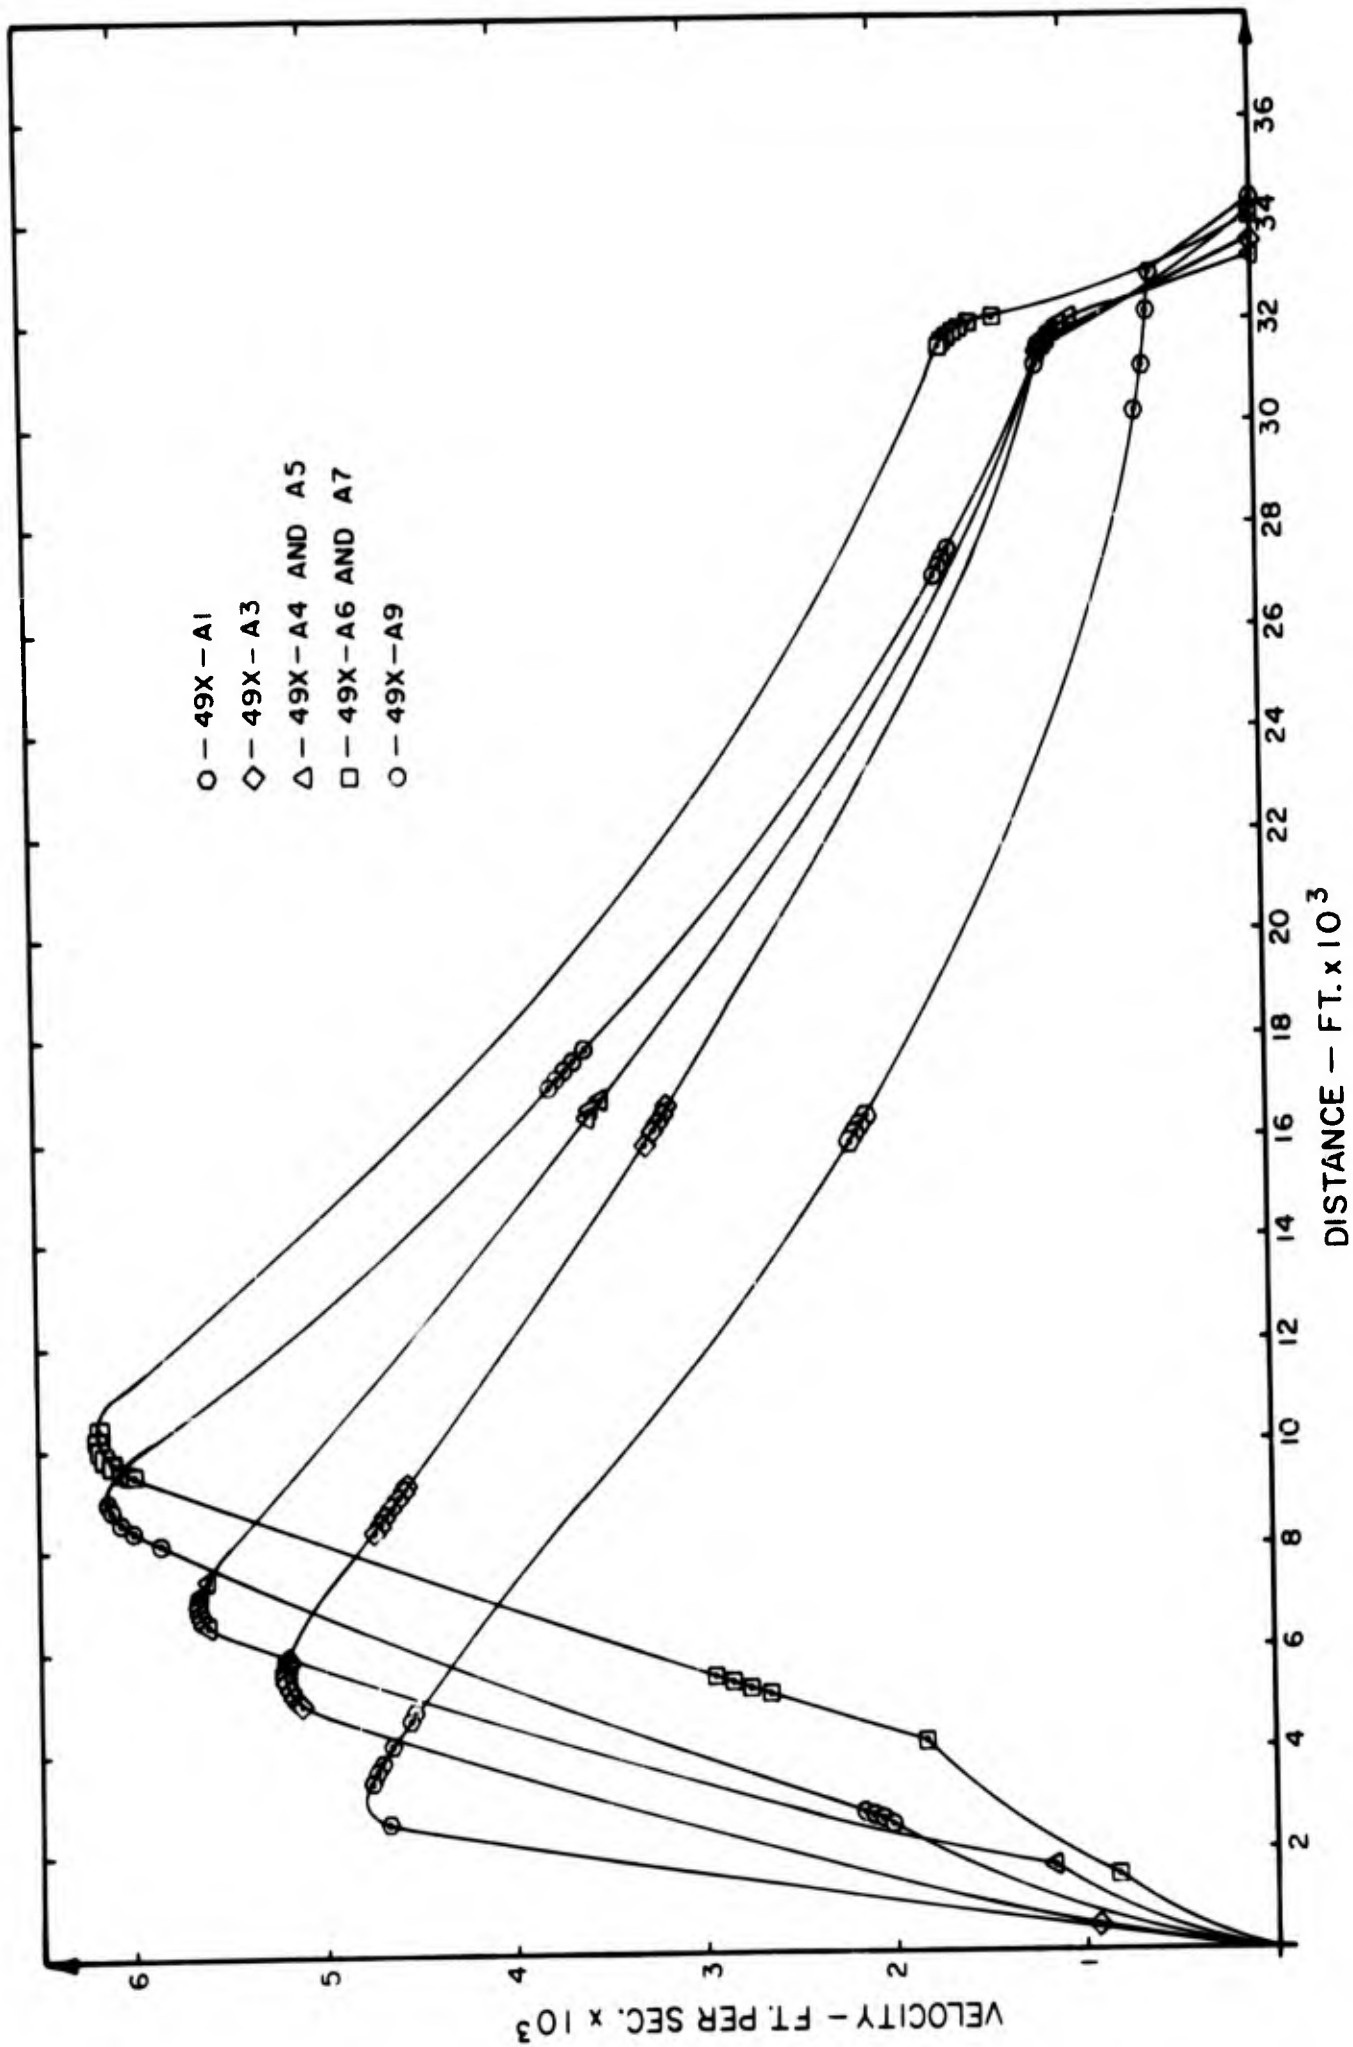
FIGURE 4 SLED VELOCITY AS A FUNCTION OF TRACK DISTANCE

Figure 4 presents the actual velocity and distance profiles obtained by spot velocity measurements on the runs of this test series. The final stage geometry was identical on all runs except for the addition of a small antenna as noted in the discussion of the results of individual runs.

The maximum velocity was approximately 100 feet per second lower than predicted. There are indications that the wet rail and fog reduced the velocity. Examination of Figure 4 shows that on run 49X-A6D and 49X-A7D with a lower staging velocity (approximately 200 feet per second less) the same maximum velocity was obtained as on this run. The final stage sled configuration and weight was identical on run 49X-A6D and this run. Figure 4 also shows that the coast trajectories on runs 49X-A6D and this run diverge. Since the final stage sleds are identical the lower maximum velocity and divergence of the coast profile are attributed to a drag increase due to the fog and/or water on the rail.

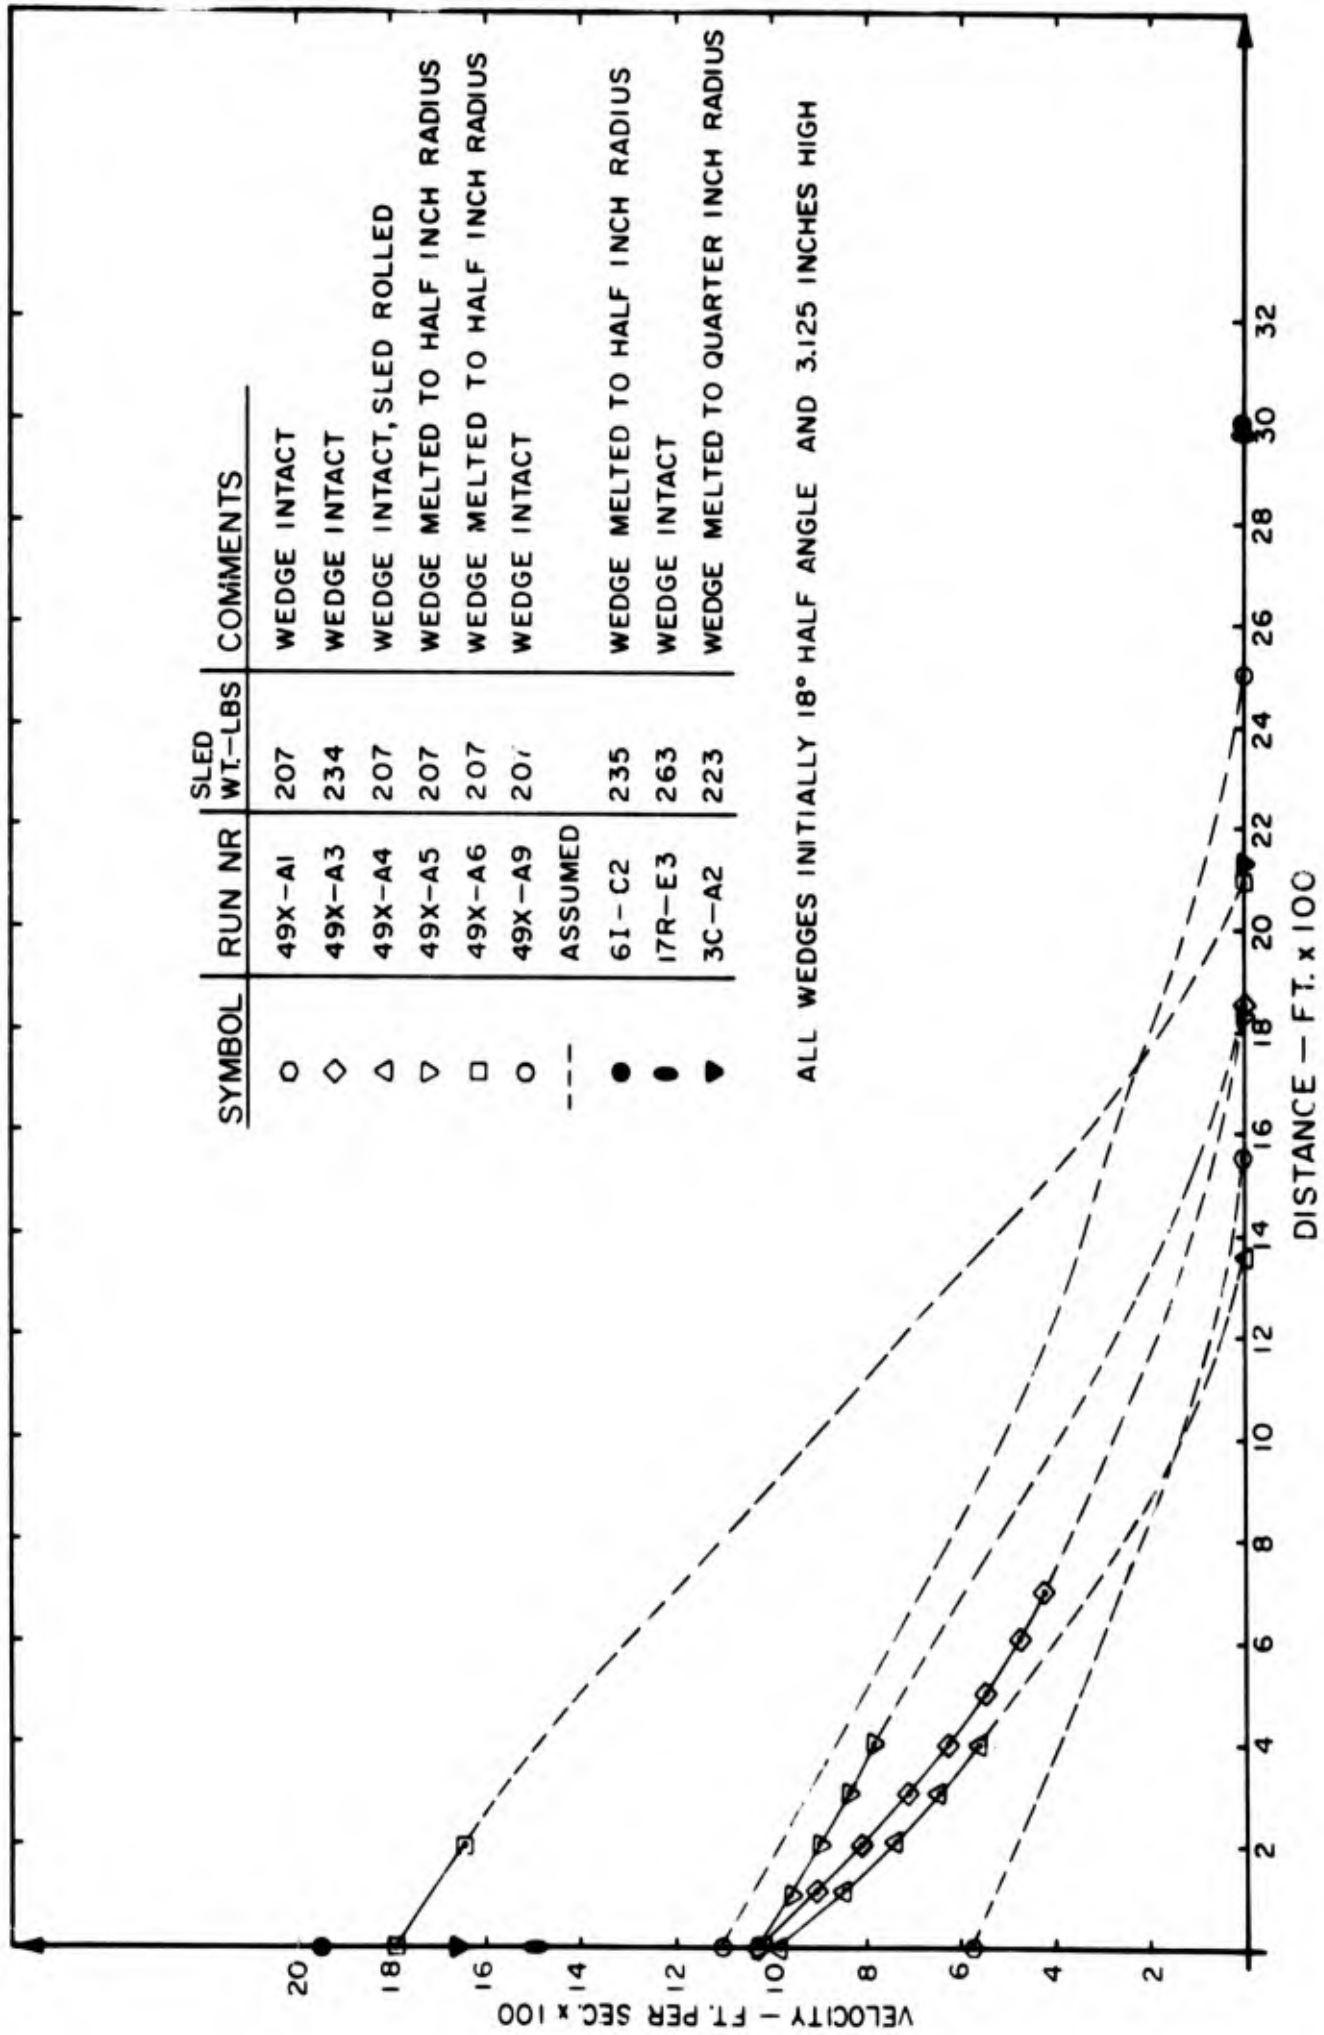
FIGURE 5 WATER BRAKING VELOCITY AS A FUNCTION OF TRACK DISTANCE

Figure 5 presents expanded data on the water braking phase of the run. Data from other test series have been added to show that this type of sled can be stopped from high velocities with variable payload weights. Table 1 presents the amounts of water filled polystyrene foam trays and polyethylene bags used for these braking profiles.

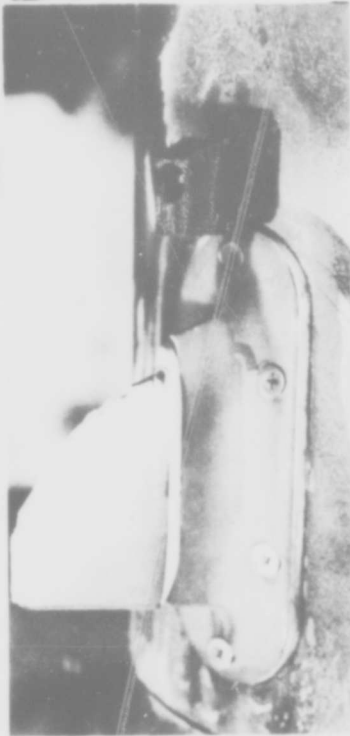
FIGURE 6 POST - RUN CONDITION OF ANTENNAS

b. The antenna showed erosive oxidation in the area of the leading edge of the teflon ring. (See Figure 6)

Except for the installation of new Cobaltec 10091 coated wedge and slippers the modular sled components were similar to those used on sled run 49X-A1. In addition to evaluating sled components at a higher velocity, a second type of antenna (Dome and Margolin Inc., AT-741/A) was mounted on top the sled body (See Figure 6).

a. Approximately 10% of the leading edge of the antenna was eroded and charred from heat generated during the sled run.

d. The antenna atop the sled was eroded by approximately 25%. The phenolic block 1 1/2 inches in height that was installed in front of the antenna base experienced approximately 10% erosion on its leading edge. However, it did prevent erosion of the metallic antenna base structure. (See Figure 6)

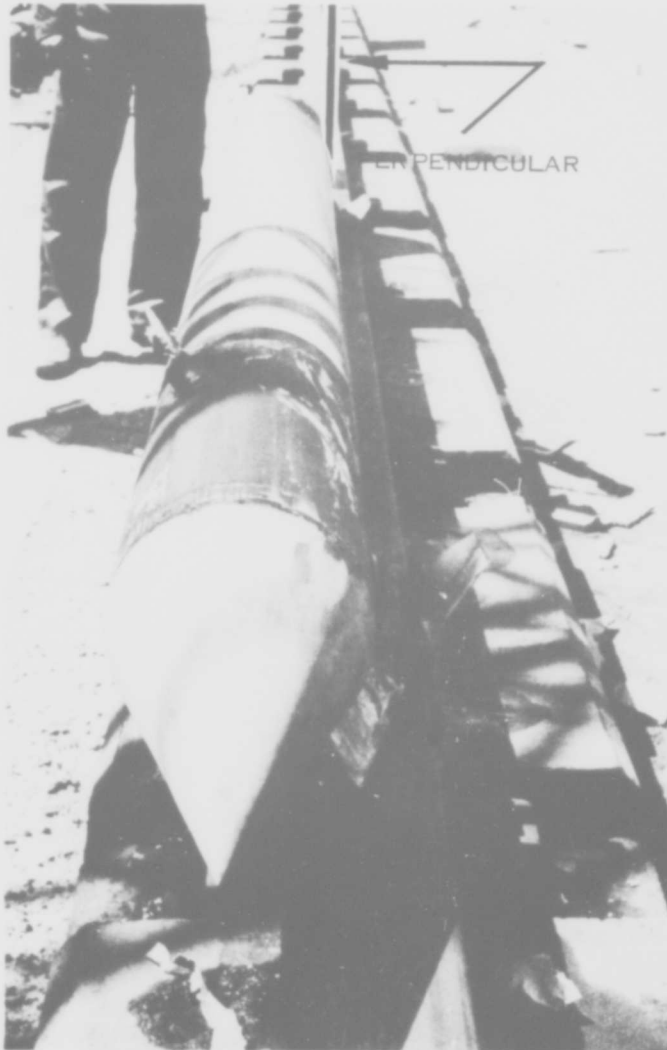
FIGURE 9 POST-RUN VIEW OF SLED IN ROLLED POSITION ON RUN 49 X - A 4

a. The sled stopped in a severely rolled condition as shown in Figure 9. It is likely that the misalignment produced or at least contributed to the roll. A hardness test of the slippers disclosed that due to an oversight they had not been heat treated to the prescribed 120,000 psi design condition.

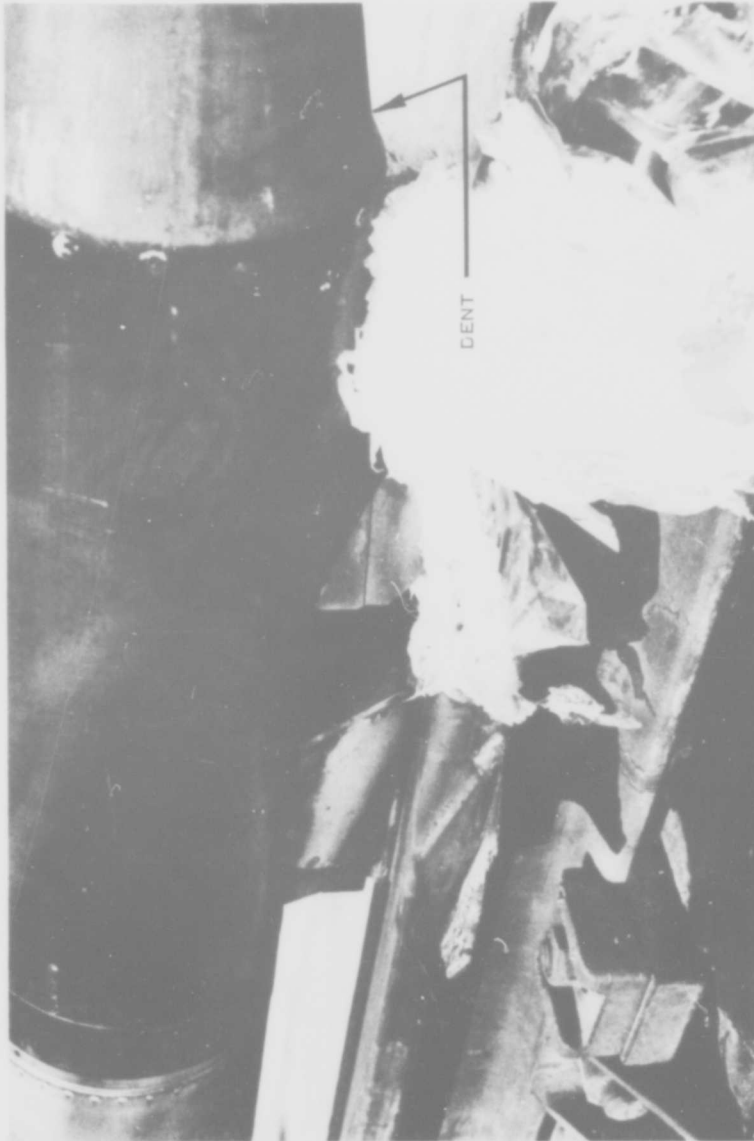
FIGURE 10 POLYETHYLENE WATER BAG MATERIAL BUILD UP ON RUN 49 X - A 6

c. Severe compaction of polyethylene bags was found between the slippers and the rail and in front of the wedge which may have enhanced the severe roll condition after entering the water brake. The buildup of polyethylene bags was typical on all runs on which they were used. (See Figure 10).

e. The polyethelene water bag buildup caused a dent in the cone. (Figure 10) An overall assessment of wedge, slipper and canard erosion damages indicate that flame sprayed Cobaltec 10091 used as a heat shield offers reasonably good protection up to sled velocities of 5,800 ft/sec.

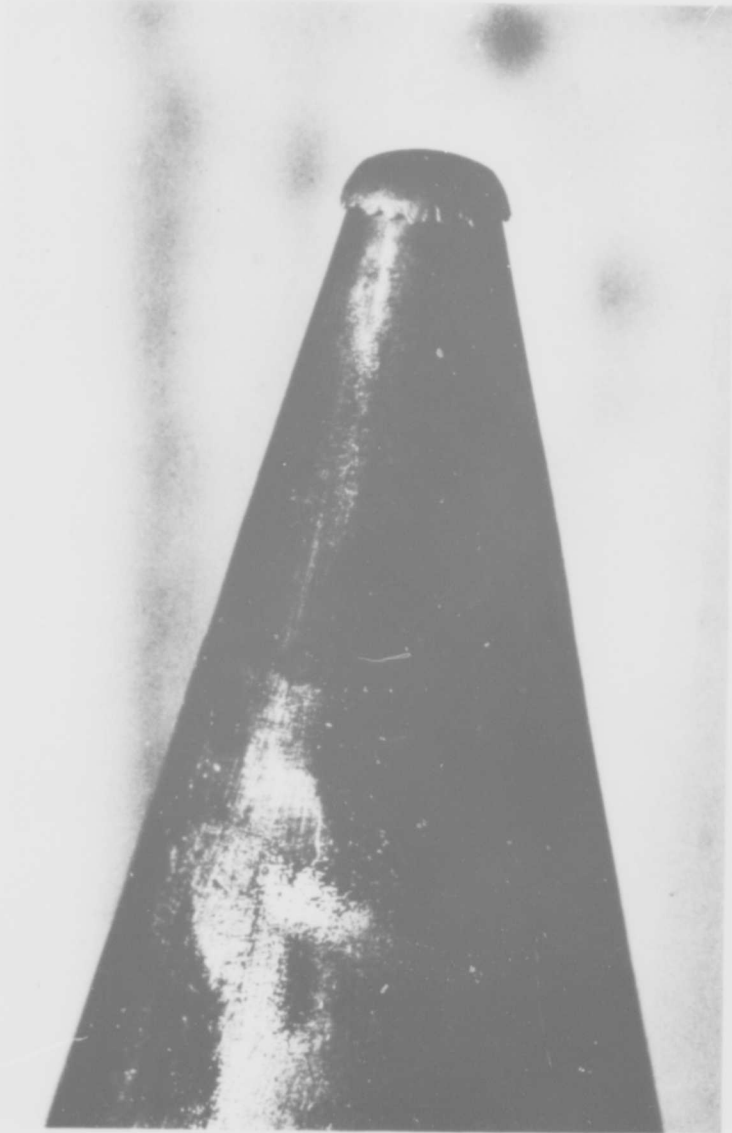
FIGURE II CLOSE UP OF MELTED CONICAL NOSE TIP

- a. The forward slipper attachment bolts had not loosened.
- b. Moderate to severe erosion to the wedge tip and canards was observed and only moderate erosion damage to the slippers occurred. There was negligible roll of the sled as indicated by the evenness of wear to the inside surfaces of the slipper.
- c. The nose cone tip was melted back approximately 1/2 an inch. (See Figure 11).

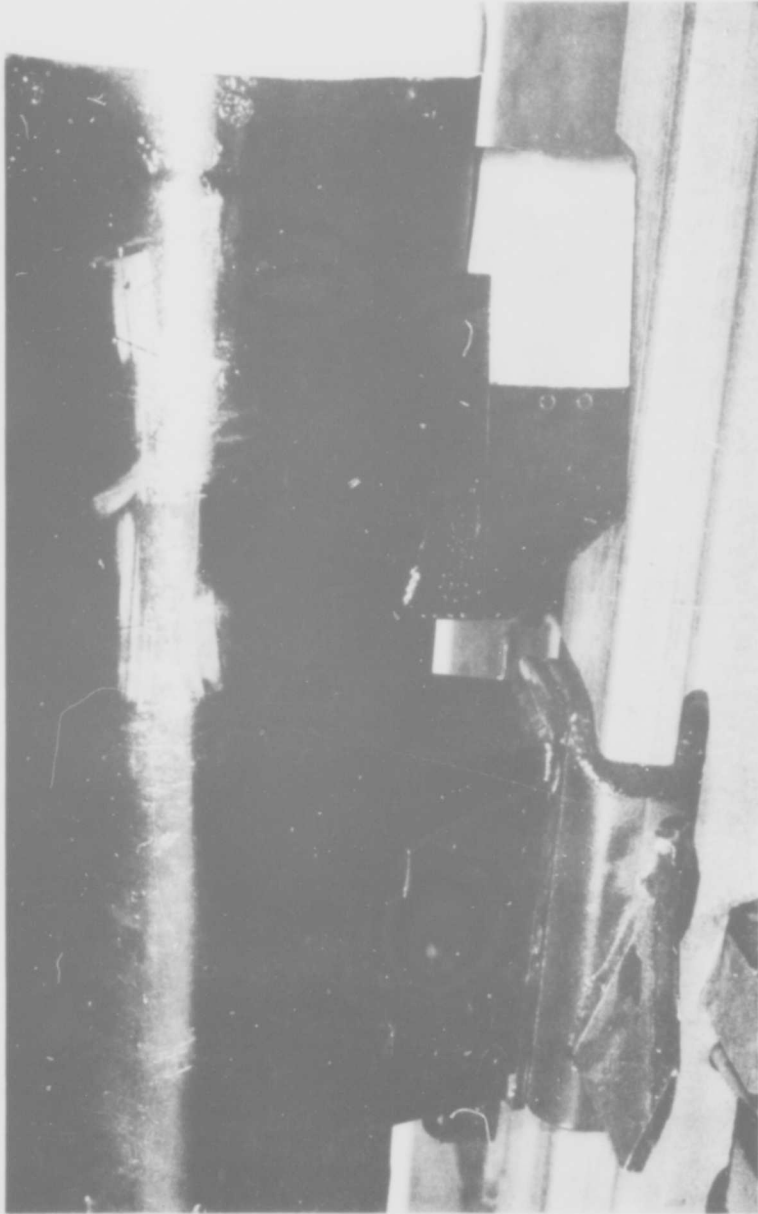
FIGURE 12 COPPER WEDGE ATTACHMENT

The sled structure for this test was the same as for the previous tests with the exception of the forward wedge section and slippers. The forward section of the wedge, which previously was steel, coated with Cobaltec 10091, was replaced by a solid piece of copper. (See Figure 12) The leading edge of the copper was rounded to a half inch radius as opposed to the 1/8" radius on the steel wedge. The copper block was intended to act as a heat sink. A method for calculating the temperature distribution in a two dimensional wedge, with time varying boundary condition, by the method of finite differences was developed by the Track Engineering Division (MDTE) and programmed by Computation Division (MDRC) at Holloman AFB. These calculations showed that the copper would conduct the heat off the wedge surface and keep the surface temperature of the copper below its melting point up to approximately Mach 6.0.

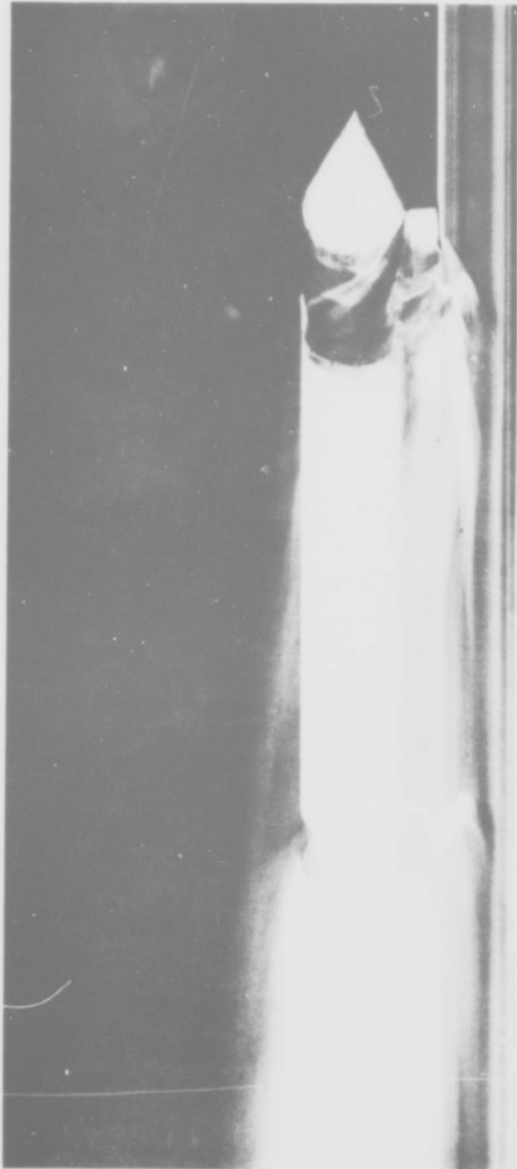
FIGURE 13 IMAGE MOTION PHOTOGRAPH OF SLED WITH COPPER WEDGE AT  
6100 FEET PER SECOND

The sled left the rail in the vicinity of track station 20,000. The cause of the failure is not known. A review of 16mm high speed camera film showed that the sled was rolling to the east prior to leaving the rail. Film data also disclosed that the entire wedge was intact and in the proper position with the sled body during peak velocity (See Figure 13) and just prior to leaving the rail.

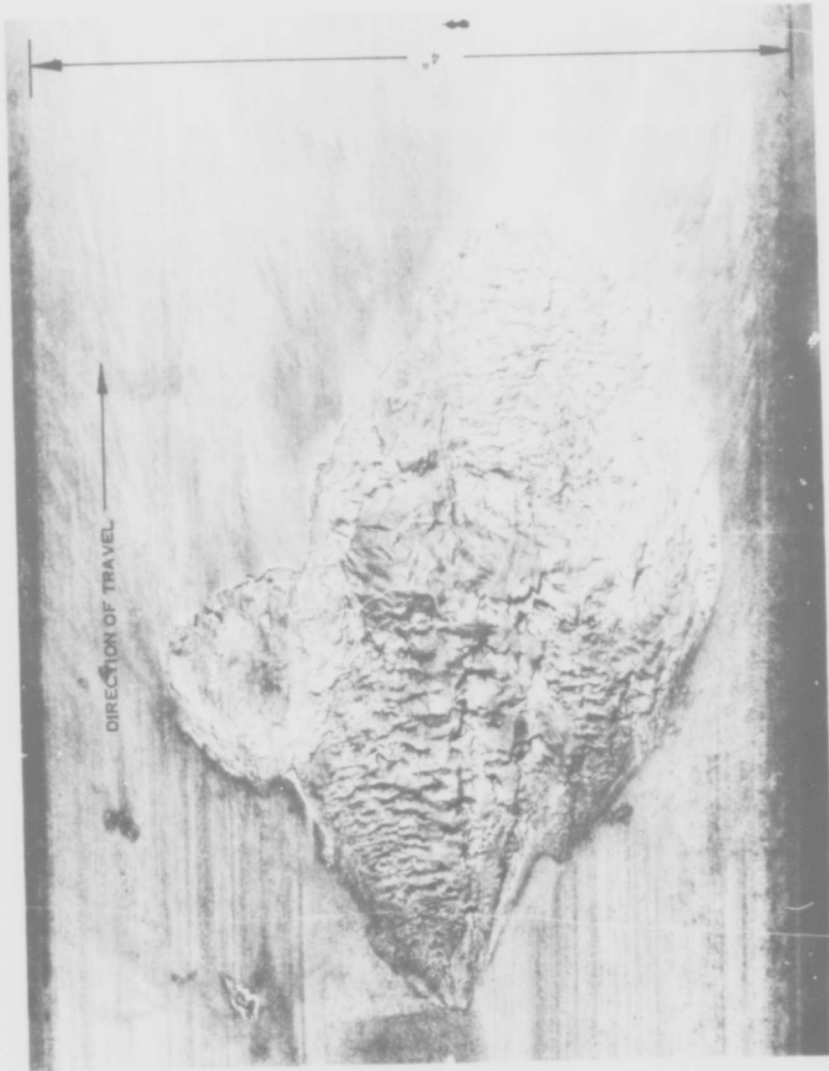
FIGURE 14 GOUGE ON TOP SURFACE OF RAIL

c. An inspection of the track rail after the run revealed a large gouge in the top of the rail at track station 9050 (See Figure 14). Small deposits of copper were found in the gouge. No other gouges were observed. Image motion camera coverage of the sled at T.S. 10,400 showed a small deformation (about 1/2 inch in length and 1/8 inch high) on the lower part of the wedge at the copper wedge and track interface. (See Figure 13) It is assumed that a breakwire stretched across the rail used for timing or camera starting was the cause of the loss of copper. The use of wire stretched across the track was discontinued on all future runs of this series. The laboratory data reported by Ohio State University in reference 5 indicates that copper has very unfavorable gouging characteristics. No direct relationship between the gouge and the run failure could be established. All indications are that the expected heat sink effect of the copper wedge was achieved.

A rail gouge is a fan or tear-drop shaped portion of the rail surface which is removed during a high velocity sled run. The surface material removed can be up to approximately 1/8 inch deep. This same pattern of material removal at times has been observed on the slipper sliding surfaces. The gouging does not take place until the rocket sled has reached approximately 6000 feet per second during the acceleration phase. The occurrence of gouging increases as the sled velocity increases and continues during the sled deceleration phase even after the sled has gone below 6000 feet per second. The mechanism of this type of local failure is not fully understood at this time. An investigation of the rail gouging problem was made by Ohio State University and is reported in reference 5. This investigation succeeded in producing similar gouges in the laboratory by means of high speed impacts under very shallow impact angles. No mention is made in reference 5 of the melting of the sled components and its possible ramifications. Reference 5 states that "Critical combinations of pressure and velocity create conditions which contribute to the occurrence of gouging. Under critical conditions the local surface finish appears to be the gouge-triggering parameter." There are indications that the molten particles of the sled become trapped between the slipper and rail thus causing or contributing to the gouging. As sleds approach 6000 feet per second with inadequate or no aerodynamic heat protection on the leading edges of various parts of the sled these parts begin to melt. As the sled velocity increases the melting becomes more severe with the maximum rate of material loss occurring during the deceleration phase below the maximum velocity. Several runs during which no significant melting at high velocities occurred showed only insignificant gouging of the rail. During run 49X-A9 which is discussed in this report, in the absence of severe melting, no rail gouging was observed. Also three runs conducted under another run series (15R) in which the sleds achieved velocities between 6100 and 6500 feet per second showed no gouging as long as no significant melting of sled components occurred. Coating the rail surface with lime appears to lessen the tendency for gouging. Reference 5 shows that certain other coatings tried in the laboratory reduced the gouging. Continued gouging of the rail will deteriorate sections of the rail thus necessitating costly and time consuming replacement of the damaged sections.

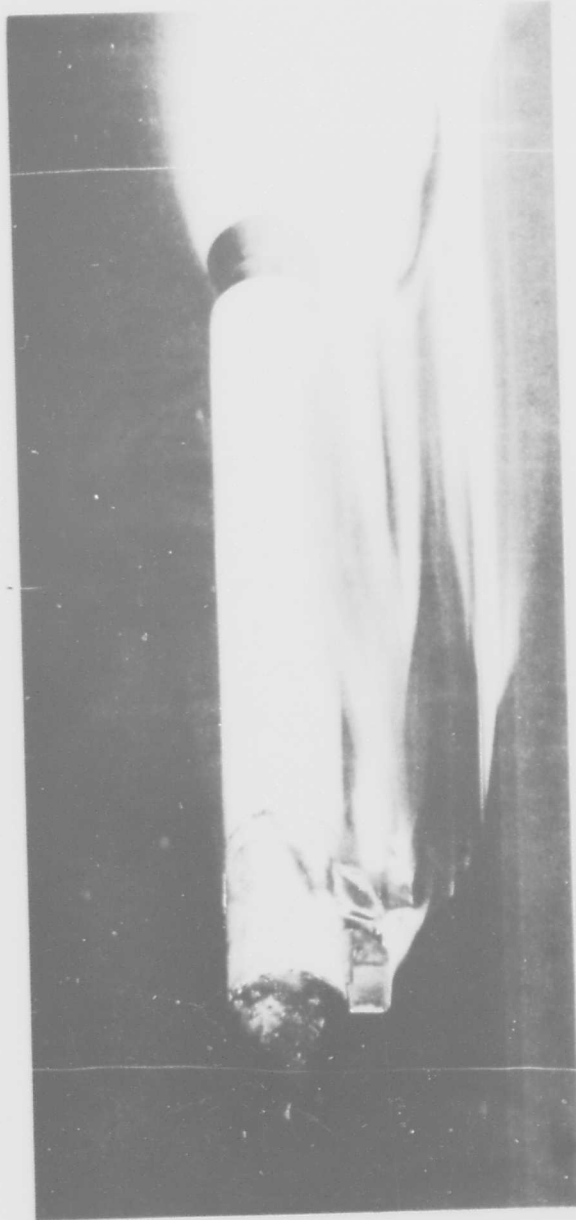
FIGURE 15 IMAGE MOTION PHOTOGRAPH OF SLED WITH TUNGTEC COATED WEDGE  
AT 6200 FEET PER SECOND

a. No wear or erosion damage to the wedge and normal wear to the slippers with slight erosive damage to the leading edge of the slippers and canards was observed. The Tungtec 10112 did not deteriorate. The sled was considered to be in excellent condition and had no indication of roll. Figure 15 shows the sled at the approximate maximum velocity of 6200 feet per second.

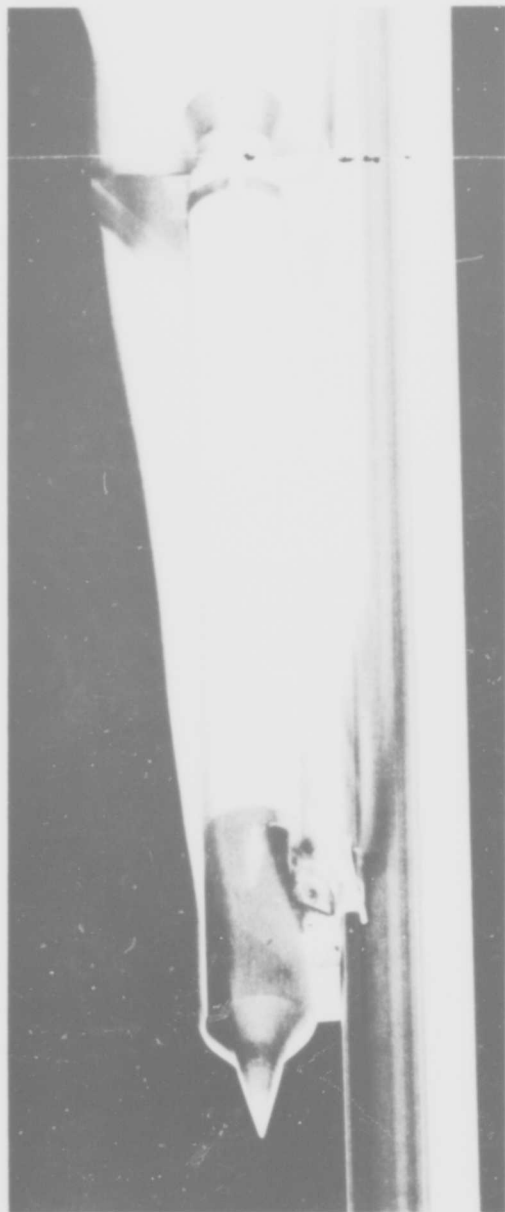
FIGURE 1-A IMAGE MOTION PHOTOGRAPH OF TEST CONFIGURATION ON  
RUN SERIES 14-R

Figure 1-A shows the overall sled configuration used on the 14R test series. There were five runs in this series. All sled runs were fired from north to south. Three runs were made with no internal payload and no fin on the rear. One run was made with a 30 pound internally packaged transpiration cooling system and no fin. The last run was a repeat of the previous one with the fin added. The maximum velocity ranged from 5400 to 5700 feet per second. No sled related problems were noted in this test series.

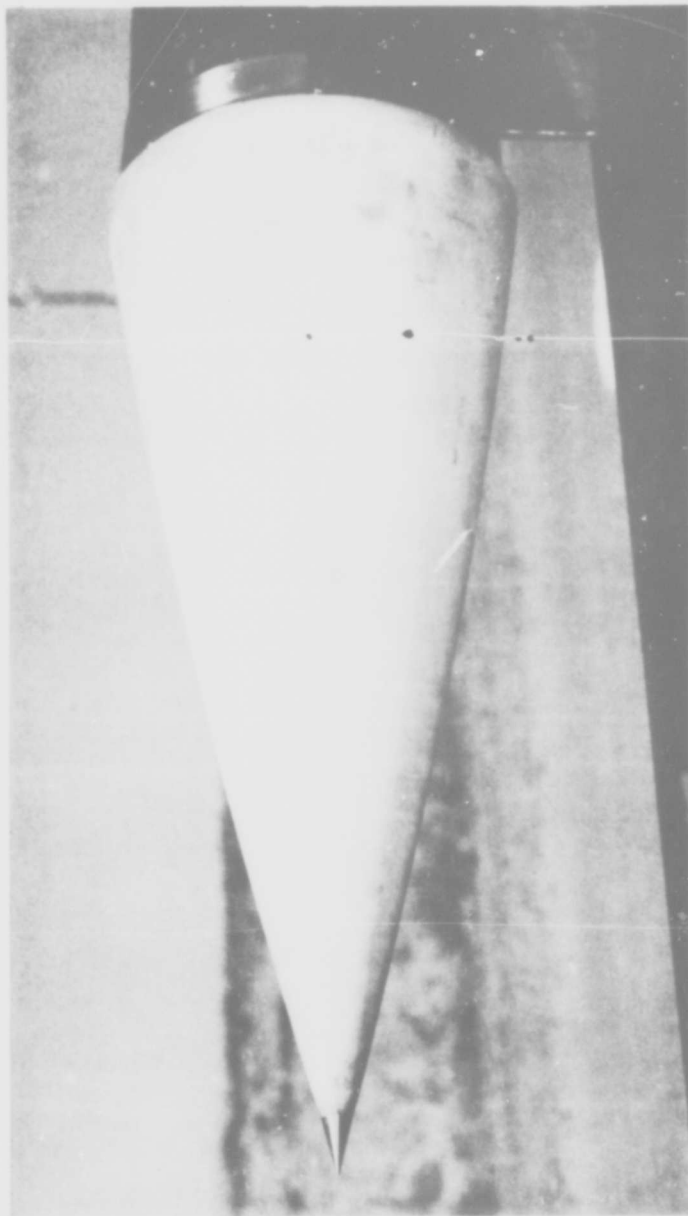
FIGURE 2-A EXTERNALLY MOUNTED THIRTY FOUR POUND TEST CONE

Figure 2-A shows the 34 pound nose cone tested on the 17R series. There were nine runs in this test series. All sled runs were fired from north to south. Thirty pounds of internally mounted telemetry was also added to the vehicle. The remainder of the sled was identical to that used on the 49X series. No sled related problems were noted in this test series.

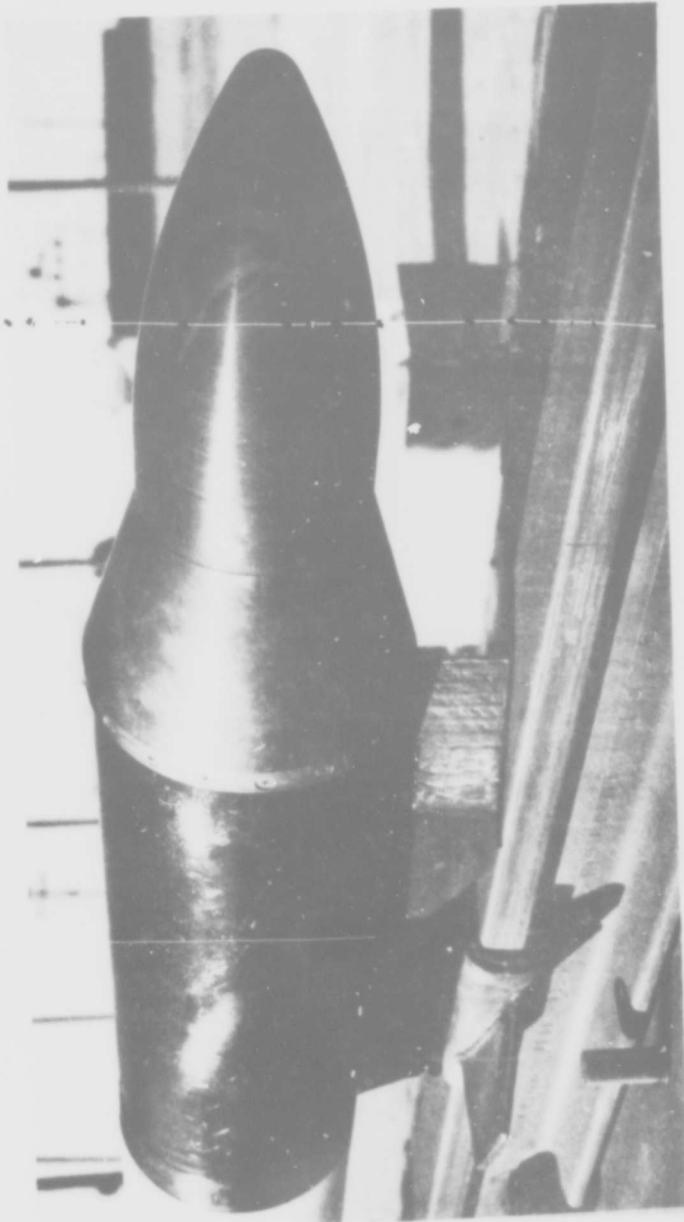
FIGURE 3-A EXTERNALLY MOUNTED TEST ITEM ON RUN SERIES 3-C

Figure 3-A shows the nose geometry tested on the 3C series. There were three runs in this test series. Seven pounds of internal instrumentation was on board. All other details of the sled configuration were the same as those of the 49X series. The maximum velocity ranged from 5500 to 6500 feet per second. A noticeable starboard roll was noted on a 6200 feet per second run. The run was conducted with the sled traveling from south to north. The final run with a maximum velocity of 6500 feet per second was fired from north to south. Post run inspection of the vehicle showed that no roll had occurred.

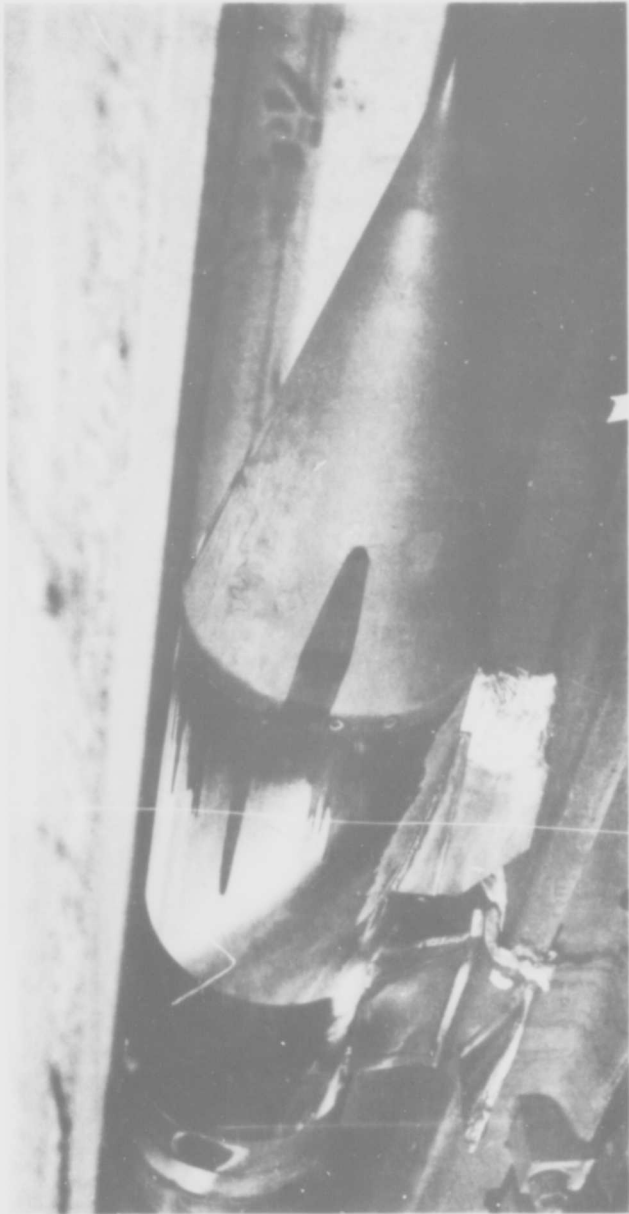
FIGURE 4 - A SLED CONFIGURATION FOR RUN SERIES 6 - I

Figure 4-A shows the sled configuration used on run series 6I. There was one run in this test series. The vehicle carried an internally mounted telemetry package which weighed 30 pounds. Maximum velocity of the run was 6100 feet per second with a water brake entrance velocity of approximately 1950 feet per second. The vehicle was run from north to south on the track. Post run inspection indicated no sled related problems had developed.
