**BAK-14/F32 RETRACTABLE CABLE SUPPORT
SYSTEM**

TECHNICAL REPORT ASD-TR-69-9

AUGUST 1969

DEPUTY FOR ENGINEERING
AERONAUTICAL SYSTEMS DIVISION
AIR FORCE SYSTEMS COMMAND
WRIGHT-PATTERSON AIR FORCE BASE, OHIO

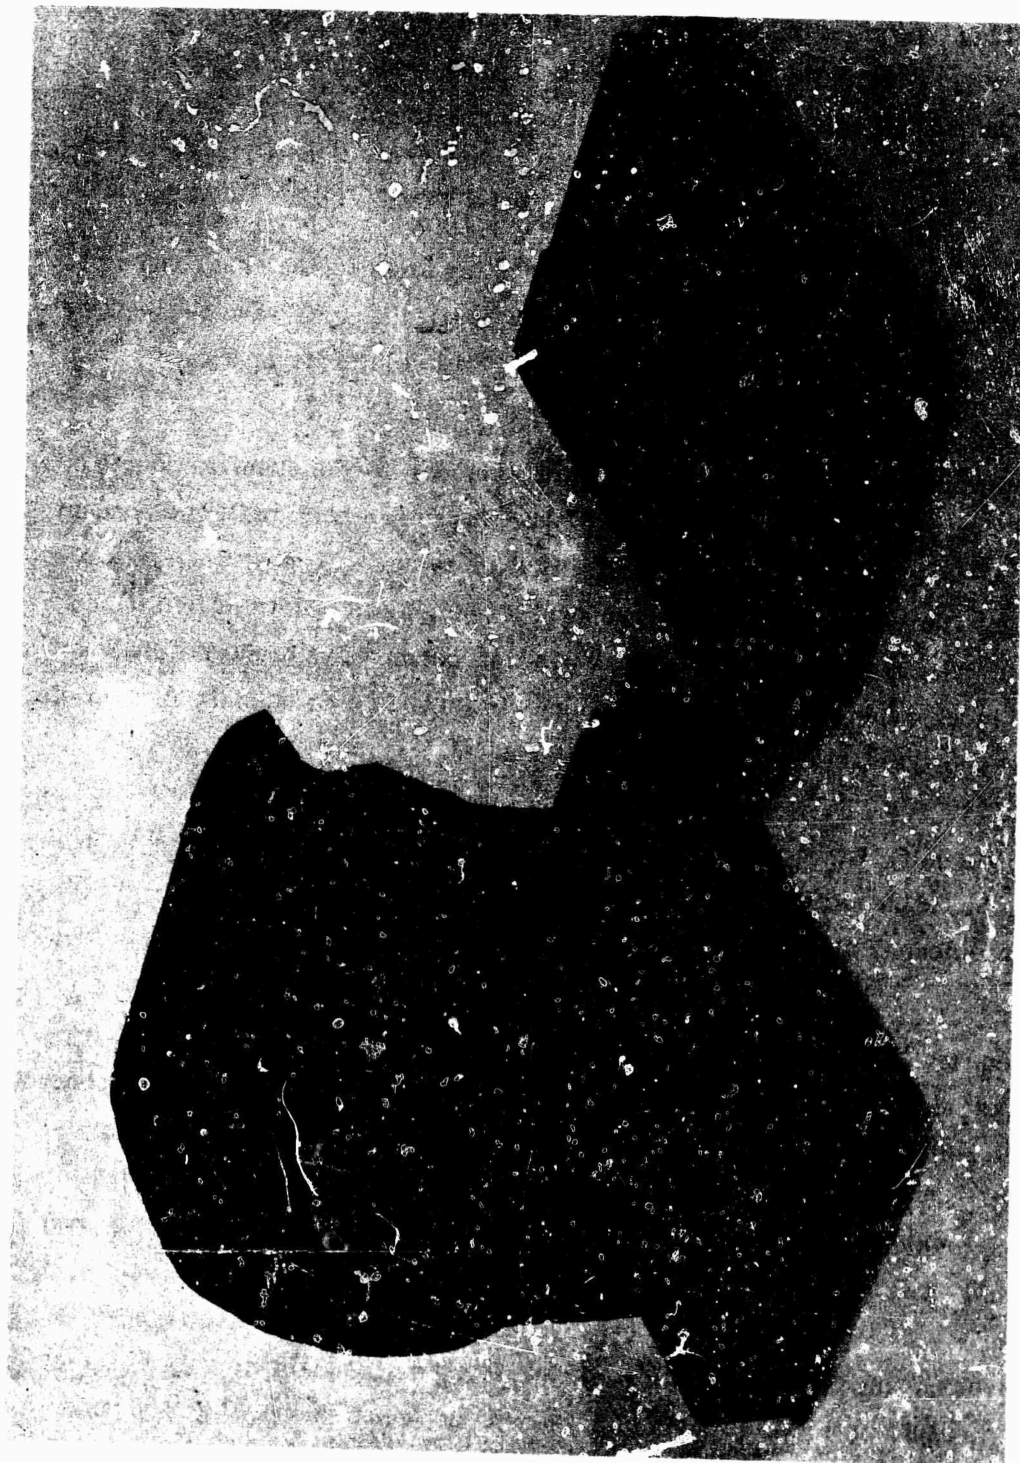
Figure 17. Type B with Separated Base Plate

The situation was remedied by imbedding a metal plate (Figure 17) into the bases of Type B and C blocks. This fix strengthened the base considerably

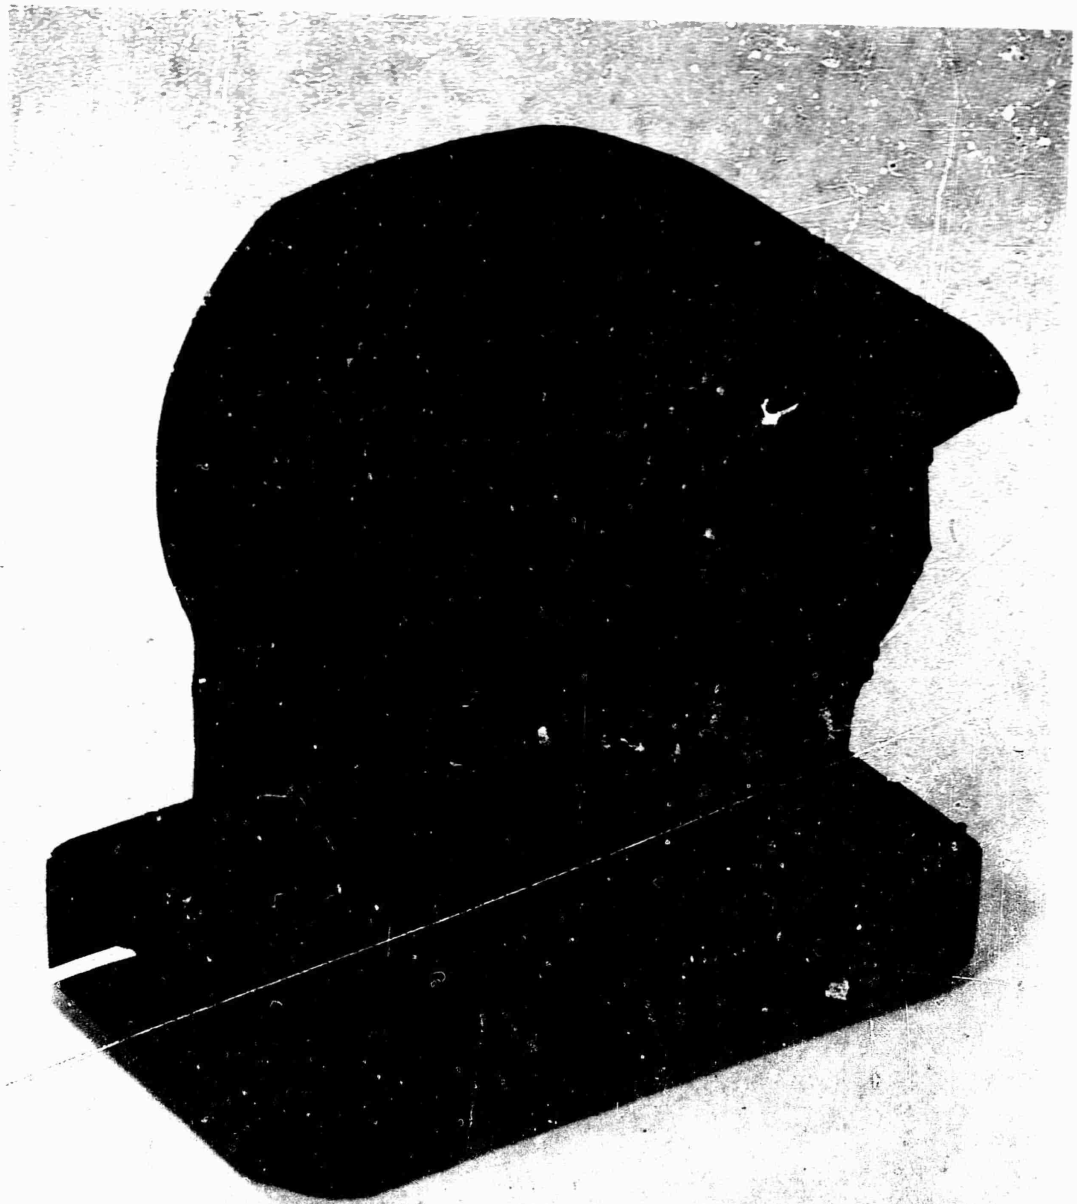
Figure 18. Type B Support with Fatigue Crack

so that the Type B blocks failed only because of fatigue in the block itself (Figures 18 and 19). At higher engaging speeds, the blocks failed by tearing apart at the fatigue cracks. The Type B supports which were newly installed for the high speed arrestments were not destroyed during the highest speed arrestments. It is believed that a softer rubber would better stand repeated arrests and not fail in fatigue until after many arrestments.

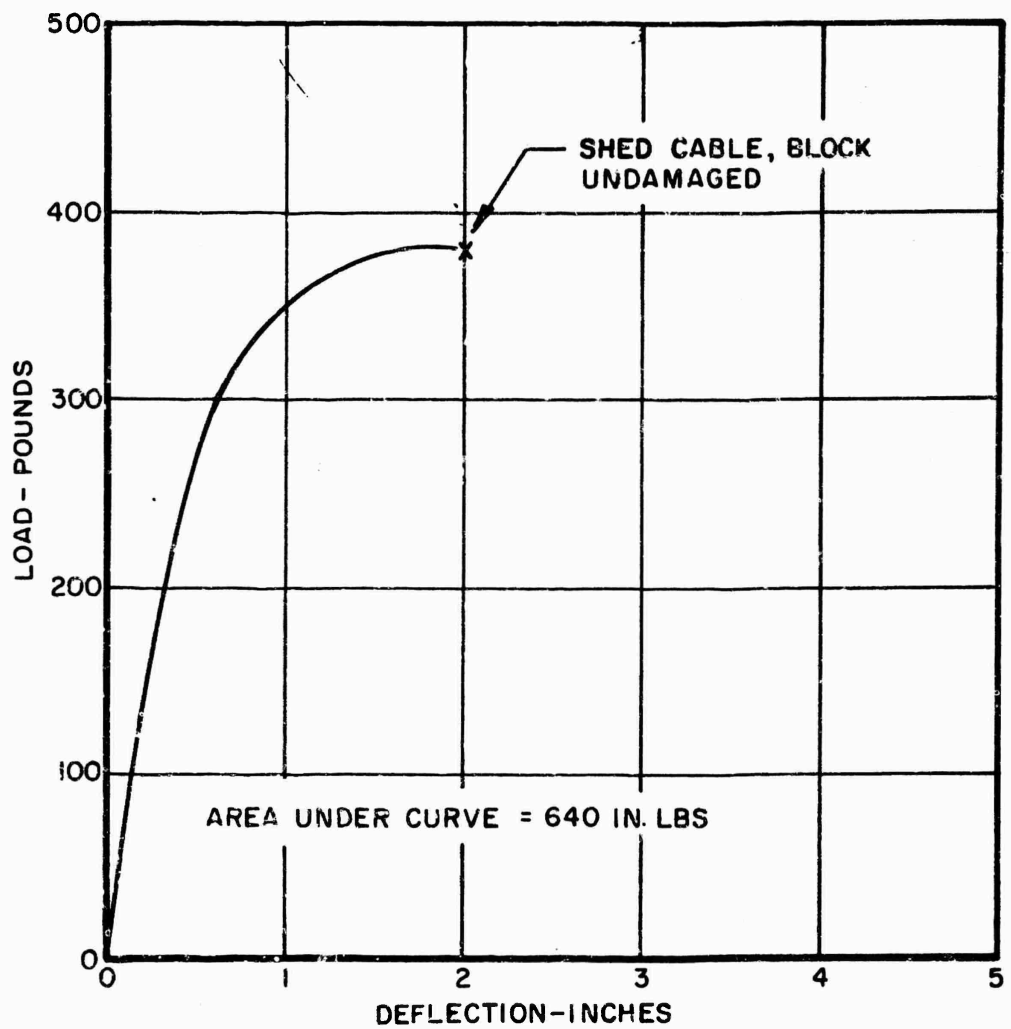
Figure 27. Deflection Curve for Slit Type B Support Blocks

The slit support was able to provide a 50 percent greater cable gripping characteristic (Figure 27) than the Type A supports.

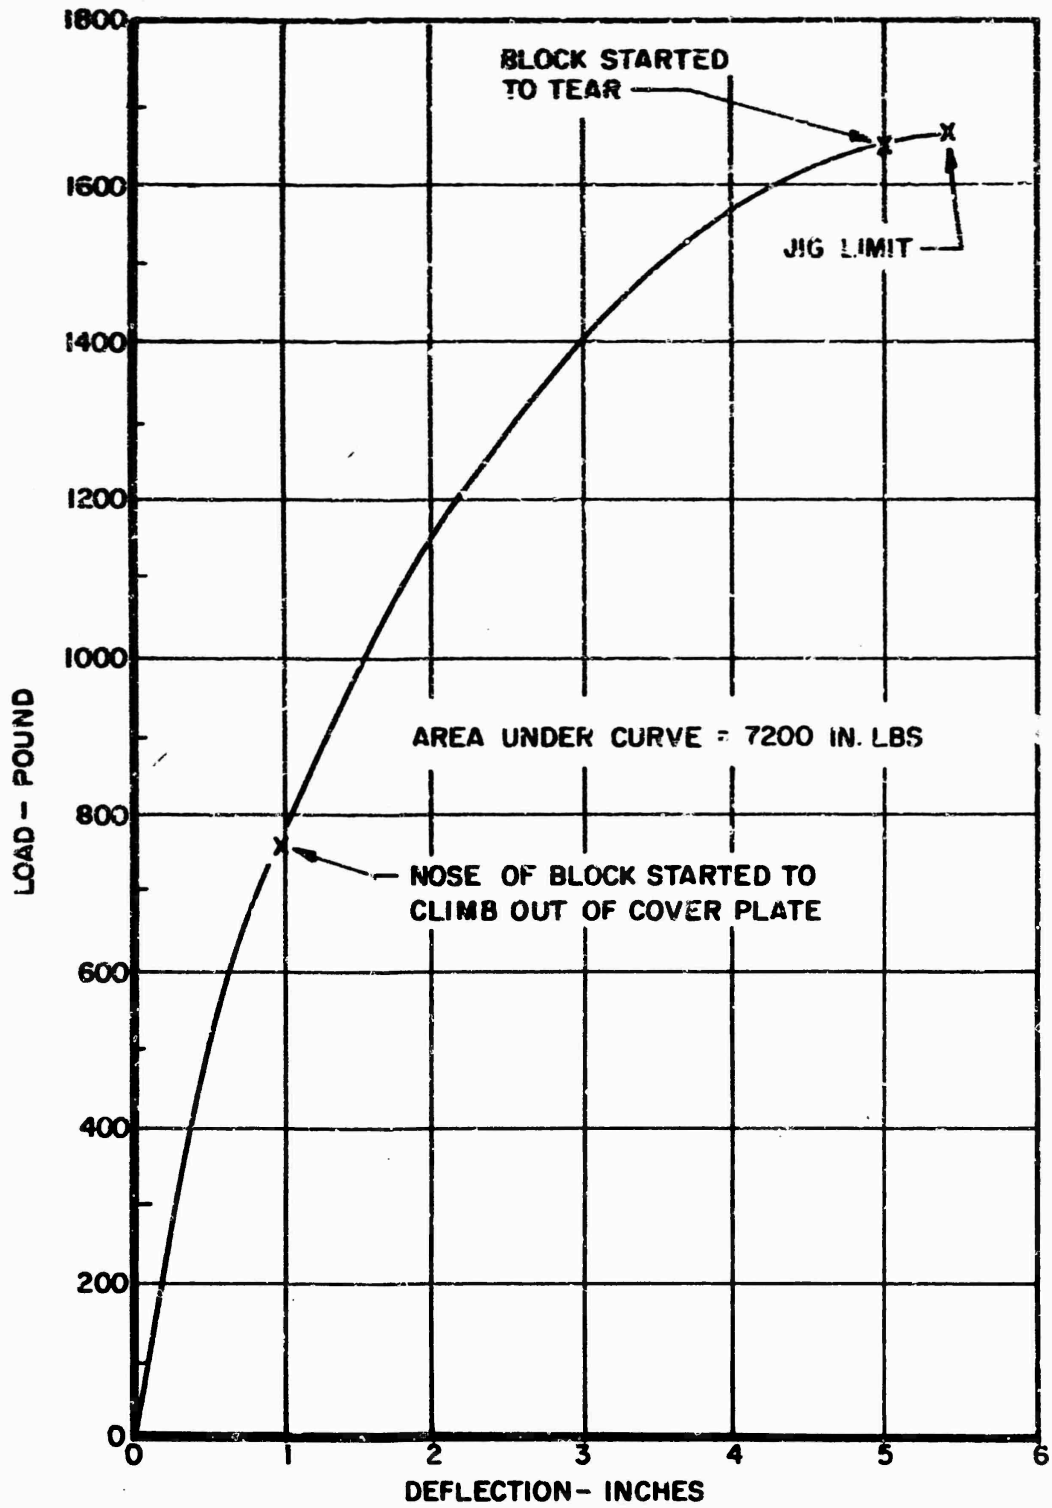
Figure 28. Deflection Curve for Unslit Type B Support Blocks

The unslit supports retained the cable after full deflection of the test fixture (Figure 28). Failure started by tearing the rubber on the tension side of the attachment plate. The tear propagated through the cylindrical portion of the neoprene and extended through the attachment plate, while
