EVALUATION OF ARMCO PH13-8Mo

Jack M. Uchida  
Boeing Company  
Renton, Washington

| DOCUMENT NO. | D6-23927 |

**COMMERCIAL  
AIRPLANE DIVISION**

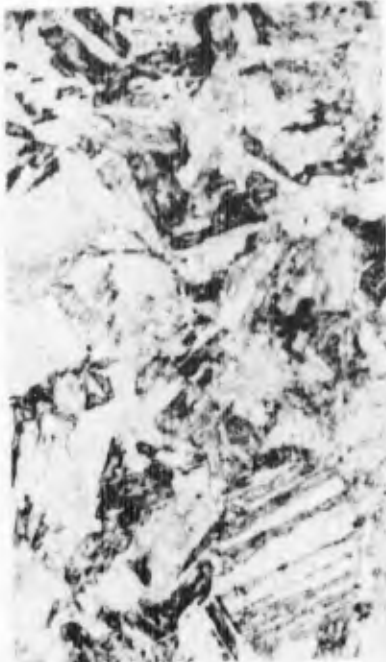
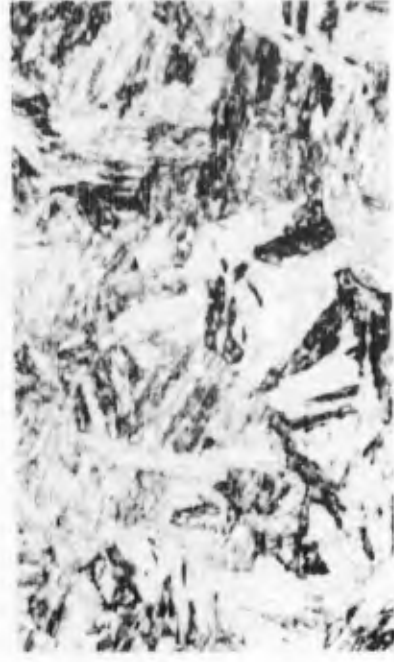
FIGURE 2

SOLUTIONED AT 1600°F  
AGED 3 HRS AT 950°F  
MAGNIFICATION 500X  
FRY'S ETCH

SOLUTIONED AT 1700°F  
AGED 3 HRS AT 950°F  
MAGNIFICATION 500X  
FRY'S ETCH

SOLUTIONED AT 1800°F  
AGED 3 HRS AT 950°F  
MAGNIFICATION 500X  
FRY'S ETCH

EFFECT OF SOLUTION TREAT TEMPERATURE  
ON THE MICROSTRUCTURE

The effects of solution and aging temperatures were investigated to confirm the vendor's data and to determine the temperature limits which could be tolerated. Solution temperatures at 1600°F, 1700°F, and 1800°F were investigated and the effects on the microstructures are presented in Figure 2. Aging temperatures from 700°F to 1700°F were used to study the effects of temperature on hardness and microstructure, and the results are presented in Figures 3 and 4.

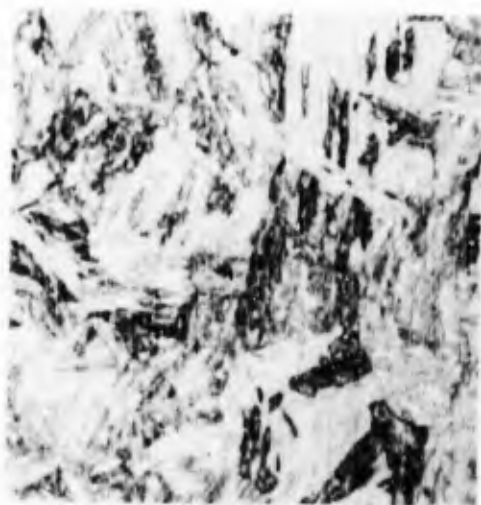
FIGURE 3  
AGING STUDY  
SOLUTIONED AT 1700°F; AGED AS INDICATED: MAG 500X; FRY'S ETCH

3 HRS @ 700°F RC 37

3 HRS @ 800°F RC 42

3 HRS @ 850°F RC 46

3 HRS @ 900°F RC 46.5

3 HRS @ 950°F RC 46

3 HRS @ 1000°F RC 46
