COMPREHENSIVE REPORT  
INVESTIGATION OF MILITARY CONSTRUCTION  
IN ARCTIC AND SUBARCTIC REGIONS  
1945-1948

APPENDIX I  
AIRFIELD SITE STUDIES  
AT NORTHWAY AIRFIELD, ALASKA

OFFICE OF THE CHIEF OF ENGINEERS  
AIRFIELDS BRANCH  
ENGINEERING DIVISION  
MILITARY CONSTRUCTION

JUNE 1950

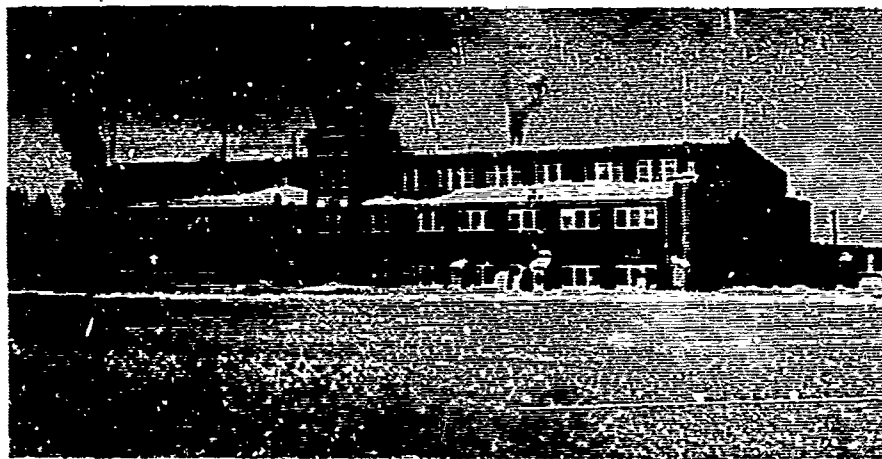
Figure I-2. Northway Airfield hangar, looking northwest. February 1947

9. HANGAR. The hangar is of the "Birchwood Type", 162.63 by 208.6 ft, exclusive of hangar door pockets and aprons. Construction of this structure was started in the summer of 1943 and completed in the late spring of 1944. Approximately the eastern half of the hangar slab and structure is supported on a compacted granular fill placed in a sand and gravel borrow pit that had previously been excavated to depths from 5 to 7 ft below surface to supply materials for construction of the original runway in 1942. The western half of the slab and structure is supported on a compacted granular fill placed after

removal of active zone materials consisting of surface moss and peat underlain by fine-grained silt and sands to variable depths from 3 ft to 5 ft. For a dimensioned layout of the hangar including locations of ground temperature observation holes, frost level observation points (probe holes), and vertical movement observation points in, or in the immediate vicinity of, this structure, see Plate I-16. Figure I-2 is a general view of the hangar.

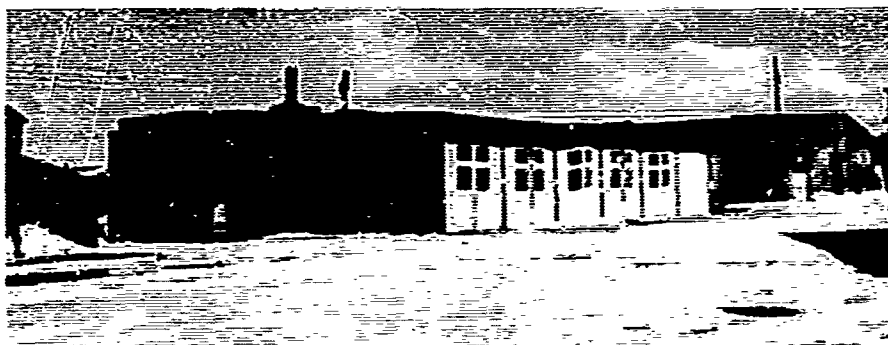
Figure I-3. Northway Airfield motor pool, looking northeast.  
May 1946

10. **MOTOR POOL.** The motor pool is a standard theater-of-operations type structure with over-all dimensions of 65.5 by 104.5 ft, exclusive of a 16.0- by 24.5-ft furnace room contiguous to its west wall. See Plate I-20 and Figure I-3. Construction commenced early in the fall of 1943 and was completed during the following winter. Prior to foundation construction, the general area top-soil consisting of moss, peat and fine-grained black sand was excavated to an average depth of 2 ft and back-filled with granular material. Deeper excavations were made for the column pier footings, the grease pit, and the furnace room.

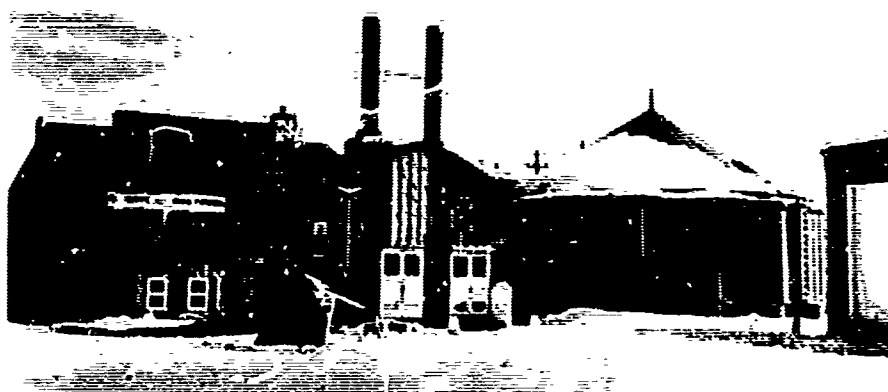
Figure I-7. Northway Airfield boiler house, looking southeast. Boiler house in center foreground. 100,000-gal. water storage tank right rear, powerhouse left rear. May 1946

frame structure constructed on a reinforced concrete floor slab, which in turn is supported on timber piling placed well into the permafrost in such a manner as to provide approximately a 2-1/2-ft air space between the bottom of the floor slab and the normal ground surface. Construction was accomplished in the spring of 1944. See Plate I-24 and Figure I-7.

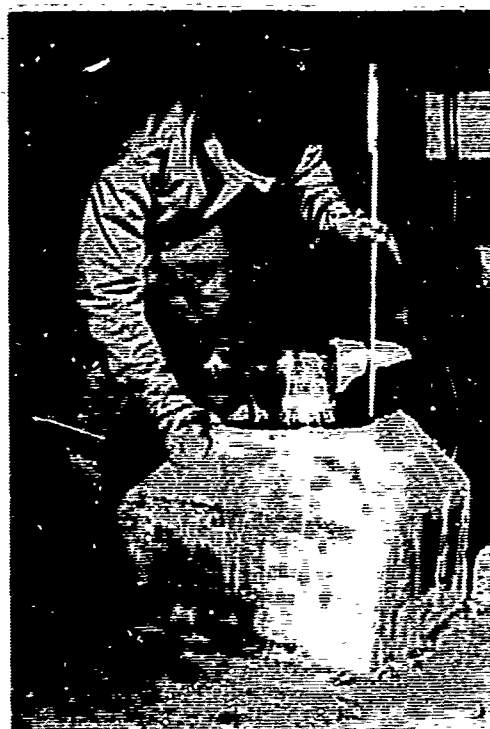
Figure I-9. Northway Airfield pump house no. 2, interior view showing settlement of pump footing. April 1946

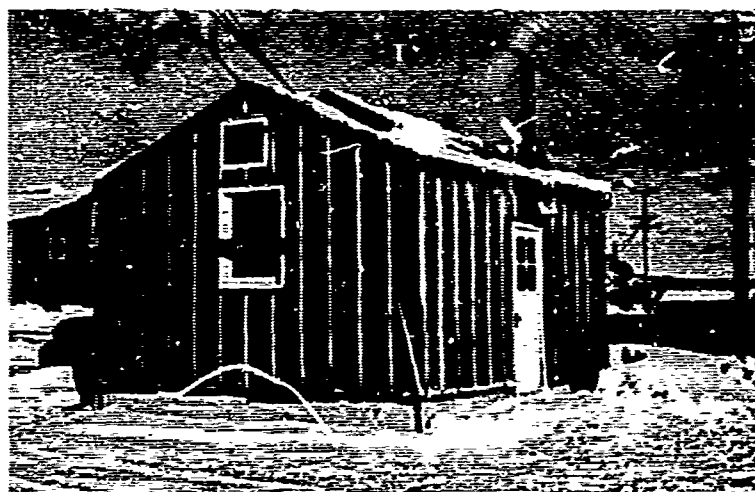
Figure I-10. Northway Airfield pump house no. 1, looking northeast. February 1947

16. PUMP HOUSE NO. 1. Pump house no. 1, located approximately 70 ft north of the northwest corner of the hangar, serves as the source of water supply for the main

operational buildings of the airfield, the utilidor system, and the 100,000-gal. water tank used for the fire-fighting supply. See Plate I-1 and Figure I-10. Well drilling operations at this location were started late in the fall of 1943, conducted through the 1943-44 winter season, and completed early in the spring of 1944. Due to the extremely low winter temperatures ( $-30^{\circ}$  to  $-40^{\circ}\text{F}$ ), the drill rig and its appurtenant operating equipment were inclosed in a heated temporary structure to facilitate operations. Drilling operations were performed by continual steam jetting inside of and in advance of driving the 6-in. steel well casing.

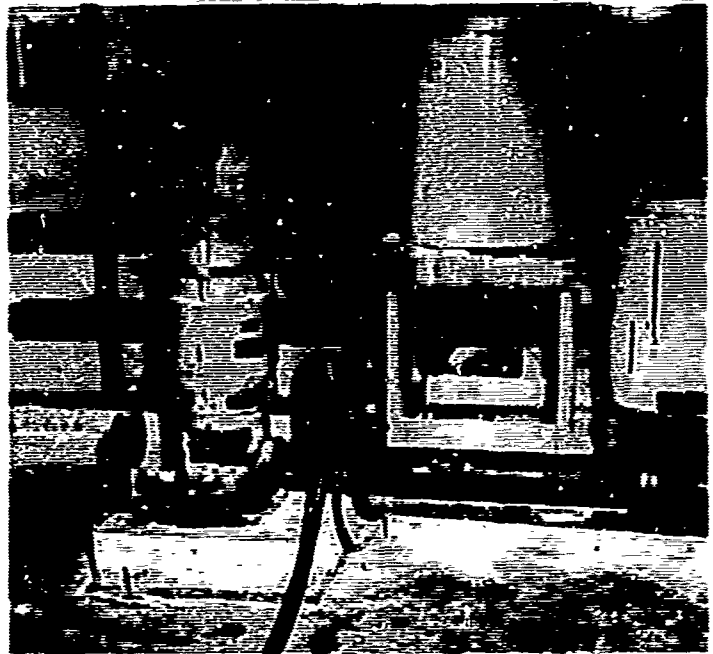
a depth of approximately 150 ft below the surface. A suitable water-bearing gravel stratum was obtained at a depth of 242 ft. Upon completion of drilling operations the pump house was constructed. As a result of the continuous heating operations in the temporary structure enclosing the drill rig, the underlying surface and subsurface materials were thawed to a depth in excess of 6.0 ft. These thawed fine-grained materials were removed and replaced with granular materials, which were compacted to serve as a base for the pump house structure, the pressure water tank and the pump foundation proper. The structure is of the same type as pump house no. 2, see Plate I-24. As this structure is stable and in good condition, no observations were taken in or around it. A combination of the effect of the steam drilling and the temporary structure heat had undoubtedly compacted the underlying subsoils sufficiently to provide suitable bearing capacity, and subsequent frost action was prevented by the thawing action of continuous pumping operations. See Figure I-11 for an inside view of the pump house.

Figure I-11. Northway Airfield pump house no. 1, interior view showing stability of pump foundation. December 1947

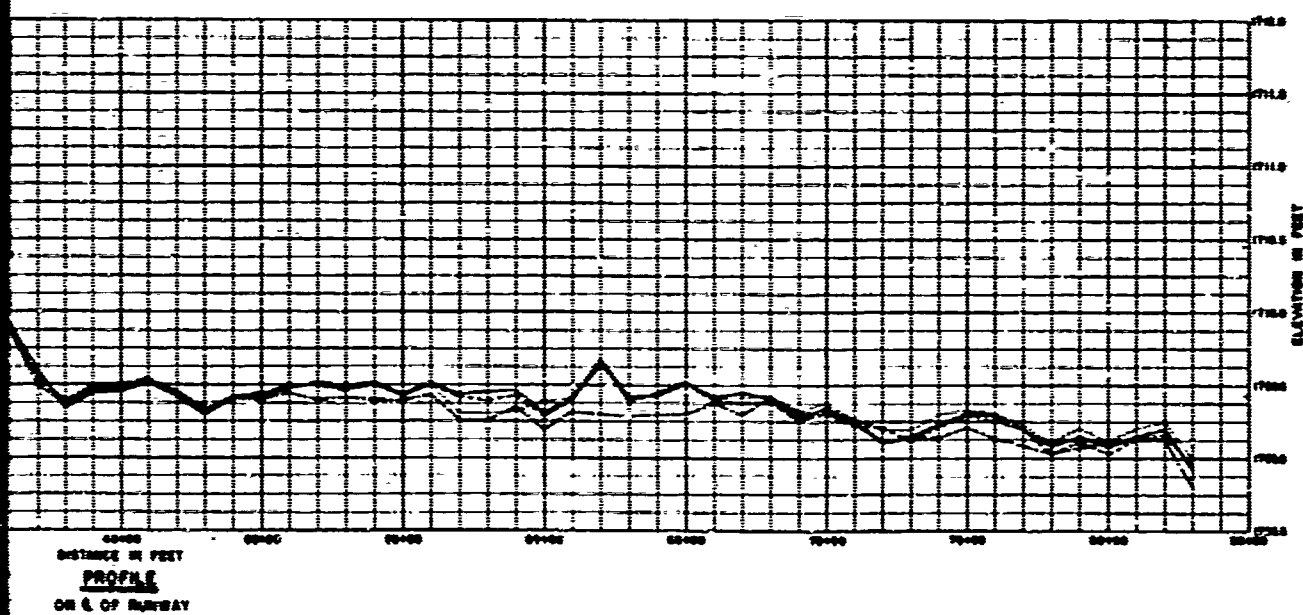
PERMAFROST INVESTIGATION  
 NORTHWAY AIRFIELD, ALASKA  
 LONGITUDINAL SETTLEMENT  
 PROFILE-6 OF RUNWAY

immediate vicinity of the temperature holes. The probe holes were relocated to positions adjacent to the temperature holes in September 1946, and the observations gave the following information: Average maximum depth to frost in October 1946 from probings was 9.1 ft, from 0°C isotherms was 10.5 ft; in October 1947 from probings was 10.3 ft, from 0°C isotherms was 9.7 ft. No probings were taken in 1948 but the average maximum depth from 0°C isotherms was 10.6 ft in October 1948. A typical cross section of the runway, station 60+00, showing a comparison of the vertical movements of the bituminous runway surface and the maximum depths to the permafrost table, as indicated both by probings and depths to the 0°C isotherm, is shown on Plate I-14. A review of all the runway vertical movement observations taken at intervals for the period from 7 March 1945 through 8 April 1947 shows a general over-all surface settlement of only 0.04 ft. However, it should be noted that the runway was resurfaced in August 1945 and August 1947. The maximum settlement, which was local in nature, occurred at cross-section station 20+00 and averaged approximately 0.50 ft; conversely the maximum rise, which was more general in nature, occurred at cross-section station 40+00 and averaged approximately 0.14 ft. Profiles of successive runway center line vertical movement observations are shown on Plate I-15. These profiles show that the runway has reached a stable condition.
