MISCELLANEOUS PAPER N-70-5

# AIRBLAST LOADING OF A LARGE METAL SHIPPING CONTAINER

Laboratory Investigation

This report describes the tests of two Container Express (CONEX) containers that were instrumented and subjected to blast loads in the Large Blast Load Generator (LBLG) facility at the U. S. Army Engineer Waterways Experiment Station (WES).

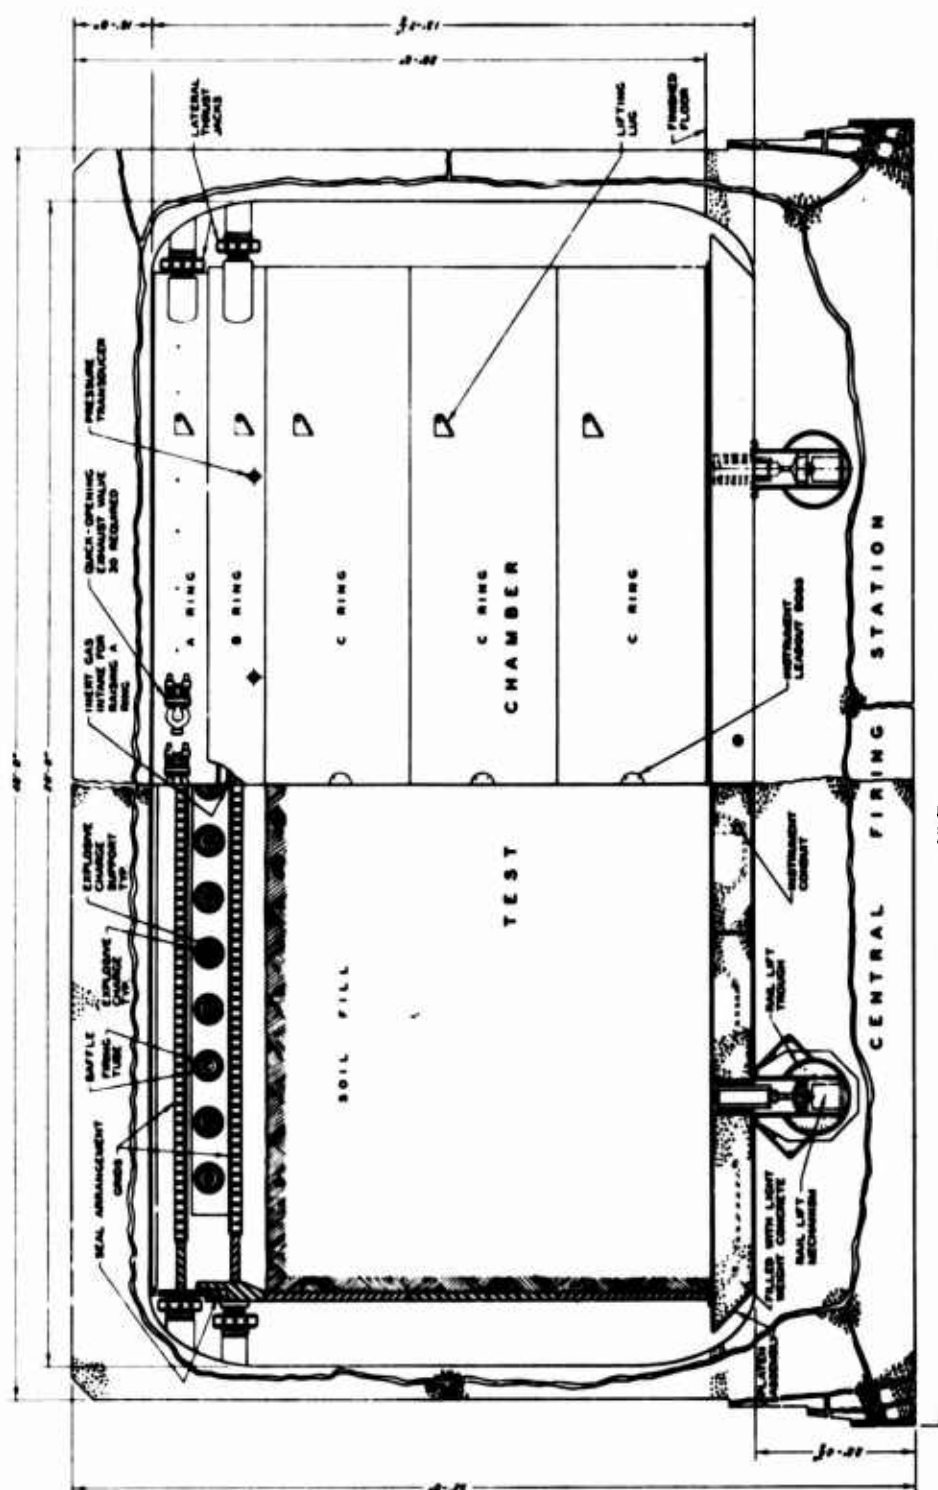
Figure 2.2 Half-section of the Blast Load Generator.

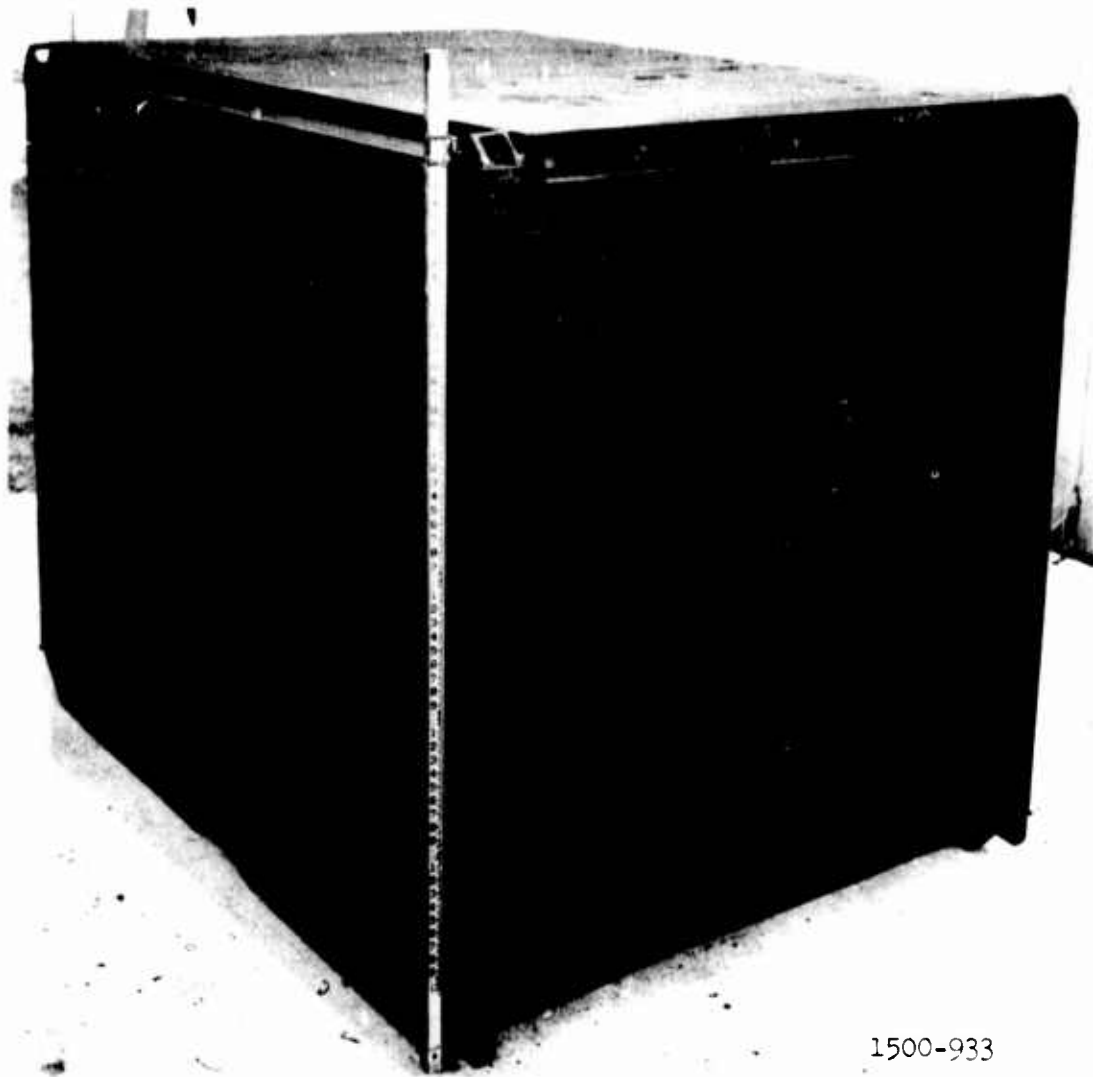
Figure 2.3 Large CONEX.

The CONEX (Figure 2.3) is a large, metal, box-shaped, reusable shipping container. Two sizes, 135 and 295 ft<sup>3</sup>, are available, however, only the larger size was considered for this test program. The load-carrying capacity of the large container is 10,000 pounds. Its tare weight is approximately 1,600 pounds. Access to the container is provided by two doors that close to form the container front and are secured with a quick-opening door handle.

The container has internal dimensions of 8 feet 2 inches long, 6 feet wide, and 6 feet high. Outside dimensions are 8 feet 6 inches long, 6 feet 3 inches wide, and 6 feet 10-1/2 inches high. Inside and outside volumes of the container are 295 and 365 ft<sup>3</sup>, respectively.

The large container is fabricated from 18-gage-thick corrugated steel welded at all joints. A double wall thickness is provided at the container roof and floor. This double thickness is
