FROST INVESTIGATION 1944-1945

REPORTS ON
OTIS FIELD, SANDWICH, MASS.
AND
HOULTON AIRFIELD, HOULTON, MAINE

CORPS OF ENGINEERS, U.S. ARMY
U.S. ENGINEER OFFICE, BOSTON, MASS.
JUNE 1945

REPORT ON
OTIS FIELD
SANDWICH, MASSACHUSETTS

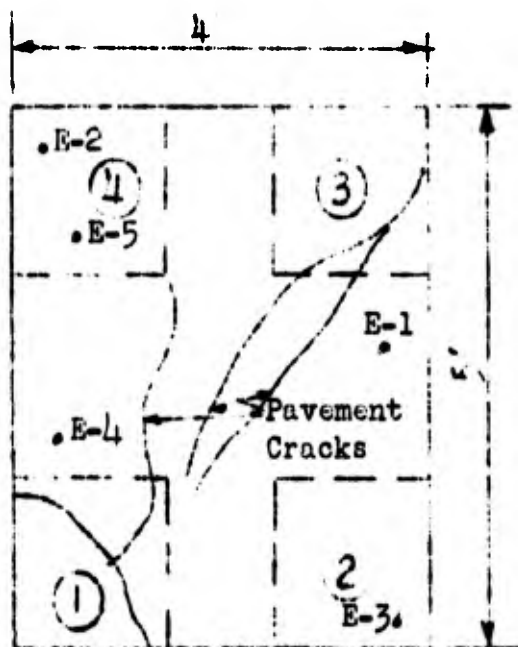
PLAN OF TEST PIT T500p
NE-SW Runway
Station 51 / 00
40' left of ℓ

FROST DATA FROM TEST PIT T500p

17 FEBRUARY 1943

Average Depth of Frost Penetration 24.6"

To investigate the depth of the frost penetration and the character of the subgrade soils in an area of severe frost heaving, a test pit, T500p, was excavated to a depth of 4 feet on 17 February 1943 during a cold

spell (13° Fahrenheit). After removal of the pavement, continuous water contents of the top 8 inches of subgrade were obtained from each of the four sections of the pit. Locations and data from these samples, E-6 to E-17, are listed together with a sketch of the pit in Table 1. The location of T500p is shown on Plate 3. Directly beneath the top 8 inches of subgrade, 12 continuous water contents were taken. Results of tests on samples E-74 to E-85 are listed in Table 1. A few thin frost lenses were observed in the top 8 inches of the subgrade. The thickest and greatest number of ice lenses were found in the lower sandy silt subgrade to a depth of 2 feet which was the depth of maximum frost penetration. These ice lenses varied in size from very thin flakes to a maximum thickness of about 1/8 inch. Sample E-85, showing a low water content of 4.7 percent consisted of clean fine to medium sand and was located at a depth of 36 inches directly beneath the silty layer. A group of 9 observation wells was installed 24 February 1943 during a thaw period, on the NE-SW Runway left of the centerline between stations 41 + 20 and 42 + 20. The wells were installed in the portion of the pavement where frost heaves were most severe. It was observed that a greater quantity of surface water existed on the turf shoulders adjacent to this area than elsewhere along the runway. The underdrains described in Paragraph 4b were not installed on this date which may

explain the high perched water table, 6 to 12 inches below the surface during the 2-day thaw spell. The top 8 inches of material were not frozen during this period although the depth of frost penetration was 2 feet. During several days in the frost melting period, attempts were made to observe the effect of 30,000 pound plane loads on the bituminous concrete pavement. There was no visual evidence of weaving or disturbance of any kind.

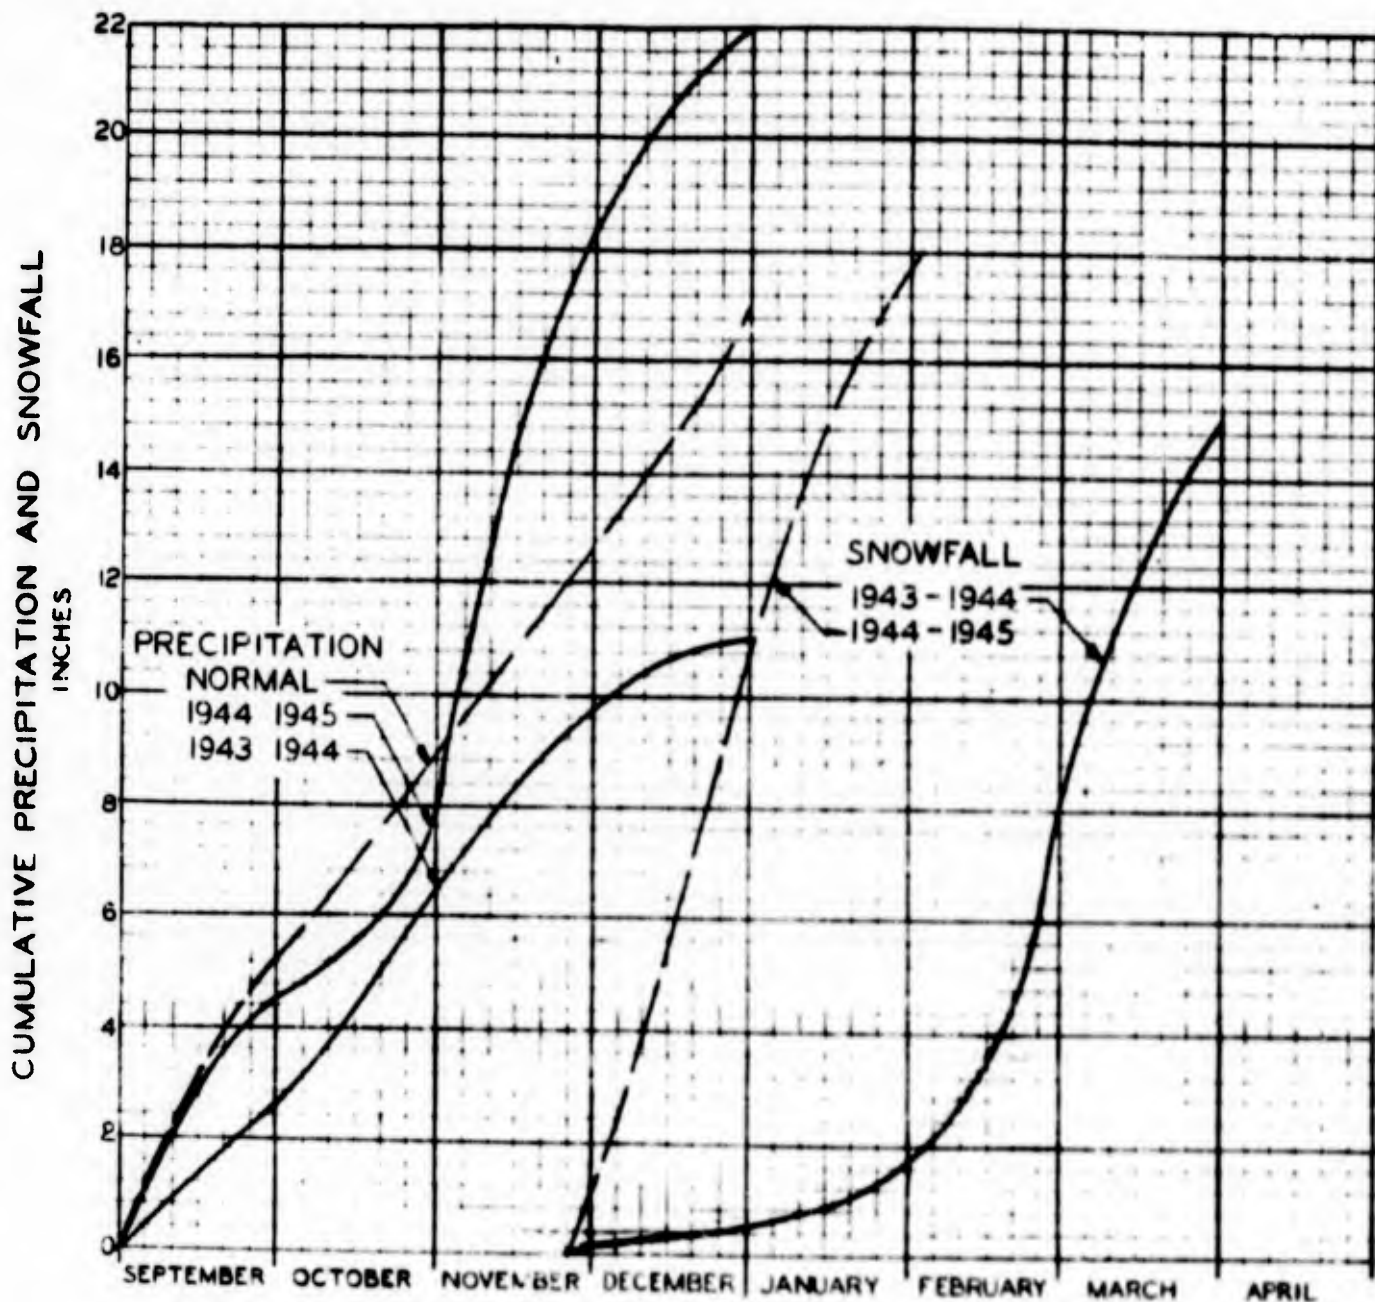
FIG. 3

FROST INVESTIGATION
 OTIS FIELD, SANDWICH, MASS.
 WEATHER AND FROST
 PENETRATION DATA
 JUNE 1945
 FROST EFFECTS LABORATORY

The normal total precipitation for the three and one-half month period from 1 September to 15 December is 15 inches. The total precipitation for the same three and one-half months preceding the freezing period for 1944 was 21 inches or about 40 percent above normal. The weather conditions were, therefore, more favorable for frost action to occur in relation to freezing temperature and autumn rainfall. The cumulative snowfall in 1944-1945 was in excess of the previous season. These data are presented in detail in Figures 1 and 3 on Plate 2.

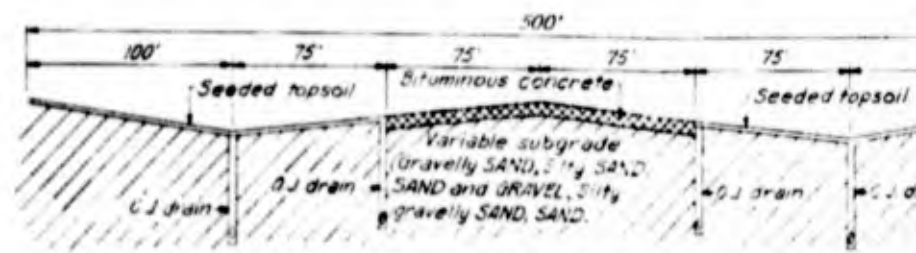
TYPICAL CROSS SECTION OF LANDING STRIP

NOTE: PAVEMENT CONSTRUCTED DIRECTLY ON COMPACTED SUBGRADE

SECTION A-A

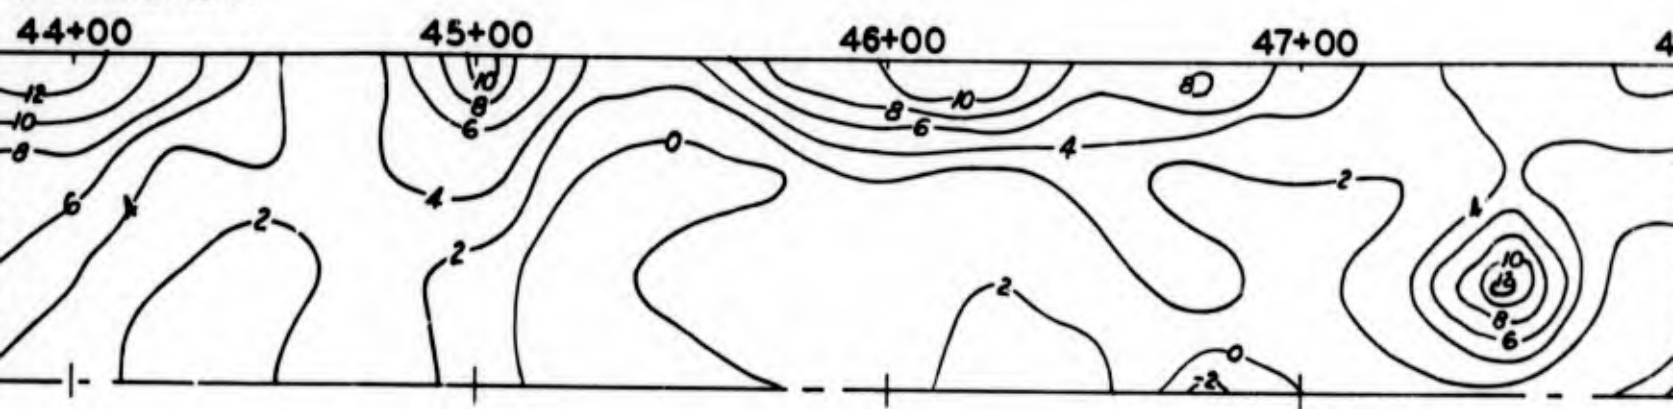
SURVEY: 15 DECEMBER 1944 — 31 JANUARY 1945
HEAVE CONTOURS

CONTOURS IN HUNDREDTHS OF FEET
CONTOUR INTERVAL = 0.02'

- (2) Pavement Heave. Level Surveys were made over the entire test area which was divided into a 25-foot grid system. The initial survey was made on 15 December 1944 before frost had entered the ground. The surveys were repeated in mid-winter on 31 January 1945 and after the frost melting period on 15 March 1945. Pavement heave contours based upon the elevation differences indicated by surveys on 15 December 1944 and 31 January 1945 were computed and are plotted on Plate 4. The subsidence of the pavement or return to normal condition after the frost melting period, based upon the elevation differences indicated by surveys on 31 January 1945 and 15 March 1945, are similarly shown by contours on Plate 4.

- (4) Pavement Heave. The effect of frost action during 1944-1945 on pavement heave is considered negligible. The maximum heave measured was 0.16 feet and this occurred in a small circular area along the edge of pavement adjacent to the turf. In general, the pavement heave was 0.10 feet and the heaved area was predominately closer to the edge of runway pavement. The subsidence of the pavement measured on 15 March 1945 indicated that the pavement did not return completely to the original elevations.

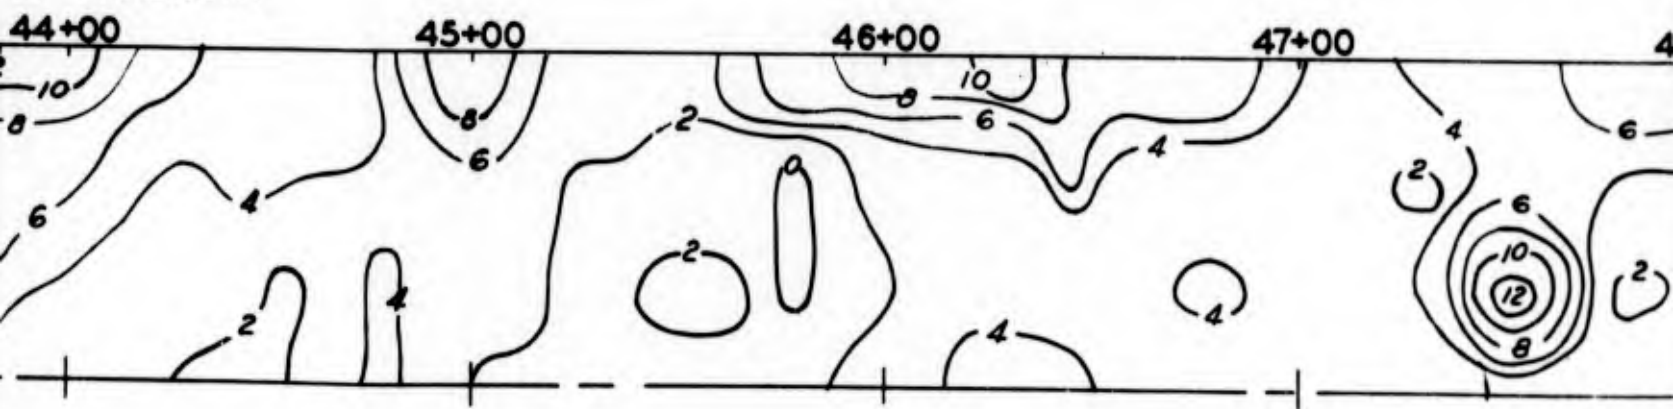
SURVEY: 31 JANUARY 1945 — 15 MARCH 1945
SUBSIDENCE CONTOURS

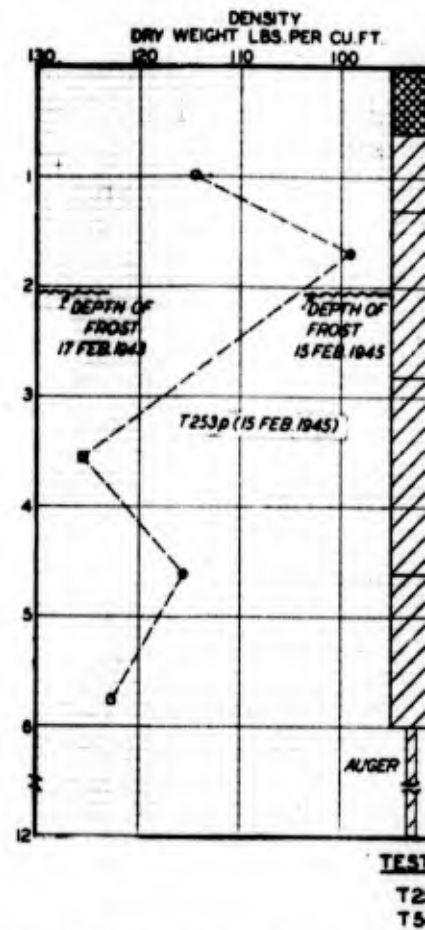
FIG.1

WATER CONTENT-DENSITY-SOIL PROFILE

- (2) Density. The density and water content of the sub-grade were obtained to depth of approximately 6 feet to determine density changes due to frost action. The results of these tests are plotted in Figure 1 on Plate 5 in relation to the soil profile and for comparison with water contents. Figure 3, Plate 5 shows plot of density versus water content for all tests made.

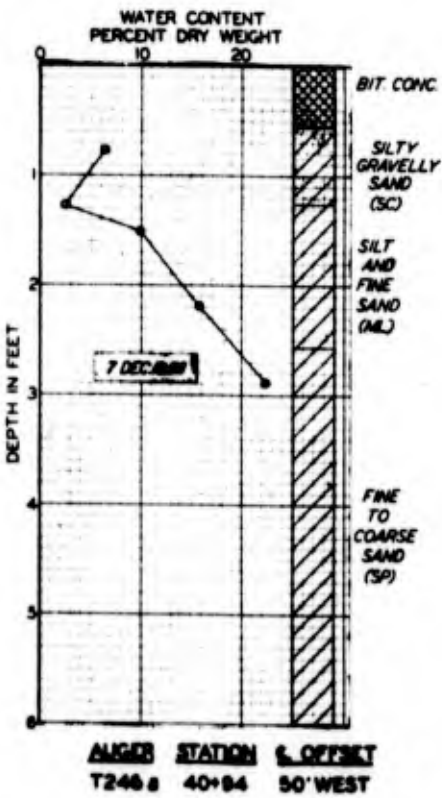
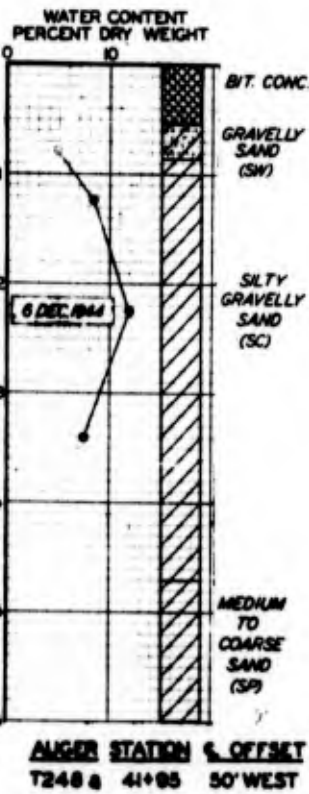
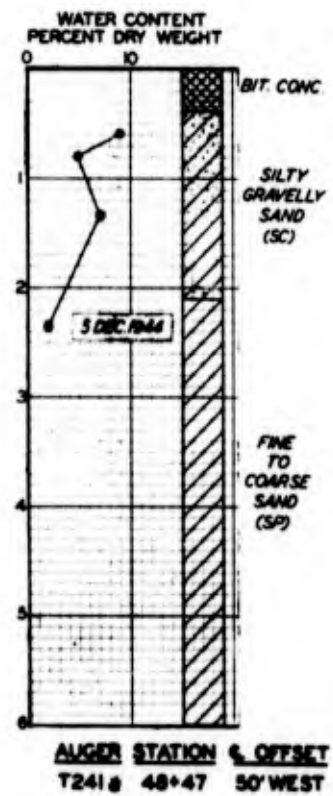
FIG.2

WATER CONTENT-SOIL PROFILE

- (1) Water Content. Continuous water contents were obtained in the test pits and auger holes excavated during the fall, winter, and spring. The tests were made for the purpose of determining the migration and accumulation of water as the result of frost action. The water content data are plotted in relation to the soil profile in Figures 1 and 2 on Plate 5. All water content results are further summarized in Table 2.

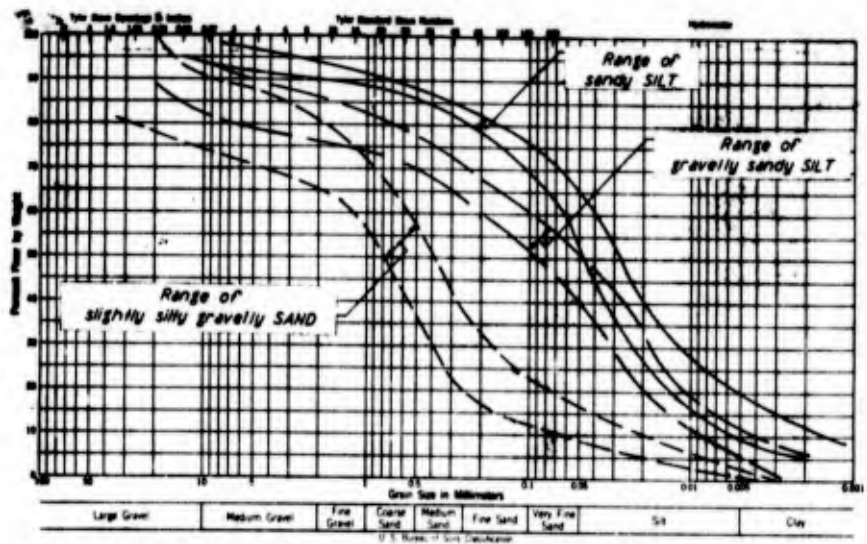
FIG. 4

GRADATION OF SUBGRADE MATERIALS

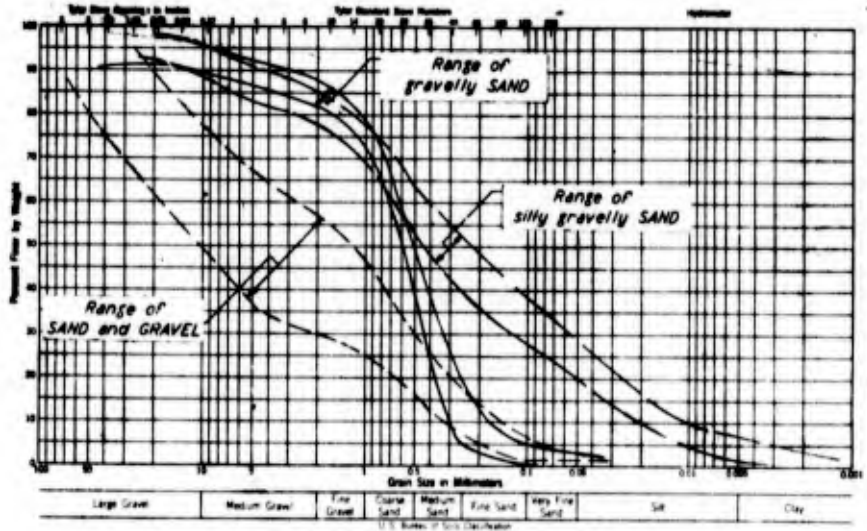
FIG. 5

GRADATION OF SUBGRADE MATERIALS

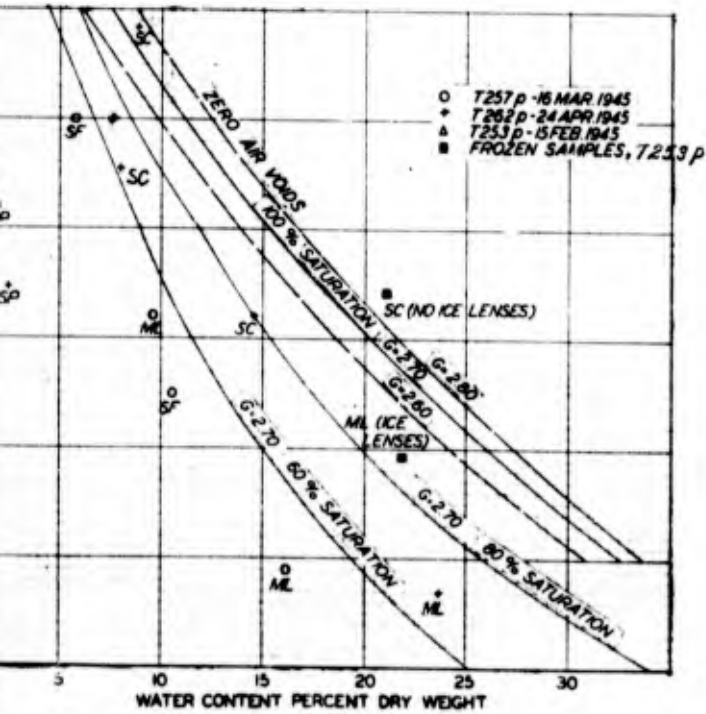
FIG. 3

WATER CONTENT-DENSITY

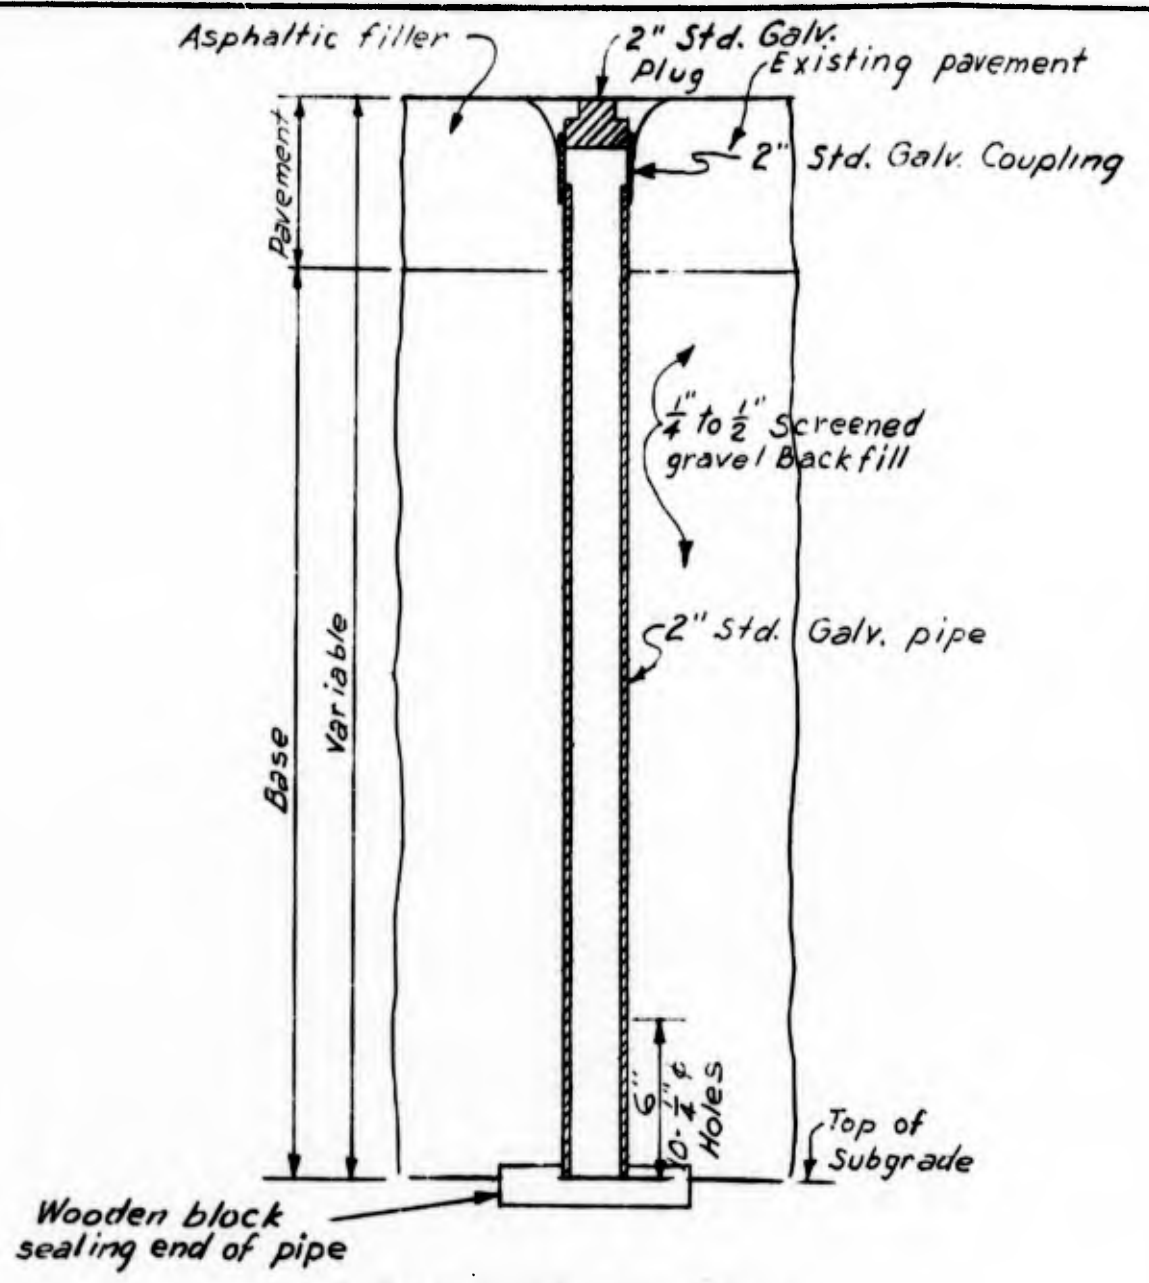
FIG.1

OBSERVATION WELL

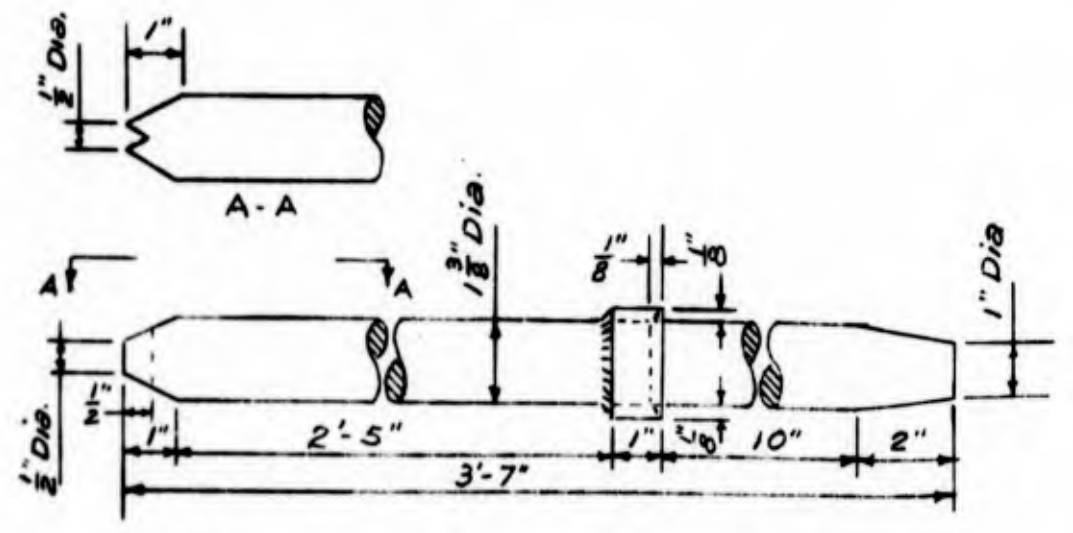
FIG.3

BENCH MARK EXTENSION ROD

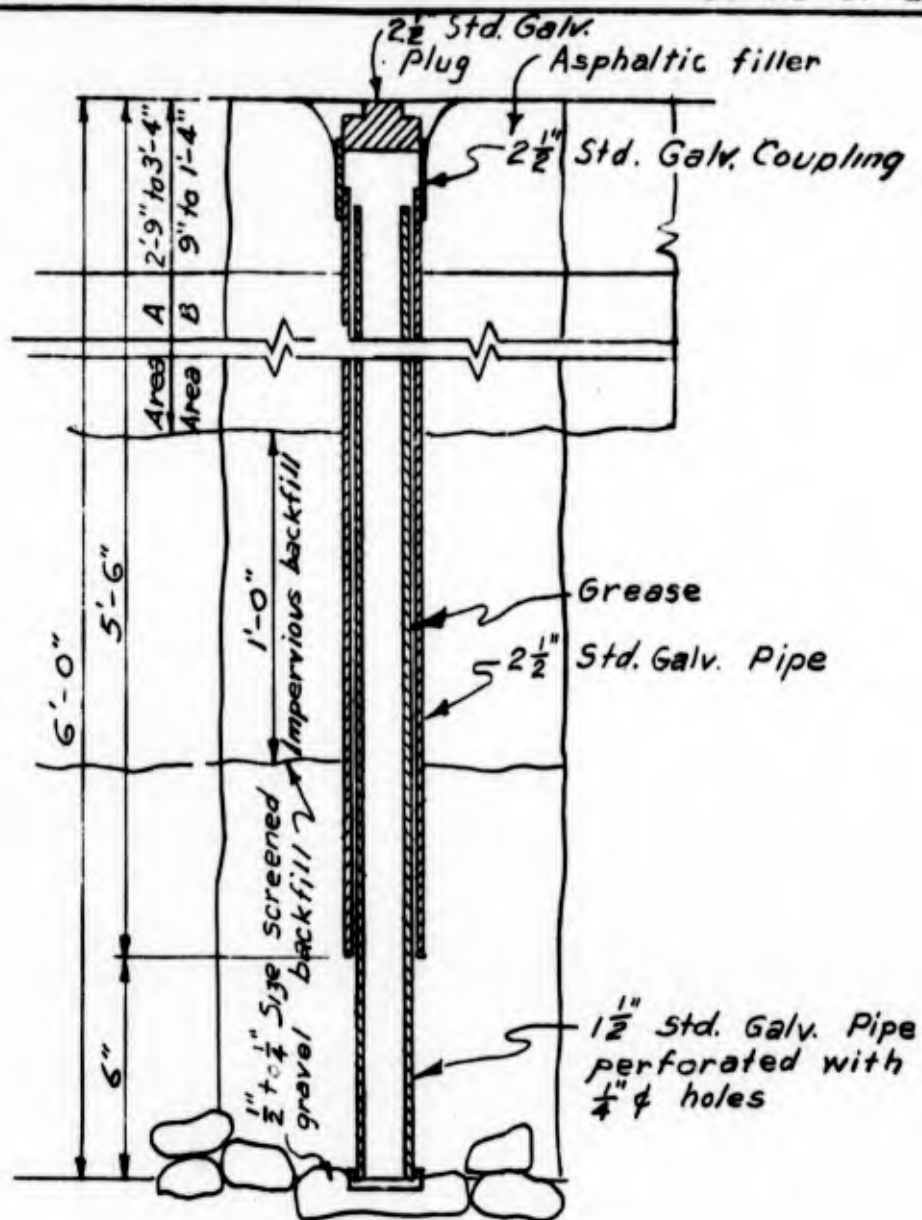
FIG. 2
Scale: 1 1/2" = 1-0'

BENCH MARK-OBSERVATION WELL

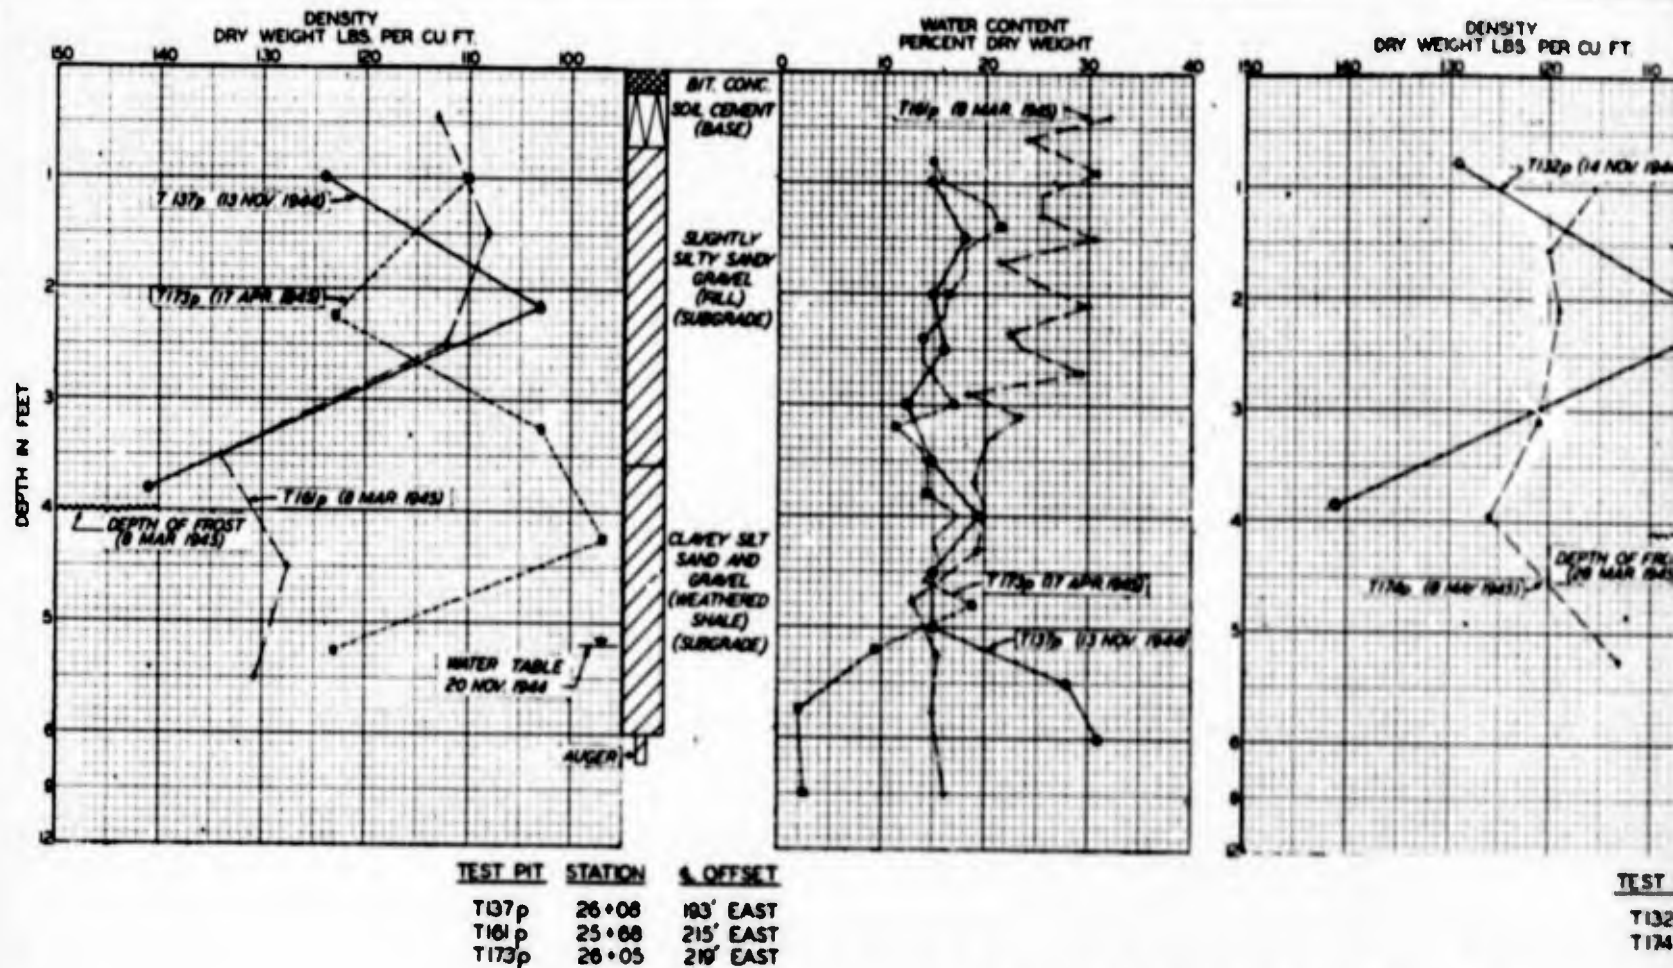
FIG. 1

WATER CONTENT-DENSITY-SOIL PROFILE
TEST AREA A

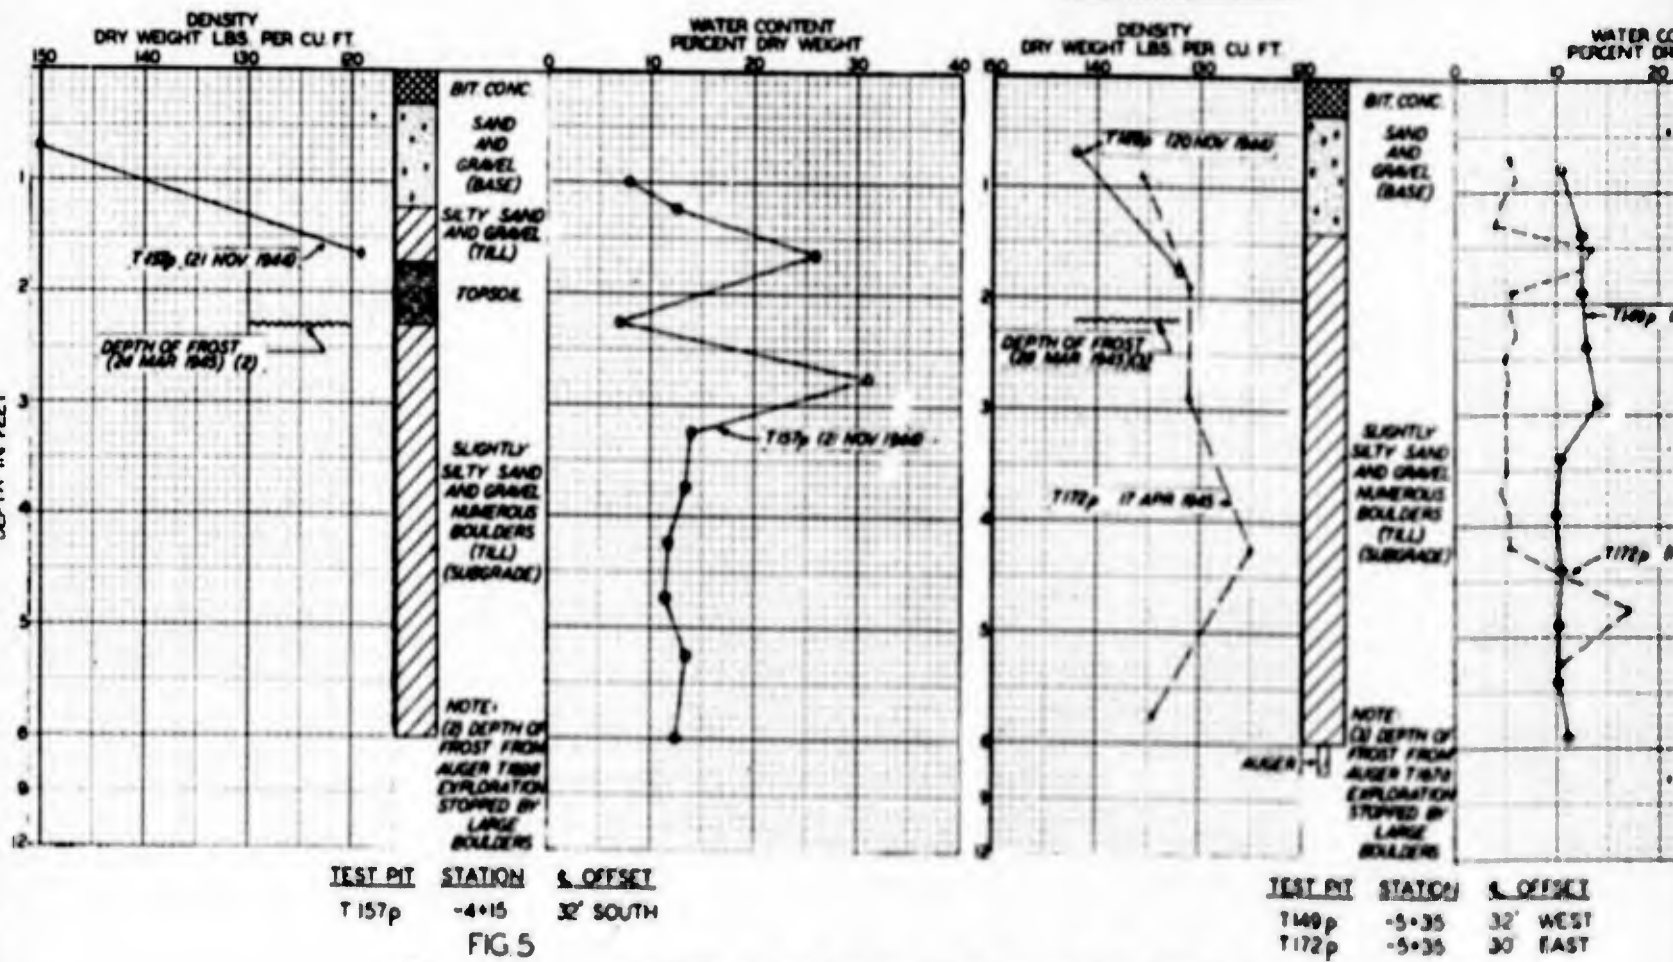
FIG. 5

WATER CONTENT-DENSITY-SOIL PROFILE
TEST AREA B

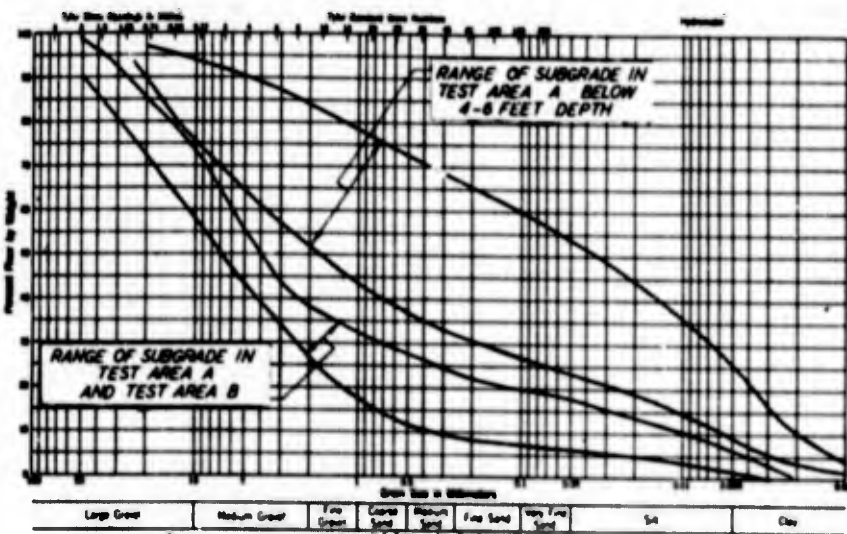
FIG 3

GRADATION OF SUBGRADE MATERIAL

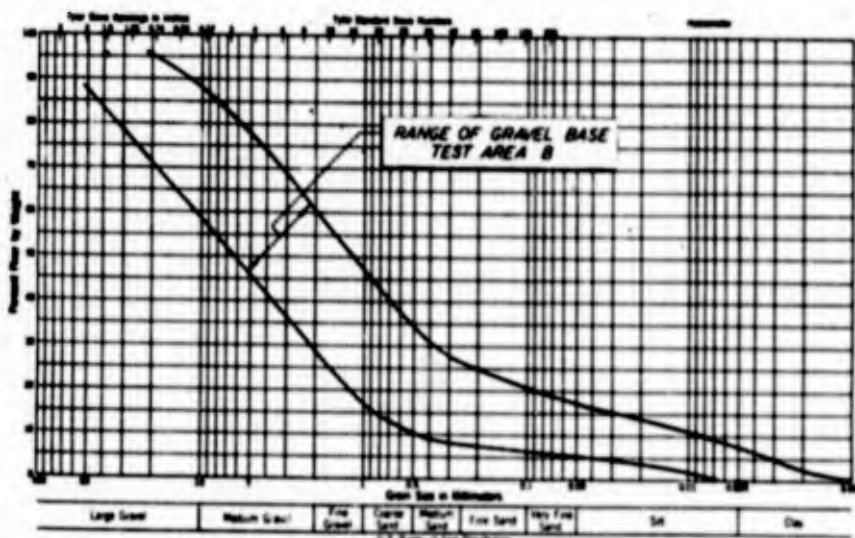
FIG 4

GRADATION OF BASE MATERIAL

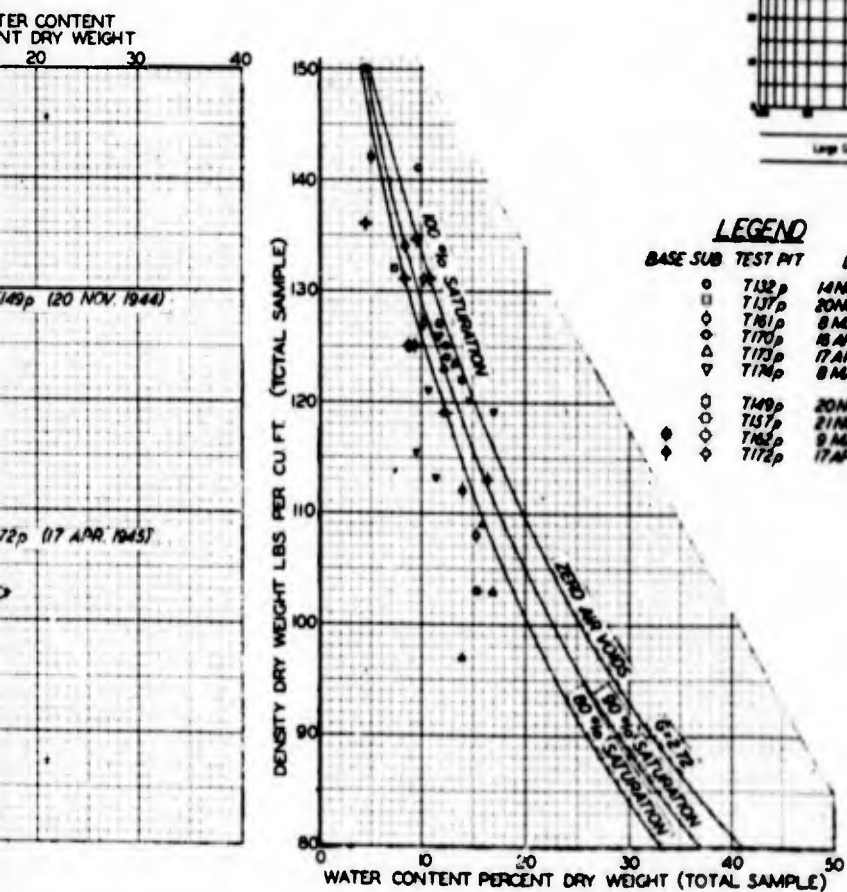
FIG. 7

WATER CONTENT-DENSITY
TEST AREAS A & B

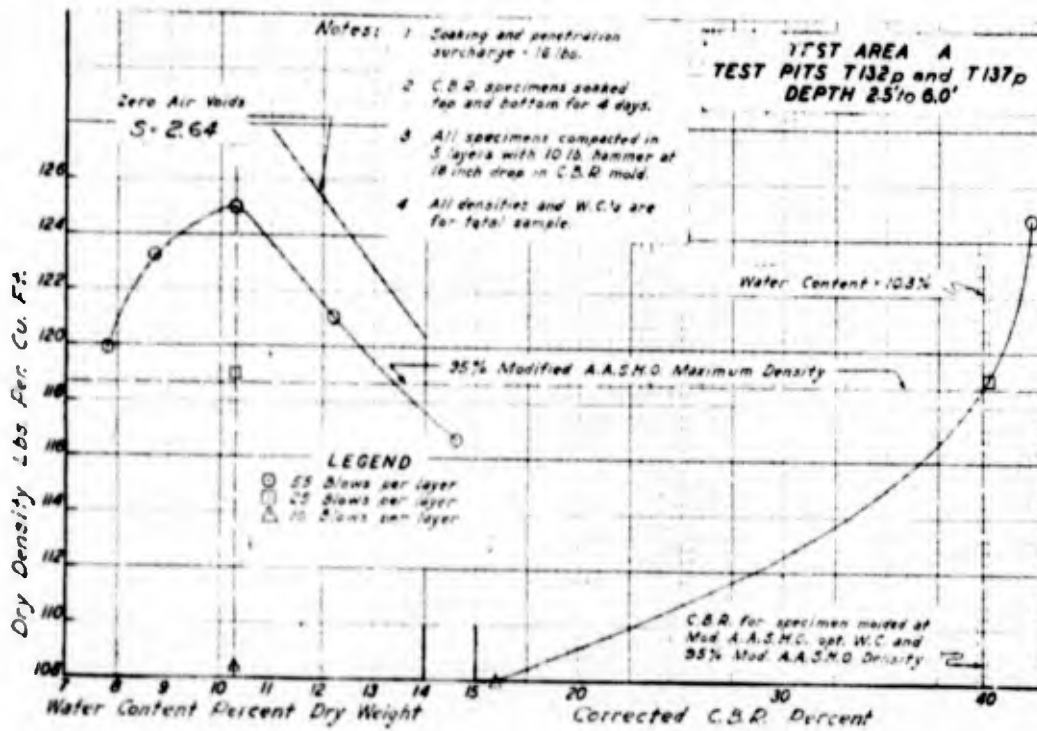
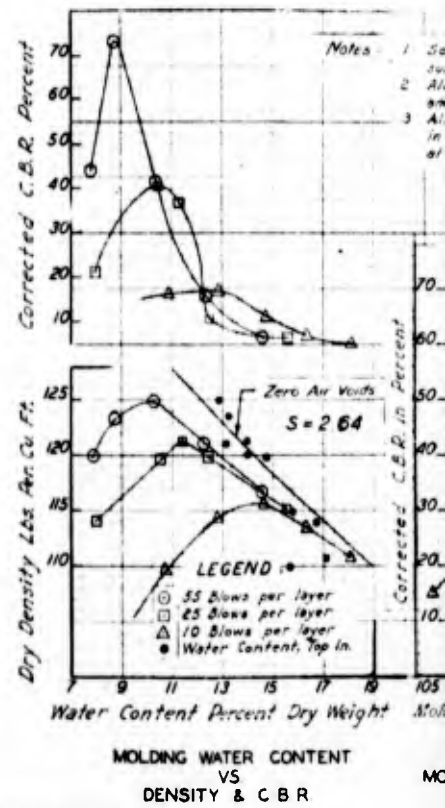
FIG. 1

SUBGRADE MATERIAL
TEST AREA A AND B

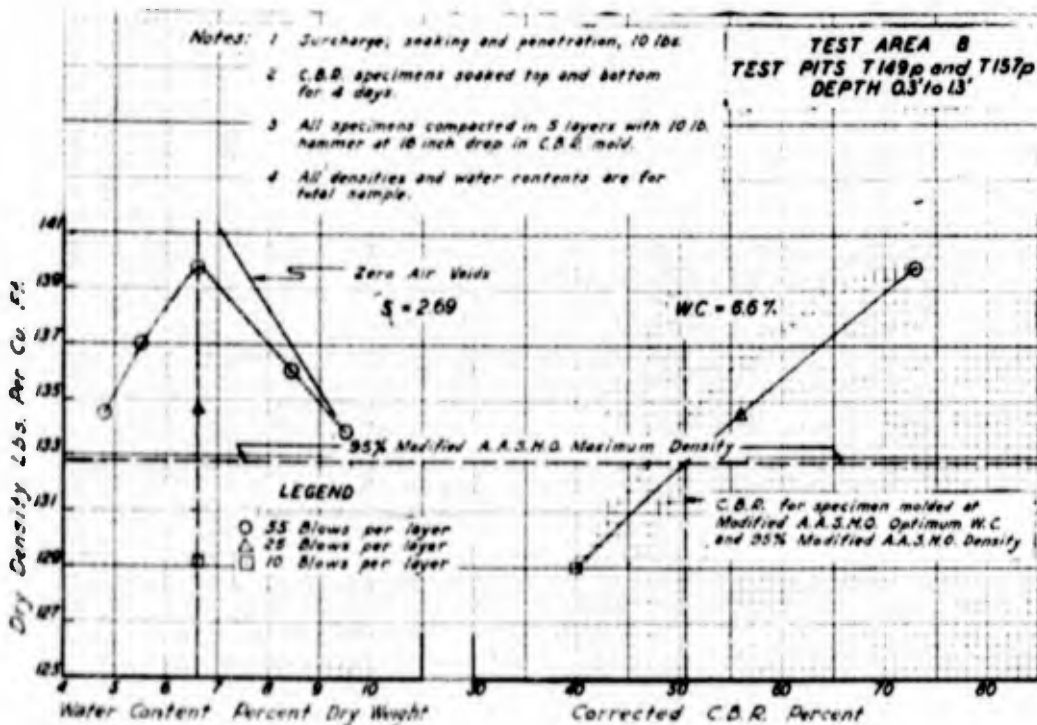
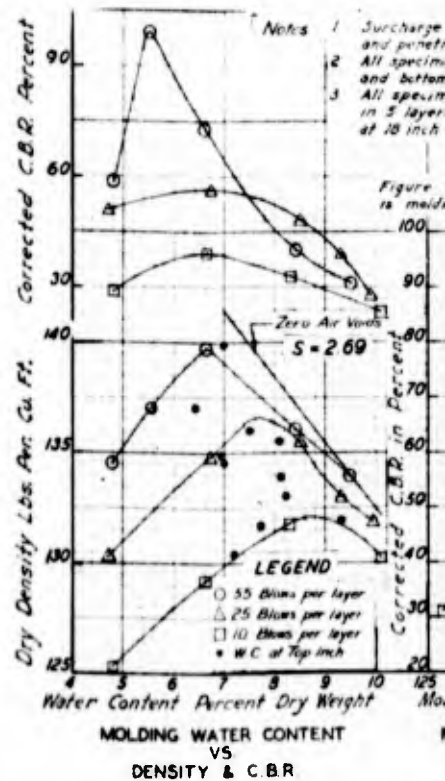
FIG. 3

BASE MATERIAL
TEST AREA B
