**NASA TN D-6098**

**A COMPARISON OF AIRCRAFT AND  
GROUND VEHICLE STOPPING PERFORMANCE  
ON DRY, WET, FLOODED, SLUSH-, SNOW-,  
AND ICE-COVERED RUNWAYS**

**Final Report on Project Combat Traction,  
a Joint USAF-NASA Program**

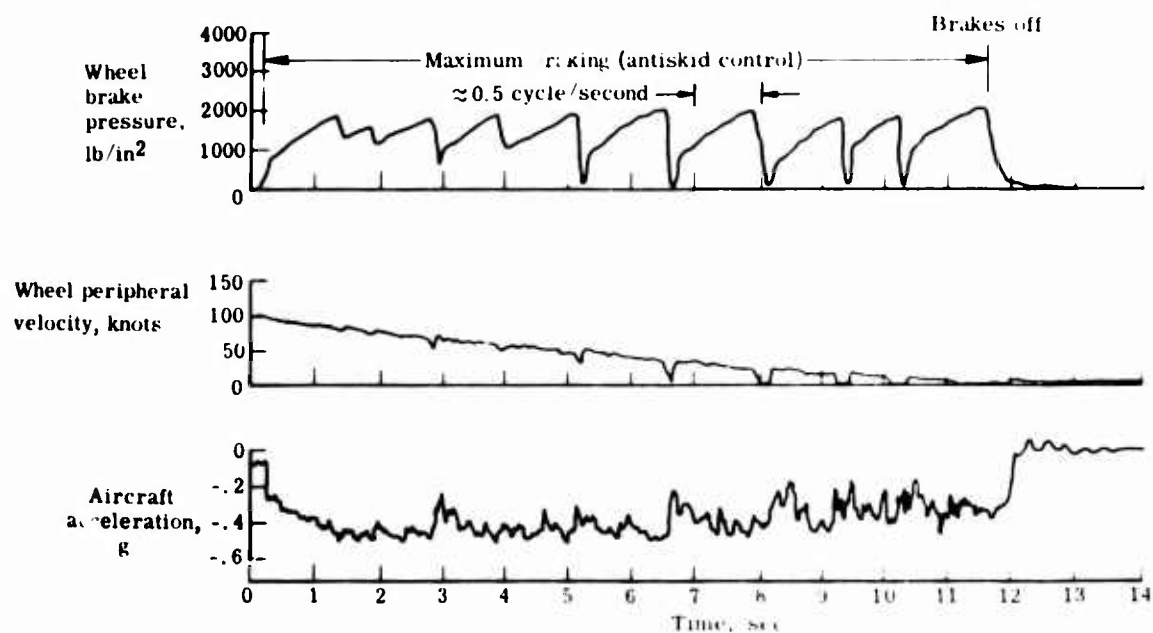
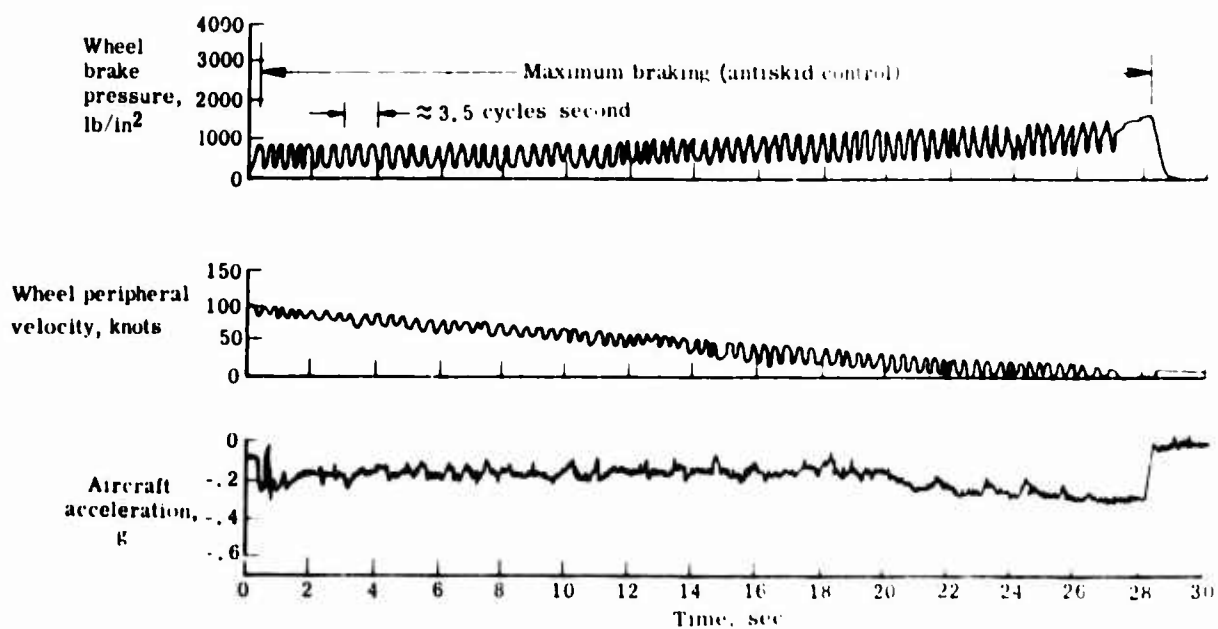
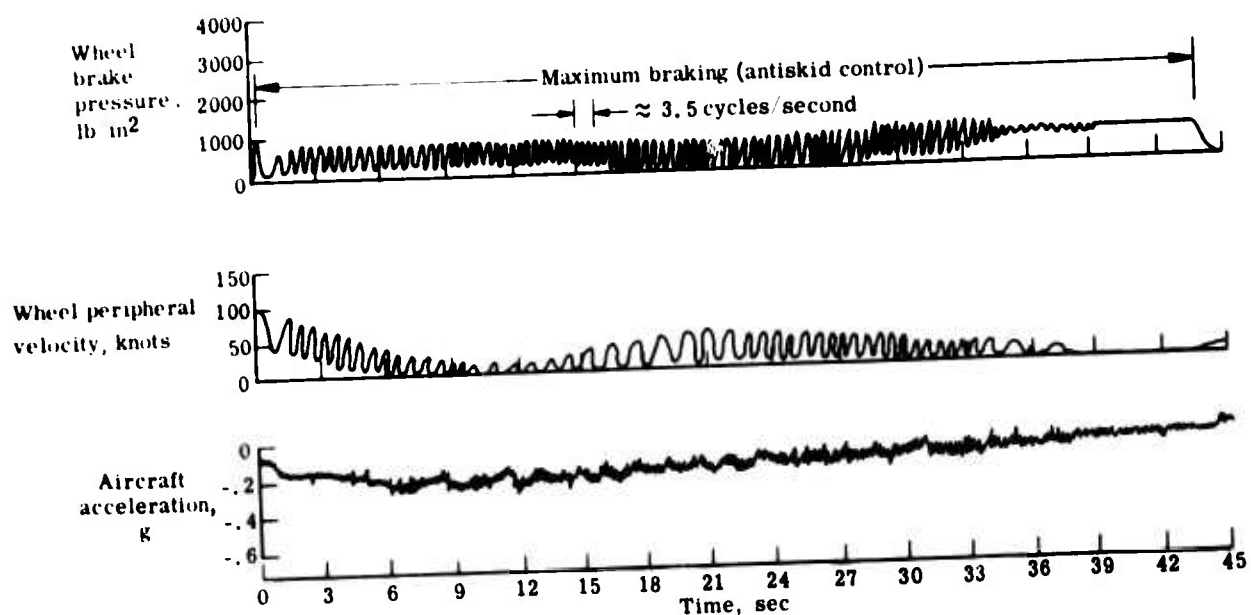
(a) Dry runway condition. Porous friction course at Marham RAFB.

(b) Wet runway condition (low friction). Concrete runway at England AFB.

Figure 6.- Examples of variation in C-141A aircraft wheel brake pressure and velocity and aircraft acceleration during maximum braking conditions on dry, wet, and ice-covered runway surfaces (left rear inboard wheel).

(c) Glazed-ice and snow-covered runway condition. Slurry seal runway at Loring AFB.

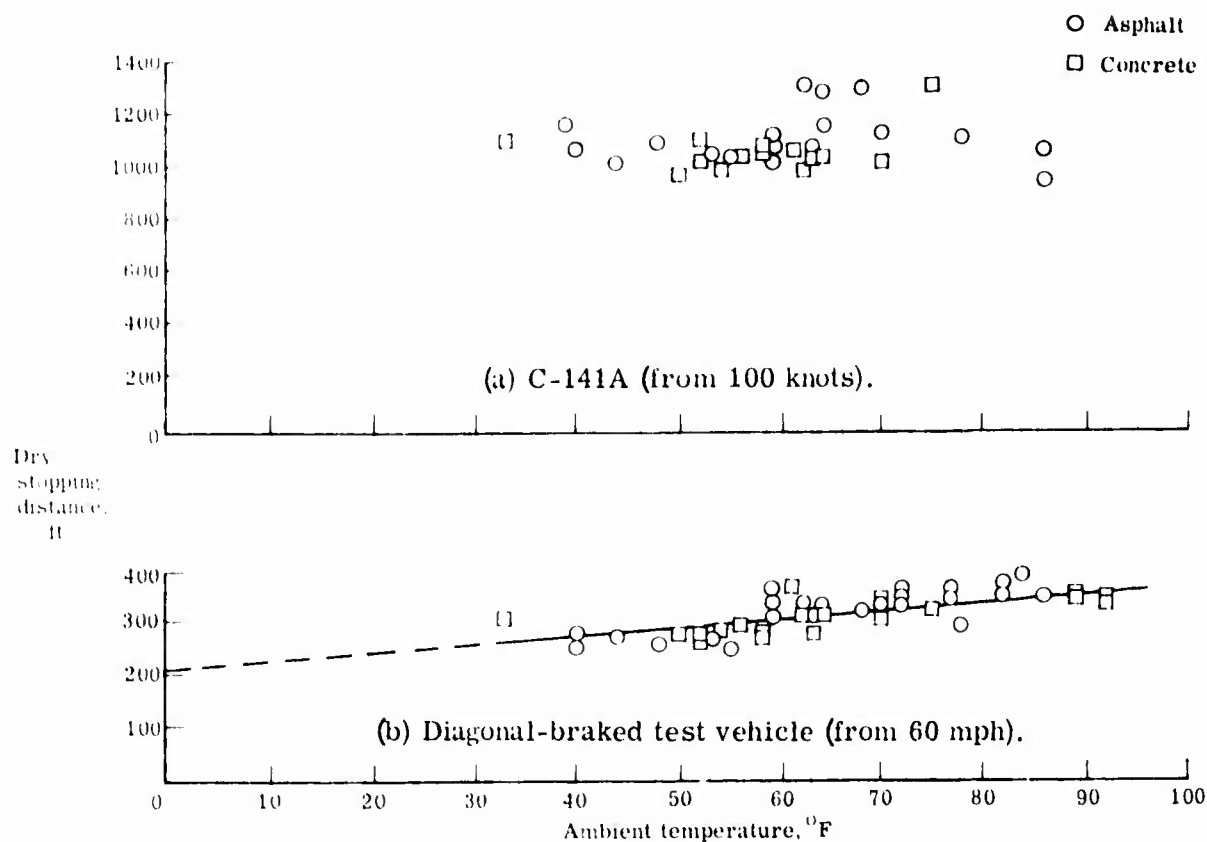
Figure 7. - Effects of runway ambient air temperature on aircraft and test vehicle dry runway stopping distance.

where  $T_r$  is the runway ambient air temperature in degrees Fahrenheit, and  $D_{\text{vehicle,dry}}$  is the stopping distance (from 60 mph) in feet. Equation (1) was derived from the range of runway ambient air temperature (33° F to 92° F) studied in this investigation. It is noted in figure 7 that considerable data scatter exists from the values predicted by equation (1). The aircraft tires used were from several different tire manufacturers, whereas the ASTM tires used on the test vehicle were constructed by one tire company according to rigid and detailed ASTM specifications on tire construction and tread rubber composition. Therefore the data scatter shown for the vehicle dry stopping distance cannot be attributed to the vehicle test tires. It is probable that factors such as measurement accuracy, wind velocity and direction, runway slope, and possibly changes in vehicle rolling resistance contributed to the scatter of the vehicle dry-stopping-distance data.

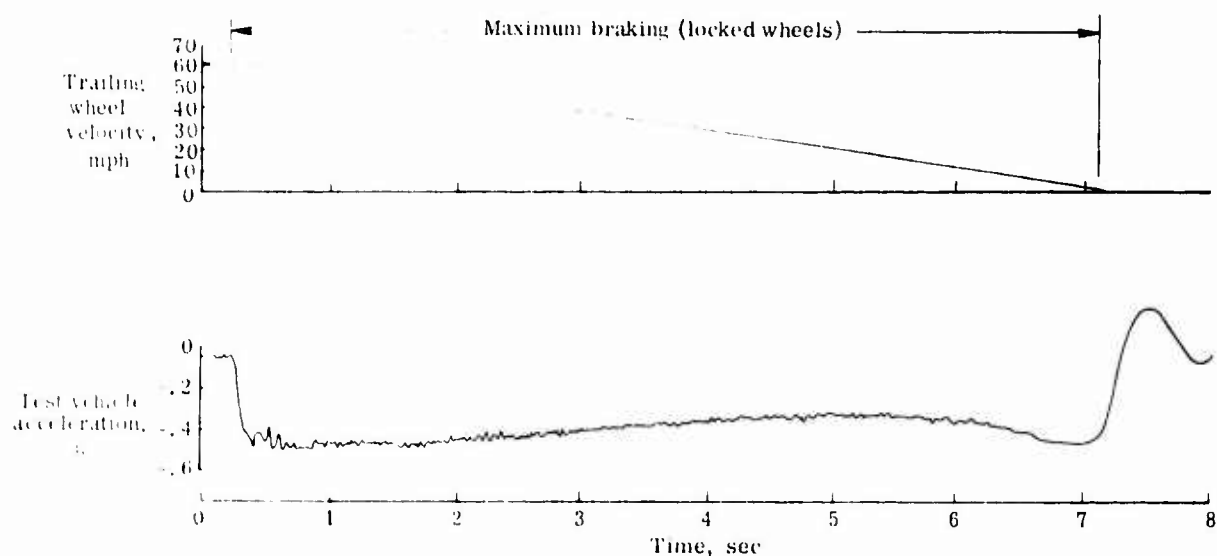
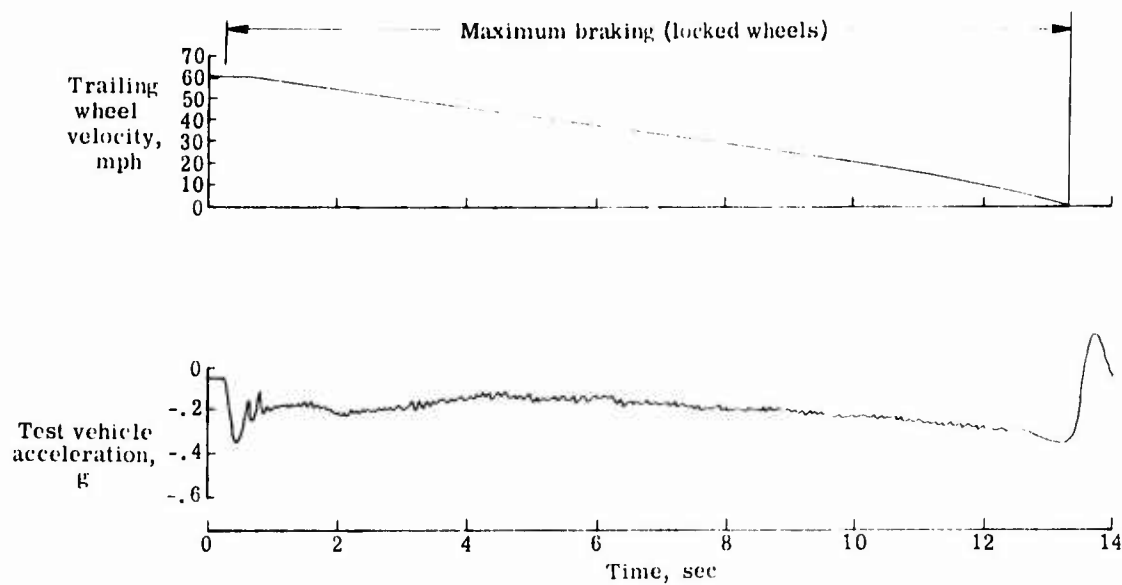
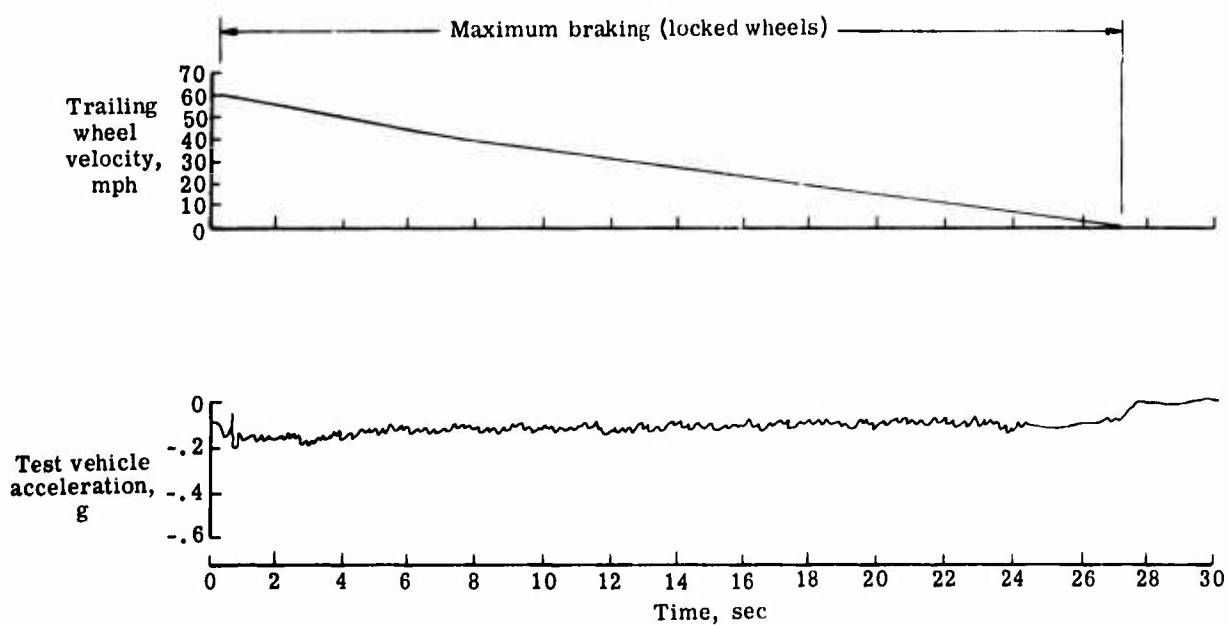
(a) Dry runway condition. Concrete runway at England AFB.

Figure 8. - Examples of variation in diagonal-braked test vehicle velocity and acceleration under locked-wheel braking conditions on dry, wet, and ice-covered runways.

(b) Wet runway condition. Concrete runway at England AFB.

(c) Glazed-ice and snow-covered runway condition. Slurry seal runway at Loring AFB.

The braking system utilized on the NASA diagonal-braked test vehicle caused the diagonal pair of ASTM smooth tread tires to be locked upon brake application by the driver. Thus, the kinetic energy developed by the test vehicle at 60-miles-per-hour brake-application speed on a dry runway was absorbed in a small contact patch on each of the two smooth tread tires. A typical time history of a dry runway braking stop by the diagonal-braked test vehicle is shown in figure 8(a). It can be seen that the deceleration of the test vehicle decreases with time from the initial high value at brake application speed until at some lower speed, the deceleration increases and reaches a peak value similar in magnitude to the initial deceleration peak at brake engagement speed. It is

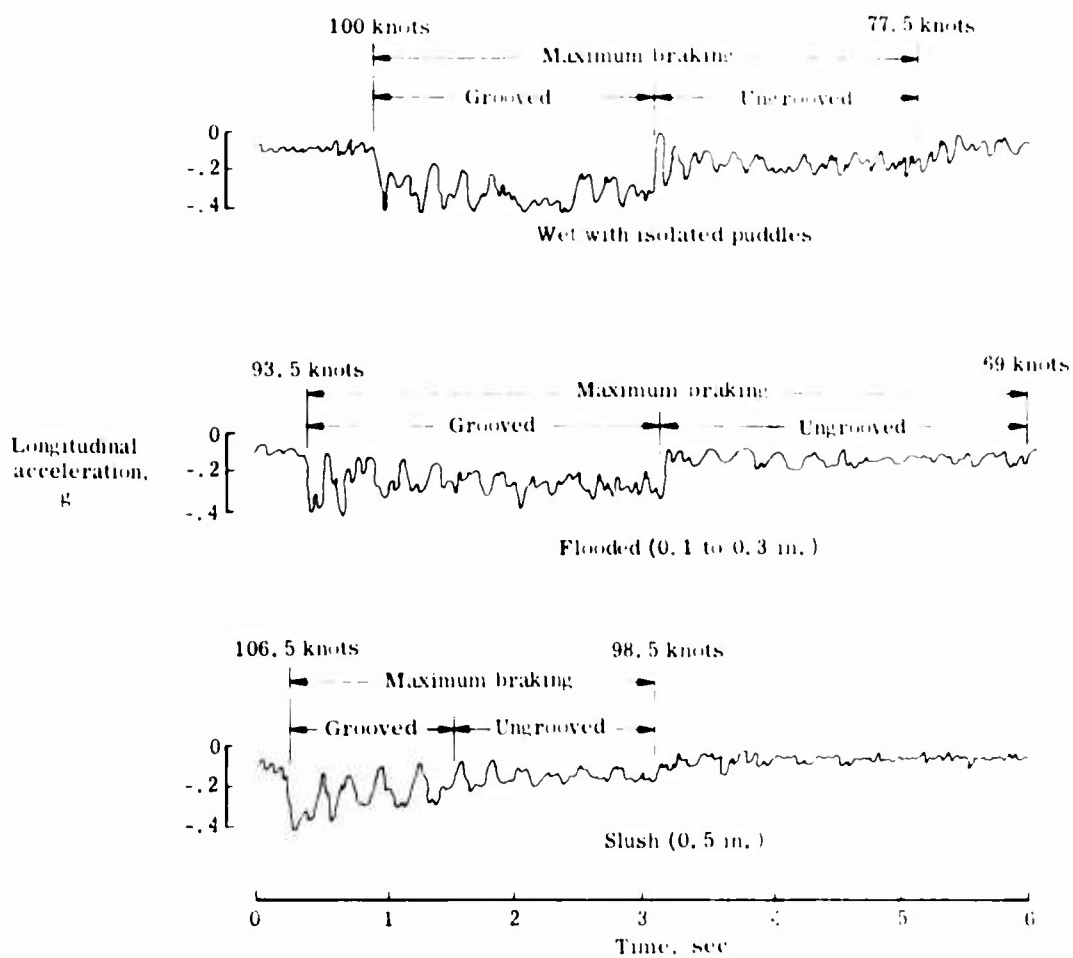
(a) General trends.

Figure 10.- Effects of grooving on raw data time histories.

(b) Tread effects (wet).

(c) Tread effects (flooded).

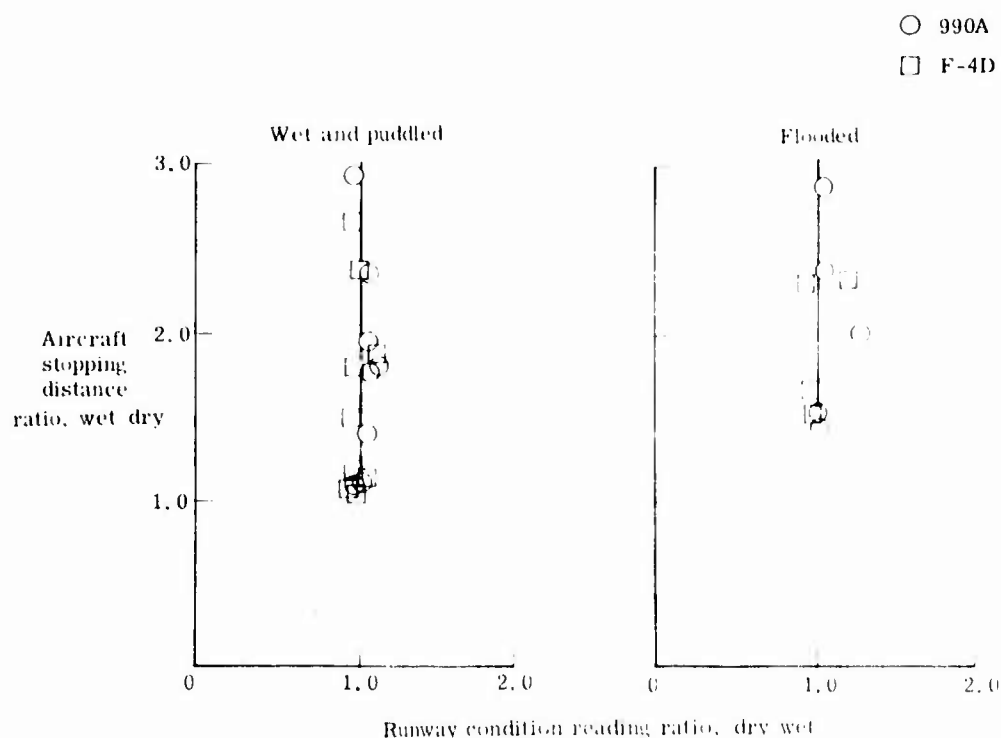
Figure 15.- Comparison of aircraft stopping distance ratios with RCR ratios.

Comments on the RCR system. - The data obtained from aircraft and ground vehicles during the present investigation offer an explanation for the unconservative performance of the RCR system in predicting aircraft stopping capability on wet runways and the conservative performance of the RCR system on snow- and ice-covered runways. The RCR system has a James brake decelerometer (damped pendulum instrument) installed securely on the floor of the front part of an airport ground vehicle, usually a station wagon. The brakes of the vehicle are firmly applied until all four wheels are fully locked at a ground speed ranging between 20 and 30 miles per hour on the runway to be tested. The maximum reading of the instrument, which is the deceleration in  $\text{ft}/\text{sec}^2$ , is noted; this value is the RCR number. The vehicle must be equipped with standard or snow tires in good repair. The standard tires just described have an efficient tread design for improving tire traction on wet pavements. At a vehicle speed of 20 to 30 mph, it can be expected on wet pavements that the vehicle performance will be influenced more by tire-tread design than by the basic runway slipperiness. As a further example of this point, consider the data shown in figure A1(h) for the Lockbourne Air Force Base wet concrete runway. At a ground speed of 20 knots, there is little difference between the aircraft wet and dry friction coefficients (lower part of fig. A1(h)); this result is the same as that indicated by the RCR vehicle at approximately the same speed, 23 dry and 22.5 wet. However, it will be noticed that at high speeds (up to 100 knots), the wet runway is very slippery to the aircraft as indicated by the much lower friction coefficients obtained. This condition results in a relatively high stopping distance ratio (2.05) which

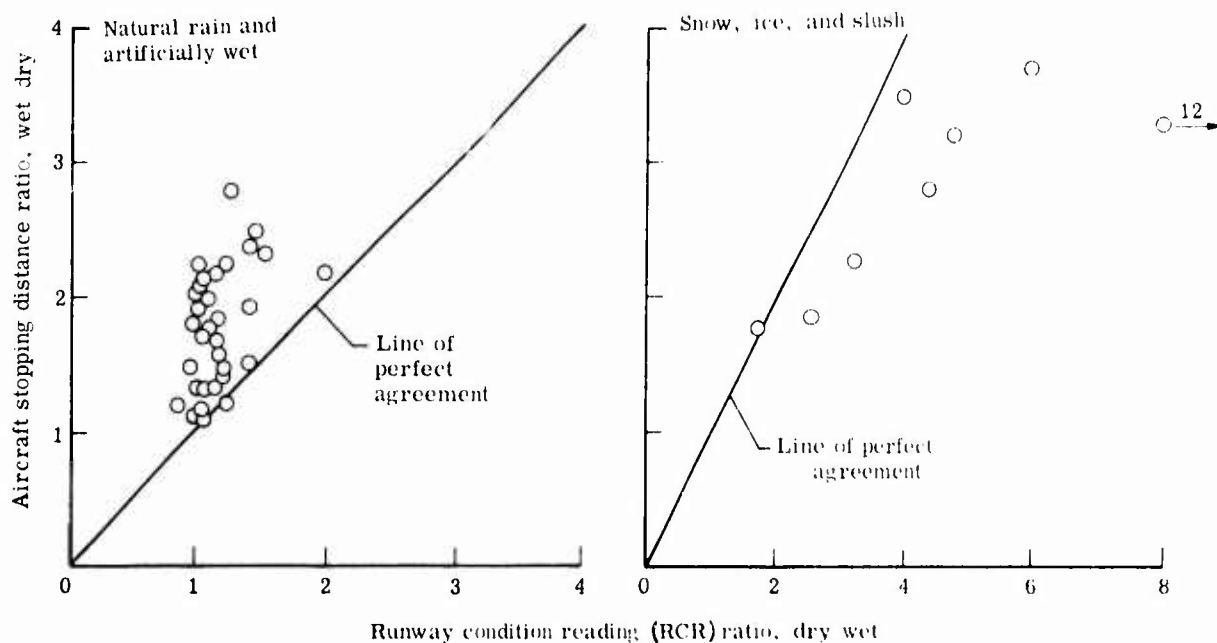
Vehicle test conditions: velocity, 30 mph; four-wheel skid; typical production tires; tire pressure, 24 lb/in<sup>2</sup>; tire vertical load, 1012 lb (1968 NASA-Air Force Study, ref. 1).

Figure 16.- Correlation between C-141A aircraft and RCR test vehicle.

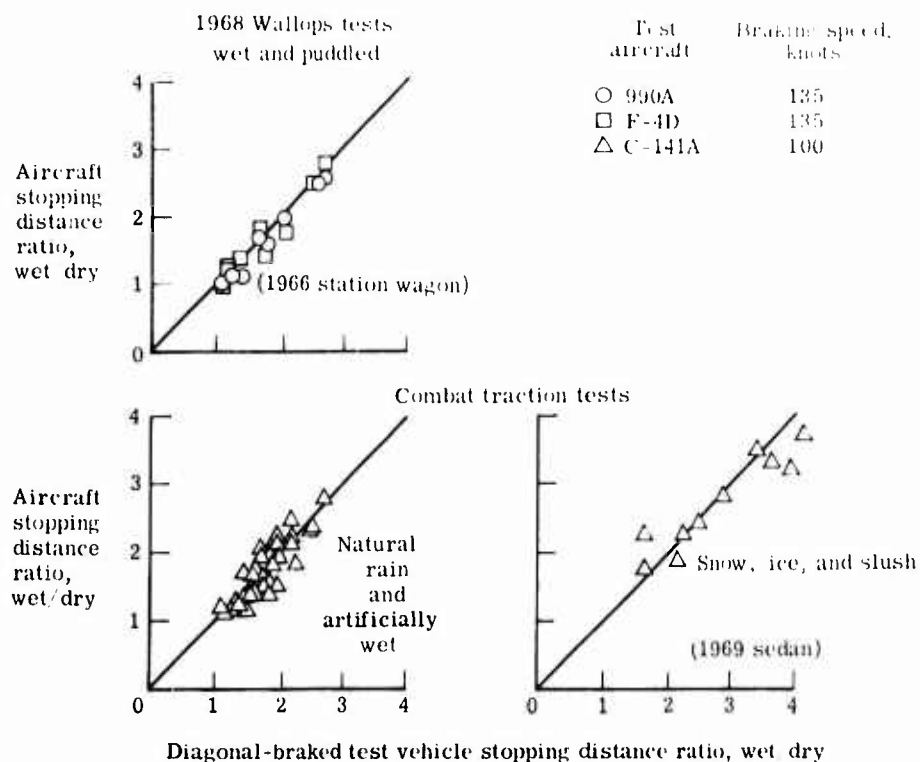
Figure 17.- Correlation between aircraft and test vehicle stopping distance ratios. The diagonal-braked test vehicle stopping distance ratio was determined by using a dry stopping distance of 302 feet for the snow, ice, and slush tests.

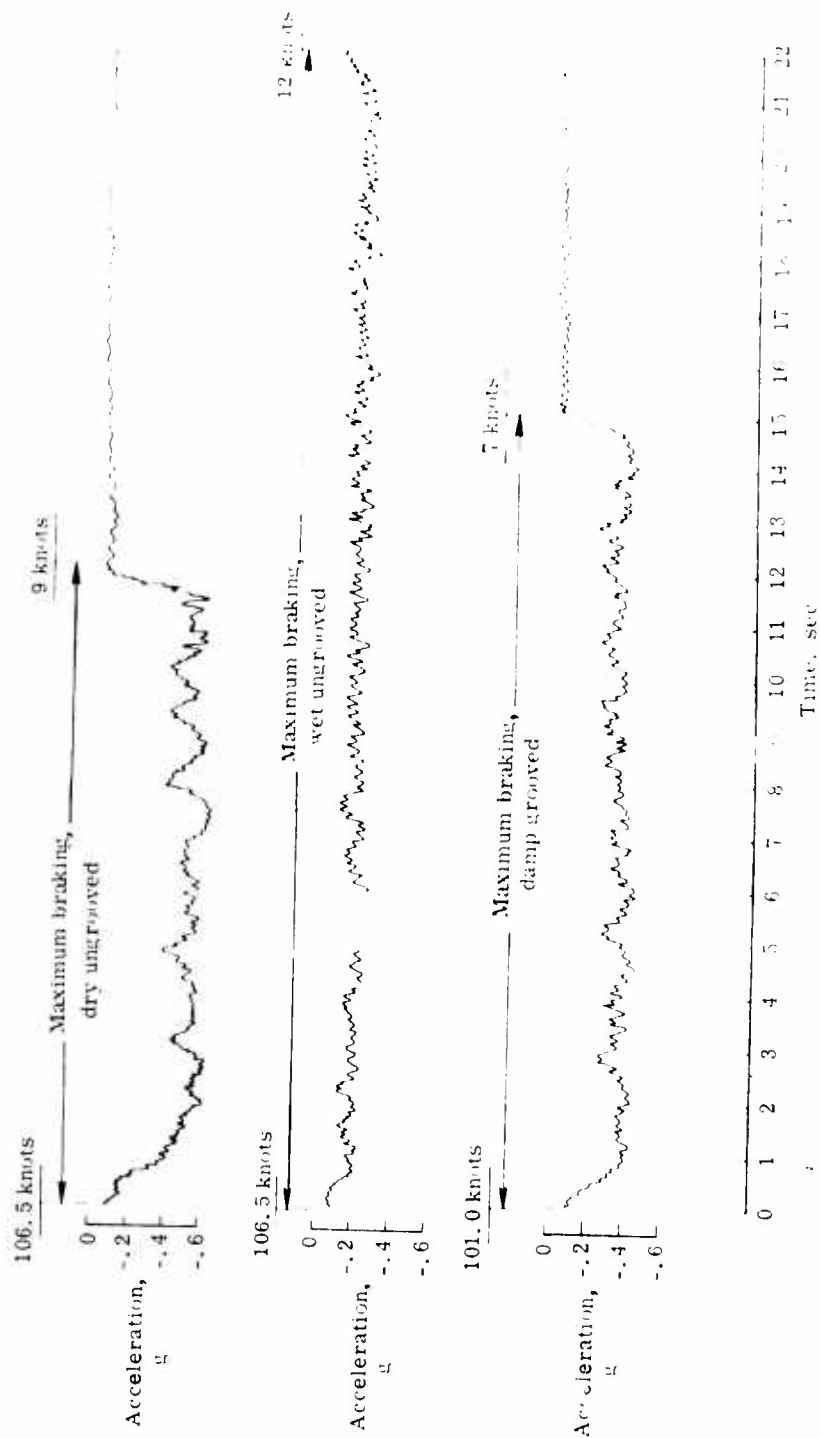
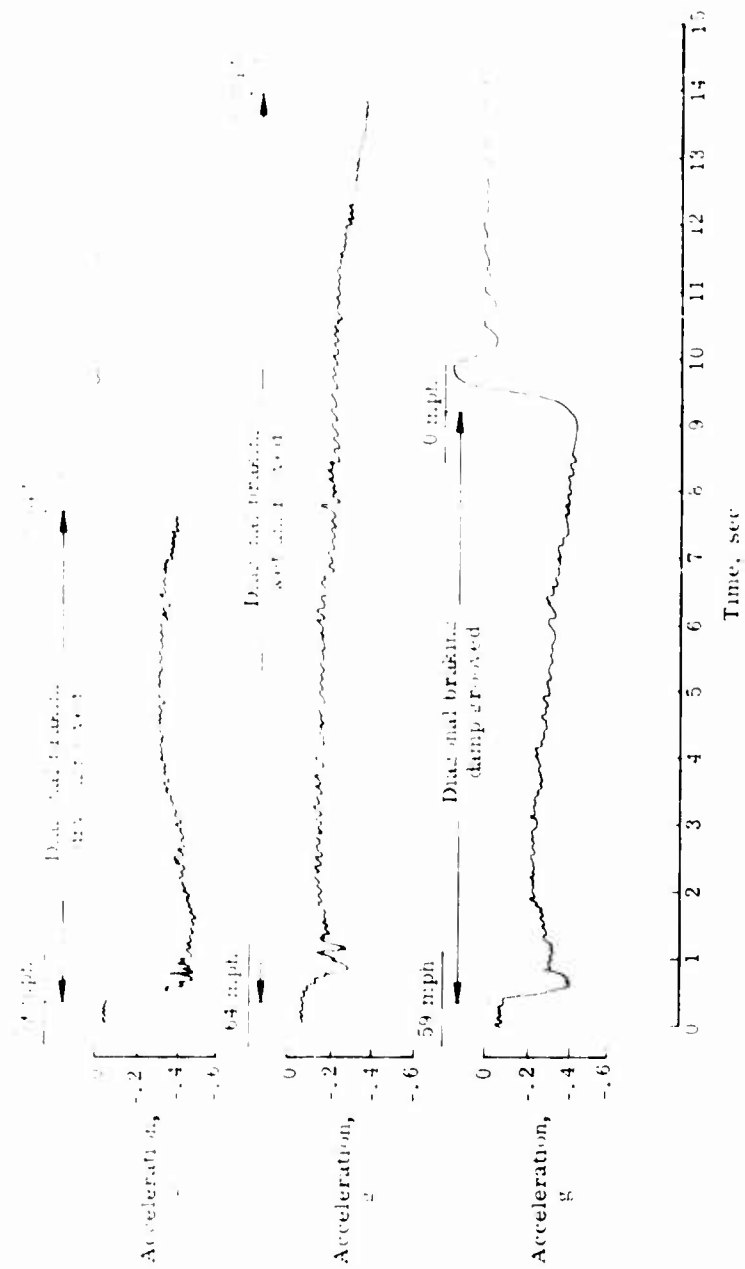
(a) C-141A aircraft.

Figure 18.- Braking at Offutt AFB on ungrooved and grooved runway surfaces under dry and wet conditions.

(b) Diagonal-braked test vehicle.

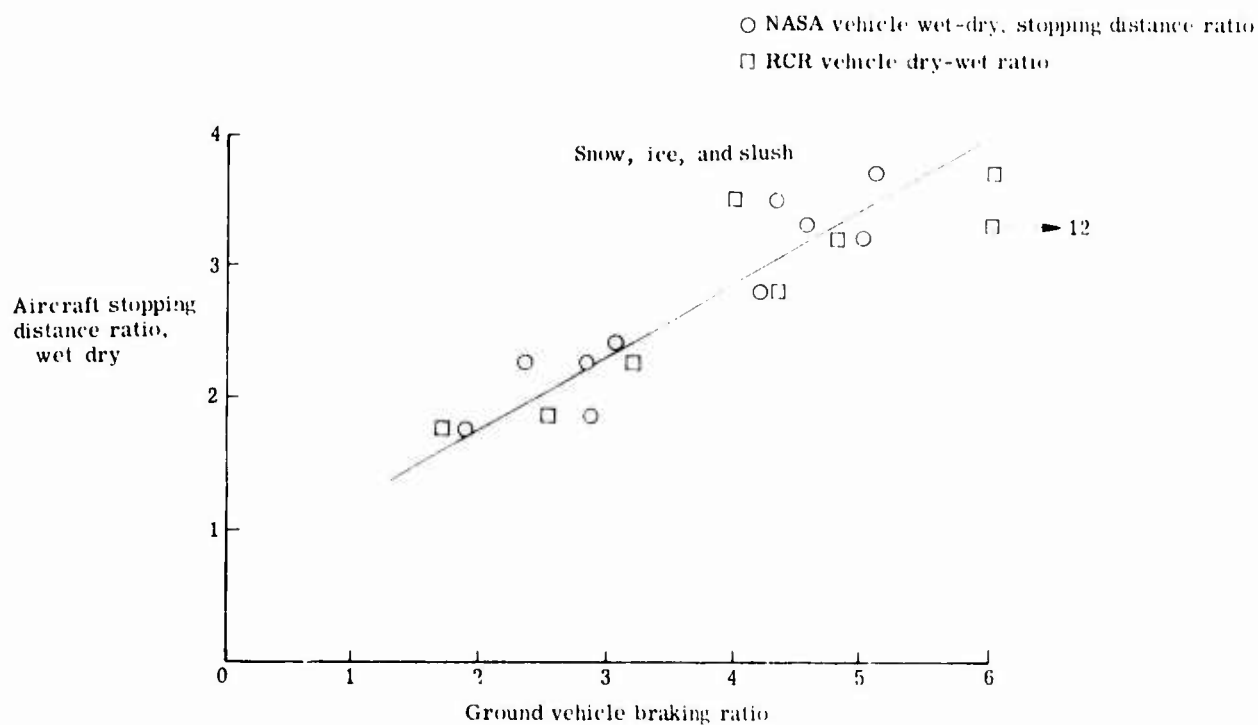
Figure 20.- Correlation between aircraft and ground vehicle braking ratio.

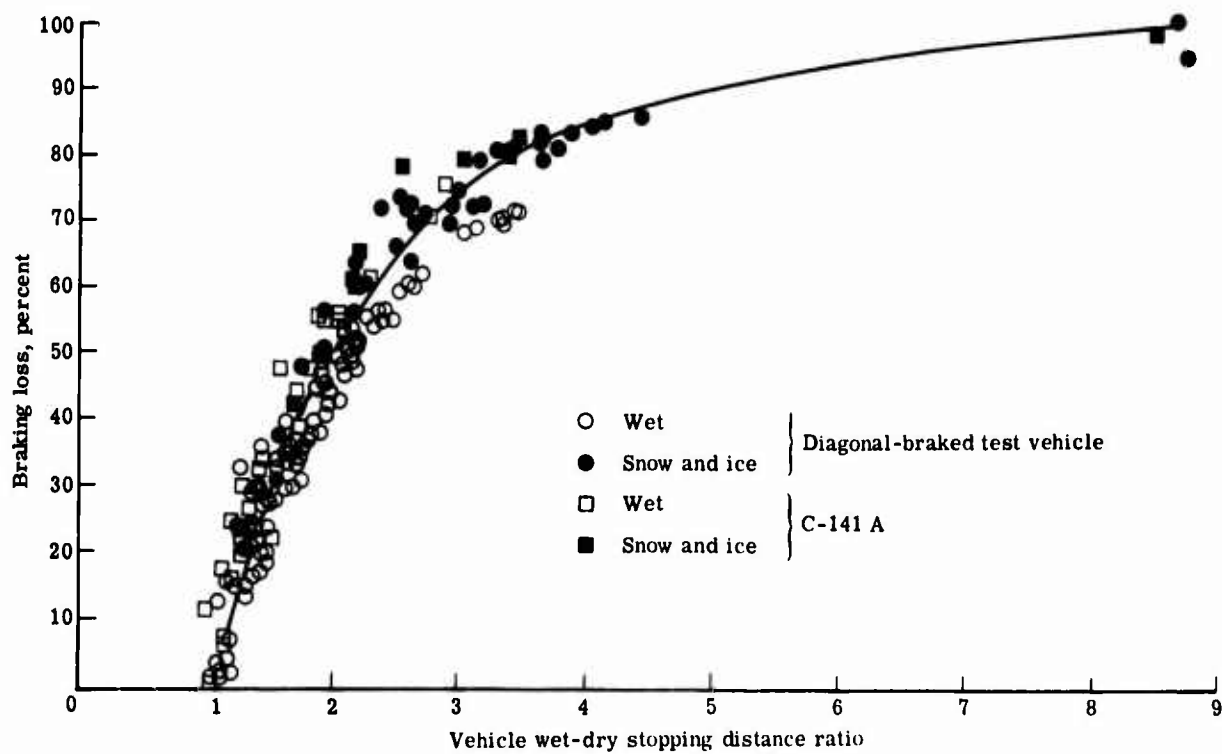
Figure 21. Effect of runway slipperiness on stopping distances and tire traction of C-141A aircraft and NASA diagonal-braked test vehicle.

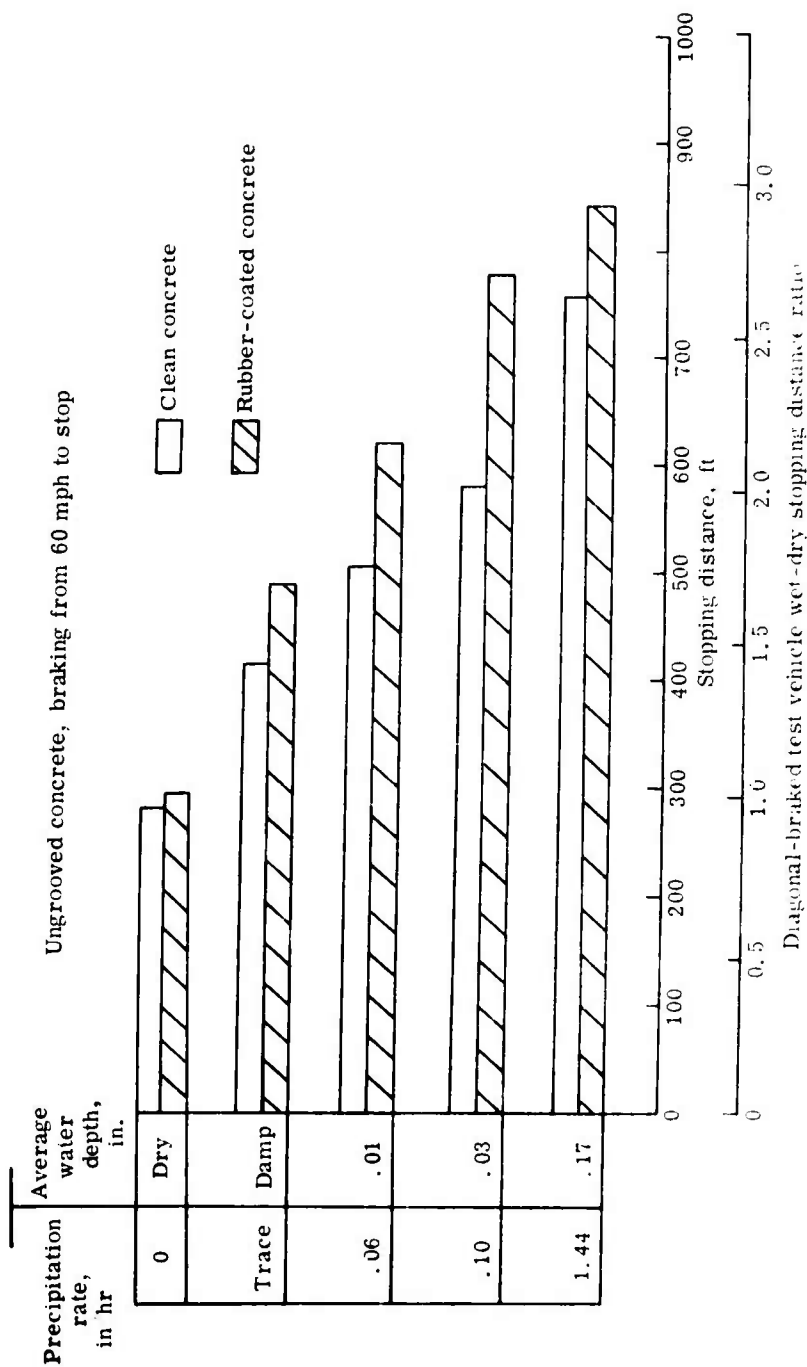
Sketch (a)

As discussed earlier in the paper, U.S. Air Force aircraft flight manual take-off and landing distance charts are based on RCR numbers. This section of the paper develops a method for converting diagonal-braked test vehicle wet-dry stopping distance ratios to equivalent RCR values. These charts are constructed on the basis of a linear variation of RCR and aircraft braking coefficient as shown in sketch (a).

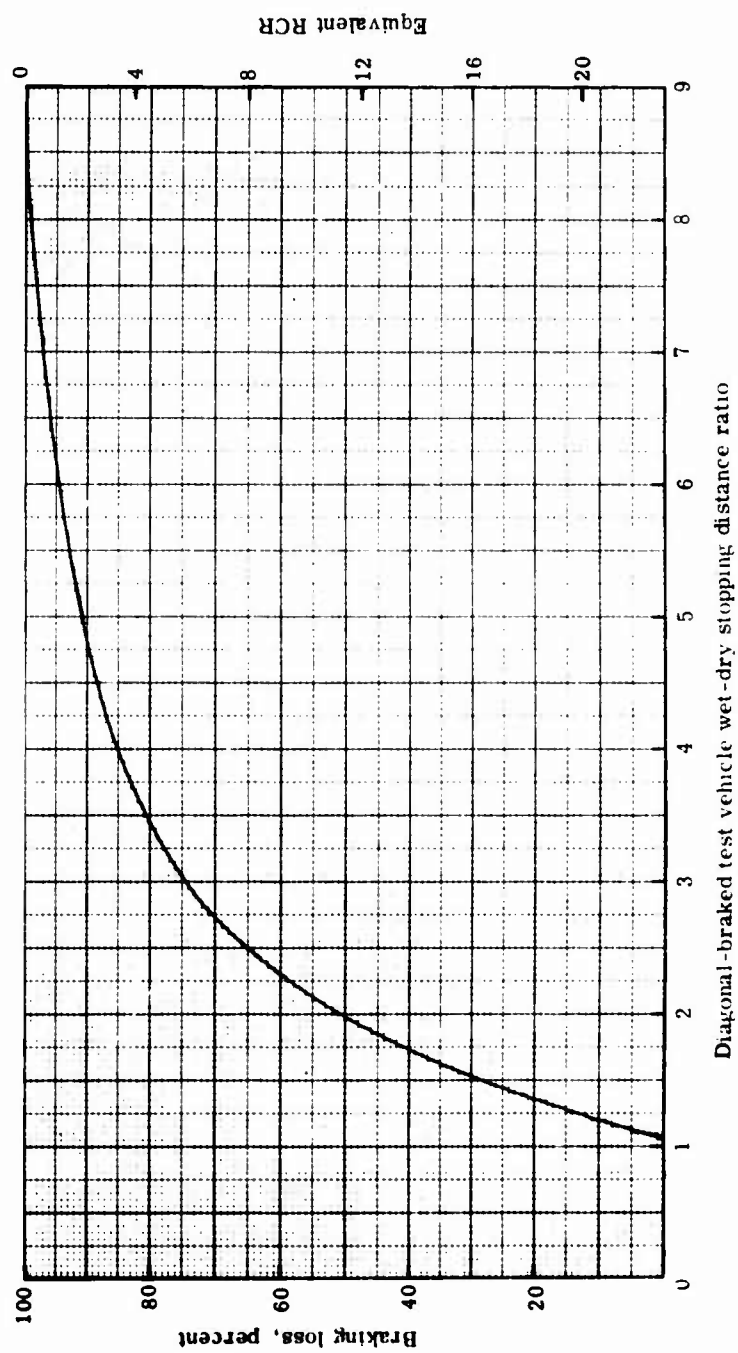
Figure 23.- Conversion of diagonal-braked test vehicle wet-dry stopping distance ratio to the equivalent RCR.

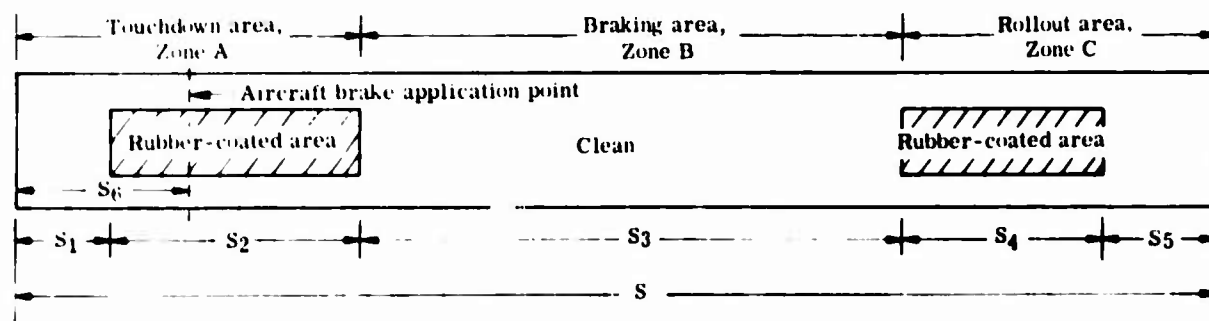
Figure 25.- Method for calculating the average diagonal-braked test vehicle wet-dry stopping distance ratio  $\bar{X}$  for a given aircraft landing condition.

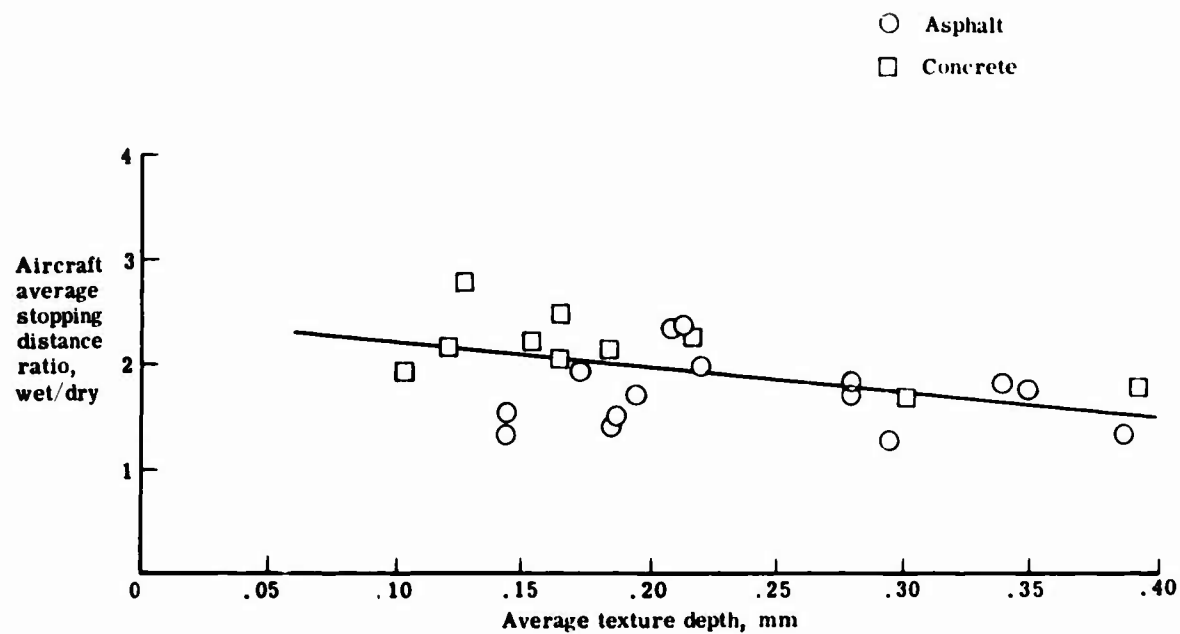
Figure 26.- Variation of aircraft wet-dry stopping distance ratio with runway surface average texture depth (NASA grease test).

Conventional surface treatments (snow- and ice-covered conditions). - When snow or ice accumulate on a runway surface to a depth and density that prevents aircraft tires from actually contacting the bare pavement surface, it is obvious that the particular pavement surface treatment underlying the snow or ice cover will have no effect on the aircraft or ground vehicle braking action. The safety hazards that snow and ice create on a runway surface are readily apparent from the magnitude of the aircraft wet-dry stopping distance ratios which are as high as 3.71 (table II). It is noted that these values were

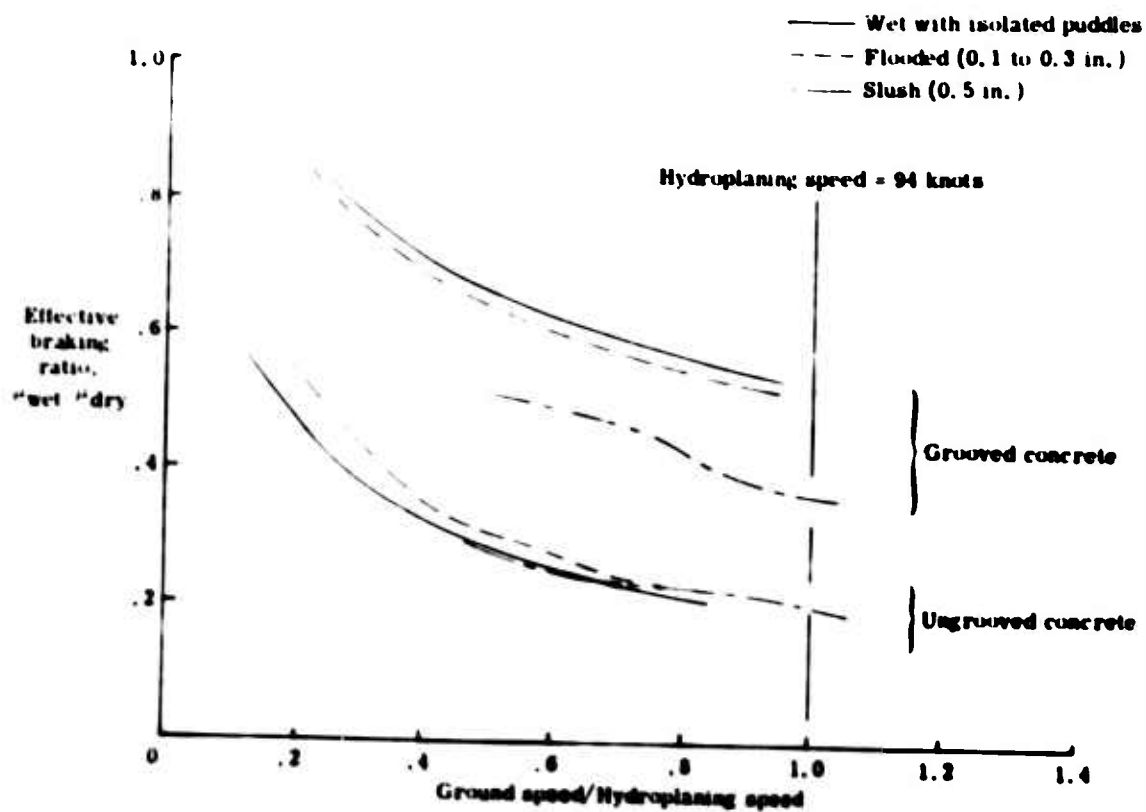
(a) 990A aircraft; five-groove tire; inflation pressure, 160 lb/in<sup>2</sup>.

Figure 27.- Effect of runway grooves on aircraft braking performance.

(b) C-141A aircraft; five-groove tire; inflation pressure, 110 lb/in<sup>2</sup>.

Unconventional surface treatments (slush, snow, or ice conditions).- The limited braking tests at Wallops Station show that for the C-141A and 990A aircraft, grooved pavements are superior to ungrooved pavements when under a slush cover. (See fig. 27.) The porous asphalt friction course was not studied under a slush condition in this

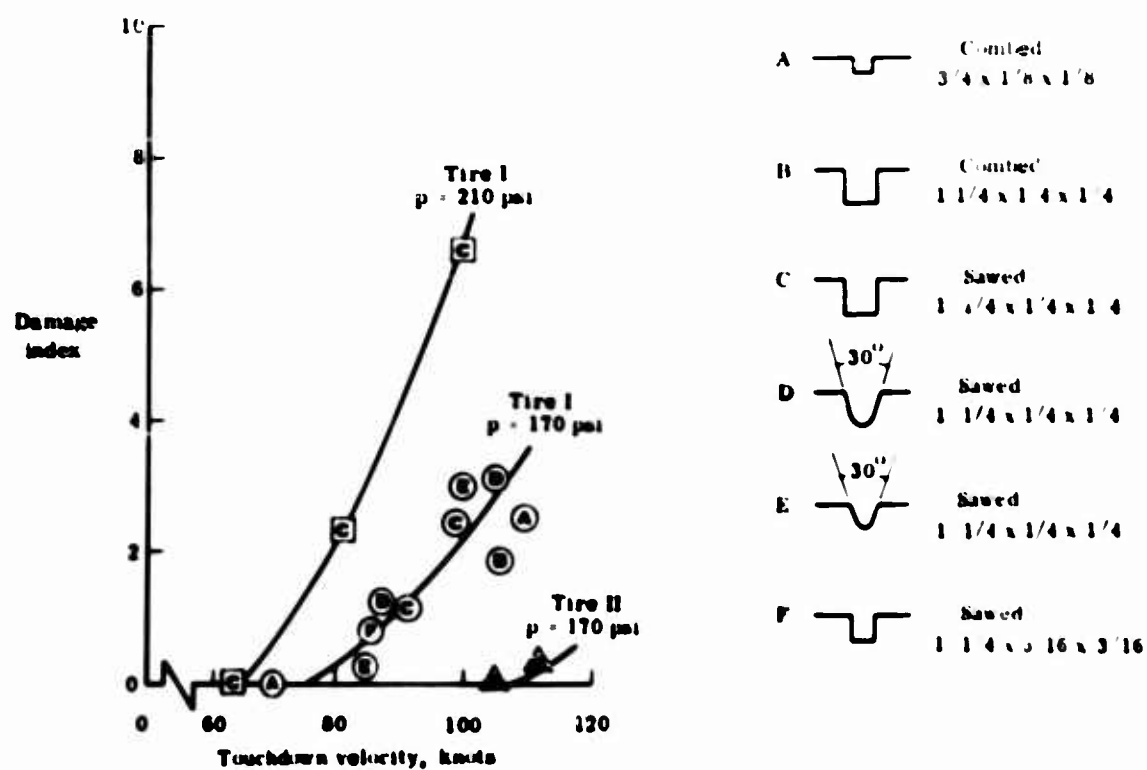
Figure 28.- Tire chevron cutting on grooved surfaces. 49 x 17 tire; vertical velocity, 2.5 ft/sec. Measurements are in inches for runway surfaces unless otherwise noted.

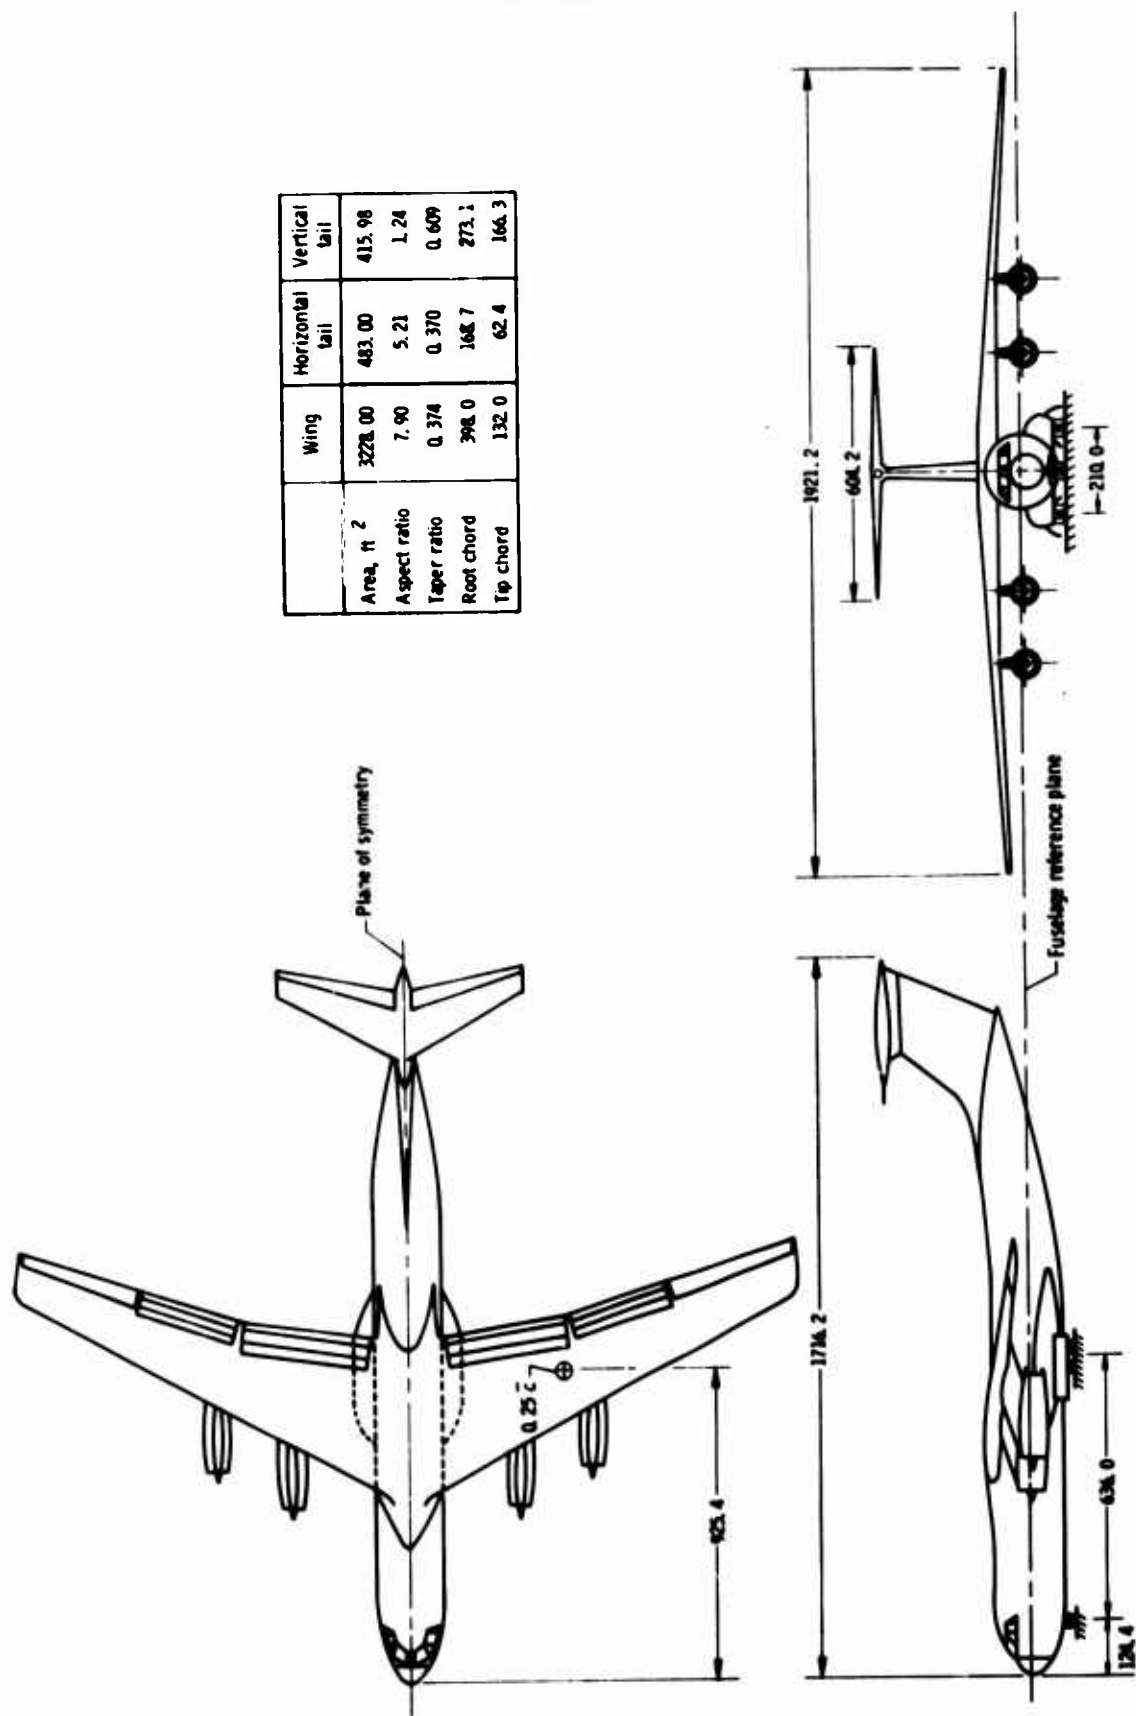
Figure B1.- Three-view drawing of C-141A test aircraft. All dimensions are in inches unless otherwise specified.
