**NASA TN D-6098**

**A COMPARISON OF AIRCRAFT AND  
GROUND VEHICLE STOPPING PERFORMANCE  
ON DRY, WET, FLOODED, SLUSH-, SNOW-,  
AND ICE-COVERED RUNWAYS**

**Final Report on Project Combat Traction,  
a Joint USAF-NASA Program**

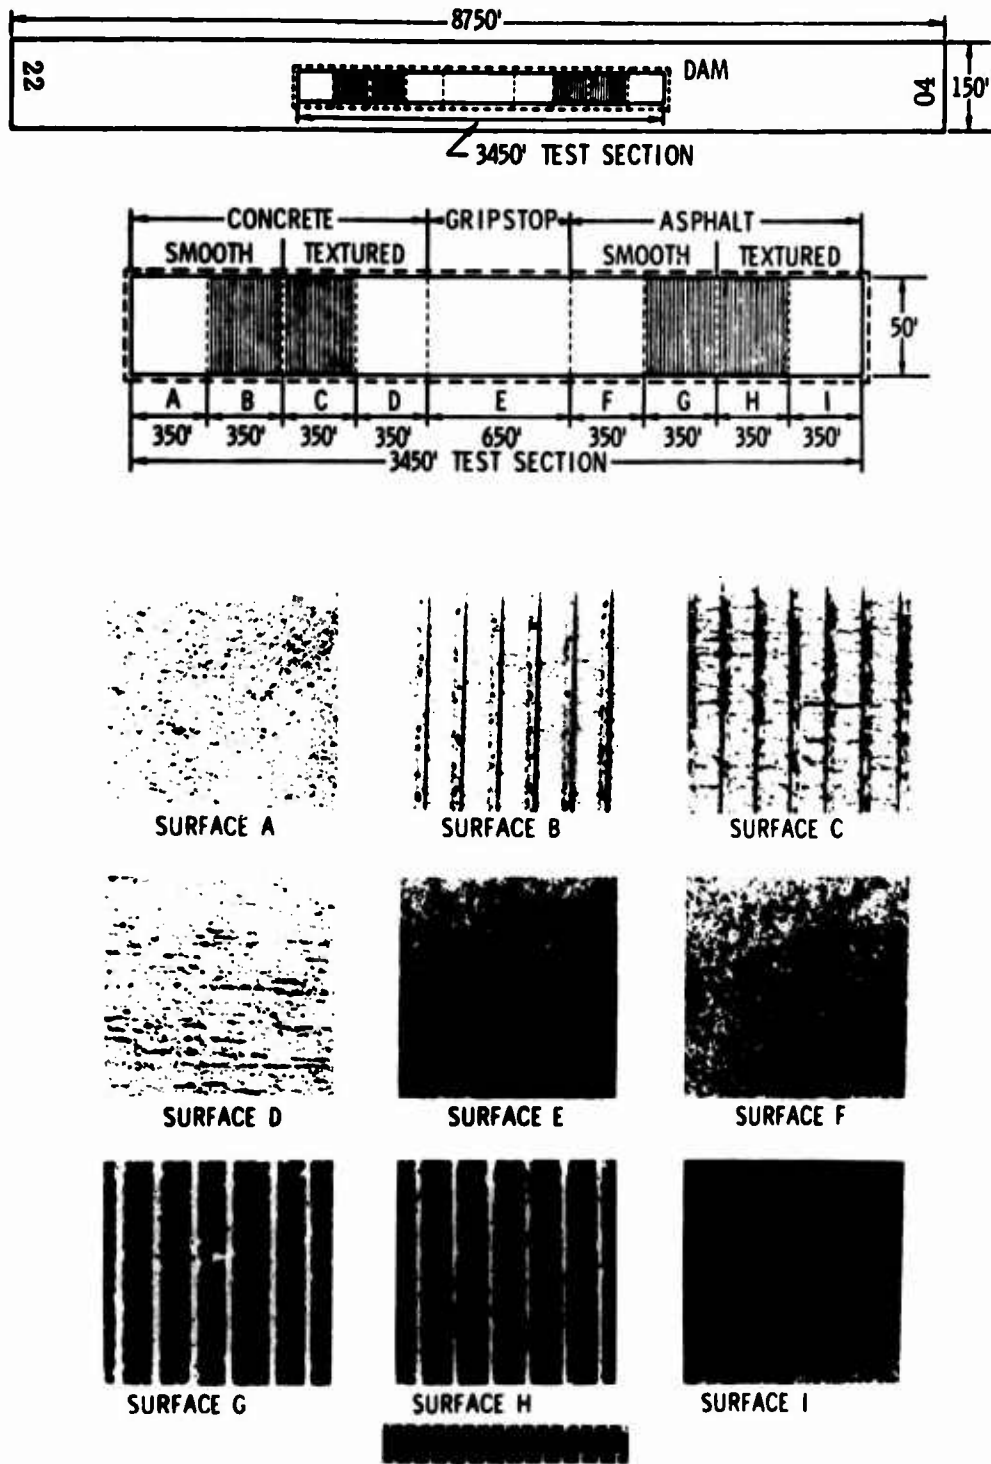
Figure C1.- Landing research runway at Wallops Station, Virginia.

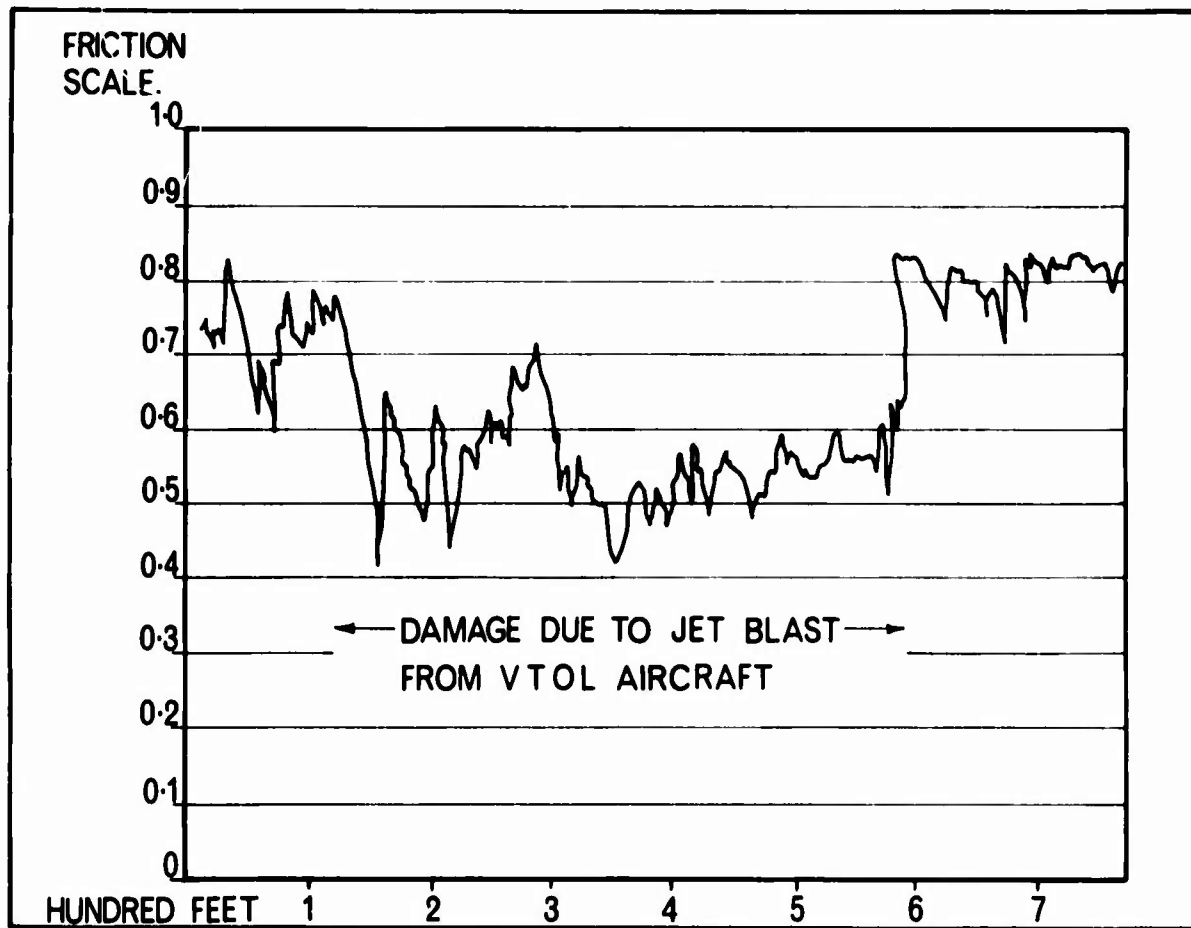
Figure D3.- Friction meter record of runway damage due to jet blast from VTOL aircraft.

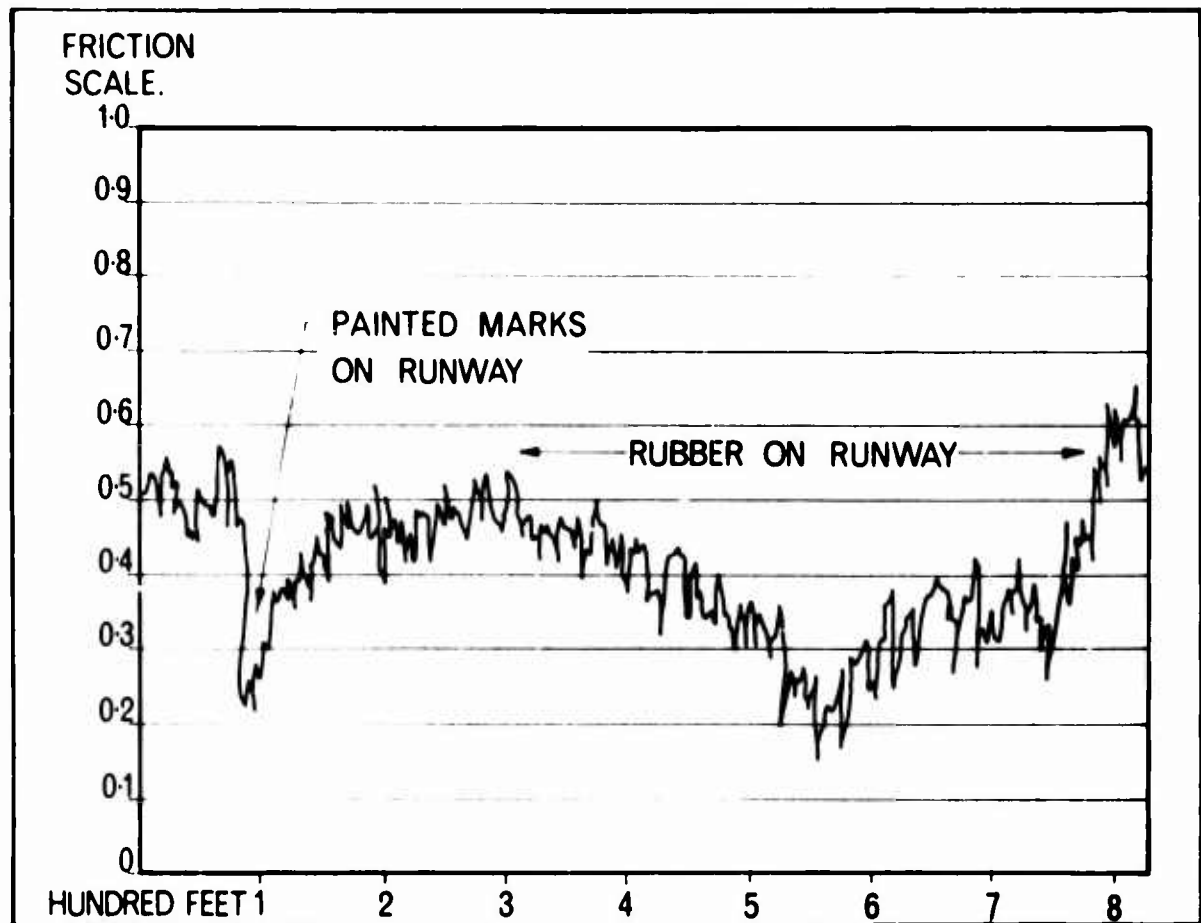
Figure D4.- Part of friction meter record showing rubber deposits in touchdown area.
