Technical Report

**ULTIMATE HORIZONTAL SHEAR STRENGTH OF  
PRESTRESSED SPLIT BEAMS**

Technical Report R-707

S. B. Nosseir and R. N. Murtha

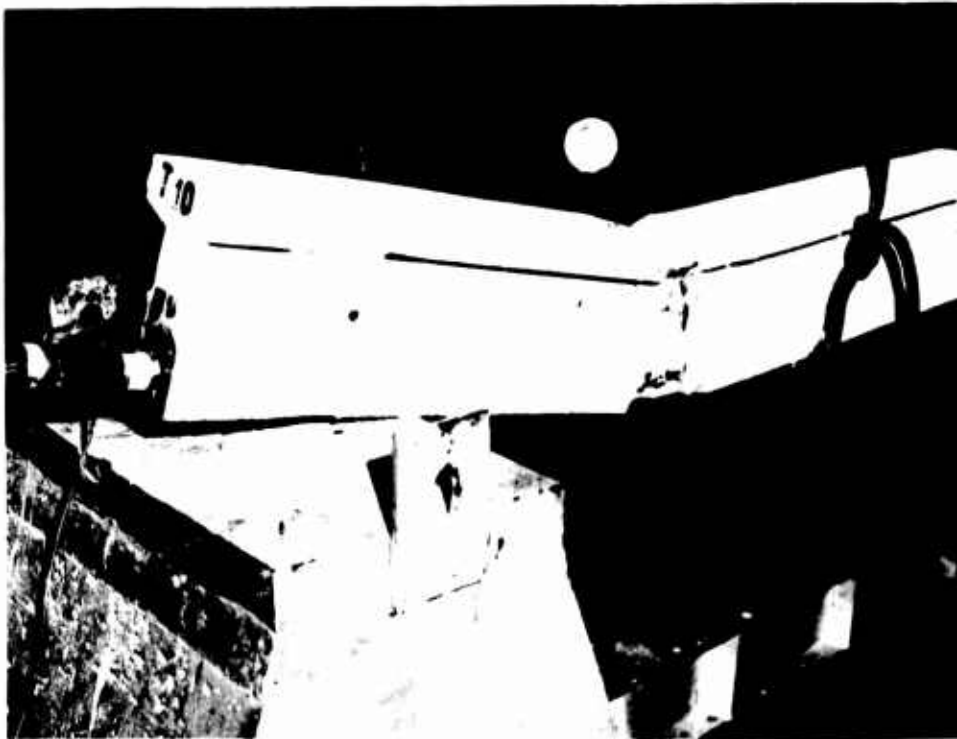
Figure 13. Flexural failure of beam S2.0.

Failure occurred by the crushing of concrete underneath a loading point as shown in Figure 13; this was accompanied by a separation along the interface between the two supports. At failure, the increase in the value of the prestressing force at the beam end was 7.5 kips.
