INVESTIGATION TO DEVELOP A HIGH STRENGTH STRESS-CORROSION RESISTANT NAVAL AIRCRAFT ALUMINUM ALLOY

BY J. T. STALEY

FINAL REPORT

Alcoa Research Laboratories

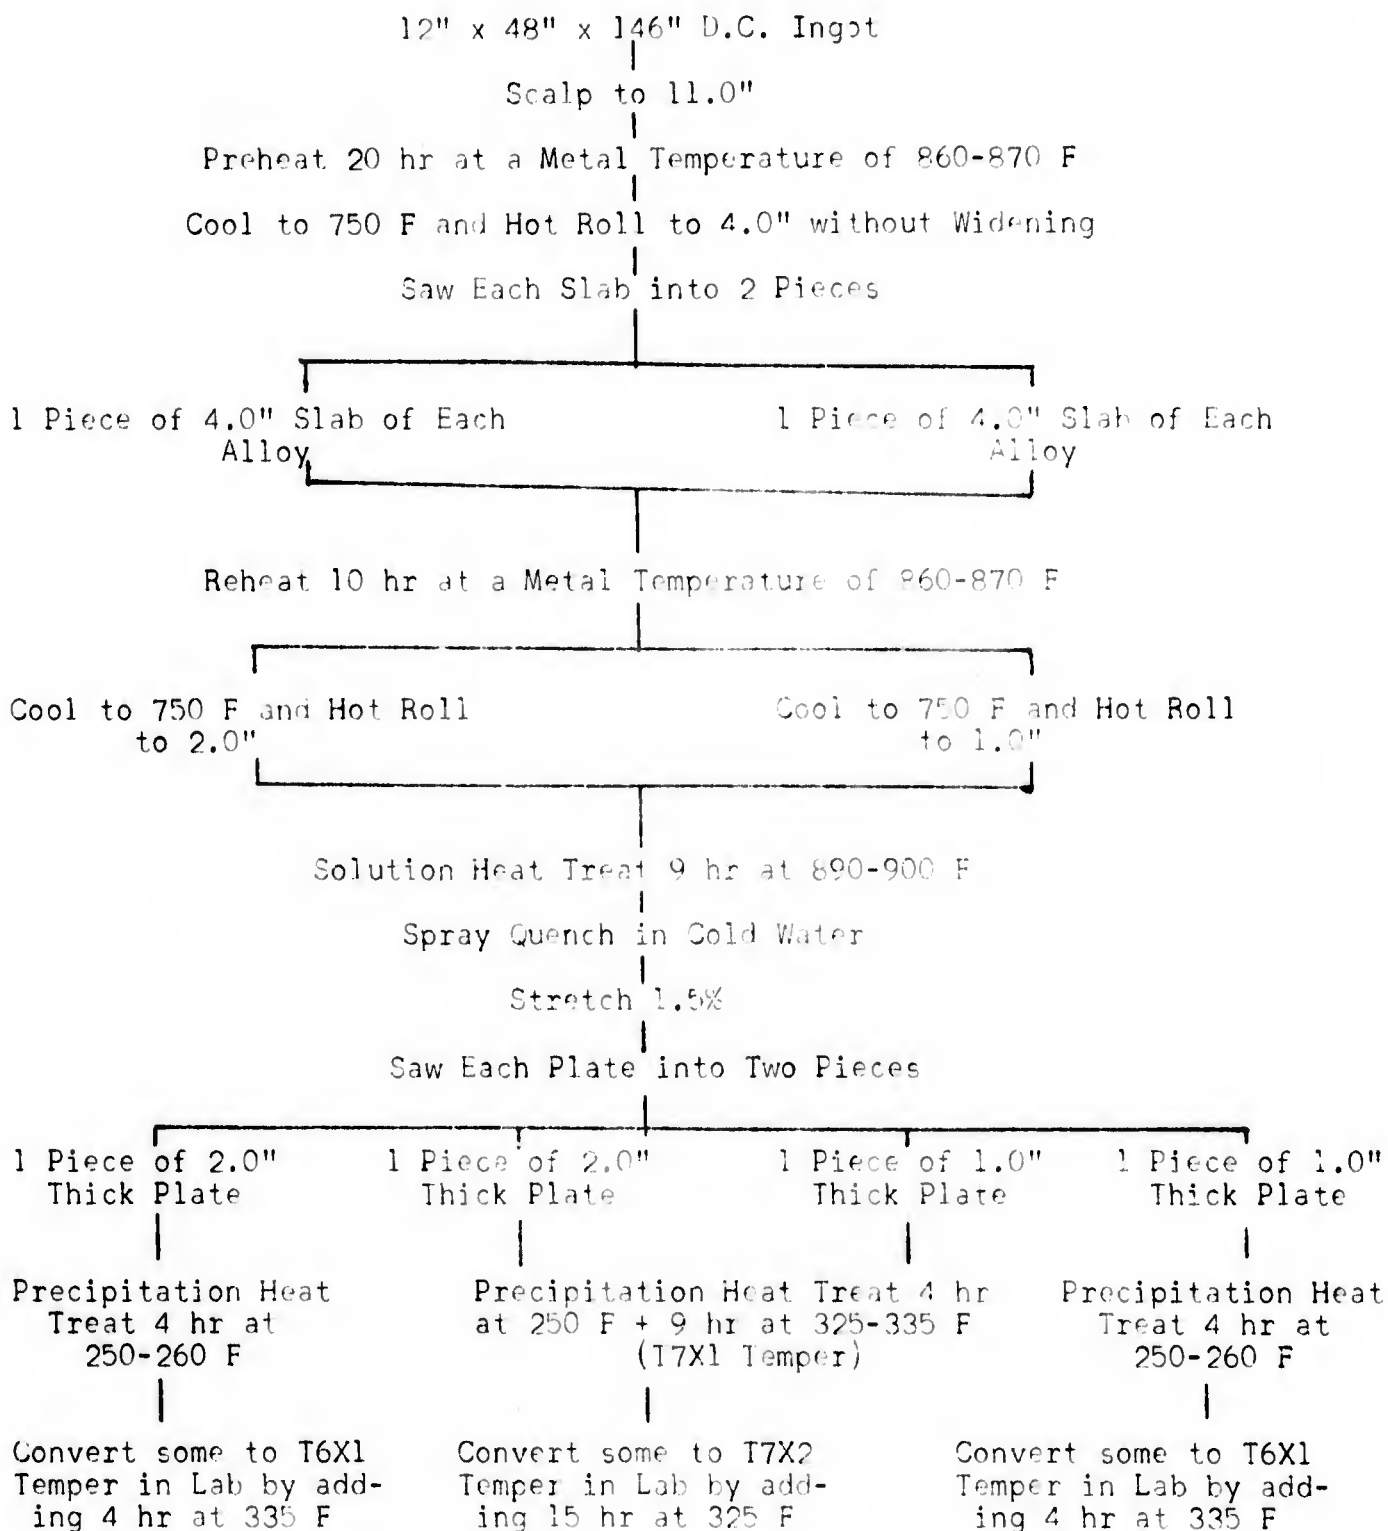
Figure 1

FABRICATION AND HEAT TREATMENT OF 1.0" AND 2.0" THICK MA15 PLATE

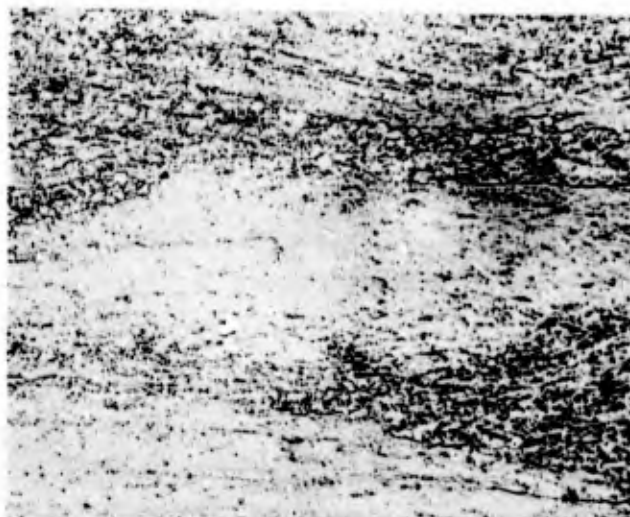
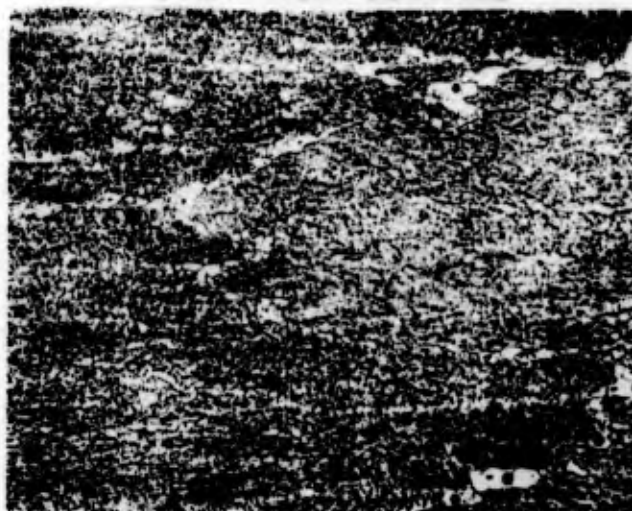
**FIG. 7 GRAIN STRUCTURE OF FOUR-INCH  
THICK PLATE**

The microstructures of the MA15 plate are presented in Figures 5 through 8. The grain structures of the one, two, and four-inch thick plate are similar to the structures of corresponding products of 7XXX alloy plate containing Cr, but because of the lower iron and silicon contents of MA15, the volume fraction of undissolved constituents in the MA15 is noticeably less. The grain structures at the interior of the six-inch thick plate are also comparable to those of thick 7XXX alloy plate. The twin columnar grain structure is visible near the rolled surfaces.

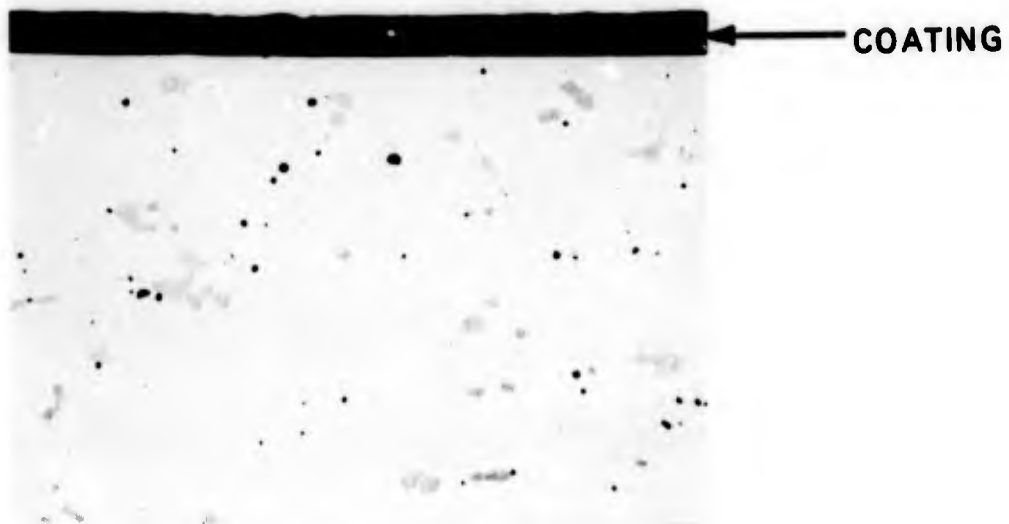
FIG. 18 SULPHURIC ACID ANODIC COATINGS

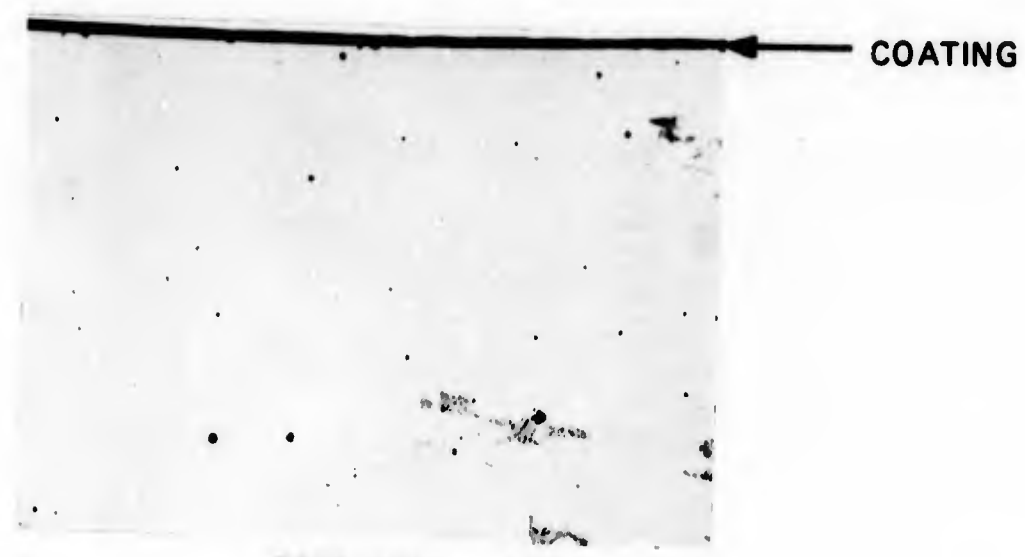
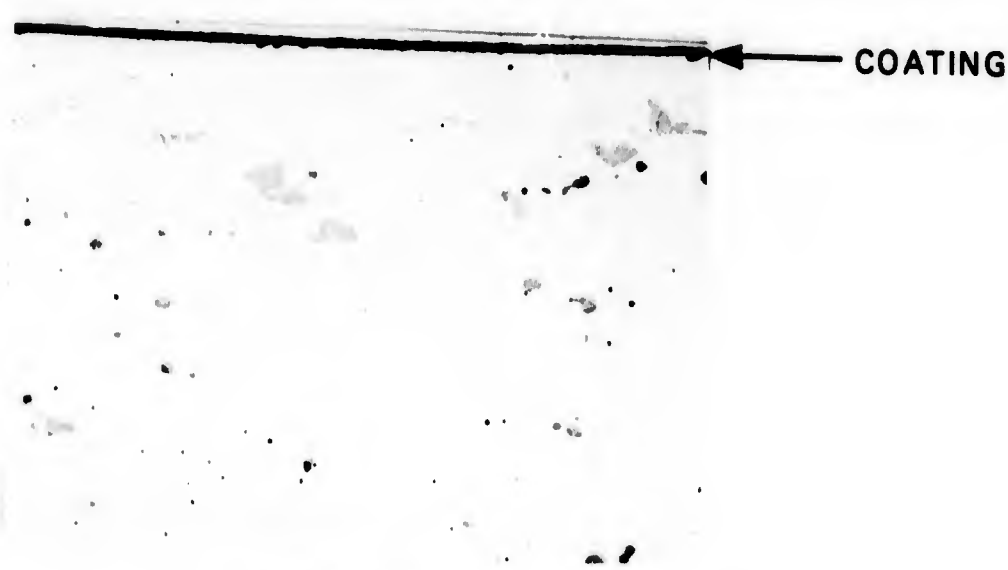
FIG.19 CHROMIC ACID ANODIC COATINGS

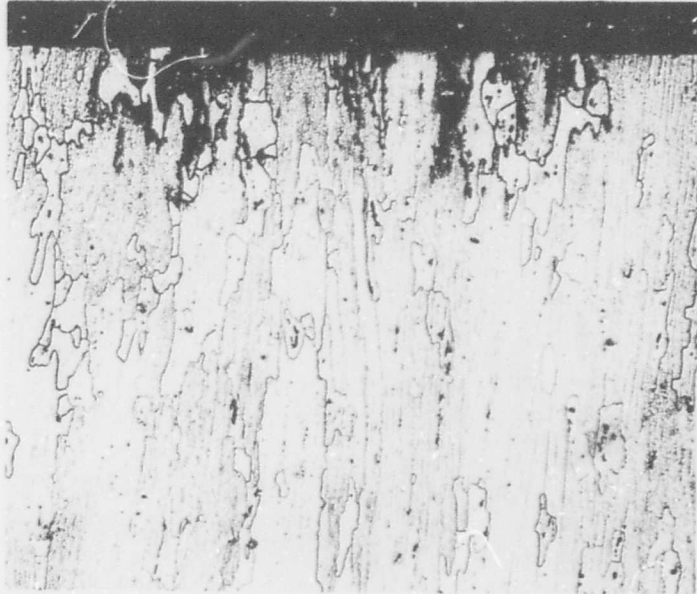
TWO-INCH THICK MA15-T6X1

FIG. 21 ILLUSTRATES CORROSION ALONG GRAIN AND GRAIN FRAGMENT BOUNDARIES IN S. NO. 379537-6-N40

MA15-T6X1 performed comparable to 7075-T651 and 7079-T651. Stress-corrosion resistance of short-transverse orientation specimens increased with increasing plate thickness, while stress-corrosion resistance of longitudinal and long-transverse orientation specimens decreased with increasing plate thickness. Corrosion attack was predominantly along grain and grain fragment boundaries, and secondary stress-corrosion cracks were evident. Fractured specimens were classified as Type 1 as discussed in the Appendix. The type of attack and the nature of the secondary cracks in a short-transverse orientation specimen are illustrated in Figures 21 and 22.

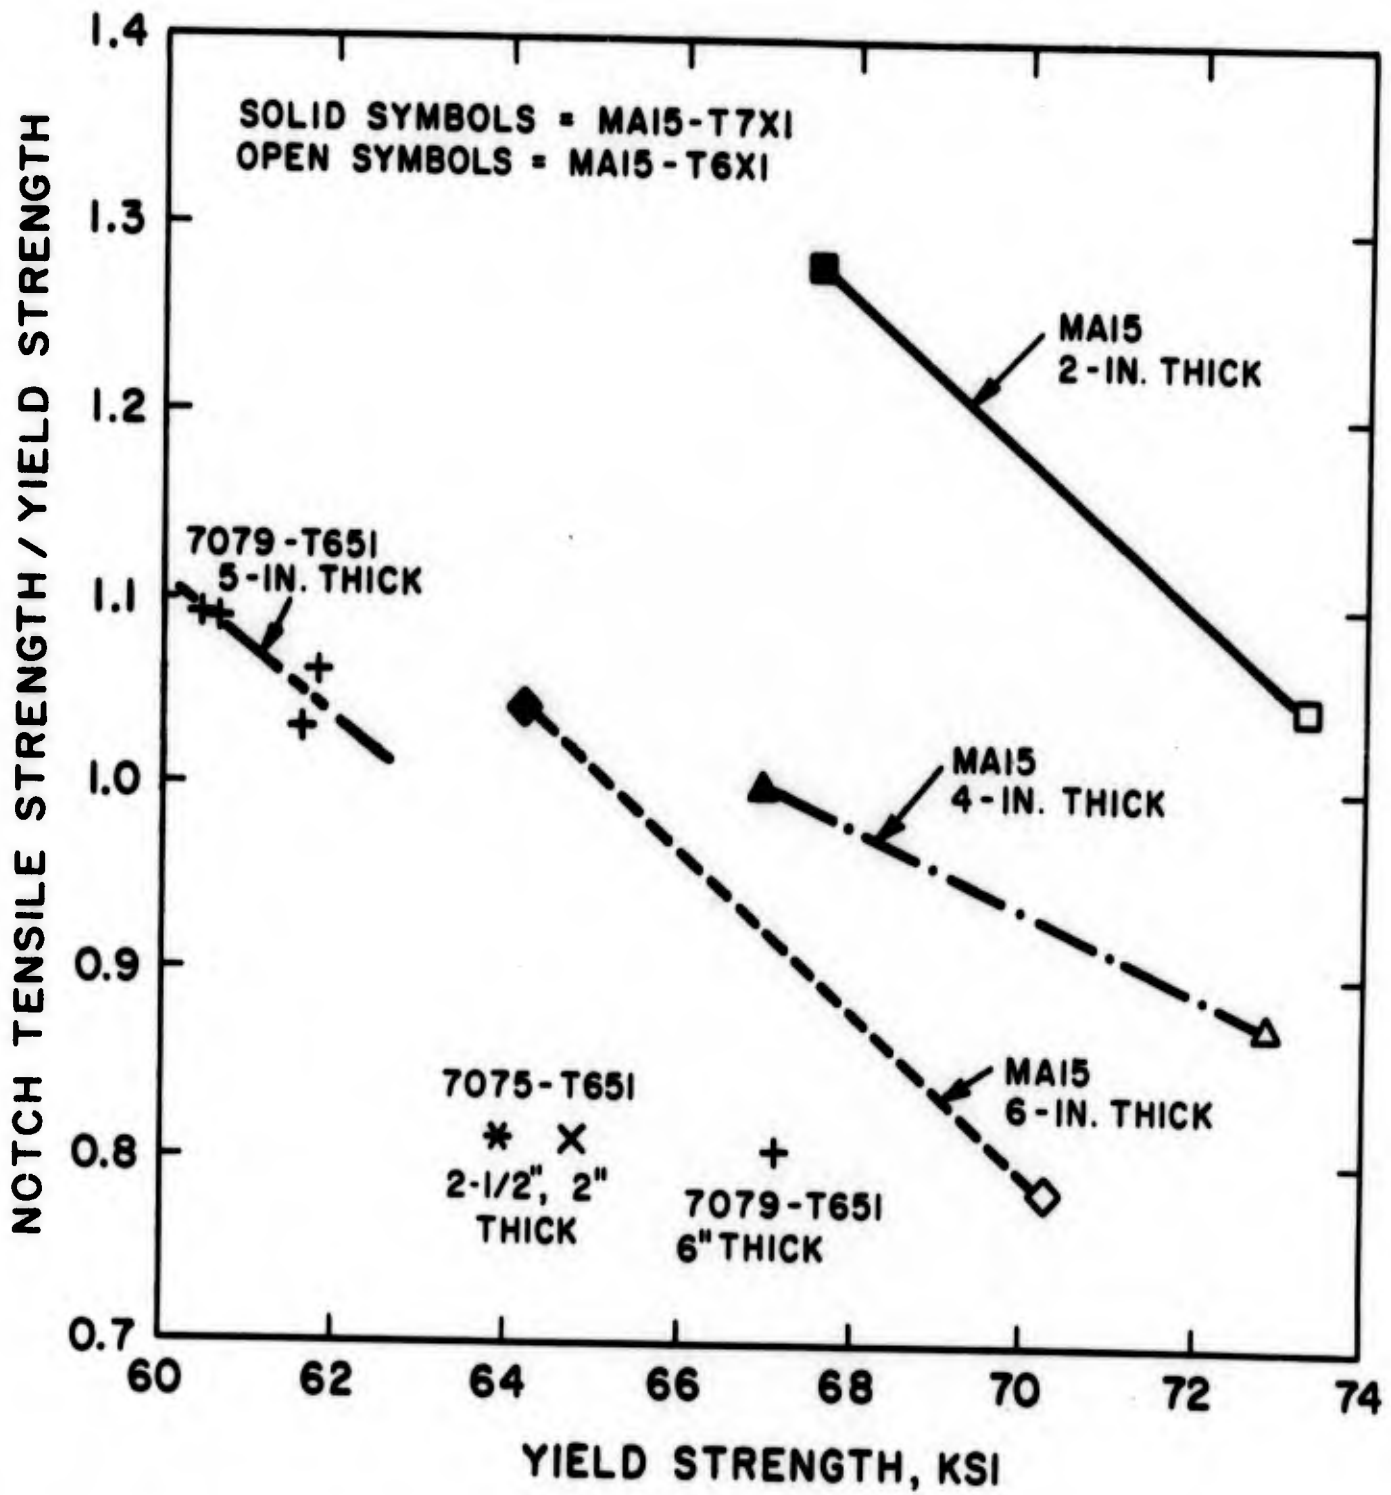
FIG. 38 SHORT - TRANSVERSE NOTCH TOUGHNESS  
2 - 6-IN. PLATE

Notch tensile strength/yield strength ratios of the MA15, 7079, and 7075 plate are presented in Tables 13, 14 and 15, respectively. Notch toughness agreed qualitatively with plane-strain fracture toughness.
