RE-70-197

**STRUCTURAL STABILITY OF A CAST Co-Cr-Mo ALLOY  
DURING IMPULSIVE THERMAL-MECHANICAL LOADING**

**TECHNICAL REPORT**

December 1970

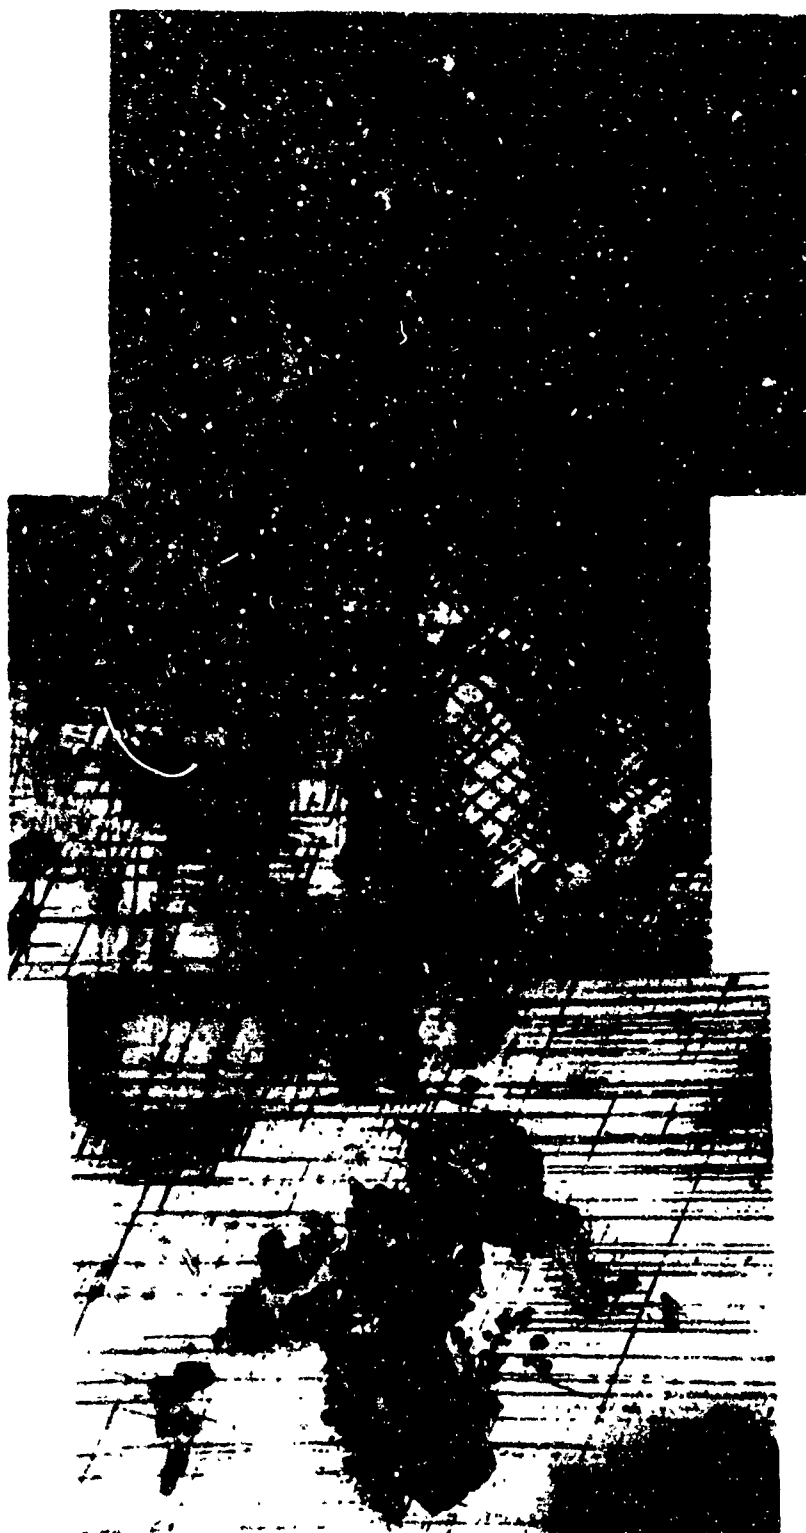
FIGURE 3 THE EFFECT OF A 25-HOUR AGING TREATMENT  
AT 816°C ON THE DEFORMED STRUCTURE  
GENERATED AFTER 3423 ROUNDS OF FIRE

by a Rockwell C hardness indent at a load of 150 kilograms, is shown in Figure 2 after chemical etching to exhibit the effectiveness of this technique. A 25-hour aging treatment at 816°C followed by chemical etching may also be used to delineate slipband structures as shown in Figure 3. However, such thermal treatments were generally unnecessary to reveal the deformed structure in this investigation.
