TECHNICAL REPORT 3-71-10

# EVALUATION OF ANCHORS USED TO SECURE MEMBRANE SURFACINGS

R. H. Grau

Conducted by U. S. Army Engineer Waterways Experiment Station, Vicksburg, Mississippi

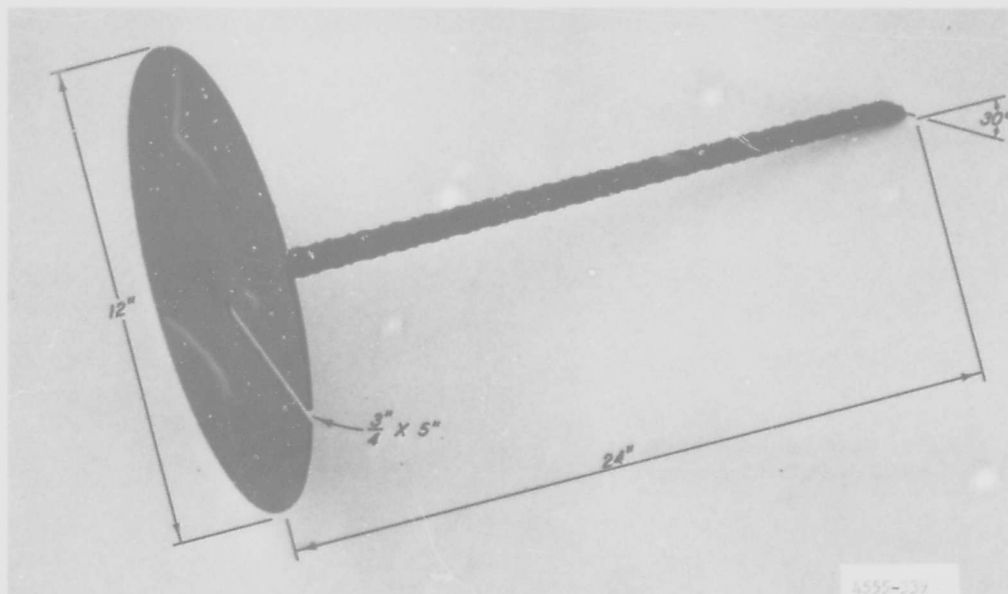
12. The guy anchor was designed and constructed at the U. S. Army Engineer Waterways Experiment Station (WES) and weighed approximately 6-1/2 lb. It was fabricated by welding a 12-in.-diam, 11-gage, hot-rolled steel plate\* to a 2-ft-long, 3/4-in.-diam, No. 6 reinforcing bar.\*\* The end of the reinforcing bar to be driven into the soil subgrade was cut at a 30-deg angle to provide a point. A slot 3/4 in. wide and 5 in. long was cut in the head of each anchor so that a cable connected to the reinforcing rod when the anchor was to be extracted from the soil could be positioned at a 90- or 60-deg angle with the surface of the subgrade. The guy anchor is shown in fig. 1. Since this anchor had been used previously during service tests,<sup>5</sup> its performance was compared with that of other anchors evaluated during this study.

Fig. 1. Guy anchor

54. Since the performance of the guy anchor was compared with those of the four experimental test anchors, sufficient data were obtained to determine that the design of the guy anchor is not adequate for present requirements. The anchor was originally designed for use in a loose sand subgrade; therefore, a 2-ft-long reinforcing bar was required to provide an adequate holding strength. At the present time, assault runways are generally surfaced with a clay backfill of adequate soil bearing strength to withstand C-130 wheel loads. Since the assault runways are surfaced with a clay backfill, the guy anchors were driven into a clay subgrade. When the anchors were driven to a depth of 24 in. into the subgrade, the heads of the anchors were either broken from the reinforcing bars or were damaged so severely that they would not fit flush with the surface of the subgrade. Tests also indicated that the anchors could not be driven vertically into a clay subgrade. The point of the anchor, which was formed by shearing the reinforcing bar at an angle of 30 deg, caused the anchor to enter the soil subgrade at an irregular angle, and the anchor would not remain in a vertical position while being driven into the subgrade.

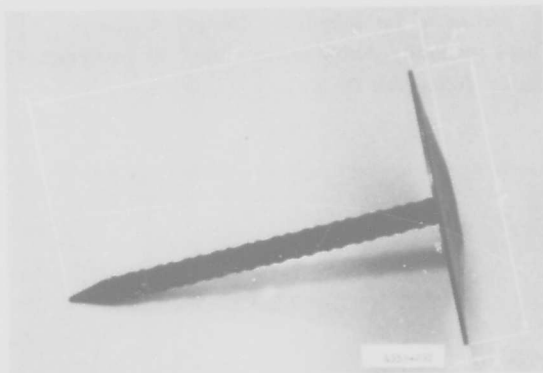
13. This anchor was designed and constructed at the WES and weighed approximately 3 lb. It was fabricated by welding an 8-in.-diam, 11-gage, hot-rolled steel plate\* to a 1-ft-long, 3/4-in.-diam, No. 6 reinforcing bar.\*\* The 8-in.-diam plate was formed so that the inner 6-in. diameter of the plate would provide a 7/16-in. crown and the remaining 1-in.-wide band would be flat. The 1-in.-wide flat band was designed to provide a bearing surface to hold membrane in place. A pyramid-shaped point was provided at one end of the reinforcing bar by cutting a 20-deg bevel on four sides of the rod. A slot 3/4 in. wide and 3 in. long was cut in the head of each anchor so that a cable connected to the reinforcing rod when the anchor was to be extracted from the soil could be positioned at a 90- or 60-deg angle with the surface of the subgrade. The disk-type anchor shown in fig. 2 was evaluated during the anchor driving tests, and the slotted disk-type anchor shown in fig. 3 was evaluated during the anchor holding-strength tests.

Fig. 2. Disk-type anchor

55. This anchor was easily driven vertically into the soil subgrade with a sledgehammer. As the anchor was driven into the subgrade, it did not stray from the vertical because of the shape of the point. The pointed end of the reinforcing bar was beveled on all four sides. When the anchor was driven into the soil subgrade to a depth of 12 in., the periphery of the head was flush with the surface of the subgrade. No damage occurred to the anchor head or reinforcing bar when the anchor was driven into the soil subgrade to a depth of 12 in.

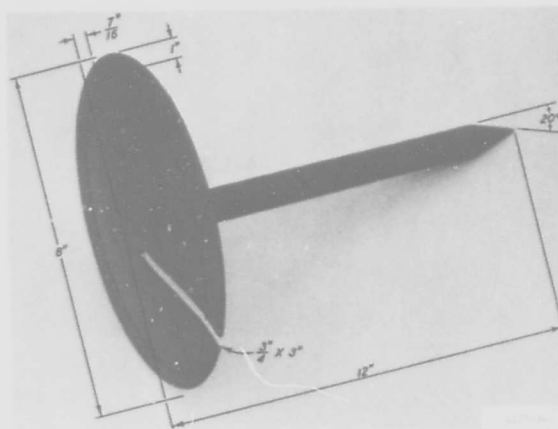
Fig. 3. Slotted disk-type anchor evaluated during holding-strength tests

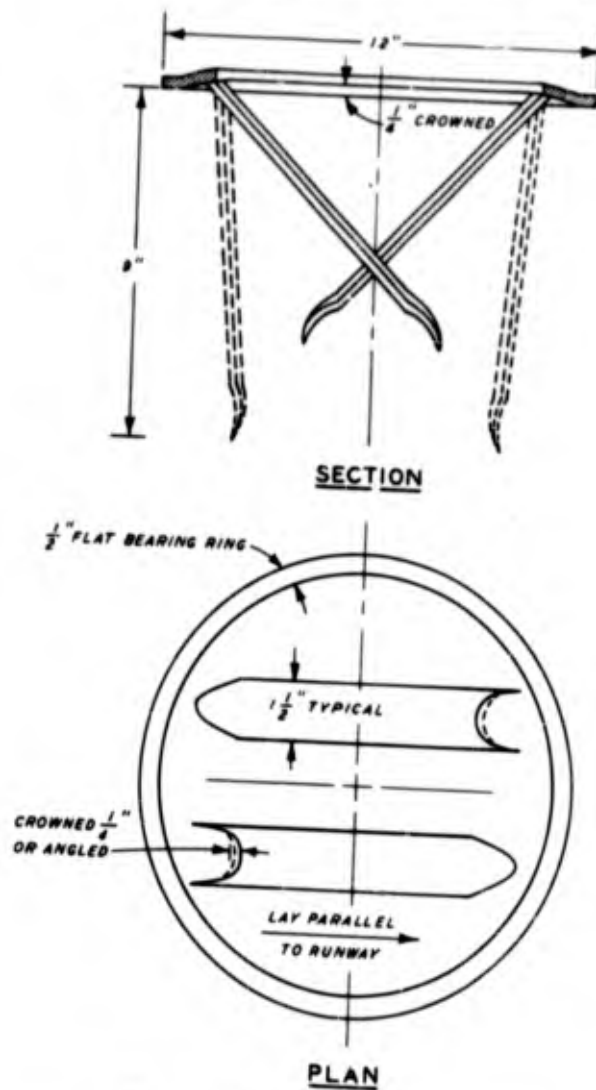
14. The design for the two-legged anchor was submitted to the WES by Defense Construction Supply Center (DCSC), Columbus, Ohio, as an employee suggestion. The anchor was constructed at the WES and weighed approximately 3-3/4 lb. It was fabricated from a 12-in.-diam, 11-gage, hot-rolled steel plate.\* The anchor was fabricated by pressing the 12-in.-diam plate to provide a 1/4-in. crown in the plate. The crowned part of the plate was 11 in. in diameter, and the remaining 1/2-in.-wide strip located around the outside edge of the plate was flat. The 1/2-in.-wide flat band provided a bearing ring to hold membrane in place. Two parallel legs, 1-1/2 in. wide and 9 in. long, were cut out of the steel plate. The legs were cut on both sides but only on one end so they would remain attached to the plate. The free ends of the legs were cut at approximately 40-deg angles to provide points. To add strength, the center of each leg was crowned 1/4 in. for the length of the leg. The two-legged anchor is shown in fig. 4.

Fig. 4. Two-legged anchor

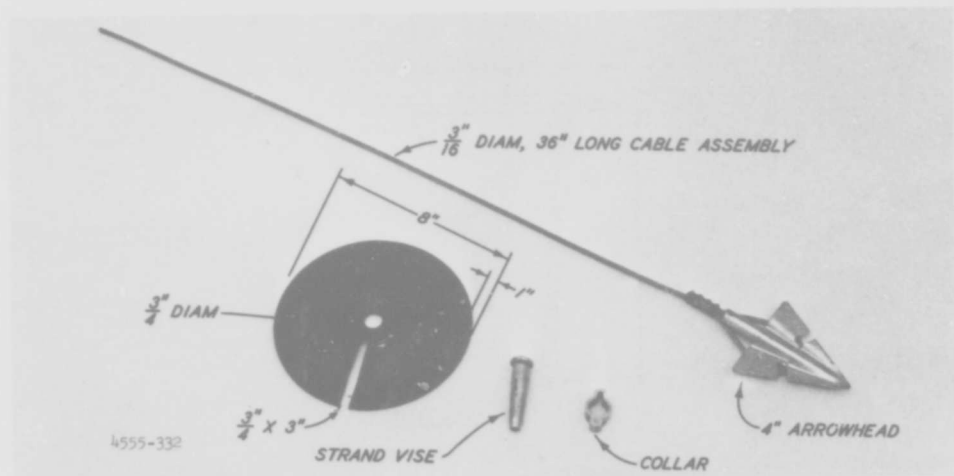
15. Four-in. arrowhead anchors were procured commercially for use with 8-in.-diam bearing plates fabricated at the WES. The anchor consisted of a 4-in. stamped iron arrowhead; a 36-in.-long, 3/16-in.-diam cable assembly; a 3/16-in. strand vise; a collar; and an 8-in.-diam, 11-gage, hot-rolled steel plate.\* Each anchor weighed approximately 2-1/2 lb. The 8-in.-diam plate was pressed so the inner 6-in. diam of the plate would provide a 7/16-in. crown, and the remaining 1-in.-wide band would be flat. The 1-in.-wide flat band provided a bearing surface to hold membrane in place. A 3/4-in.-diam hole was drilled in the center of the plate so the strand vise could be inserted. A slot 3/4 in. wide and 3 in. long was cut in the head of each anchor so that a cable used when the anchor was to be extracted from the soil could be positioned at either a 90- or 60-deg angle with the surface of the subgrade. The arrowhead anchor is shown in fig. 5.

Fig. 5. Arrowhead anchor

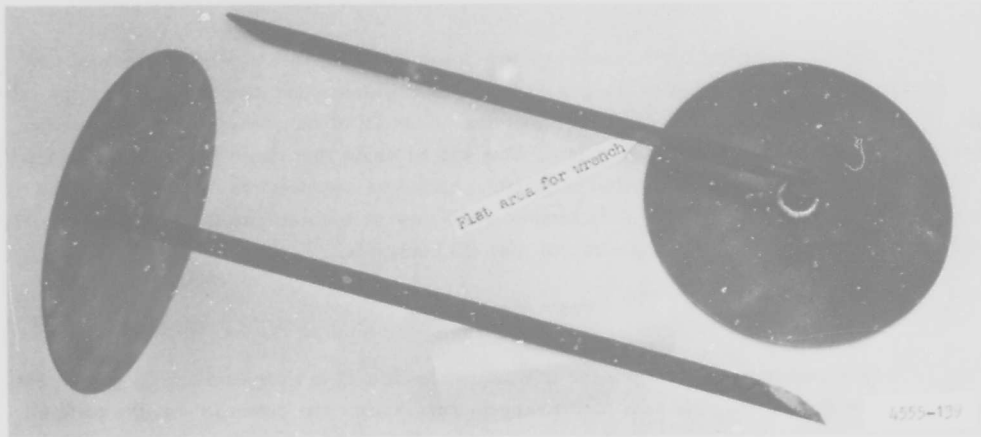
16. The design for this anchor was also submitted to the WES as a DCSC employee suggestion. The anchor was constructed at the WES and weighed approximately 7 lb. The anchor was essentially the same as the guy anchor (paragraph 12), with the exception that the No. 6 reinforcing bar was threaded at one end, and a threaded steel collar was welded to the head of the anchor. One end of the bar was threaded for a length of 1 in. with 1/2-in.-diam threads. Approximately 6 in. from the threaded end of the bar, a 1/8-in.-deep flat area was cut on two sides of the bar so the bar could be held with a wrench. The steel collar consisted of a 1-1/4-in.-diam rod that was 1-1/2 in. long. Threads 1/2 in. in diameter were cut for a depth of 1 in. into the center of the collar. The anchor was assembled by threading the reinforcing bar into the collar. A threaded guy anchor and a guy anchor are shown in fig. 6.

Fig. 6. Threaded guy anchor (top) and guy anchor (bottom)

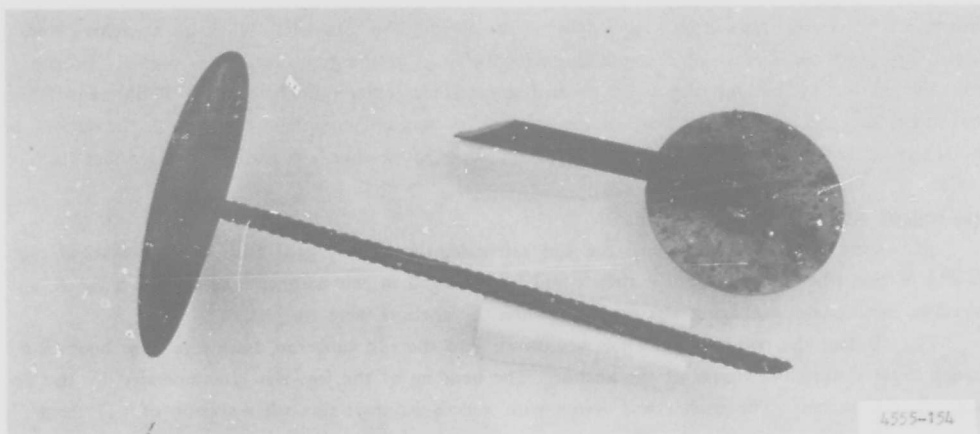
17. This anchor was designed and constructed at the WES and weighed approximately 5 lb. It was fabricated by welding a 1-1/8-in.-diam steel collar that was 1-1/2 in. long to a flat 8-in.-diam, 11-gage, hot-rolled steel plate.\* Threads 1/2 in. in diameter were cut for a depth of 1 in. into the center of the collar. A 1-ft-long, 1-1/8-in.-diam No. 9 reinforcing bar<sup>5</sup> was threaded so that it could be connected to the plate. One end of the reinforcing bar was threaded for a length of 1 in. with 1/2-in.-diam threads, and the other end was cut at a 30-deg angle to provide a point. A threaded disk-type anchor and guy anchor are shown in fig. 7.

Fig. 7. Threaded disk-type anchor (top) and guy anchor (bottom)

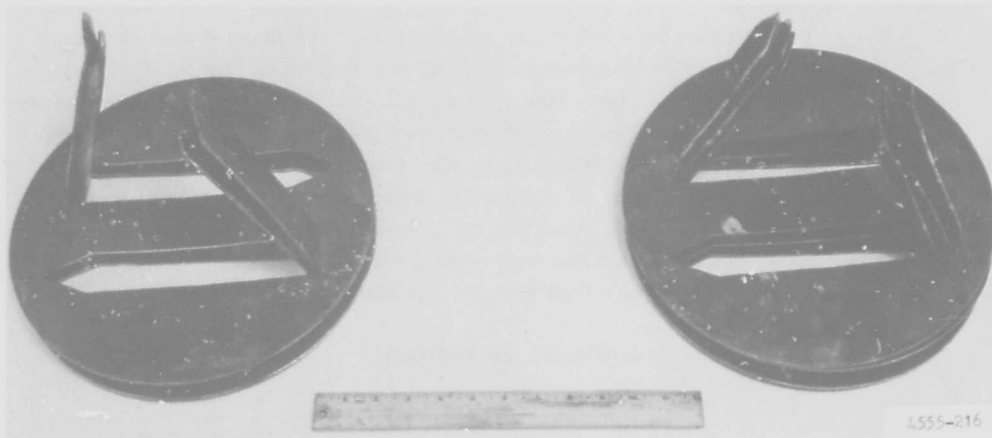
21. Prior to being driven into the soil subgrade, three two-legged anchors were stacked one on top of the other to determine if they could be packaged in this manner. As shown in fig. 8, an excellent method for packaging was provided when the anchors were stacked.

Fig. 8. Two-legged anchors stacked for packaging

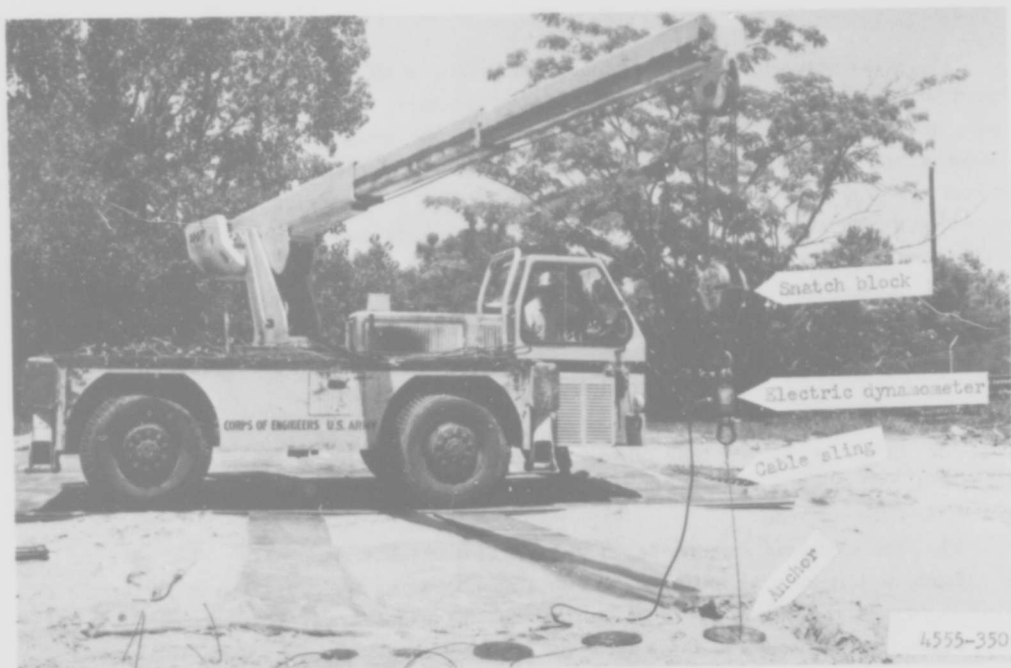
35. A mobile crane, shown in fig. 9, was used to remove each anchor from the soil subgrade. The crane was positioned over the anchors so that the anchors were removed vertically or at a 60-deg angle with the surface of the soil. The force required to pull each anchor from the subgrades was measured by a 2000-lb-capacity electric dynamometer attached between the snatch block of the crane and the cable sling that was attached to the anchor (see fig. 9). An electric recorder was used to record the data on oscillograms. The maximum force required to remove each anchor is given in table 1.

Fig. 9. Mobile crane used to remove anchors from the soil subgrade

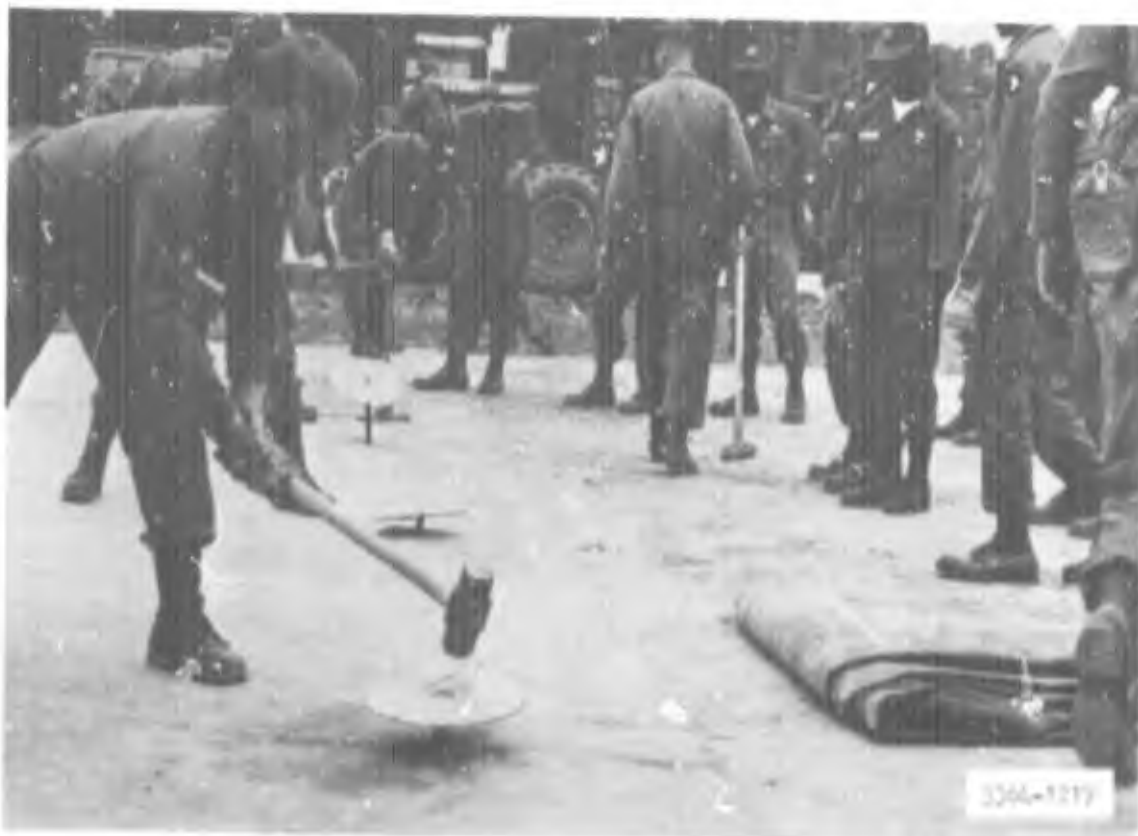
Photograph 1. Guy anchors driven into soil subgrade with sledgehammers

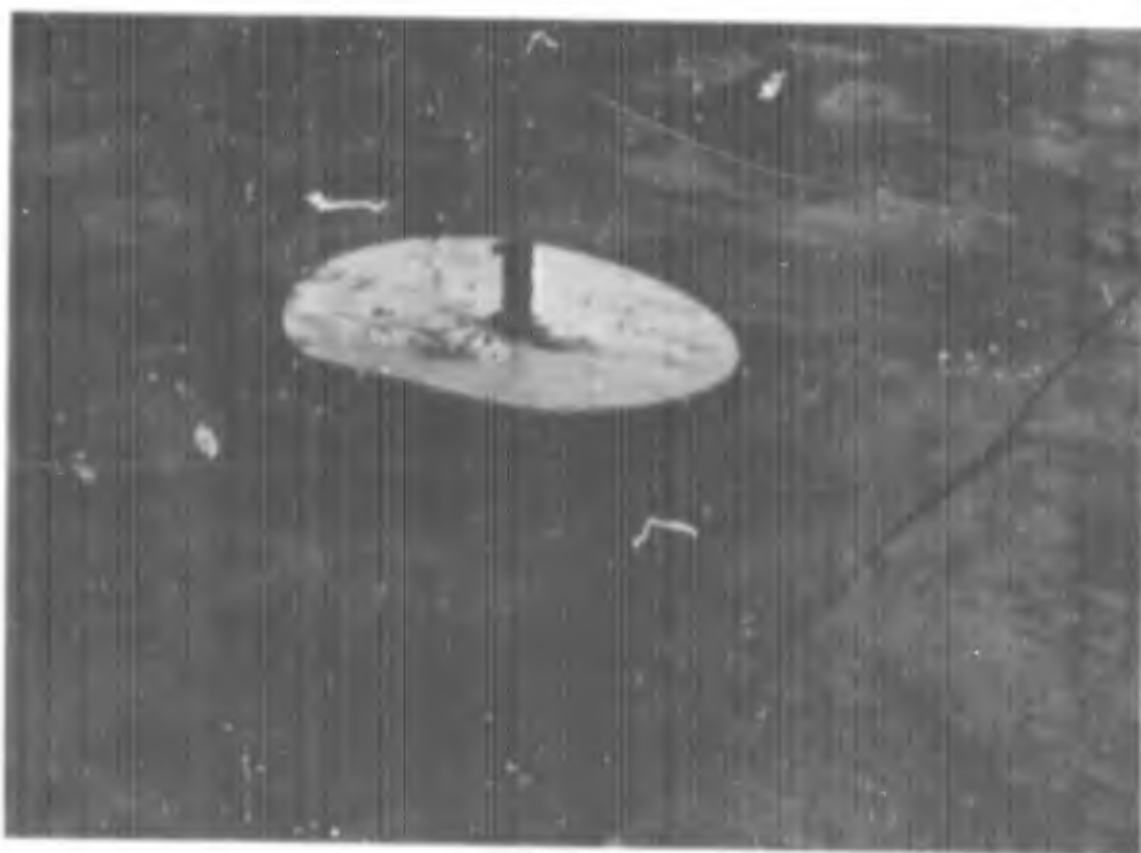
Photograph 2. Head of guy anchor broken from reinforcing bar

26. The guy anchor deviated from its vertical position as it was driven into the soil subgrade. When the guy anchor was driven into the subgrade to the full depth of 24 in., the head was bent and considerable edge curl of the steel plate head occurred. Approximately one guy anchor head out of three was partially broken from its shaft when the anchors were driven to a depth of 24 in.

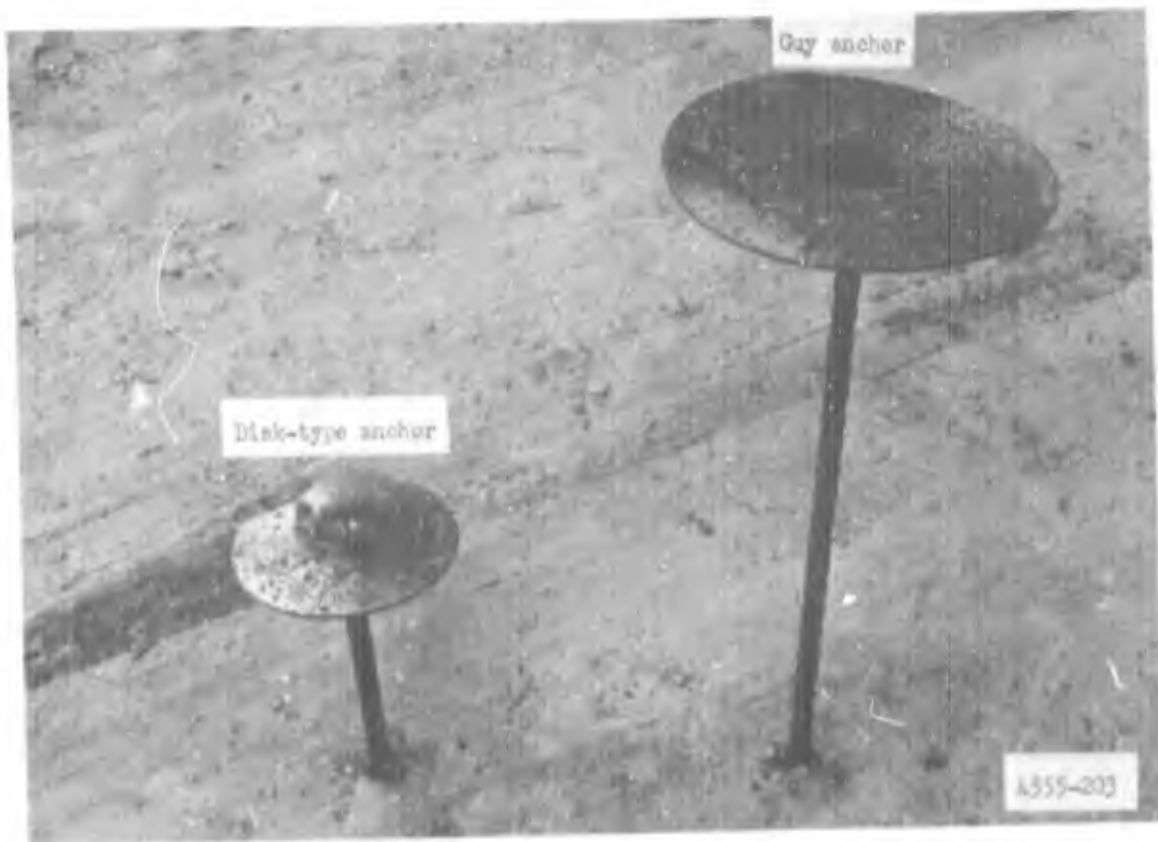
Photograph 3. Disk-type and guy anchors driven approximately 2 in. into the soil subgrade

20. The disk-type and guy anchors were driven with a sledgehammer into the same soil subgrade. Due to the difference in length of the two anchors, the disk-type anchor was driven to a depth of 12 in., and the guy anchor was driven to a depth of 24 in. Photograph 3 shows both anchors after they had been driven approximately 2 in. into the subgrade, and photograph 4 shows the same two anchors after they had been driven to depths of 6 and 12 in., respectively. At the 12-in. depth, the guy anchor began to diverge from its initial vertical position, but the disk-type anchor remained vertical after it had been driven halfway into the subgrade. When both anchors were driven flush with the surface of the soil subgrade, the head of the guy anchor was partially broken from the reinforcing bar, but the disk-type anchor remained intact (photograph 5). Photograph 5 shows that the periphery of the head of the guy anchor was not completely flush with the surface of the subgrade, but the periphery of the head of the disk-type anchor was flush with the subgrade.

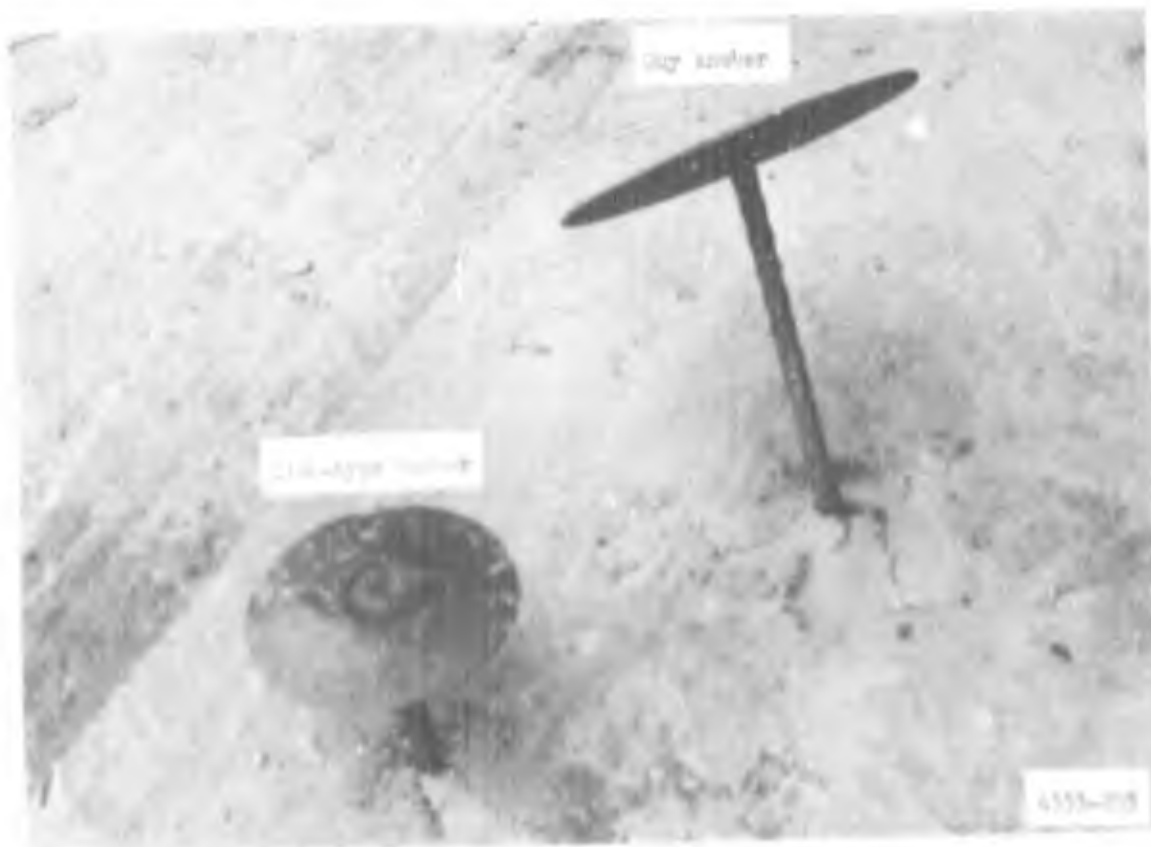
Photograph 4. Disk-type and guy anchors driven into the soil subgrade to depths of 6 and 12 in., respectively

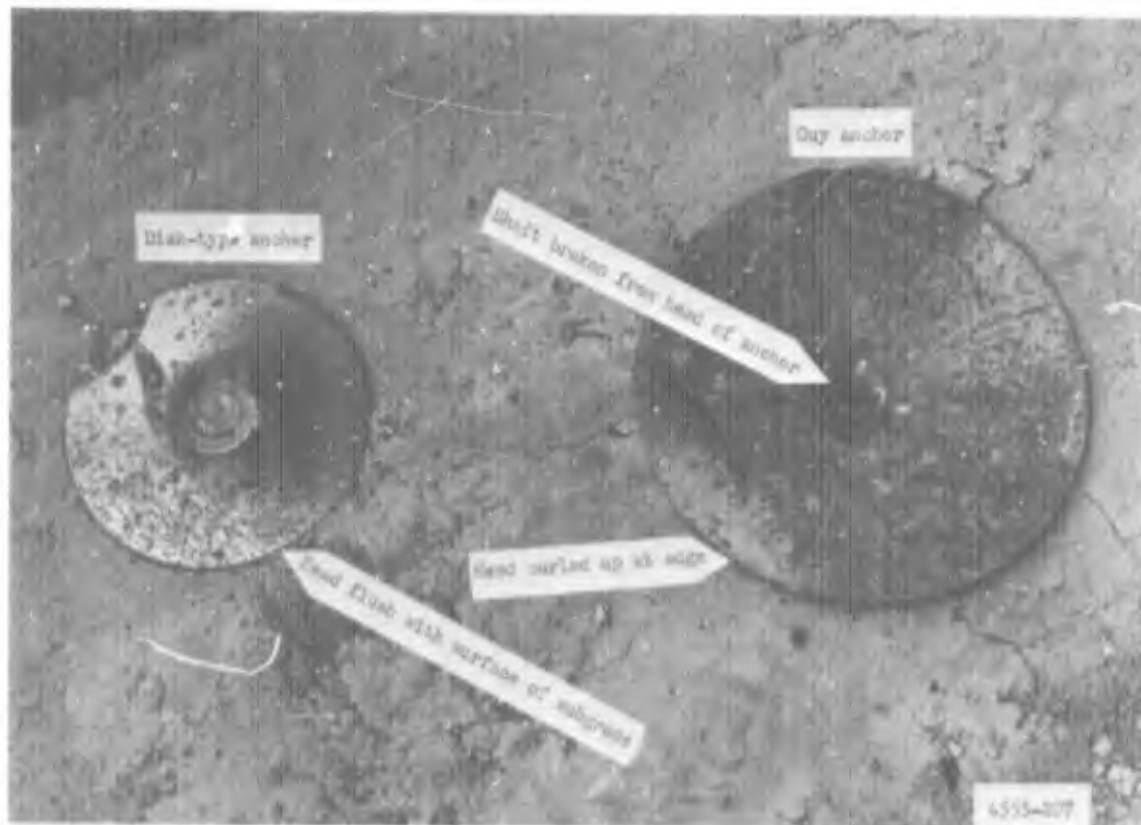
Photograph 5. Disk-type and guy anchors driven flush with the surface of the soil subgrade

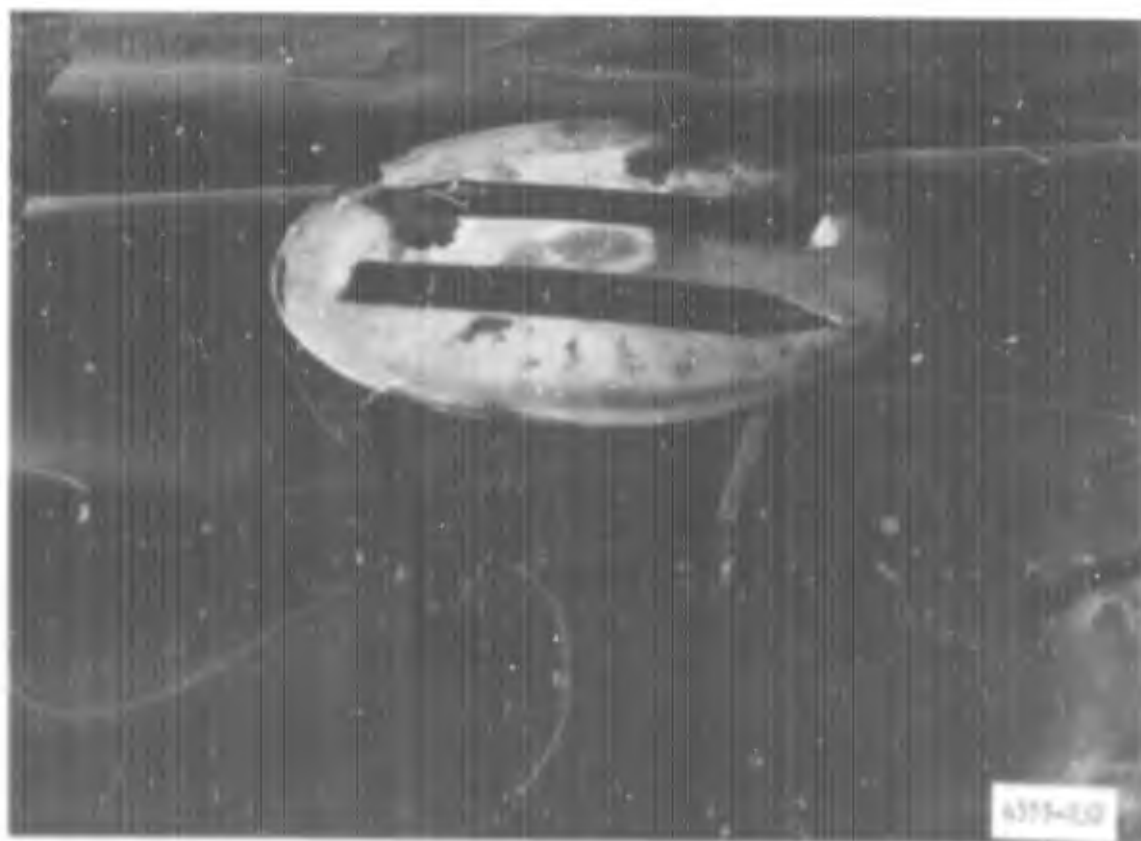
Photograph 6. Two-legged anchor driven through membrane surfacing into the soil subgrade to a depth of 1 in.

22. Before the two-legged anchor was driven into the soil subgrade, both legs were bent to a 20-deg angle toward the center of the anchor. The bending of the legs was recommended by the designer of the anchor. The anchor was driven with a sledgehammer through a section of T17 membrane into the lean clay subgrade. Care was exercised when the anchor was being driven to ensure that the sledgehammer hit the anchor head directly over each leg. Both legs of the anchor remained straight, and no apparent damage occurred when the anchor was driven a distance of 1 in. into the soil subgrade (photograph 6). One leg began to show signs of bending (photograph 7) after the

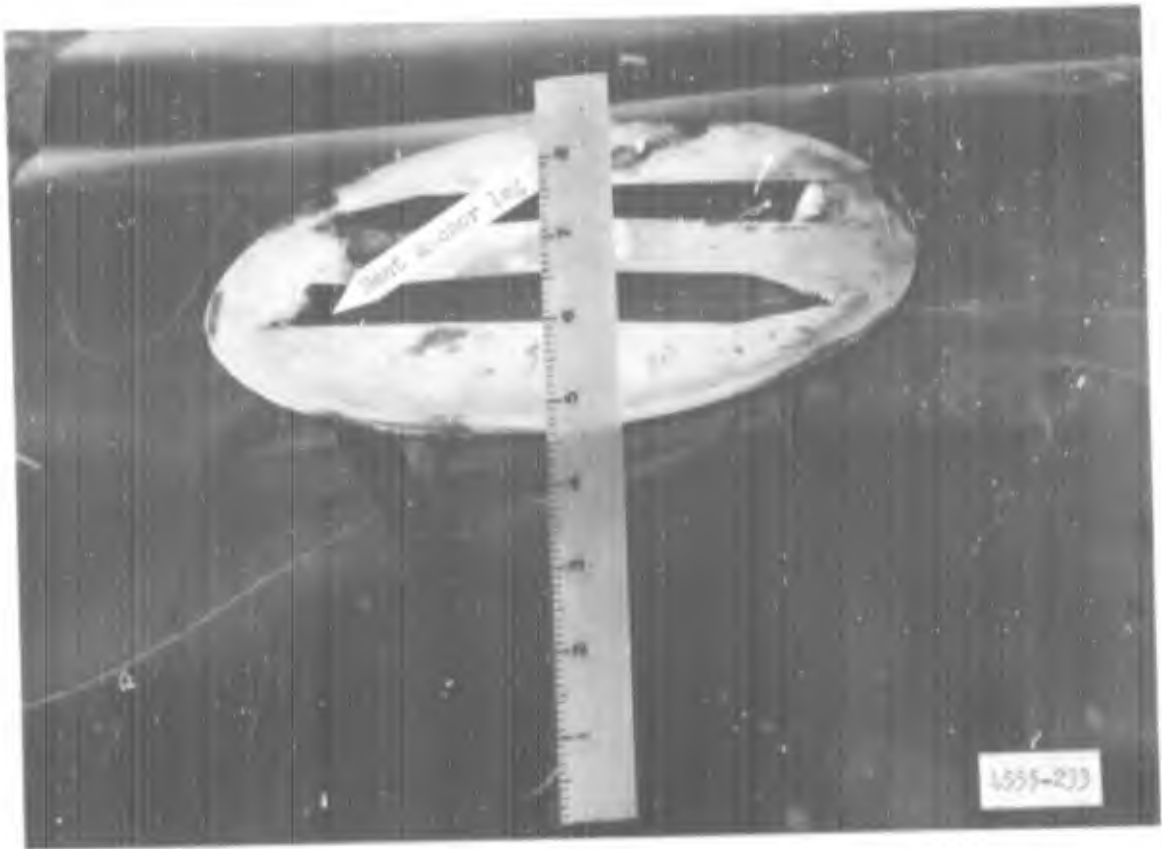
Photograph 7. Two-legged anchor driven through membrane surfacing and into the soil subgrade to a depth of 4-1/2 in.

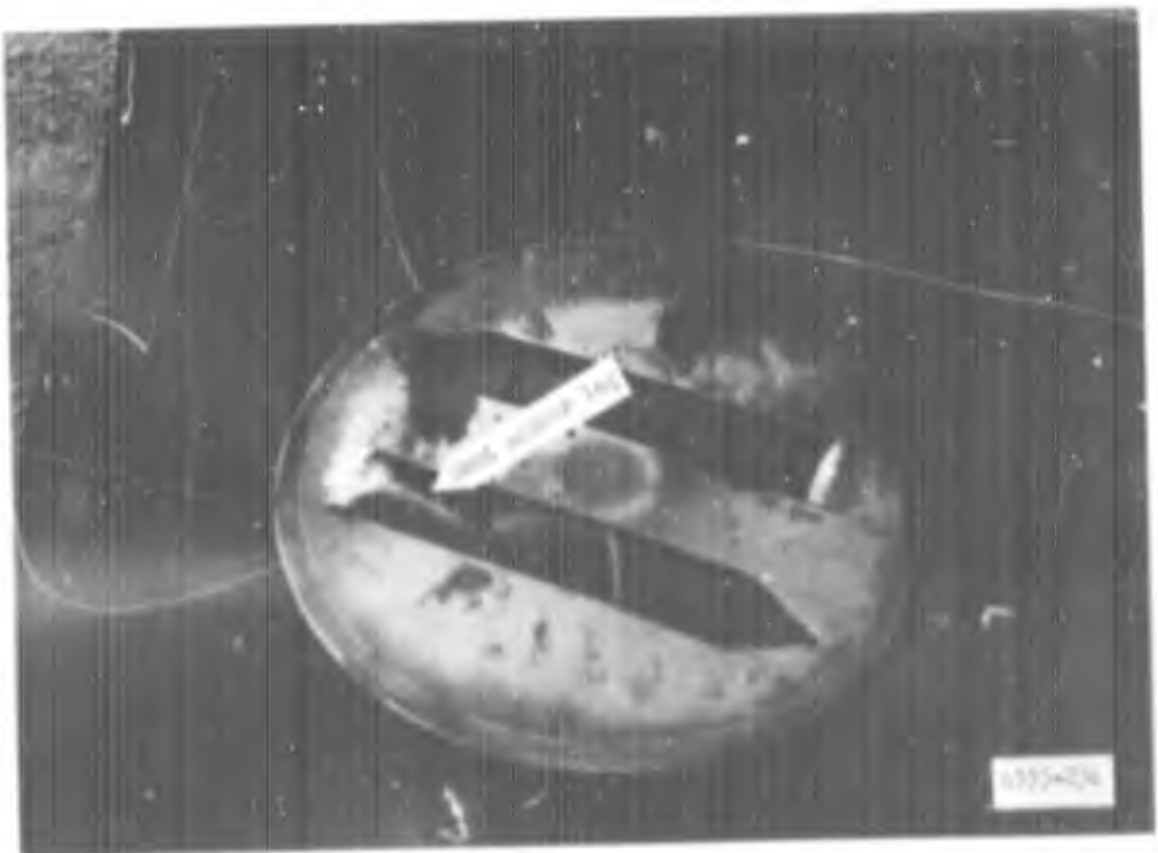
Photograph 8. Two-legged anchor driven flush with the surface of the membrane

anchor had been driven to a depth of 4-1/2 in. When the anchor was driven flush with the surface of the membrane surfacing, additional bending of the leg occurred, as shown in photograph 8. After the anchor had been driven into the soil subgrade, it was extracted and examined for damage. Photograph 9 illustrates the damage that occurred to the anchor legs when driven to a depth of 9 in. into the soil subgrade.

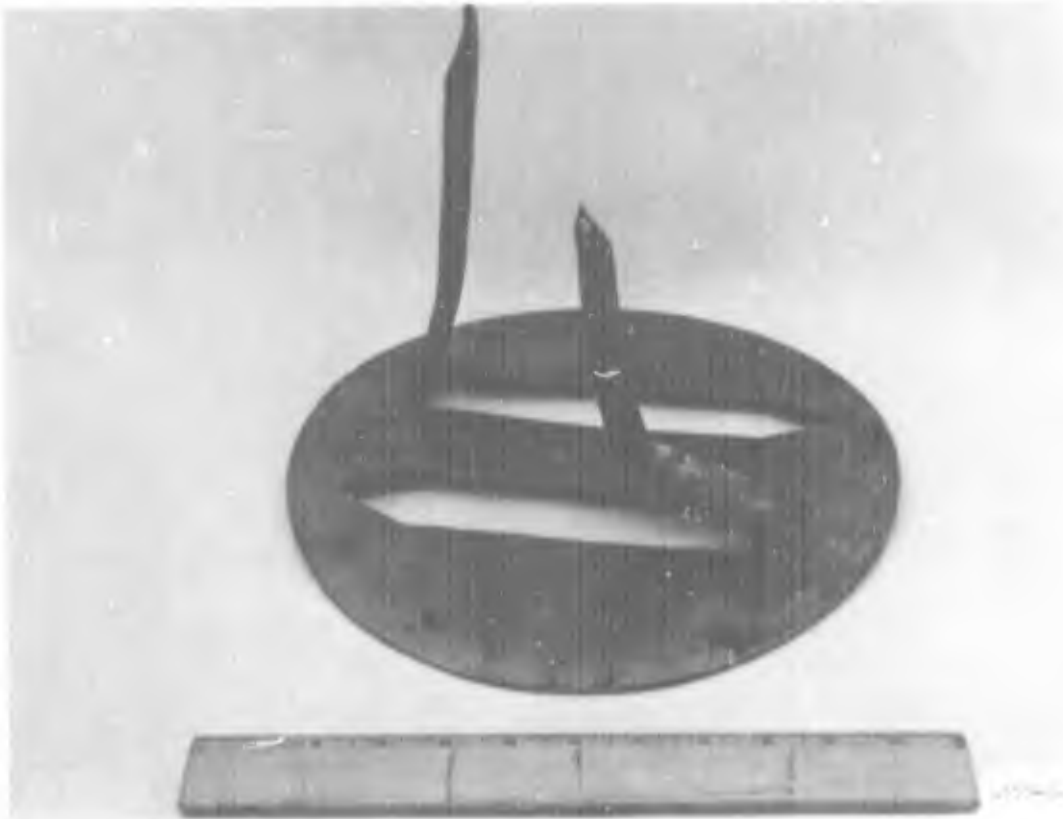
Photograph 9. Damage to the anchor legs that was caused when the two-legged anchor was driven into the soil subgrade to a depth of 9 in.

28. Initial bending of the legs of the anchors occurred when the anchors were driven to depths of 4 to 5 in. into the subgrade. When the anchors were driven into the subgrade to the full depth of 9 in., the legs bent excessively and were torn from the head of the anchor. The anchor heads were not flush with the membrane surfacing after driving had been completed. No appreciable differences in the performance of the anchor were observed when the legs of the anchors were positioned at a 20-deg angle or in a vertical position in relation to the head of the anchor. The two-legged anchors can be stacked easily for packaging.

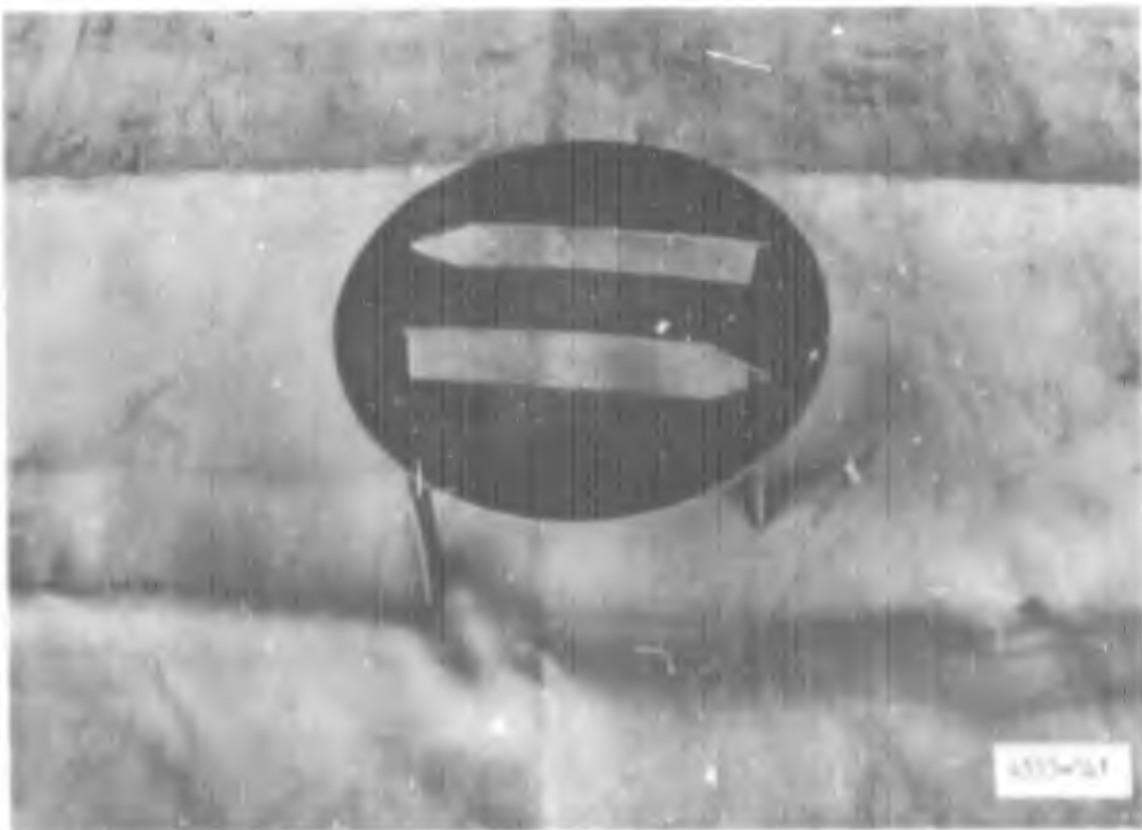
Photograph 10. Legs of two-legged anchor straightened to a vertical position and driven through membrane into the soil subgrade to a depth of 2 in.

23. After the tests described in paragraph 22 had been completed, an anchor with the legs straightened to a vertical position was driven with a sledgehammer into the soil subgrade to a depth of 2 in. without damage to the anchor, as shown in photograph 10. When the anchor was driven to a depth of 5 in., the legs began to bend, and tears occurred where the legs joined the anchor head (photograph 11). When the anchor was driven to a depth of 9 in., the legs were bent toward the periphery of the anchor head (photograph 12), and this prevented the anchor head from fitting flush with the membrane surfacing.

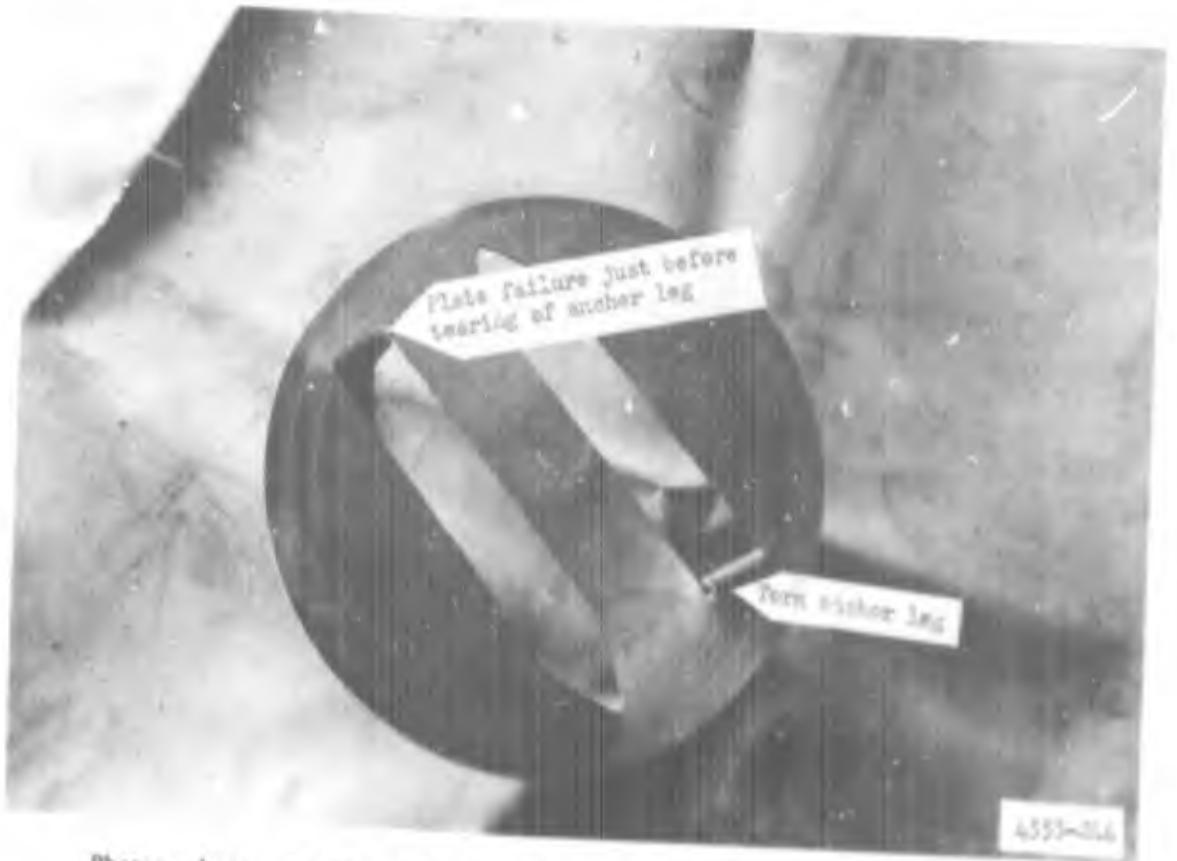
Photograph 11. Two-legged anchor with straightened legs driven through membrane into the soil subgrade to a depth of 3 in.

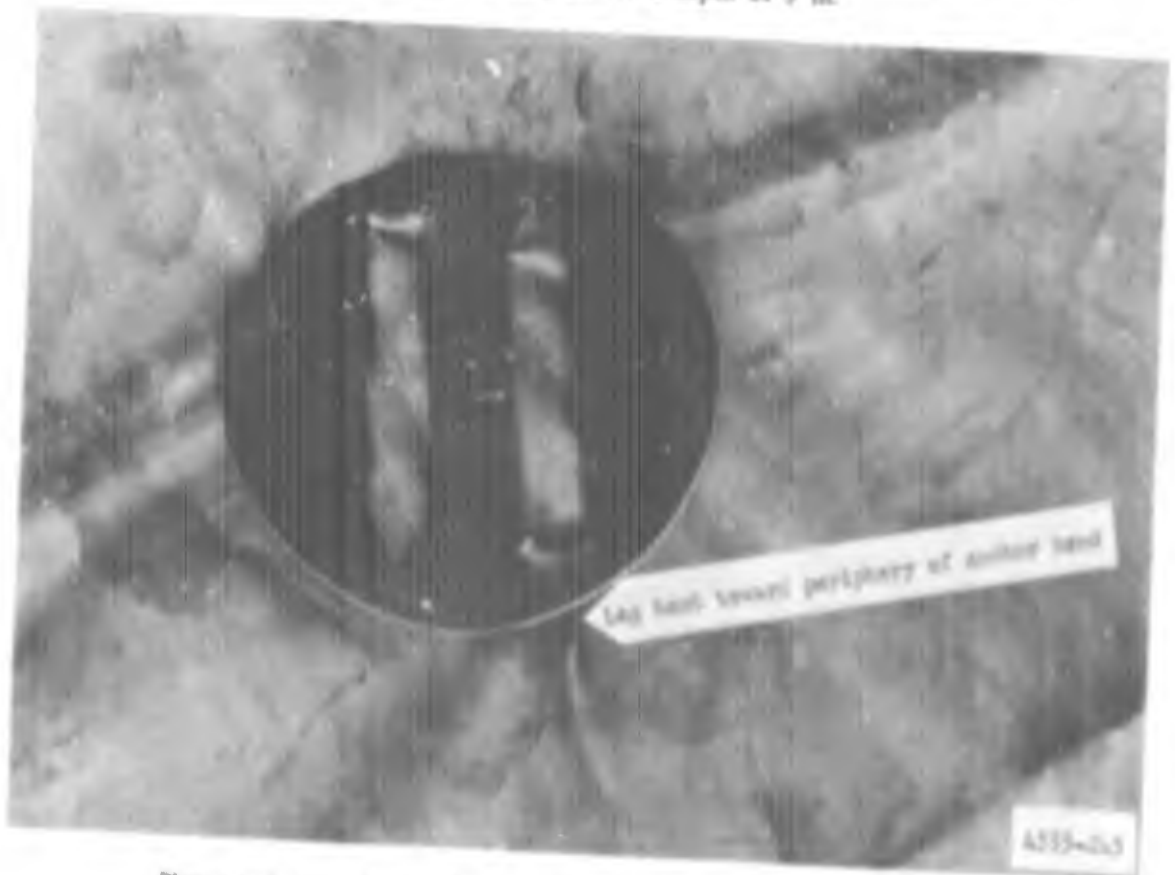
Photograph 12. Anchor with straightened legs driven through membrane into the soil subgrade to a depth of 9 in.

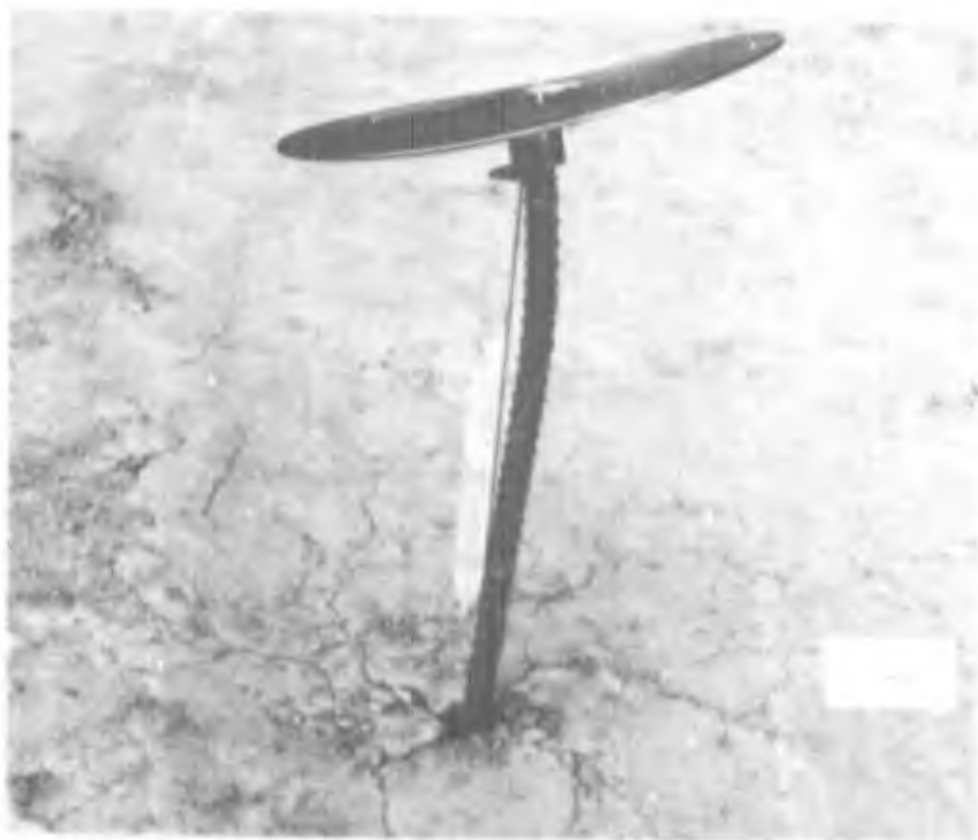
Photograph 13. Threaded guy anchor driven into the soil subgrade to a depth of 6 in.

24. This anchor was assembled by screwing the 2-ft-long reinforcing bar into the steel collar that was welded to the head of the anchor. The threaded guy anchor and the guy anchor were driven with a sledgehammer into the soil subgrade so their performances could be compared. Photographs 13 and 14, respectively, illustrate the threaded guy anchor and the guy anchor after they had been driven to a depth of 6 in. into the soil subgrade. The reinforcing bar of the threaded guy anchor began to bend, but the reinforcing bar of the guy anchor did not. The bend in the reinforcing bar of the threaded anchor was also evident after the anchor had been driven to a depth of 18 in. (photograph 15). The bend in the reinforcing bar occurred where it had been ground flat on two sides for wrench placement. No bend occurred in the guy anchor's reinforcing bar, but the head had been bent slightly to one side (photograph 16). When the threaded guy anchor was driven to a depth of 24 in., making the head flush with the surface, the head broke loose from the steel collar that connected it to the reinforcing bar (photograph 17). The head of the guy anchor was not broken from the reinforcing bar when the anchor was driven to a depth of 24 in., but considerable edge curl occurred about the periphery of the steel plate head (photograph 18).

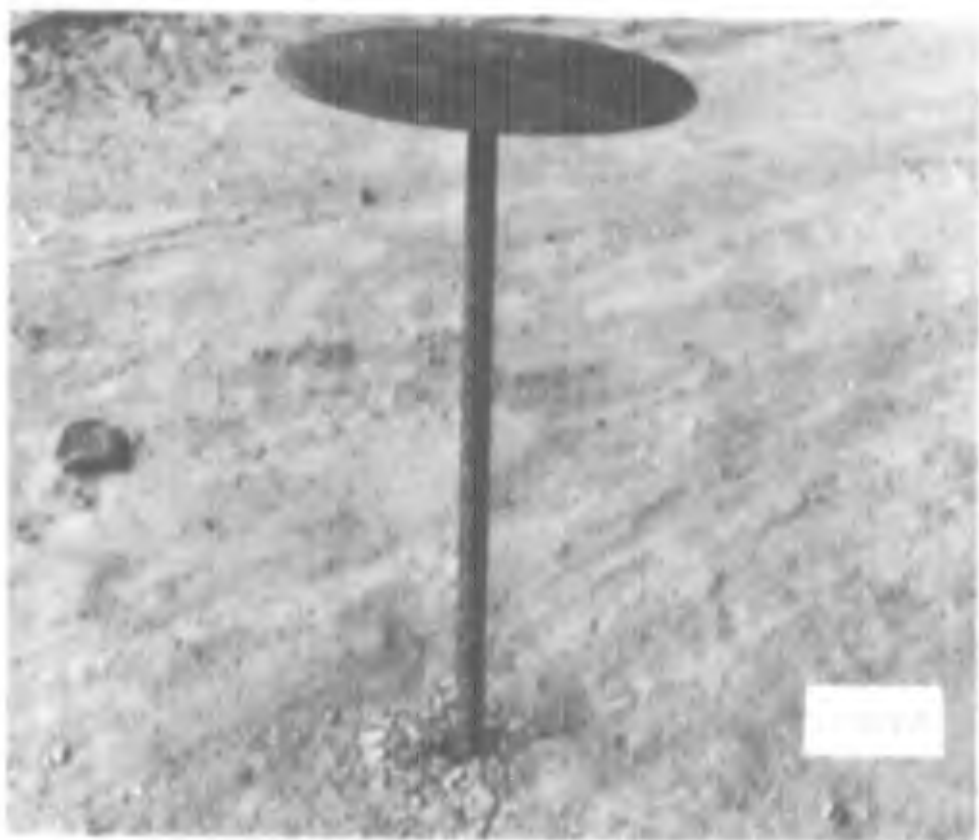
Photograph 14. Guy anchor driven into the soil subgrade to a depth of 6 in.
