TECHNICAL REPORT 3-71-10

# EVALUATION OF ANCHORS USED TO SECURE MEMBRANE SURFACINGS

R. H. Grau

Conducted by U. S. Army Engineer Waterways Experiment Station, Vicksburg, Mississippi

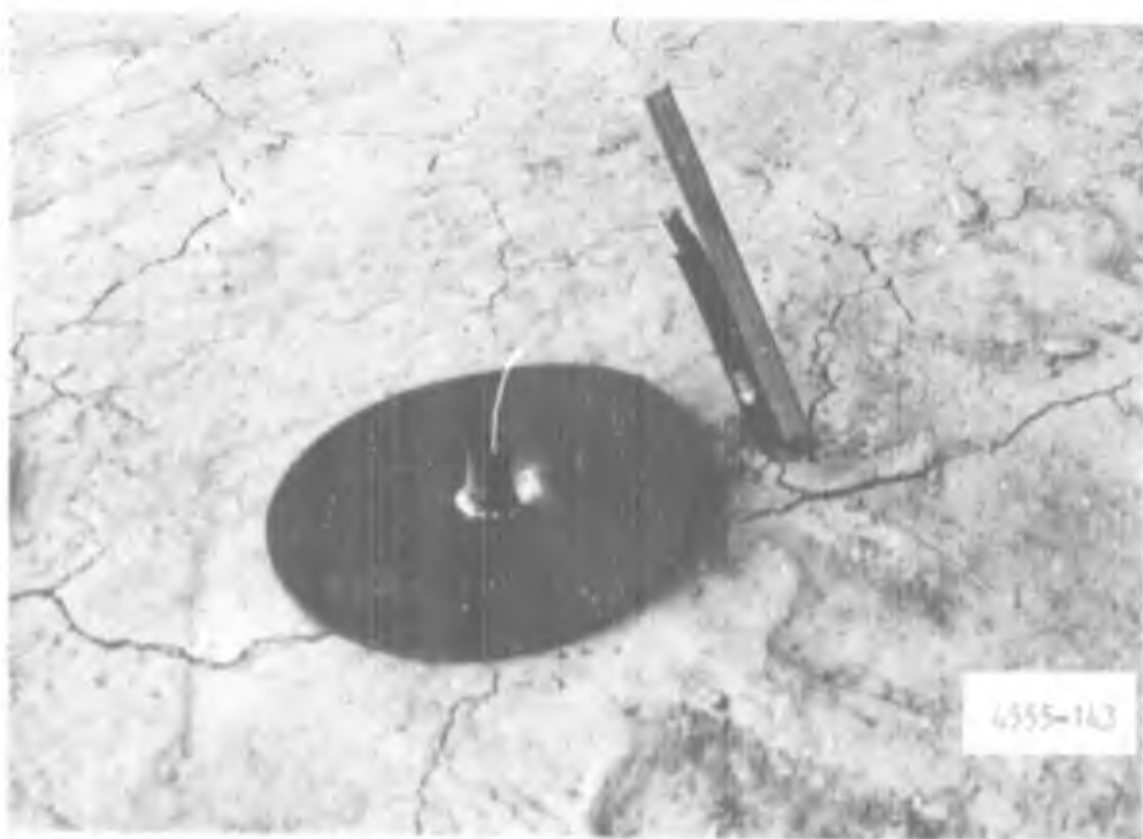
Photograph 15. Threaded guy anchor driven into the soil subgrade to a depth of 18 in.

24. This anchor was assembled by screwing the 2-ft-long reinforcing bar into the steel collar that was welded to the head of the anchor. The threaded guy anchor and the guy anchor were driven with a sledgehammer into the soil subgrade so their performances could be compared. Photographs 13 and 14, respectively, illustrate the threaded guy anchor and the guy anchor after they had been driven to a depth of 6 in. into the soil subgrade. The reinforcing bar of the threaded guy anchor began to bend, but the reinforcing bar of the guy anchor did not. The bend in the reinforcing bar of the threaded anchor was also evident after the anchor had been driven to a depth of 18 in. (photograph 15). The bend in the reinforcing bar occurred where it had been ground flat on two sides for wrench placement. No bend occurred in the guy anchor's reinforcing bar, but the head had been bent slightly to one side (photograph 16). When the threaded guy anchor was driven to a depth of 24 in., making the head flush with the surface, the head broke loose from the steel collar that connected it to the reinforcing bar (photograph 17). The head of the guy anchor was not broken from the reinforcing bar when the anchor was driven to a depth of 24 in., but considerable edge curl occurred about the periphery of the steel plate head (photograph 18).

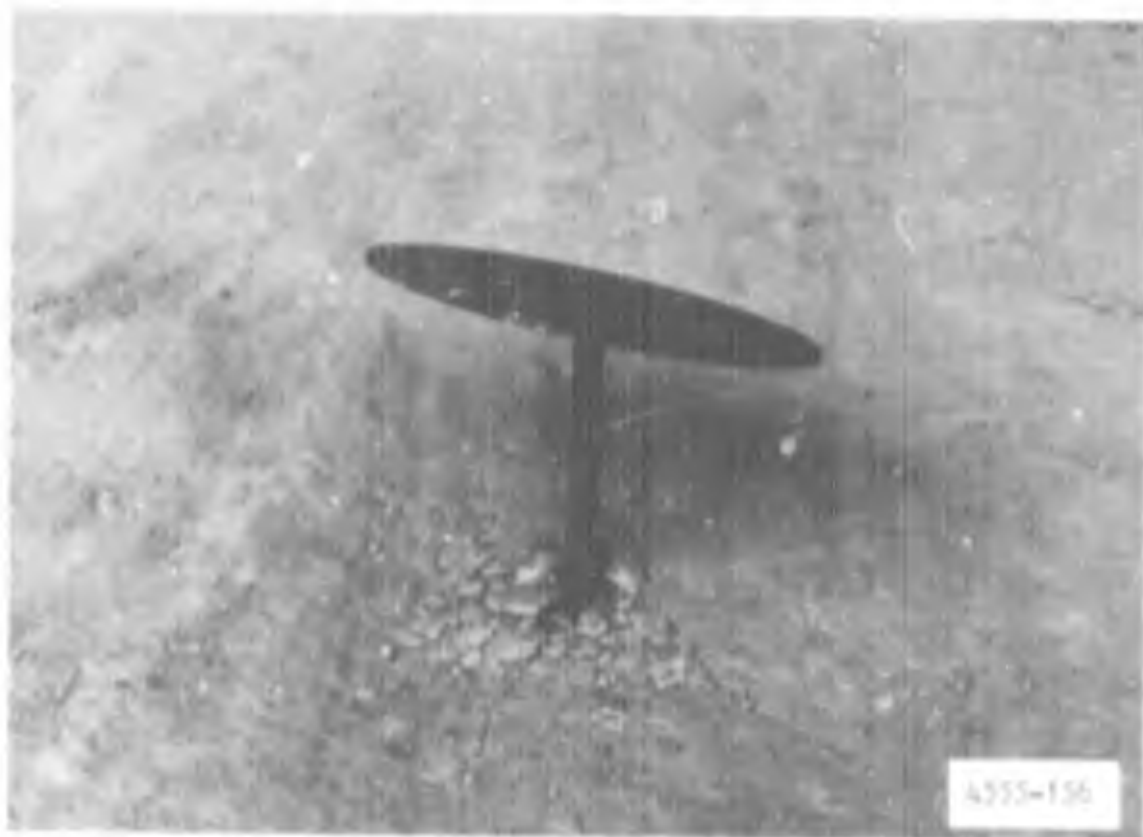
Photograph 16. Guy anchor driven into the soil subgrade to a depth of 18 in.

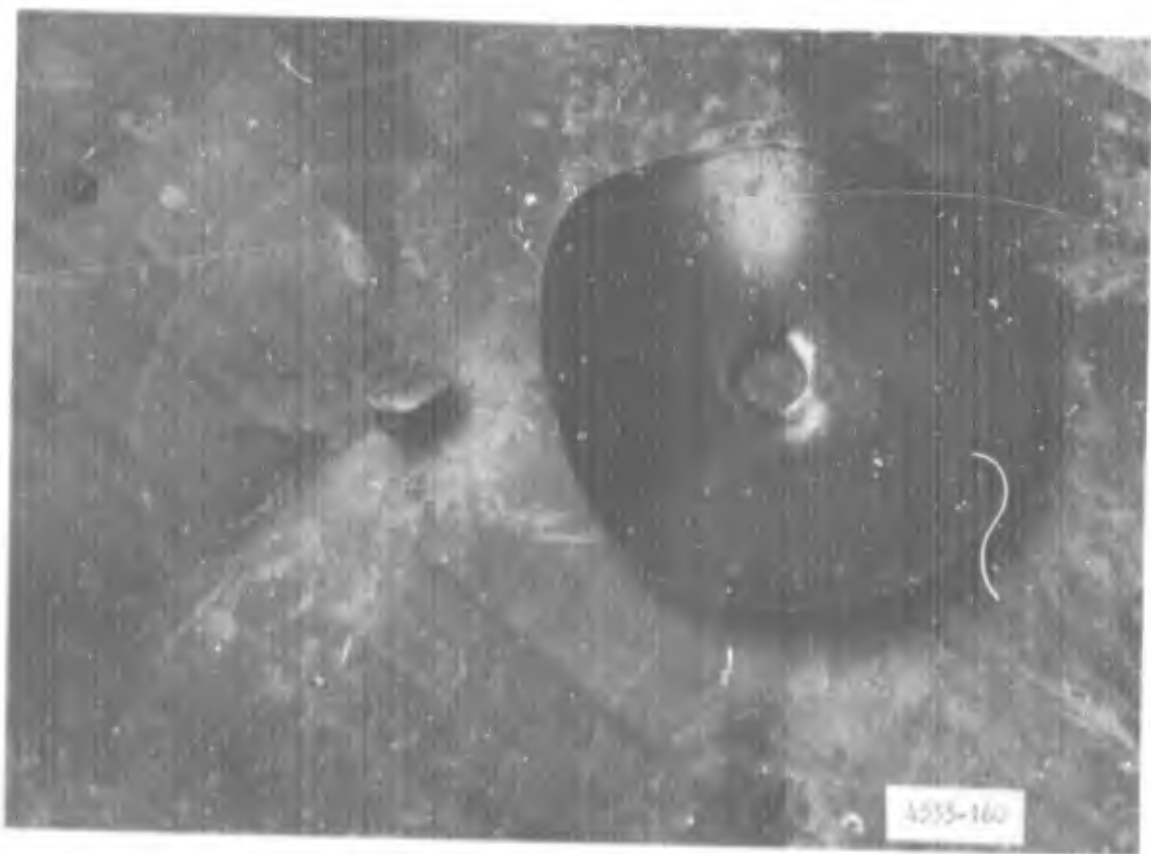
Photograph 17. Head broken from the steel collar after the threaded guy anchor had been driven to a depth of 24 in.

29. Initial bending of the 2-ft-long reinforcing bar occurred when the anchor was driven into the subgrade to a depth of 6 in. Bending occurred in the reinforcing bar where it had been ground flat on two sides for a wrench fitting, approximately 6 in. from the threaded end. The head of the anchor was broken from the steel collar when the anchor was driven into the subgrade to the full depth of 24 in.

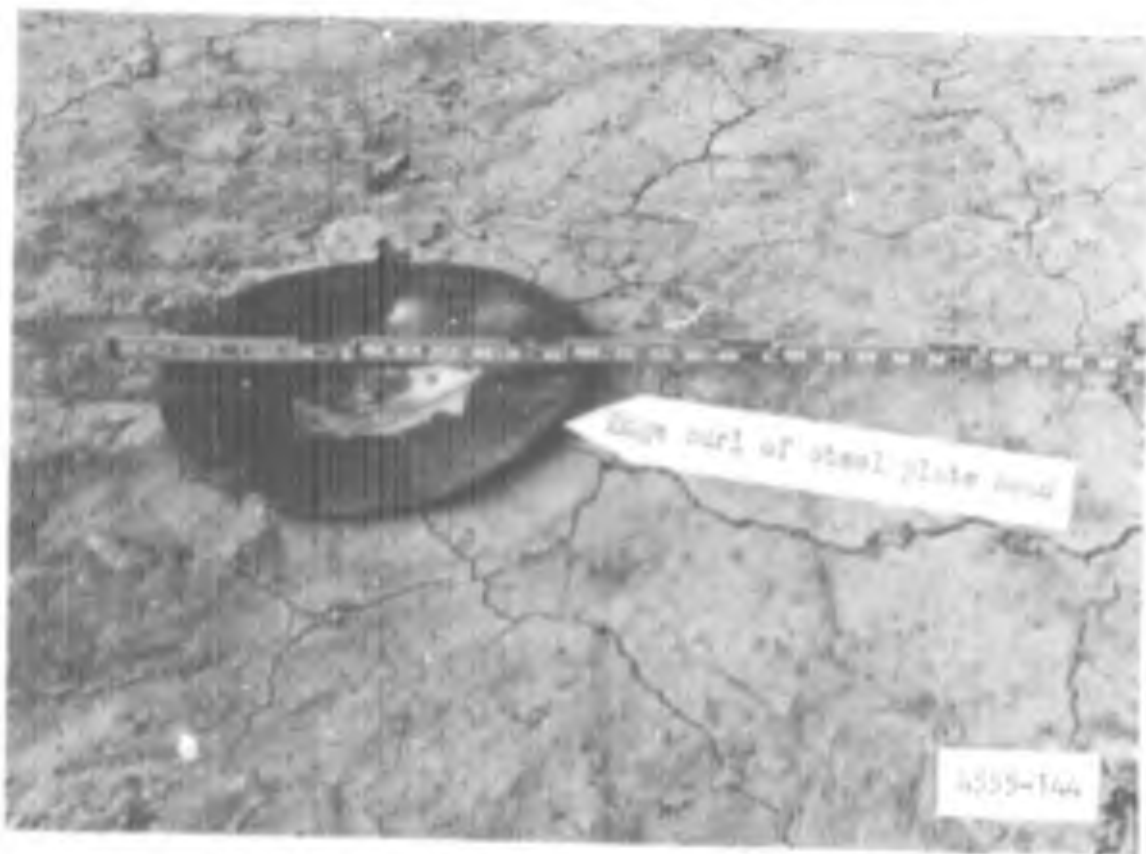
Photograph 18. Condition of guy anchor after being driven to a depth of 24 in.

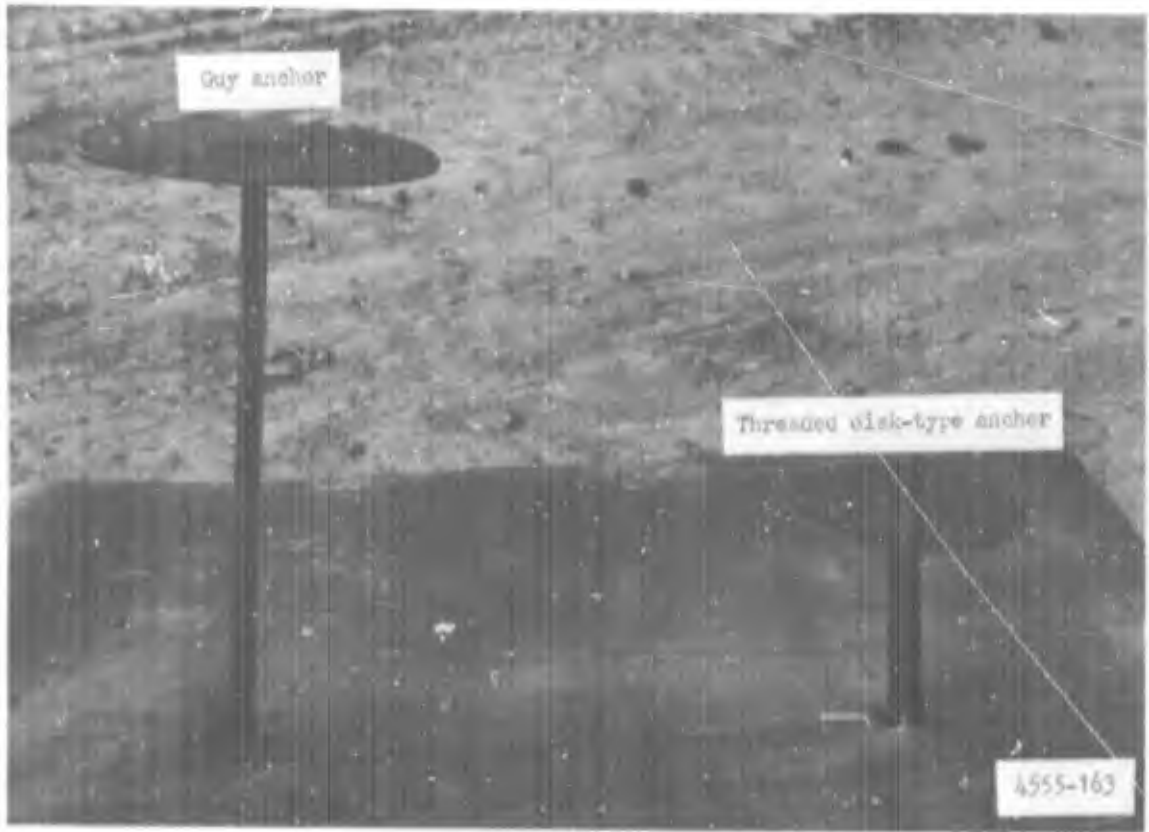
Photograph 19. Guy anchor and threaded disk-type anchor after they had been driven through membrane surfacing into the soil subgrade to a depth of 6 in.

25. Due to the difference in length of the reinforcing bars, the threaded disk-type anchor and guy anchor were driven with a sledgehammer into the soil subgrade to depths of 12 and 24 in., respectively. Photograph 19 shows both anchors after they had been driven through a section of membrane surfacing into the soil subgrade to a depth of 6 in. At the 6-in. depth, no damage had occurred to either anchor. When the anchors were driven 12 in. into the subgrade (see photograph 20), the reinforcing bar of the threaded disk-type anchor was broken; however, the guy anchor was not damaged. The reinforcing bar of the threaded disk-type anchor broke where the cross-sectional area of the bar had been reduced when the bar was threaded. The guy anchor incurred no damage when driven flush with the membrane surfacing.

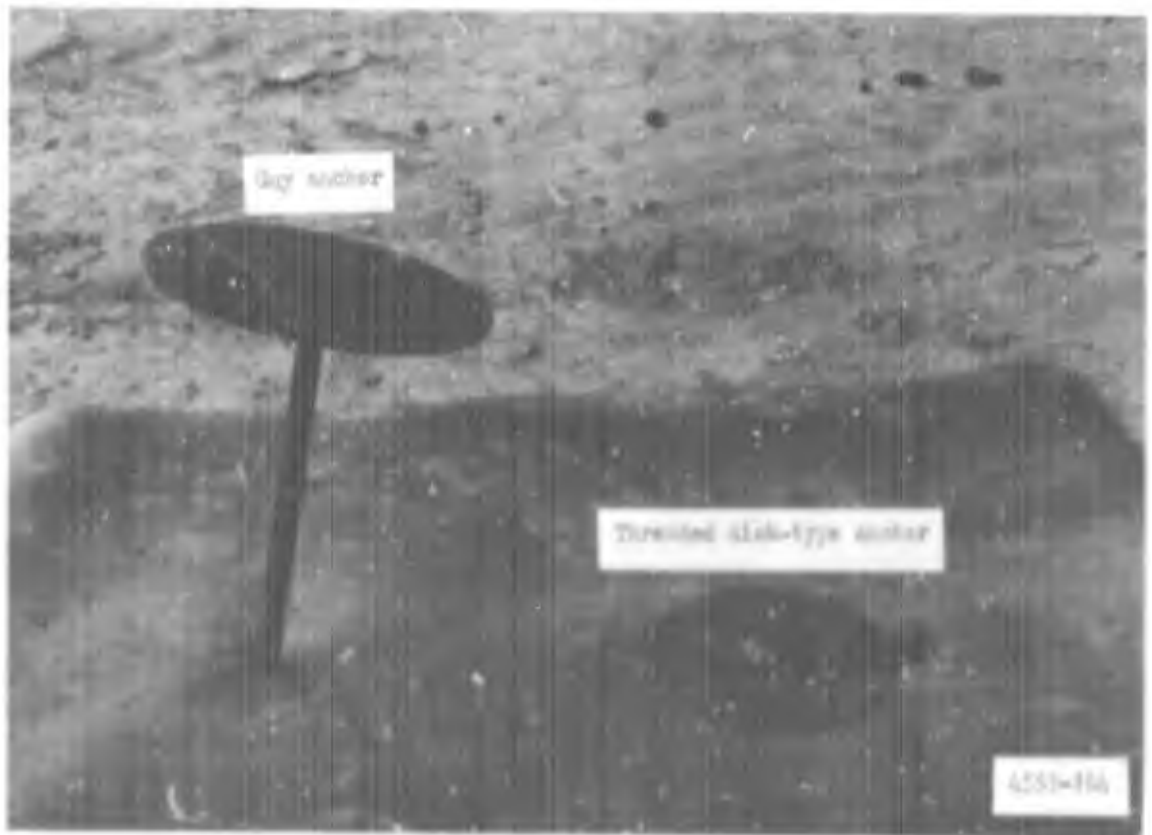
Photograph 20. Guy anchor and threaded disk-type anchor after they had been driven to a depth of 12 in.

30. When the threaded disk-type anchor was driven into the soil subgrade to a depth of 6 in., no damage occurred. The threaded end of the reinforcing bar was broken from the bar when the anchor was driven into the subgrade to the full depth of 12 in.

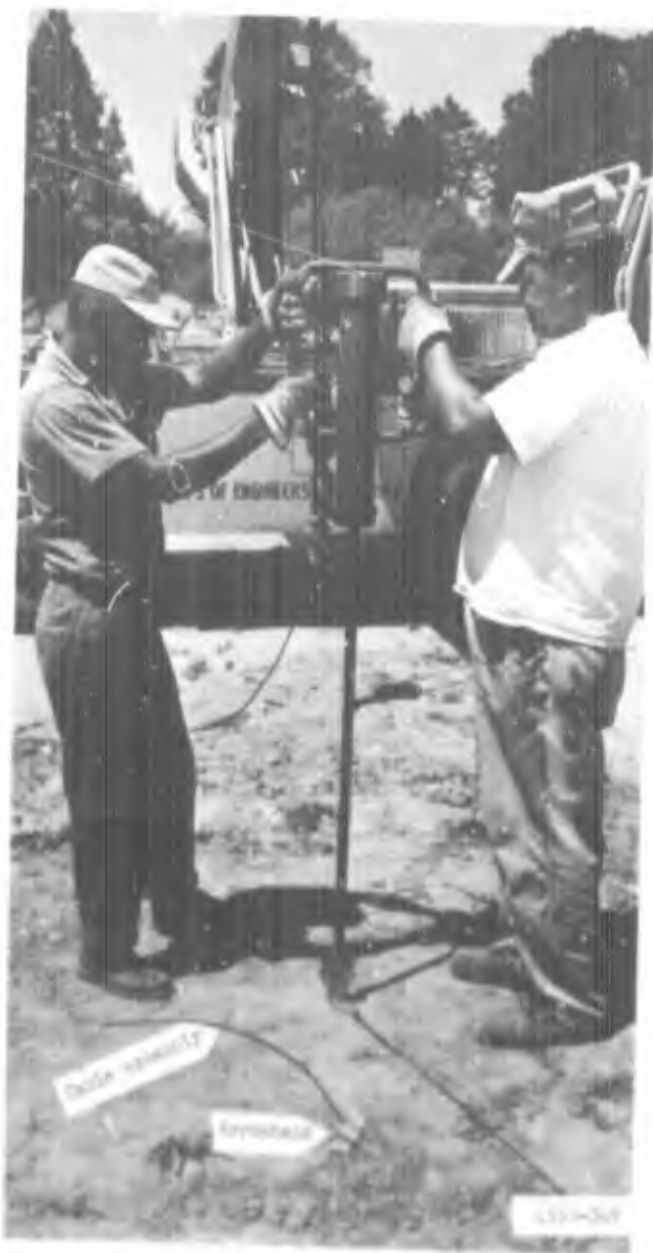
Photograph 21. Driving arrowhead anchor into subgrade with manual impact tool

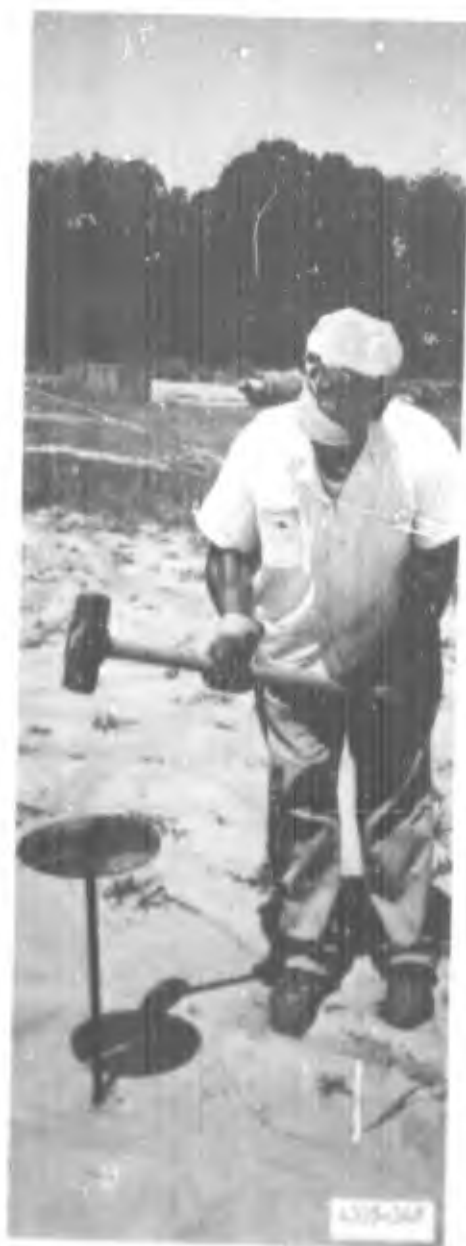
Photograph 22. Driving guy anchor into subgrade with sledgehammer

34. The guy, disk-type, and two-legged anchors were driven into the subgrade with a sledgehammer. Photograph 22 shows a guy anchor being driven into the subgrade. The guy and disk-type anchors were driven easily into the soil subgrades with a sledgehammer, but a problem was encountered when the two-legged anchors were driven into the soil subgrades with a sledgehammer. When the legs of the anchors were positioned inward or outward from a perpendicular position relative to the head of the anchor, the legs were bent inward toward the head of the anchor or away from the head of the anchor as it was driven into the soil subgrade. The legs of the anchor also crumpled as the anchor was being driven into the subgrade. When this occurred, the anchor could not be driven the full depth of the legs, thus causing a decrease in the holding strength of the anchor. Tests also revealed that the anchor legs were bent and crumpled rather easily when the head of the sledgehammer did not strike the anchor exactly on the area where the legs joined the head.

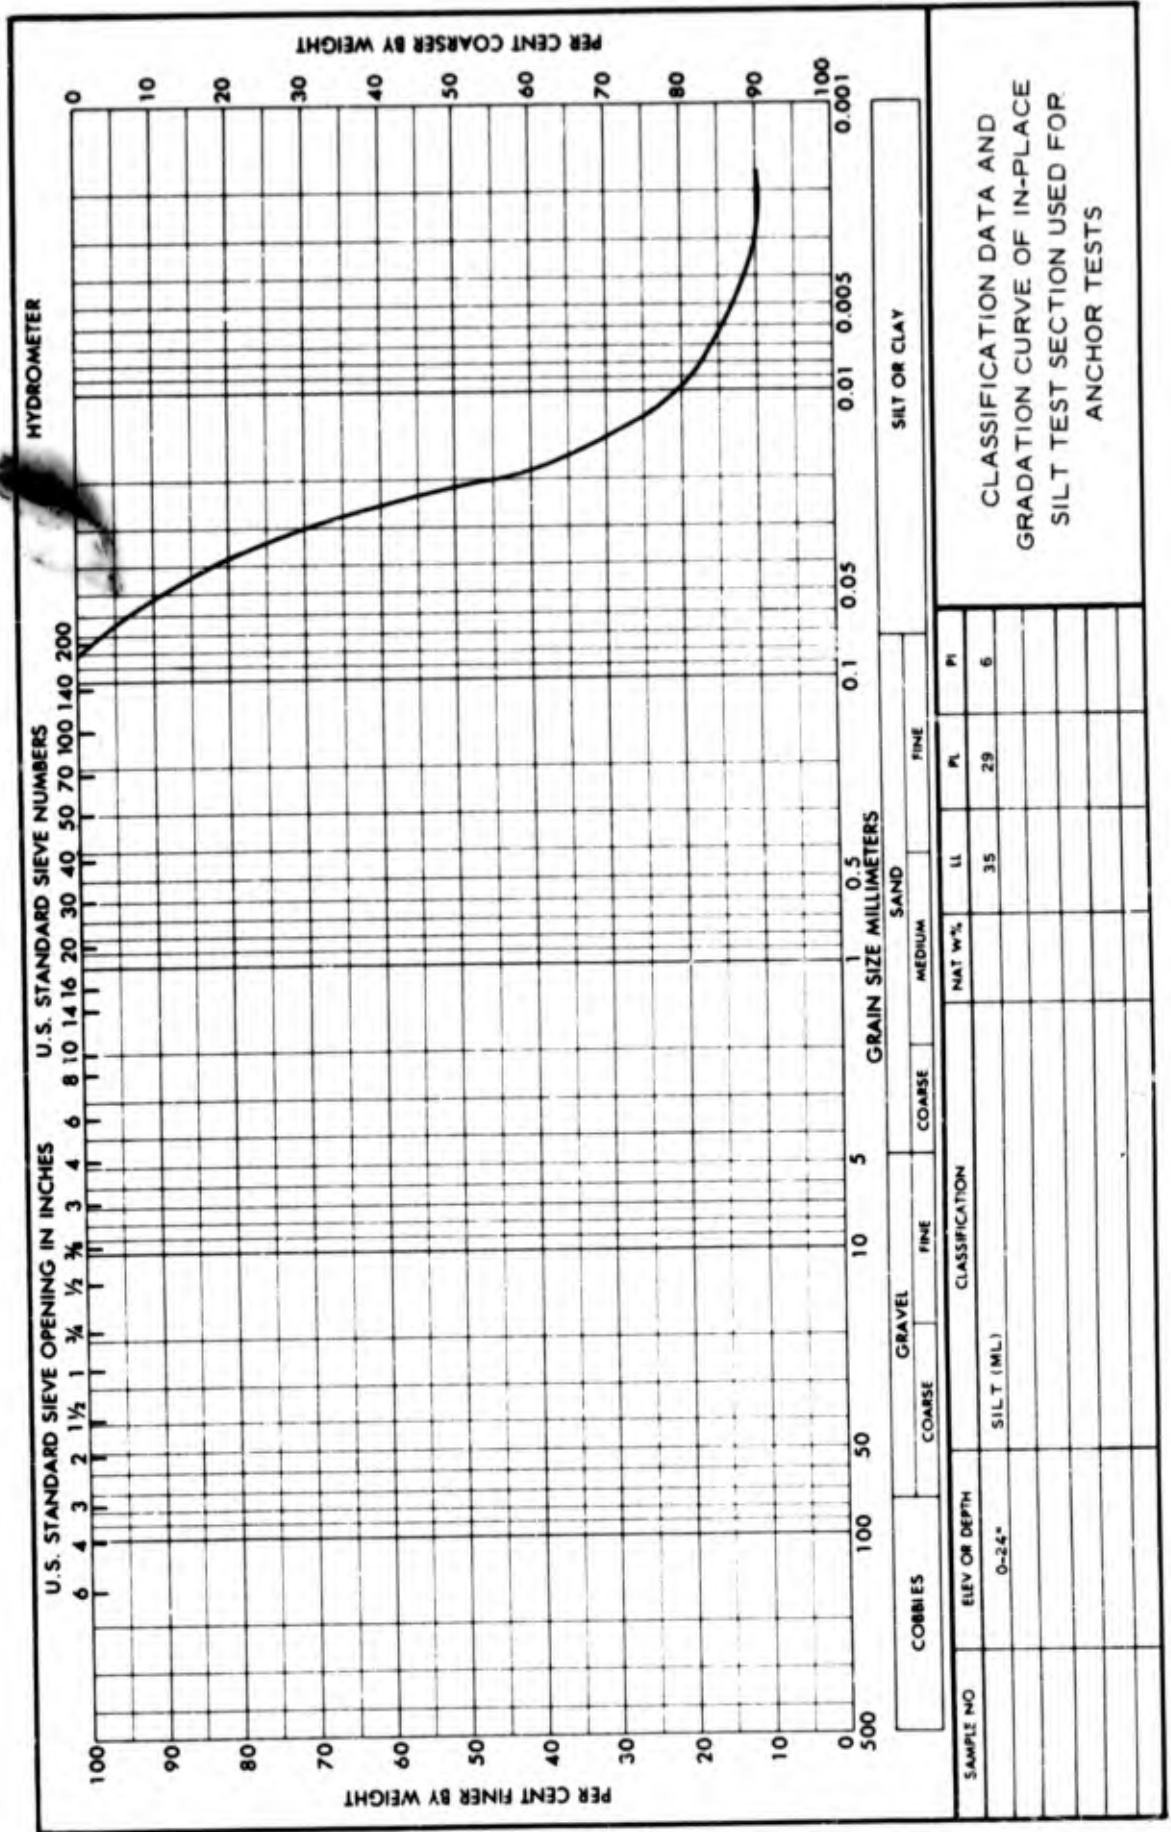
CLASSIFICATION DATA AND  
 GRADATION CURVE OF IN-PLACE  
 SILT TEST SECTION USED FOR  
 ANCHOR TESTS

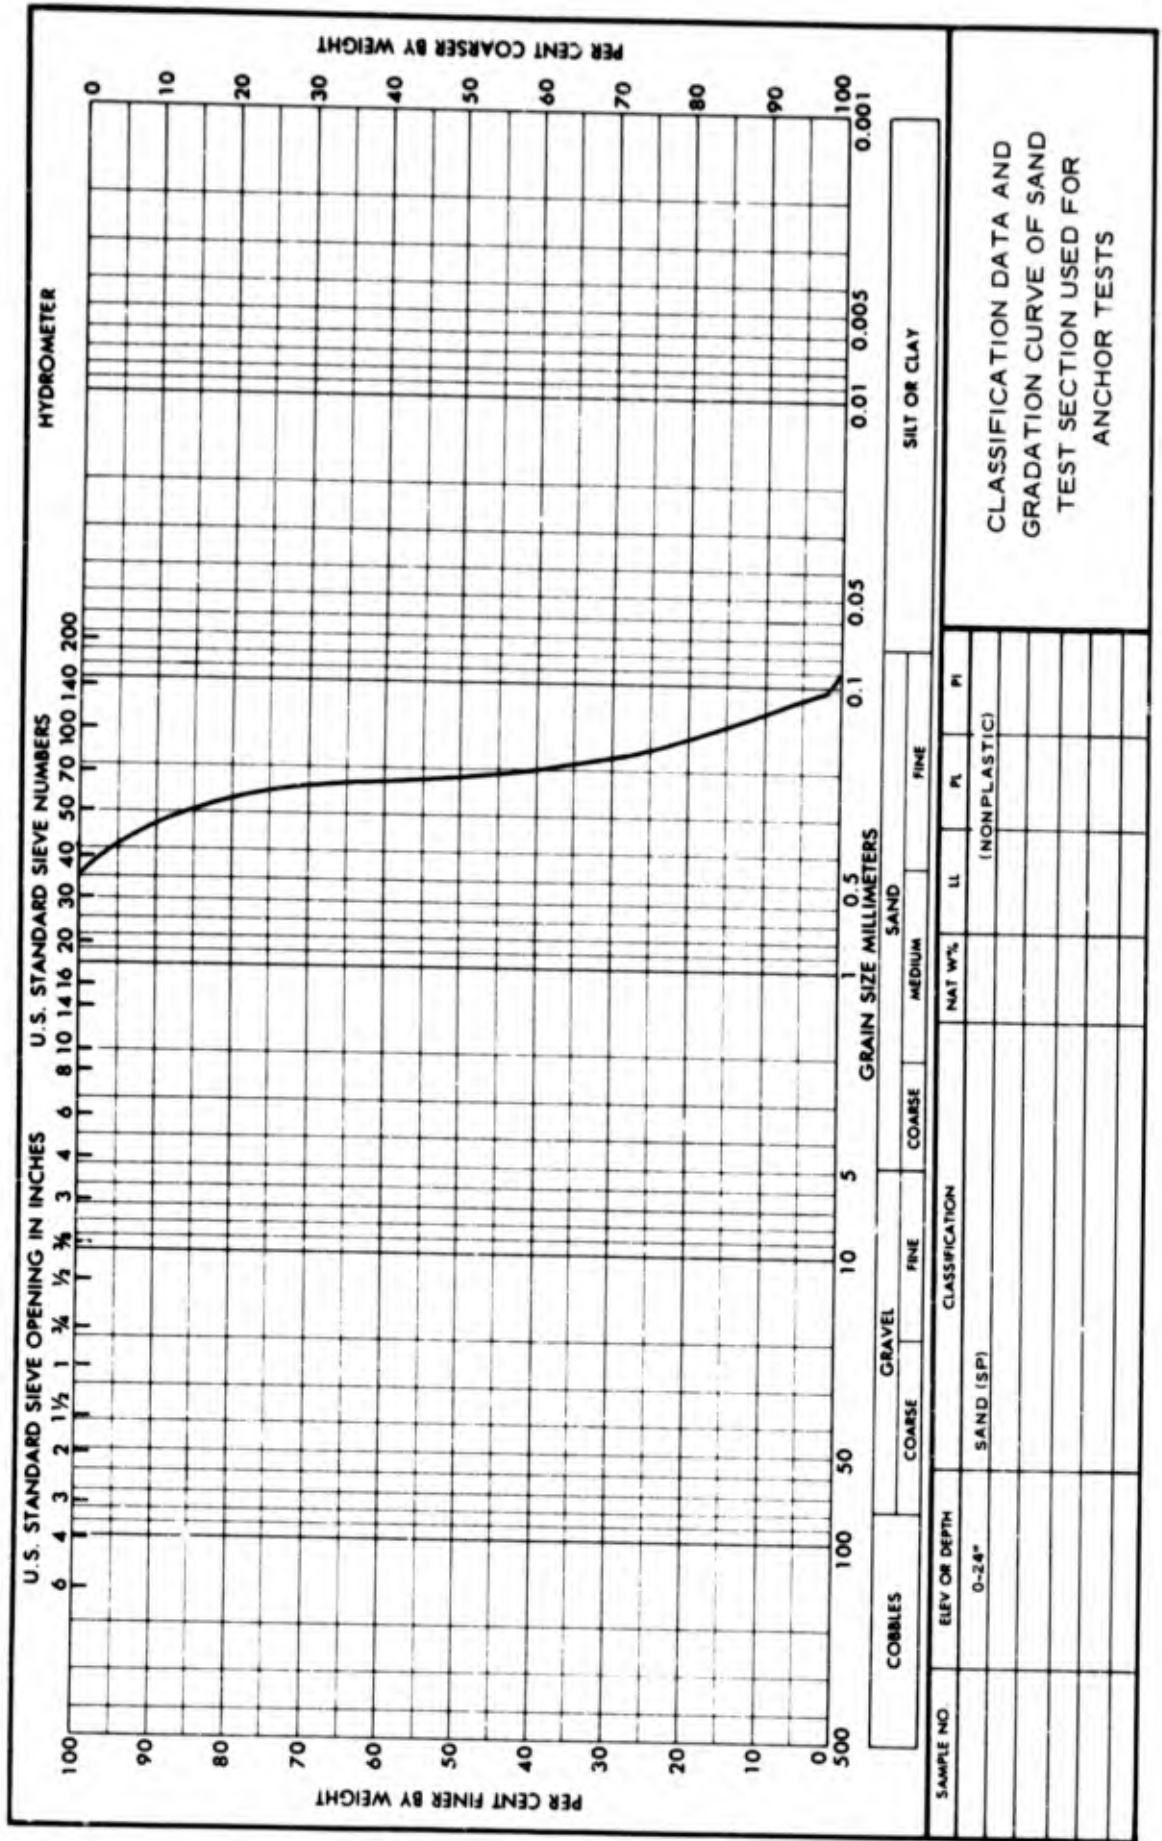
PLATE 2

CLASSIFICATION DATA AND  
 GRADATION CURVE OF SAND  
 TEST SECTION USED FOR  
 ANCHOR TESTS

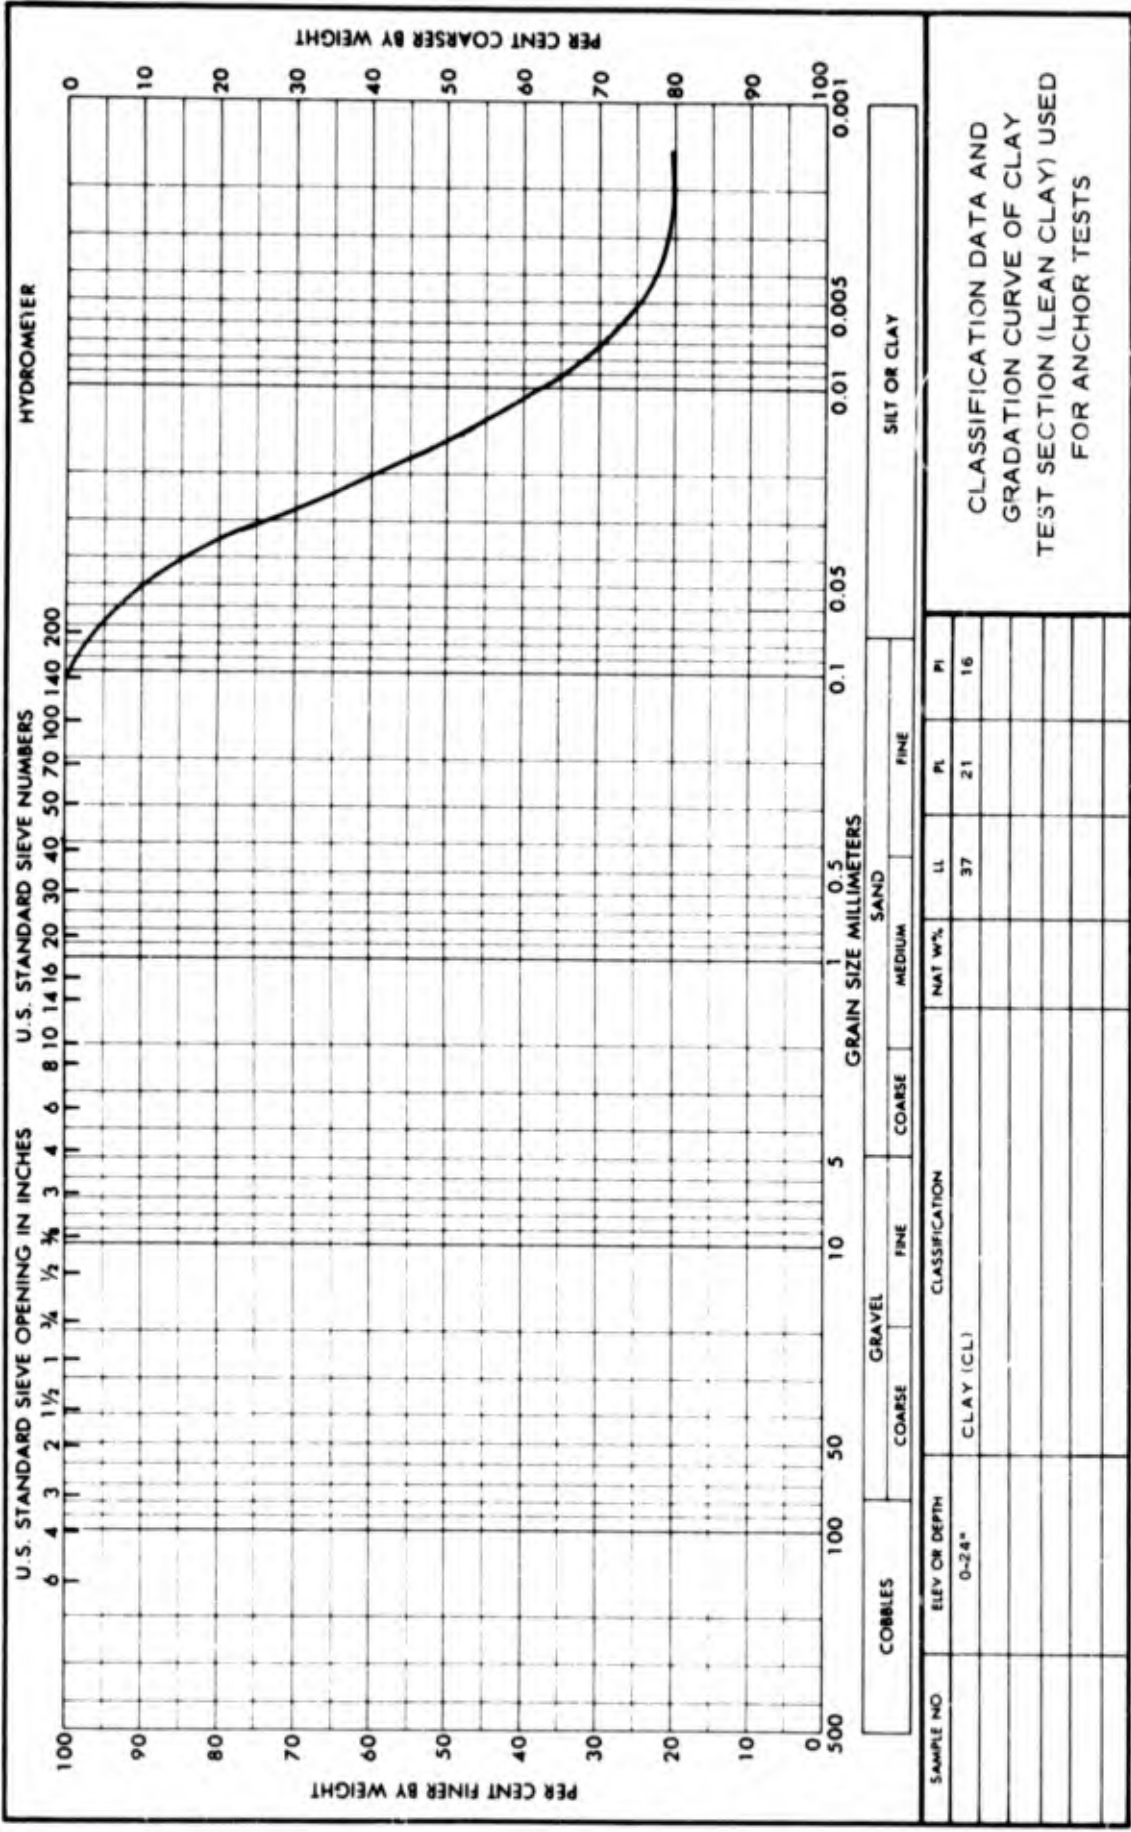
CLASSIFICATION DATA AND  
 GRADATION CURVE OF CLAY  
 TEST SECTION (LEAN CLAY) USED  
 FOR ANCHOR TESTS
