USAAMRDL TECHNICAL REPORT 71-28

STATIC AND ROTATING AIR/GAS SEAL EVALUATION

W. Paladini

**CONTRACT DAAJ02-70-C-0024
CURTISS-WRIGHT CORPORATION
WOOD-RIDGE, NEW JERSEY**

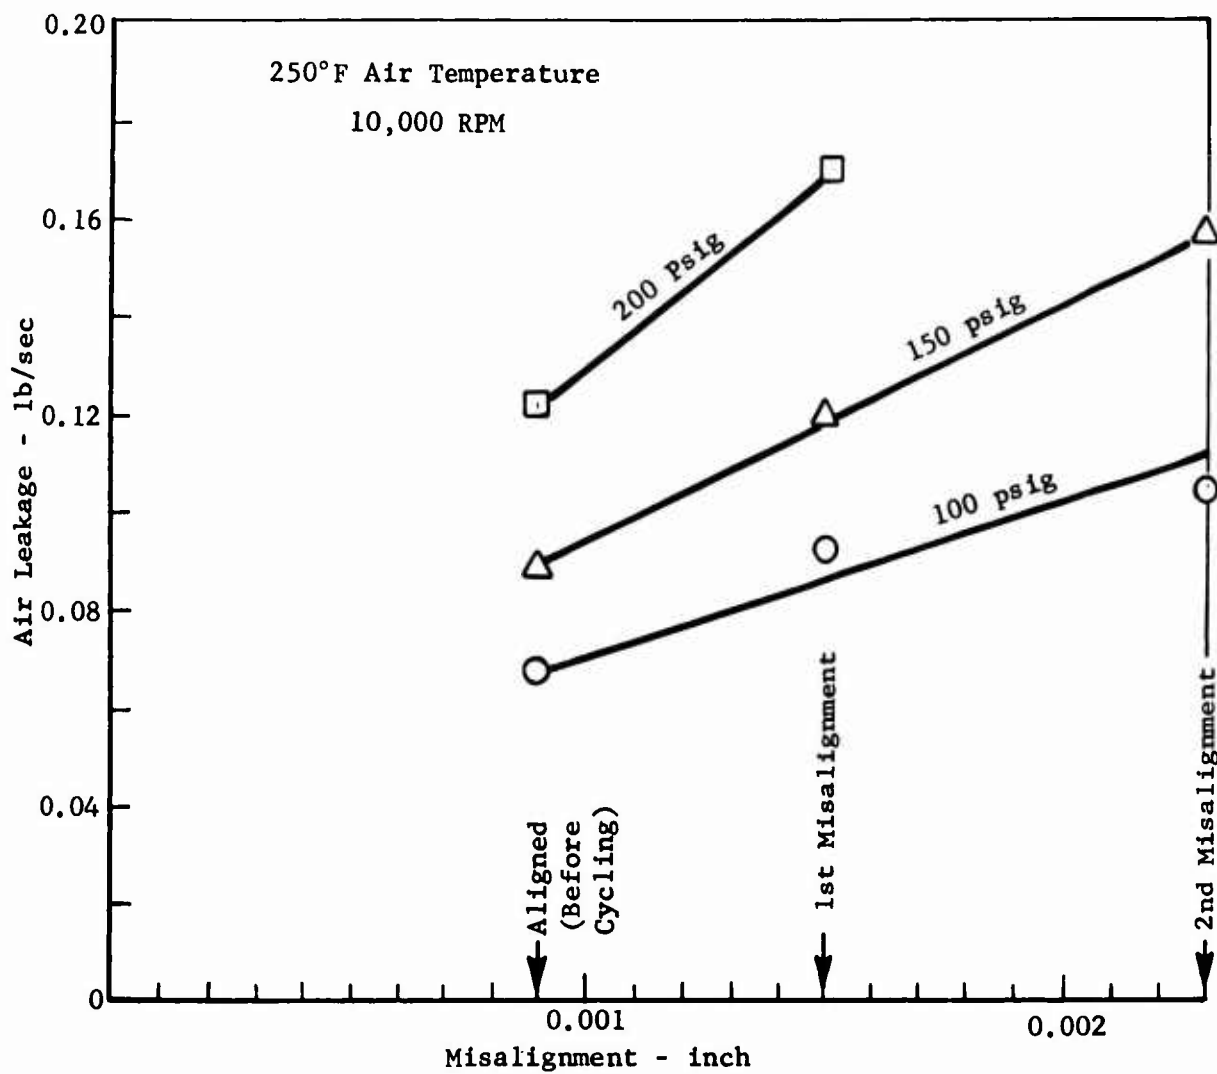
Figure 21. Labyrinth Seal Leakage Versus Misalignment.

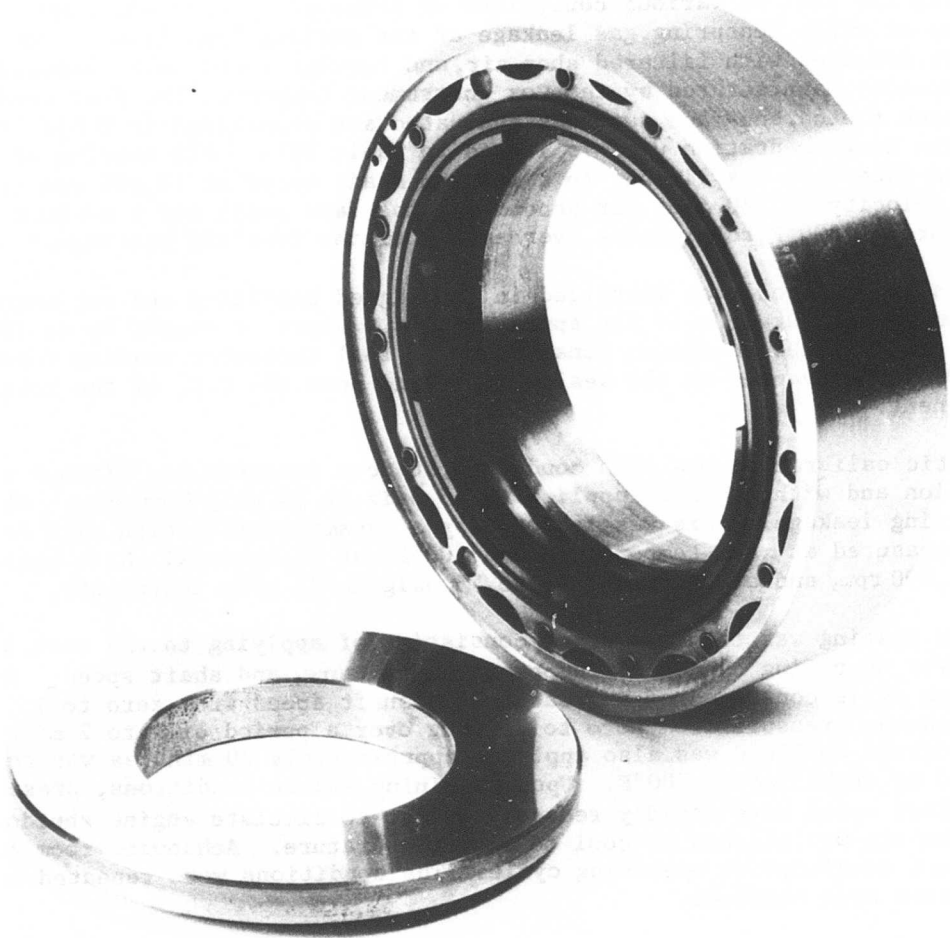
Figure 27. Carbon-Face Seal Components.

The carbon-face seal assembly and the rotating component are shown in Figure 27. A closer view of the face seal assembly is shown in Figure 28, and the rubbing surfaces of both the stationary and the rotating members are shown in Figure 29.

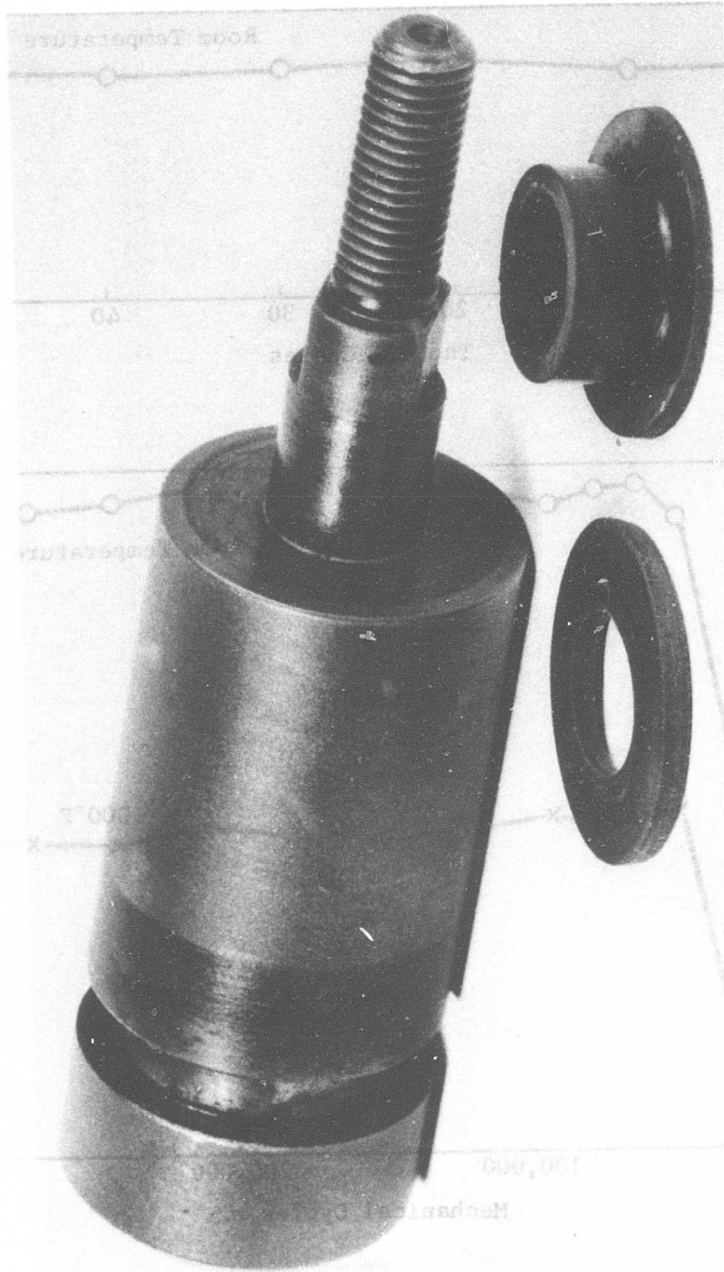
Figure 71. Compressor Variable-Geometry Trunion Mechanism After Testing.
