3. REPORT TITLE  
CORROSION OF MATERIALS IN HYDROSPACE - PART VI - STAINLESS STEELS

5. AUTHOR(S) (First name, middle initial, last name)  
Fred M. Reinhart

NAVAL CIVIL ENGINEERING LABORATORY  
Port Hueneme, California 93043

Technical Note N-1172

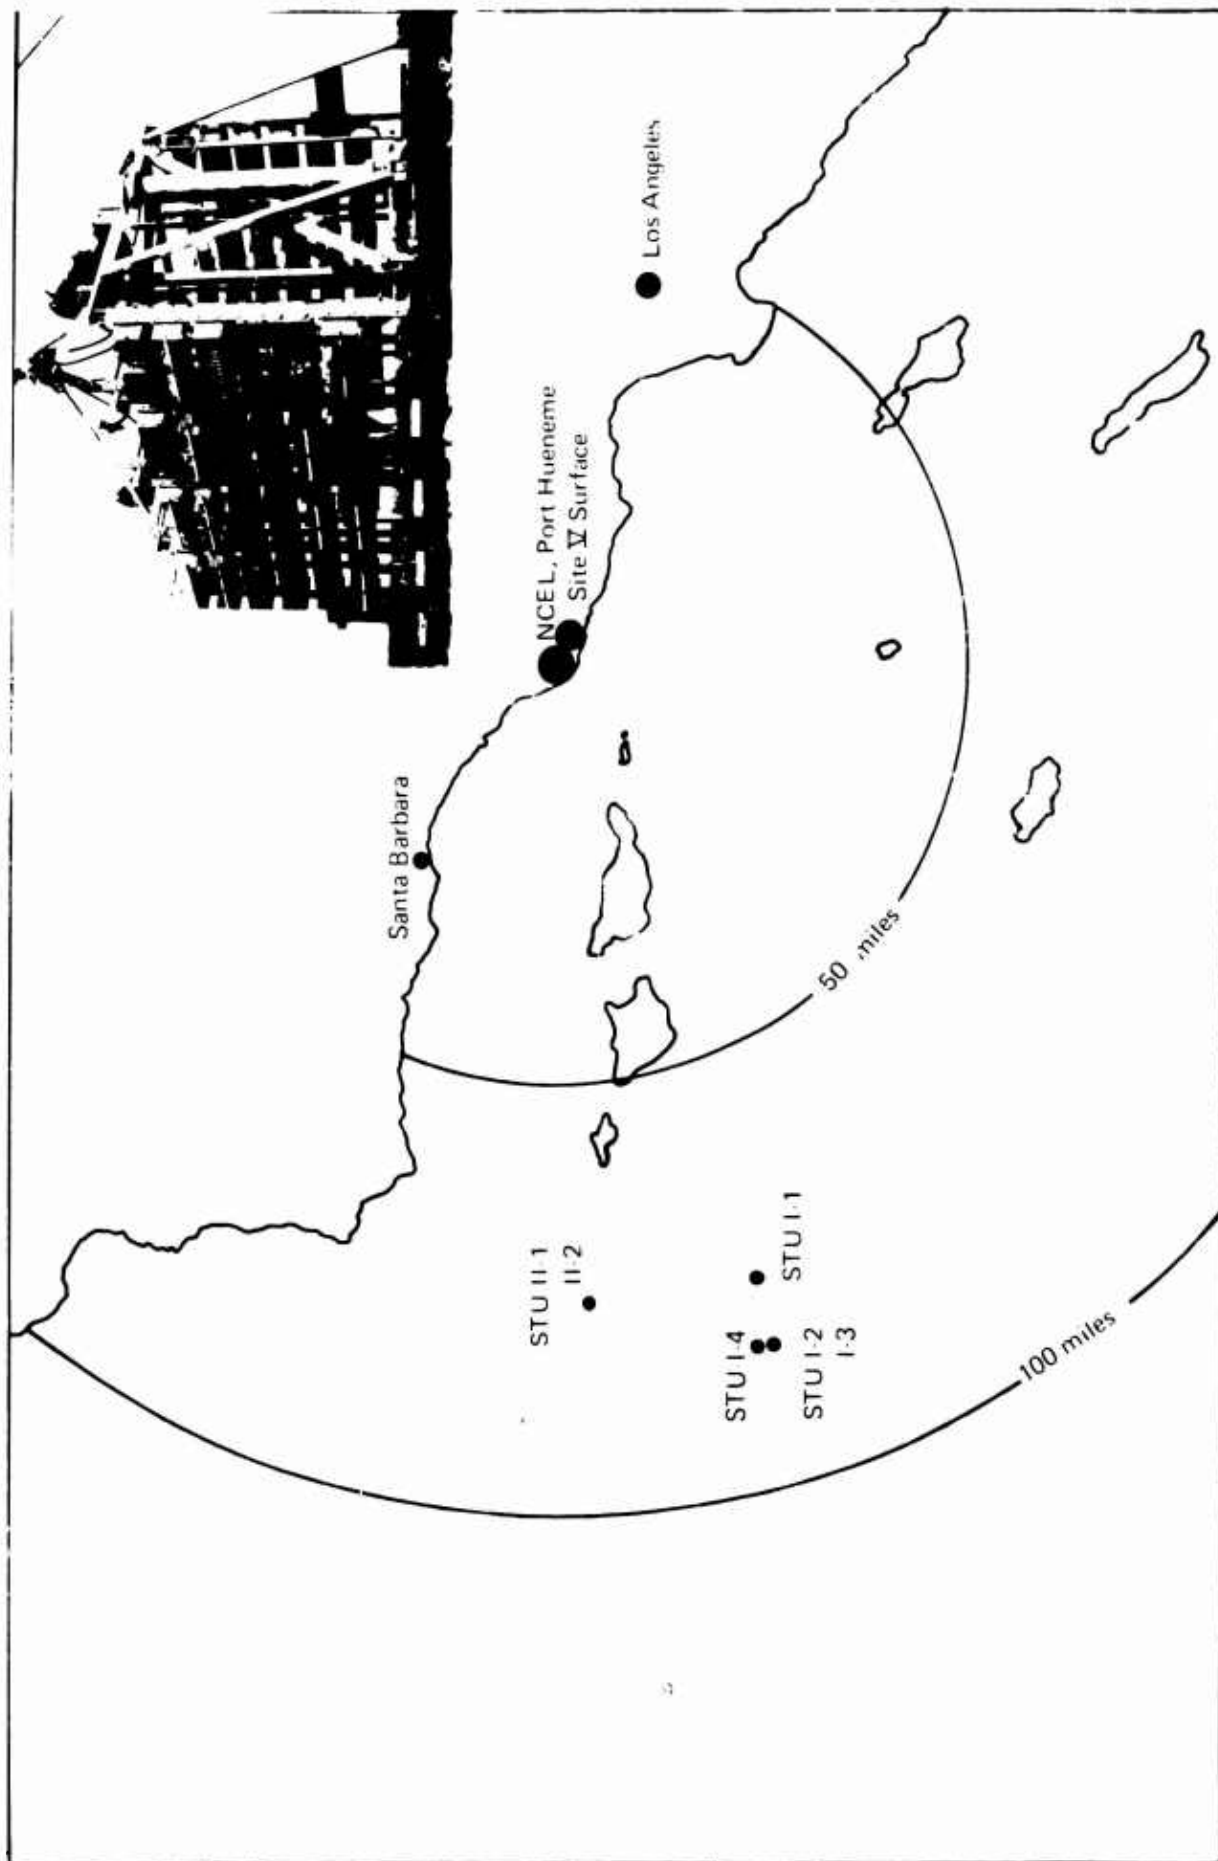
Figure 1. Area map showing STU sites off the Pacific Coast; STU structure in inset.

In order to determine the effects of deep ocean environments on the corrosion of metals and alloys, a Submersible Test Unit (STU) was designed, on which many test specimens can be mounted. A STU unit is shown in the inset of Figure 1.

The test sites for the deep ocean exposures are shown in Figure 1, and their specific geographical locations are given in Table 1. The complete oceanographic data at these sites, obtained from NCEL cruises between 1961 and 1967, are summarized in Figure 2. Initially, it was decided to utilize the site at the 6,000-foot depth (STU I-1, 2, 3 and 4). Because of the minimum oxygen concentration zone found between the 2,000- and 3,000-foot depths during the early oceanographic cruises, it was decided to establish a second site (STU II-1 and II-2) at a nominal depth of 2,500 feet. For comparative purposes the surface water Site V was established. Even though the actual depths are shown in the tables, the nominal depths of 6,000 and 2,500 feet are used throughout the text.

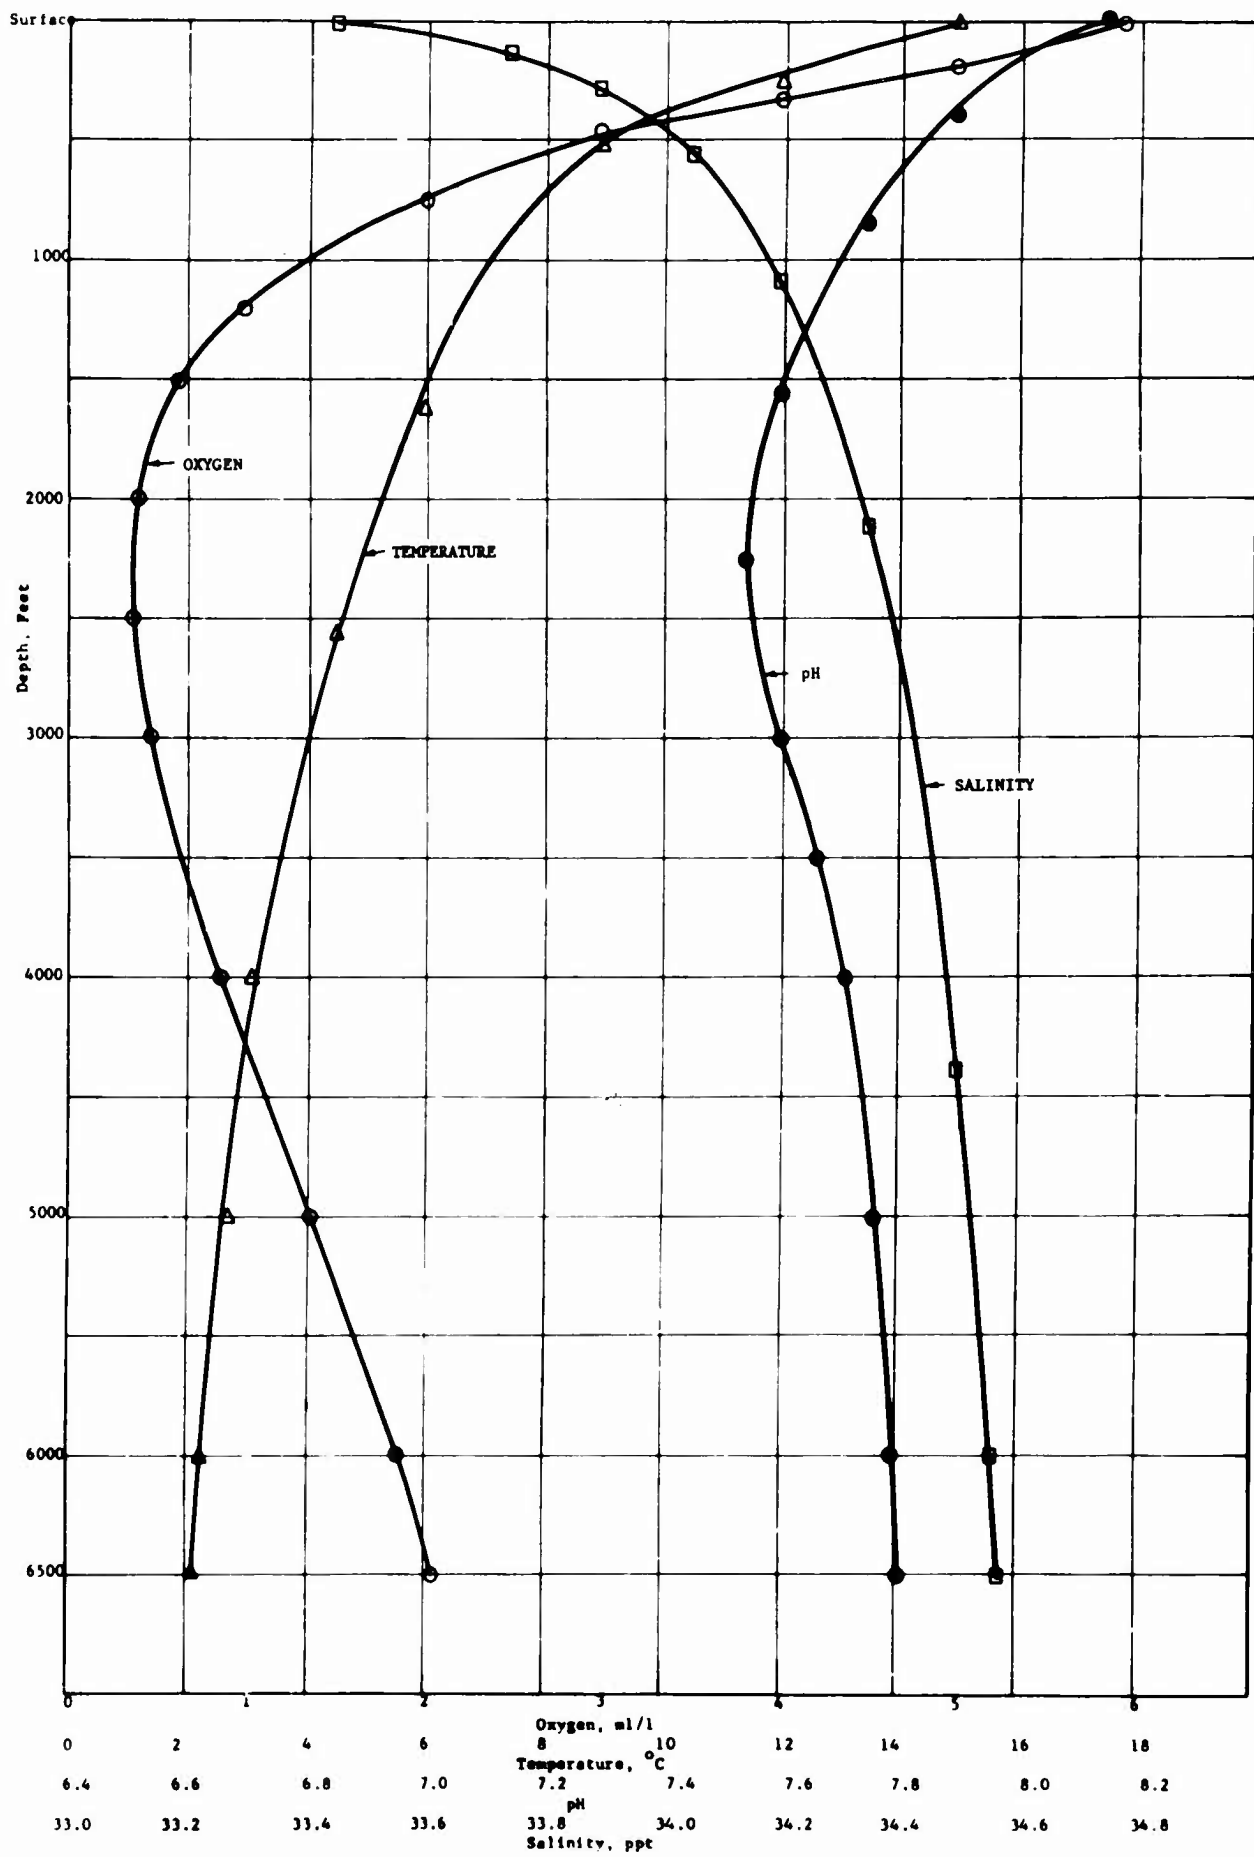
Figure 2. Oceanographic data at STU sites.

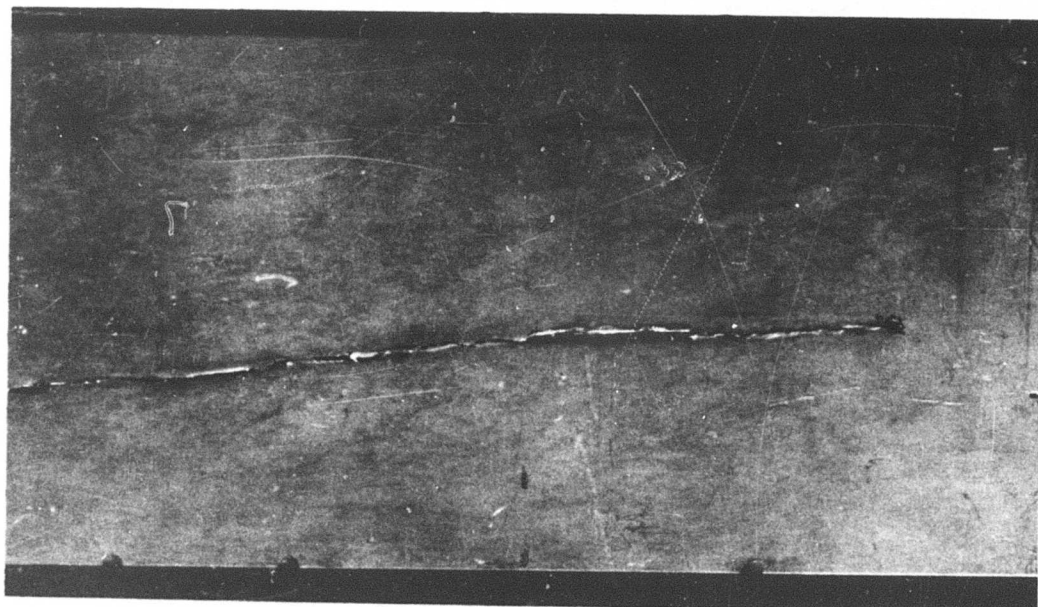
Figure 4. Tunnel corrosion extending almost the entire length of a 12 inch long specimen.

A manifestation of pitting corrosion whose presence and extent is often overlooked is tunnel corrosion. An illustration of tunnel corrosion extending almost the entire length of a 12-inch specimen is shown in Figure 4. Tunnel corrosion is also classified by some as edge, honeycomb or underfilm corrosion. Tunnel corrosion is insidious because of its nature and by virtue of the fact that many times it is not apparent from the outside surfaces of the object. It starts as a pit on the surface or on an edge and propagates laterally through the material, many times leaving thin films of uncorroded metal on the exposed surfaces.

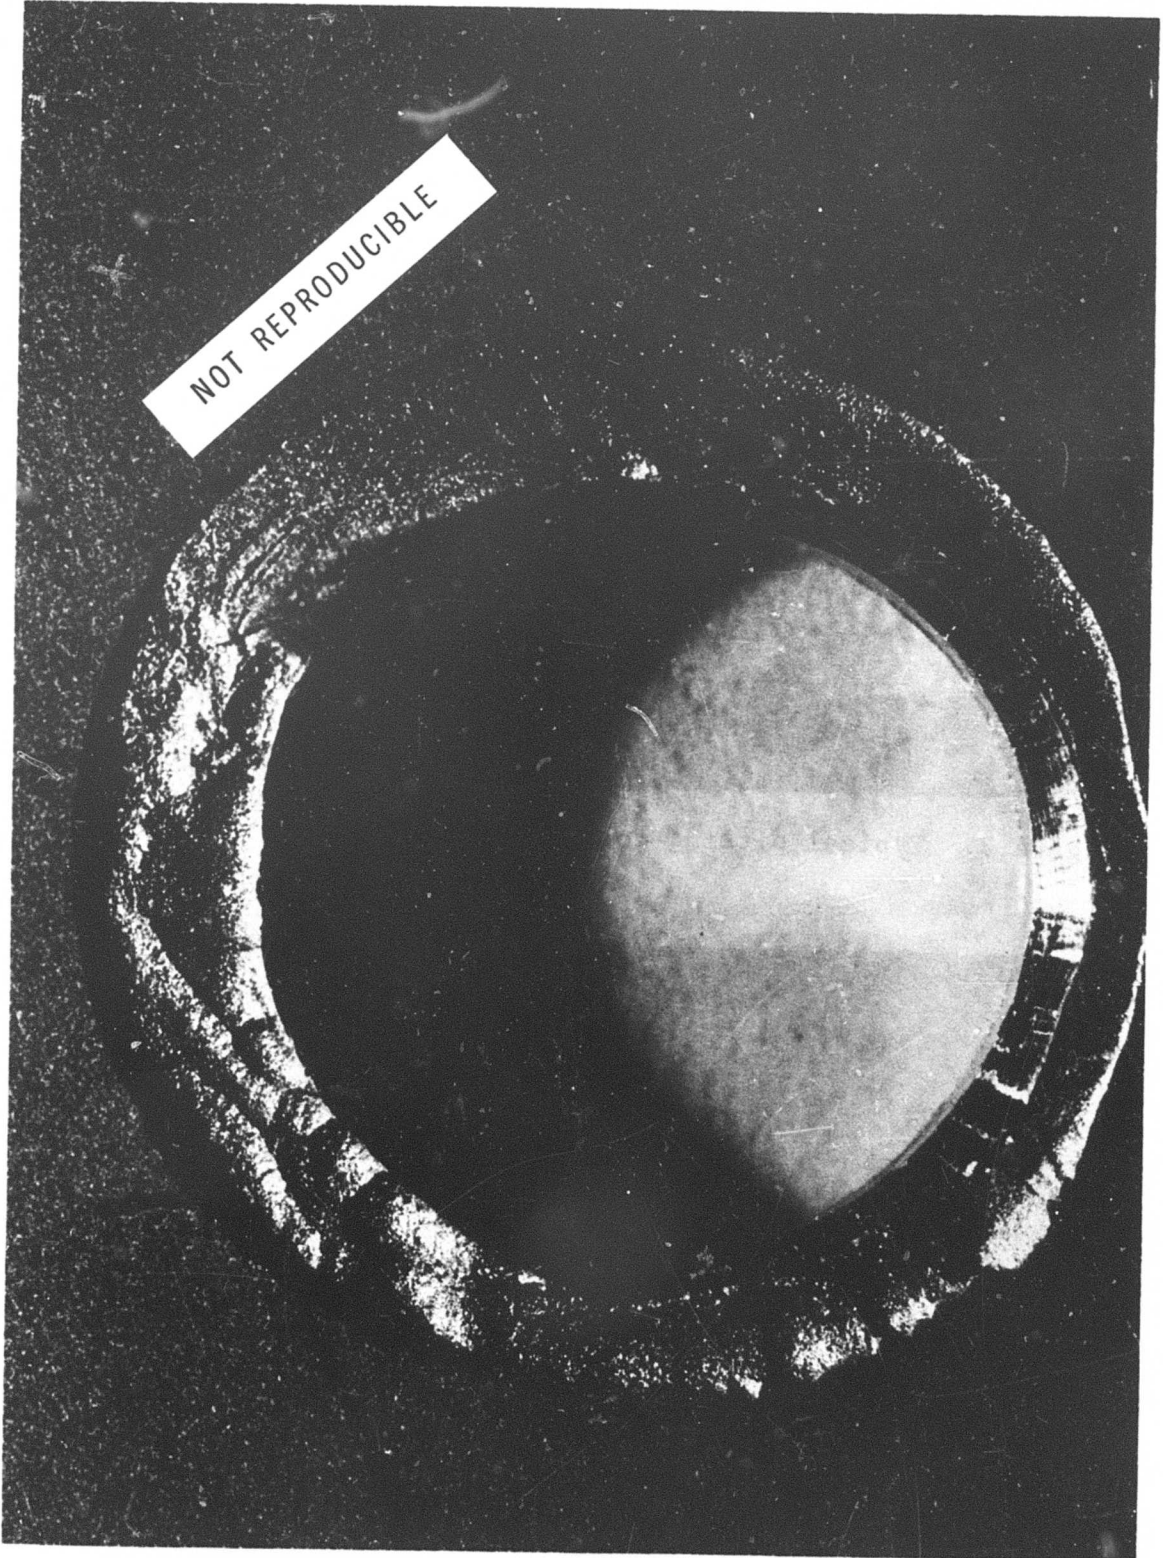
Figure 5. Crevice corrosion typical of that found in stainless steels.

Another manifestation of localized attack in stainless steels is oxygen concentration cell corrosion in crevices (usually known as crevice corrosion). An illustration typical of crevice corrosion in stainless steels is shown in Figure 5. This type of corrosion occurs underneath deposits of any kind on the metal surface, underneath barnacles and at the faying surfaces of a joint. The area of stainless steel which is shielded from the surrounding solution becomes deficient in oxygen, thus creating a difference in oxygen concentration between the shielded and unshielded areas. An electrolytic cell is created with a difference of potential being generated between the high and low oxygen concentration areas with the low oxygen concentration area becoming the anode of the cell.

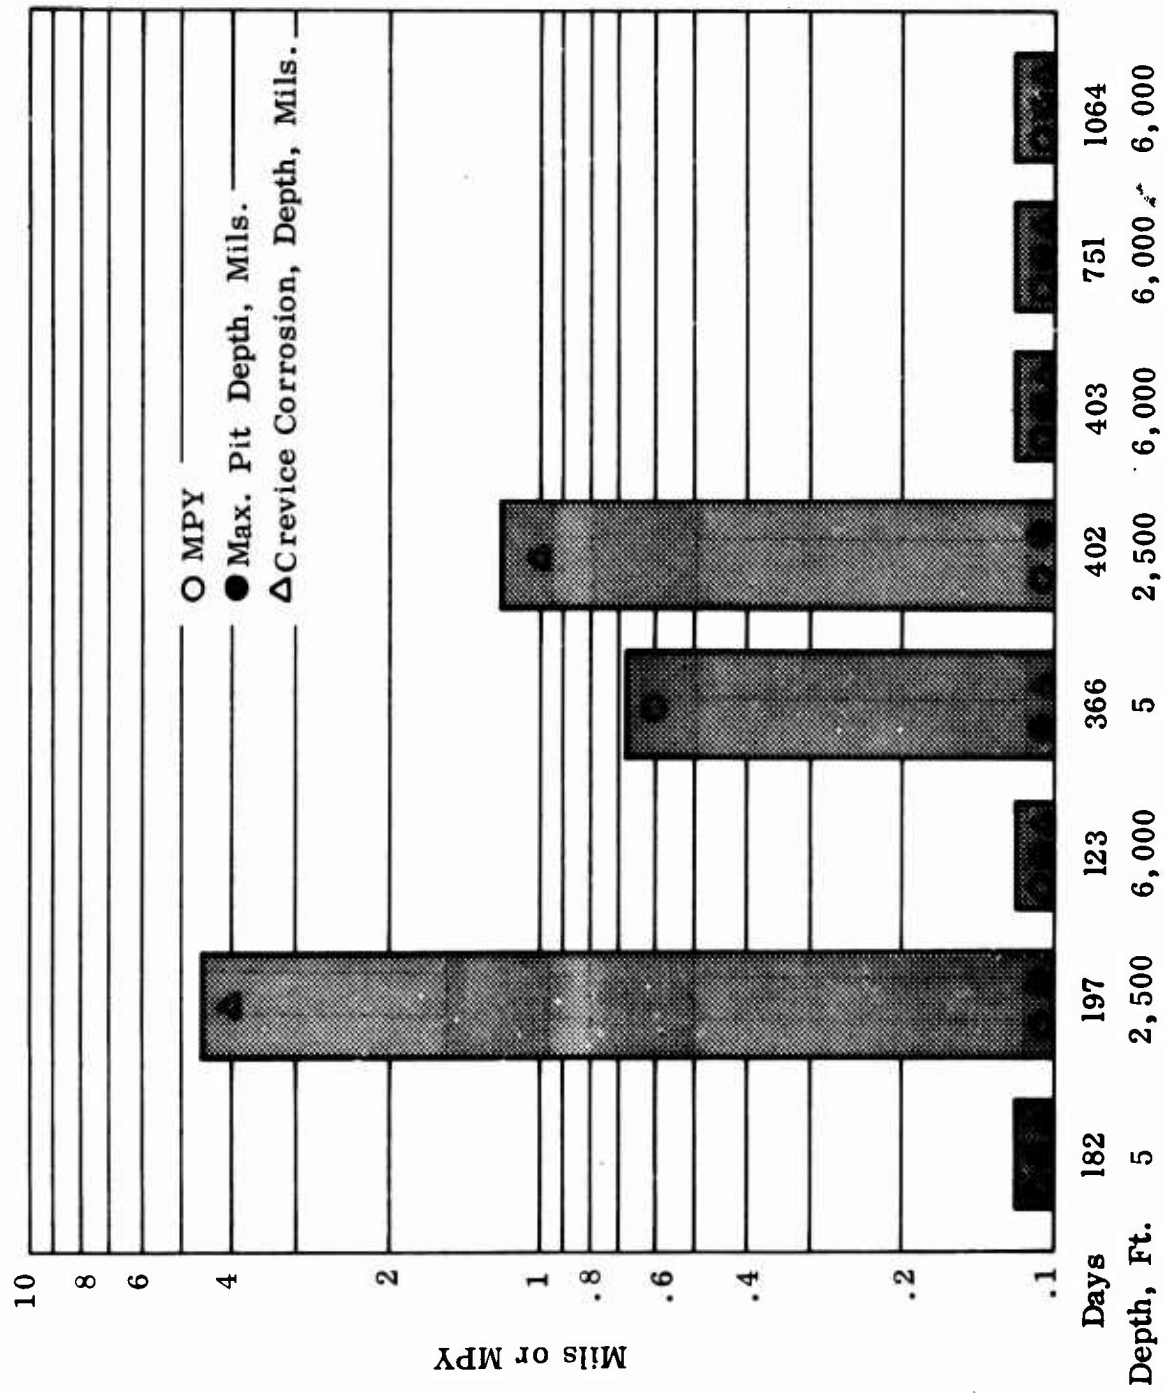
Figure 6. Corrosion rates, maximum pit depths and crevice corrosion of AISI 202 stainless steel in seawater at the surface and at depth.

Corrosion of AISI Type 201 stainless steel, Figure 6, after 6 months of exposure was more severe at the 2,500-foot depth than at the surface or at a depth of 6,000 feet because of crevice corrosion. After 1 year at the surface, there was severe edge corrosion and at the 2,500-foot depth there was crevice corrosion. There was only incipient crevice corrosion in seawater after 2 and 3 years of exposure at the 6,000-foot depth. The bottom sediments at both depths were no more corrosive than the seawater except after 3 years of exposure at the 6,000-foot depth where the specimen was perforated by pitting corrosion.

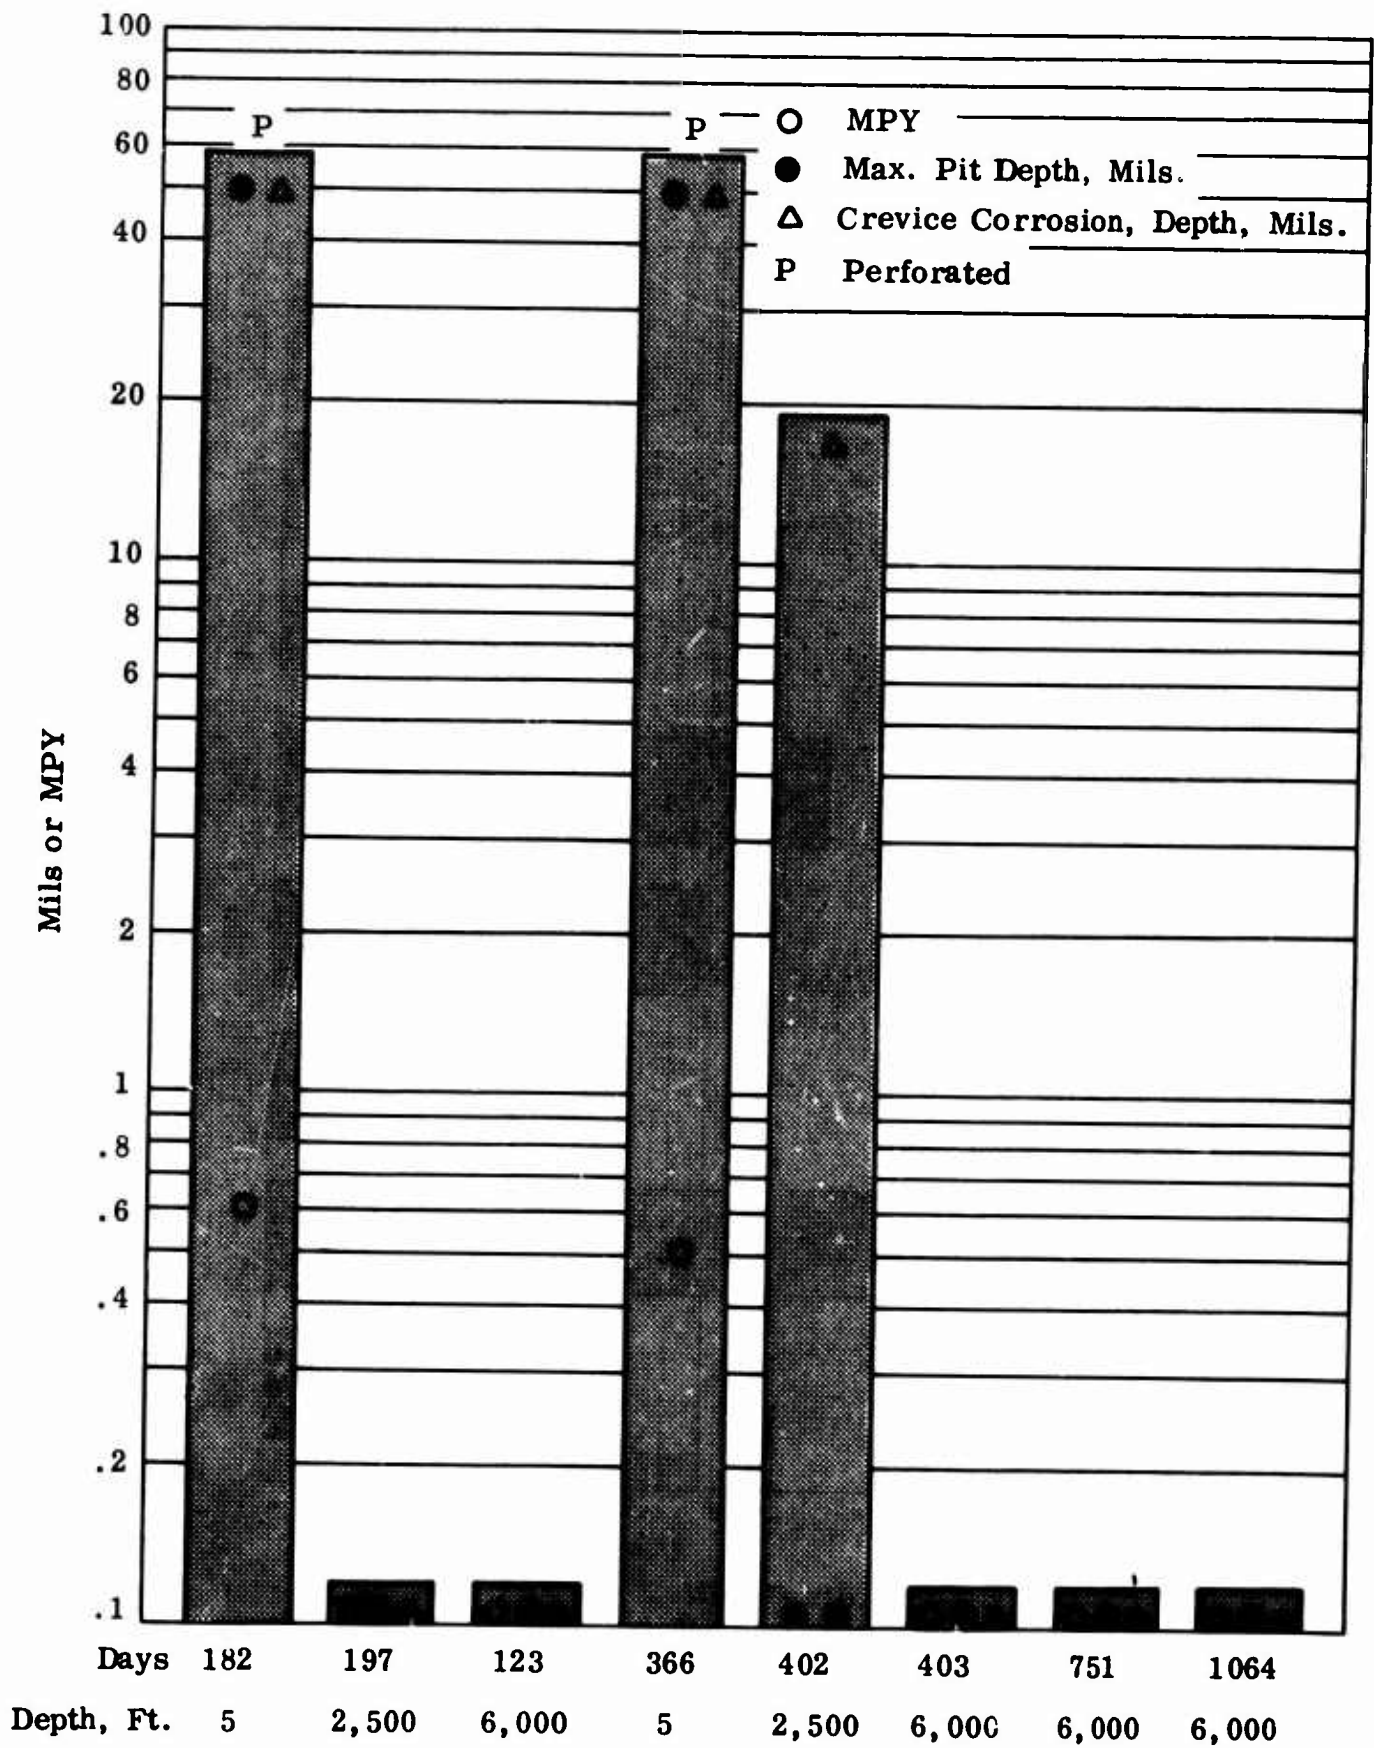
Figure 7. Corrosion rates, maximum pit depths and crevice corrosion of AISI 202 stainless steel in seawater at the surface and at depth.

AISI Type 202 stainless steel was attacked more severely in the seawater by pitting and crevice corrosion after 6 and 12 months of exposure at the surface than at depths of 2,500 and 6,000 feet, Figure 7. The 64-mil thick material was perforated both by pitting and crevice corrosion within 6 months at the surface as contrasted to incipient or no corrosion at depth. After 1 year crevice corrosion had penetrated to a depth of 17 mils at a depth of 2,500 feet with no attack at the 6,000-foot depth.

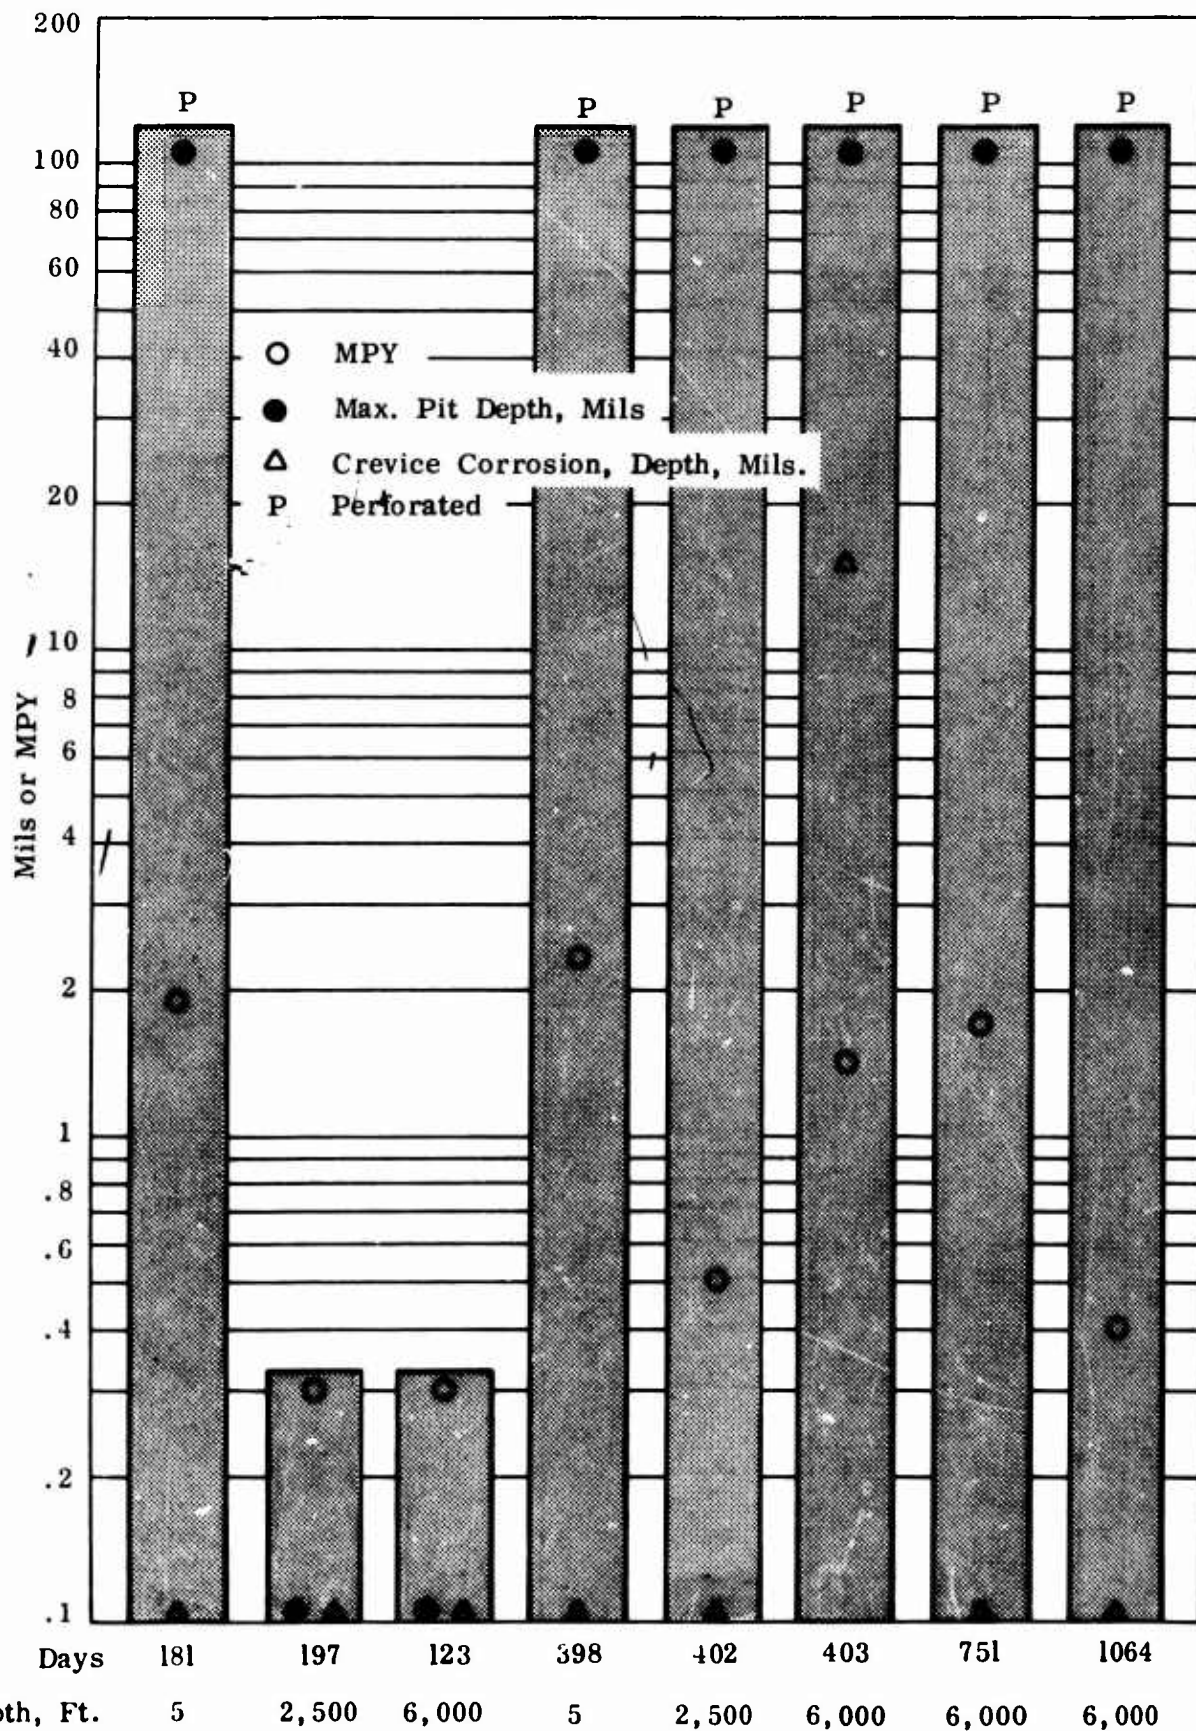
Figure 8. Corrosion rates, maximum pit depths, and crevice corrosion of AISI Type 301 stainless steel in seawater at the surface and at depth.

Corrosion of AISI Type 301 stainless steel was predominately of the pitting and tunneling types, Figure 8. The 103-mil thick specimens were perforated by pitting and tunneling within 6 months of exposure in seawater at the surface and by tunneling within 6 months of exposure at both the 2,500- and 6,000-foot depths. The bottom sediments at the 2,500- and 6,000-foot depths were about as corrosive as the seawater above.

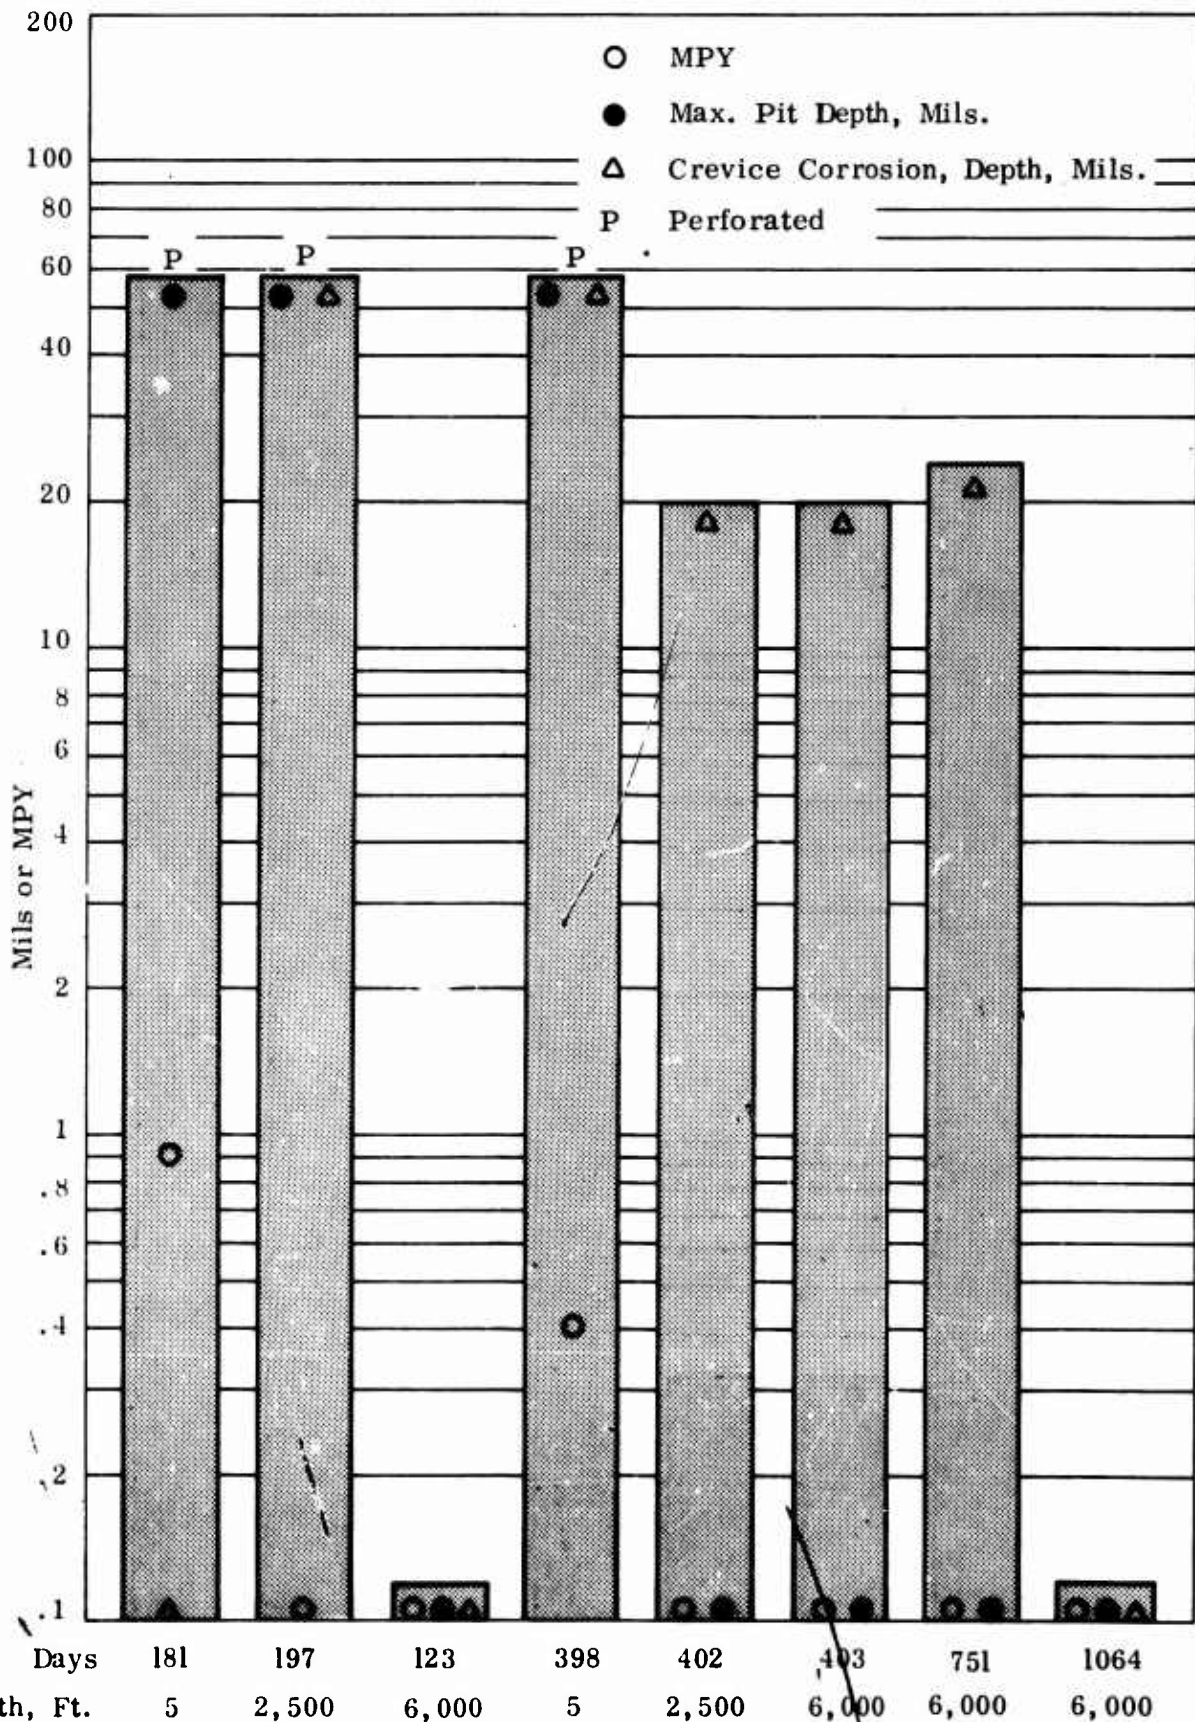
Figure 9. Corrosion rates, maximum pit depths and crevice corrosion of AISI Type 302 stainless steel in seawater at the surface and at depth.

AISI Type 302 stainless steel, Figure 9, was perforated by pitting and tunneling corrosion within 6 months at the surface and by pitting, tunneling and crevice corrosion within the same period of exposure at the 2,500-foot depth. Only crevice corrosion was significant at the 6,000-foot depth after longer than 6 months of exposure except that the alloy was perforated by tunnel corrosion after 751 days in the bottom sediment and the longest tunnel was 6 inches. The bottom sediments generally were no more aggressive than the seawater above. Crevice and tunneling corrosion were more prevalent than was the pitting type of corrosion.

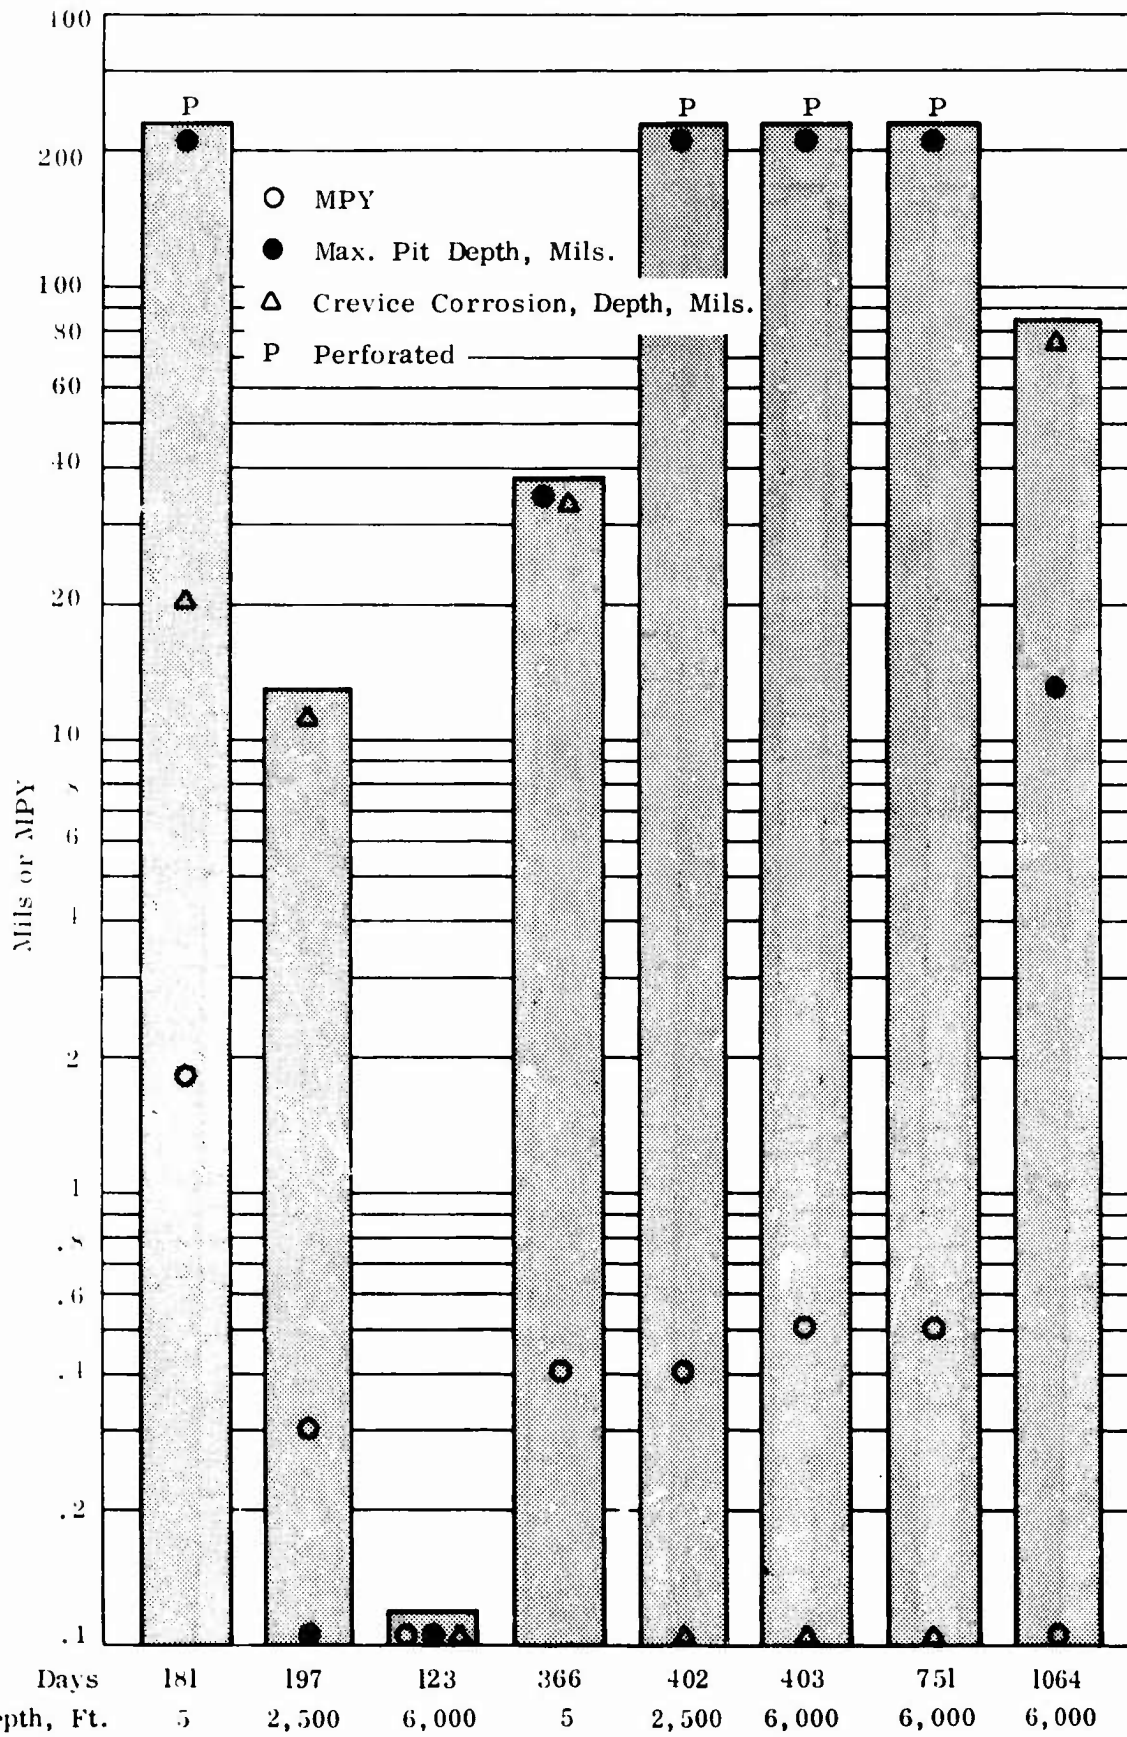
Figure 10. Corrosion rates, maximum pit depths and crevice corrosion of AISI Type 304 stainless steel in seawater at the surface and at depth.

The pitting and tunneling types of corrosion were more severe in AISI Type 304 stainless steel than was crevice corrosion, Figure 10.

The 210-mil thick specimens were perforated by pitting and tunneling after 6 months of exposure at the surface and after 1 year and longer at depths of 2,500 and 6,000 feet. Crevice corrosion was serious but its penetration rate was lower than either the pitting or tunneling rates. The bottom sediments were less aggressive at both depths than was the seawater above them.

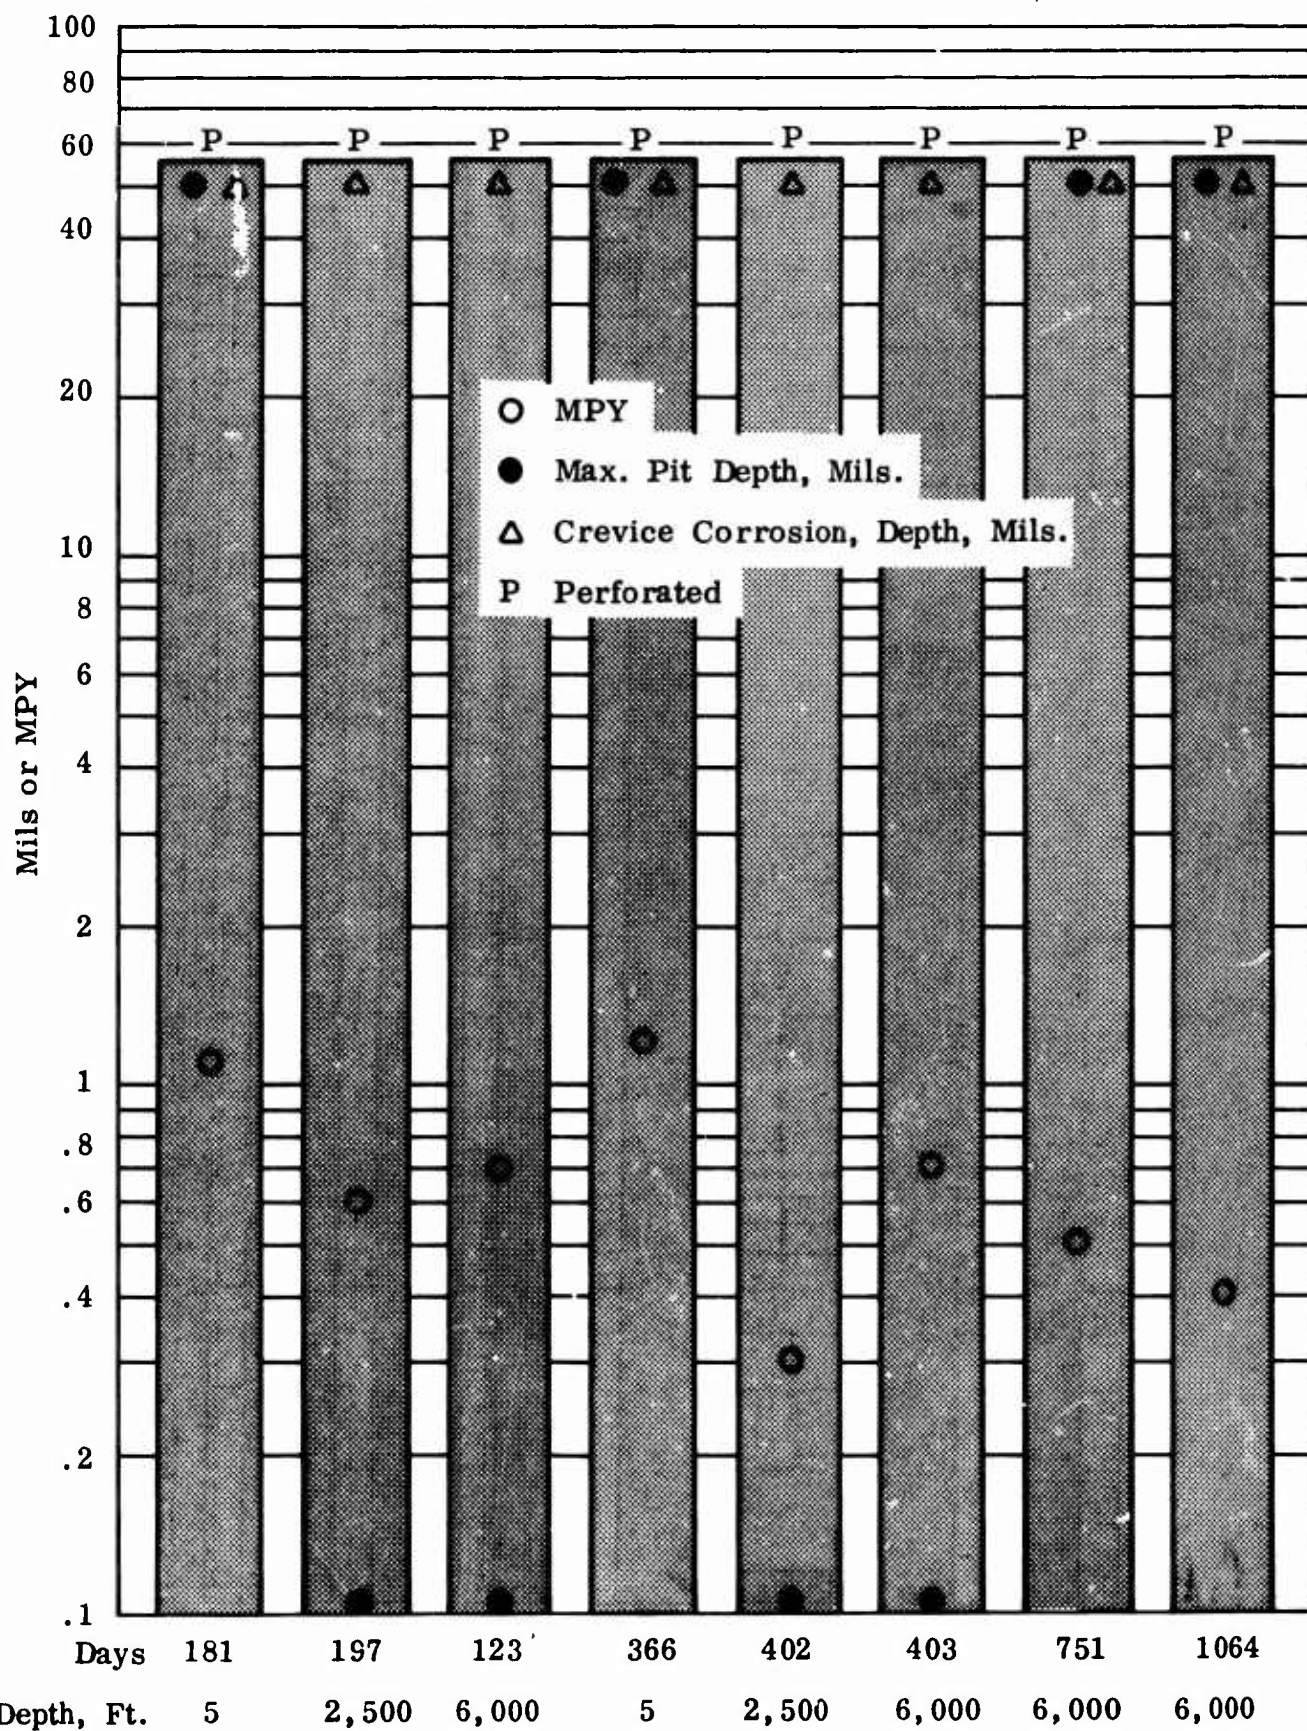
Figure 11. Corrosion rates, maximum pit depths and crevice corrosion of AISI Type 304 (sensitized) stainless steel in seawater at the surface and at depth.

Sensitized (heated for 1 hour at 1200°F and cooled in air) AISI Type 304 was more susceptible to pitting and crevice corrosion at the surface and at depths of 2,500 and 6,000 feet (Figure 11) than was the unsensitized alloy (Figure 10). The 50-mil thick specimens were perforated by crevice corrosion in all three seawater environments after 6 months of exposure. The bottom sediments of both depths were not as aggressive as was the seawater at these depths.
