3. REPORT TITLE  
CORROSION OF MATERIALS IN HYDROSPACE - PART VI - STAINLESS STEELS

5. AUTHOR(S) (First name, middle initial, last name)  
Fred M. Reinhart

NAVAL CIVIL ENGINEERING LABORATORY  
Port Hueneme, California 93043

Technical Note N-1172

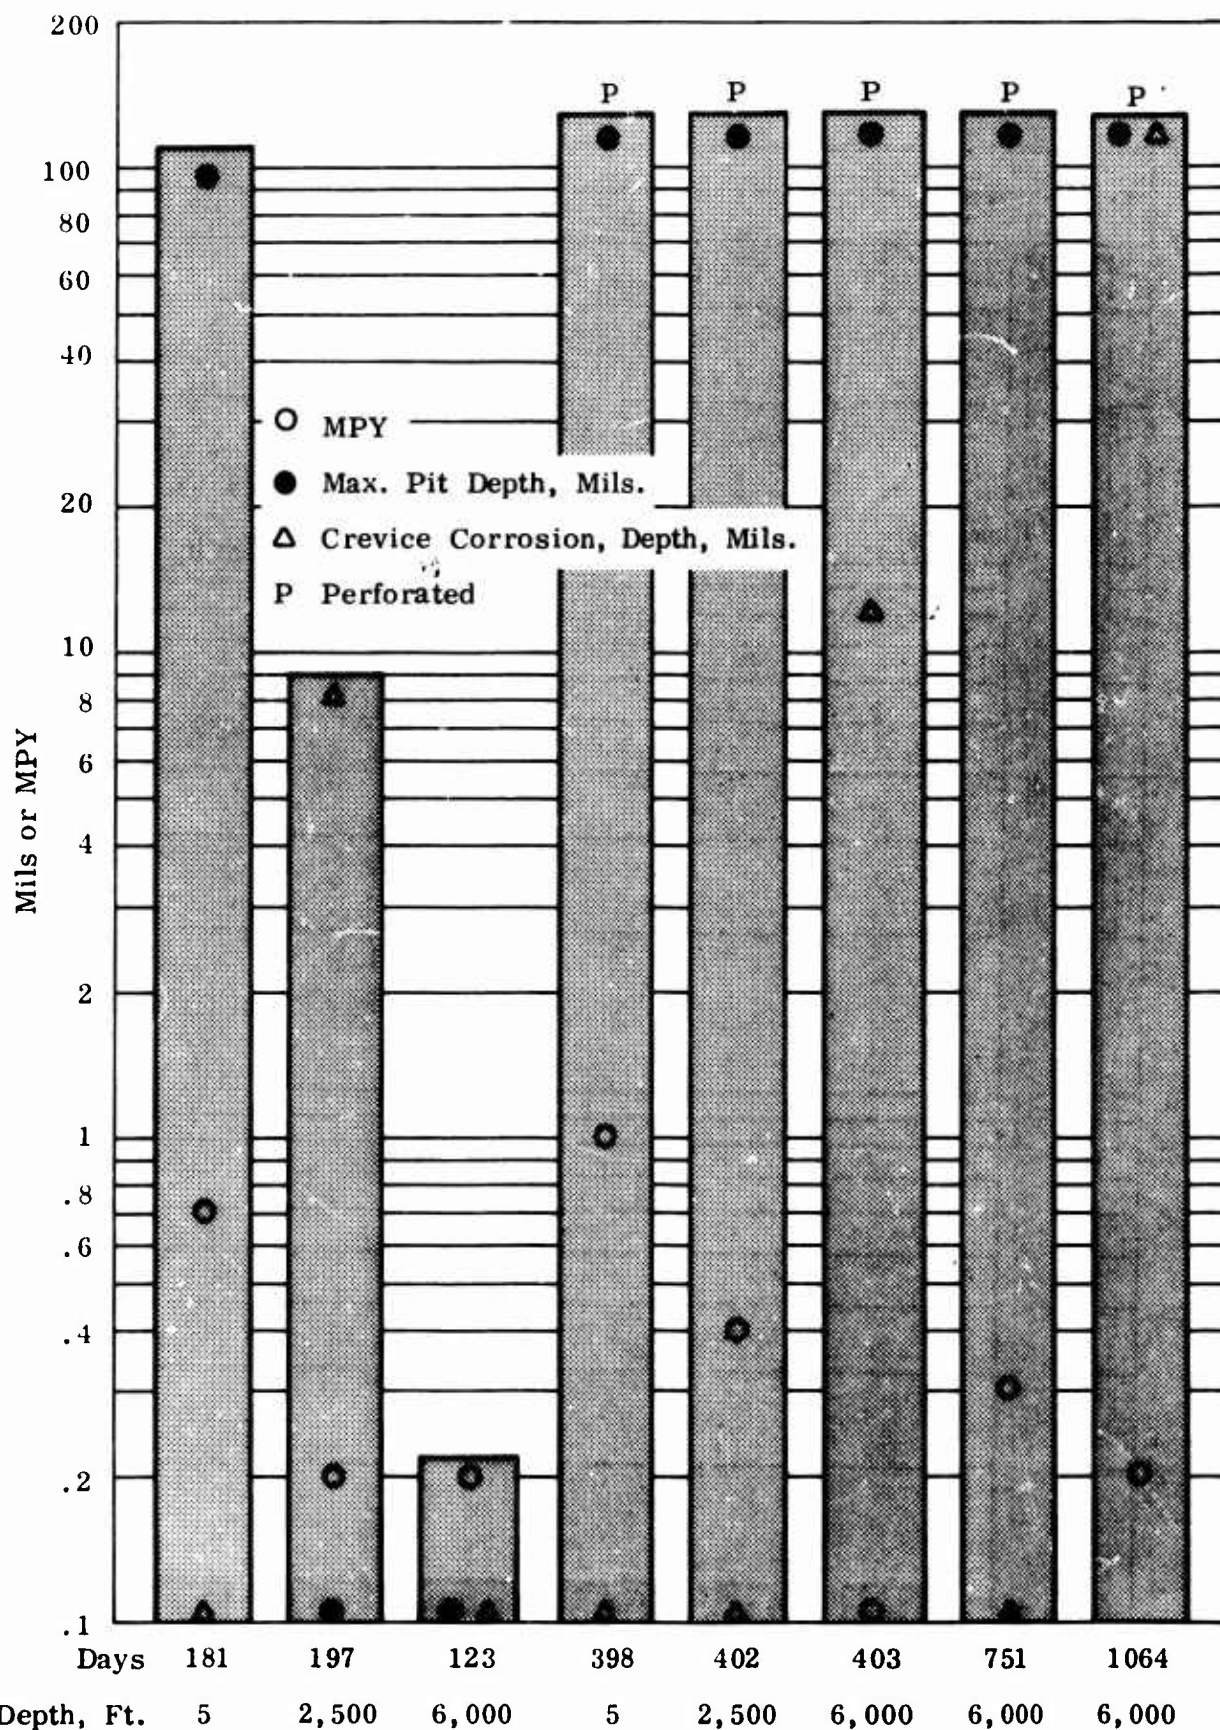
Figure 12. Corrosion rates, maximum pit depths and crevice corrosion of AISI Type 304L stainless steel in seawater at the surface and at depth.

The corrosion of AISI Type 304L stainless steel was comparable with that of AISI Type 304 stainless steel as shown by comparing Figure 12 with Figure 10. Pitting and tunneling corrosion were more severe than was crevice corrosion, the 115-mil thick specimens being perforated by the pitting and tunneling types after 1 year of exposure at the surface and at both depths, 2,500 and 6,000 feet. From the standpoint of pitting and tunneling corrosion, the seawater at the 2,500- and 6,000-foot depths was more aggressive than the bottom sediments, but from the standpoint of crevice corrosion the reverse was true.

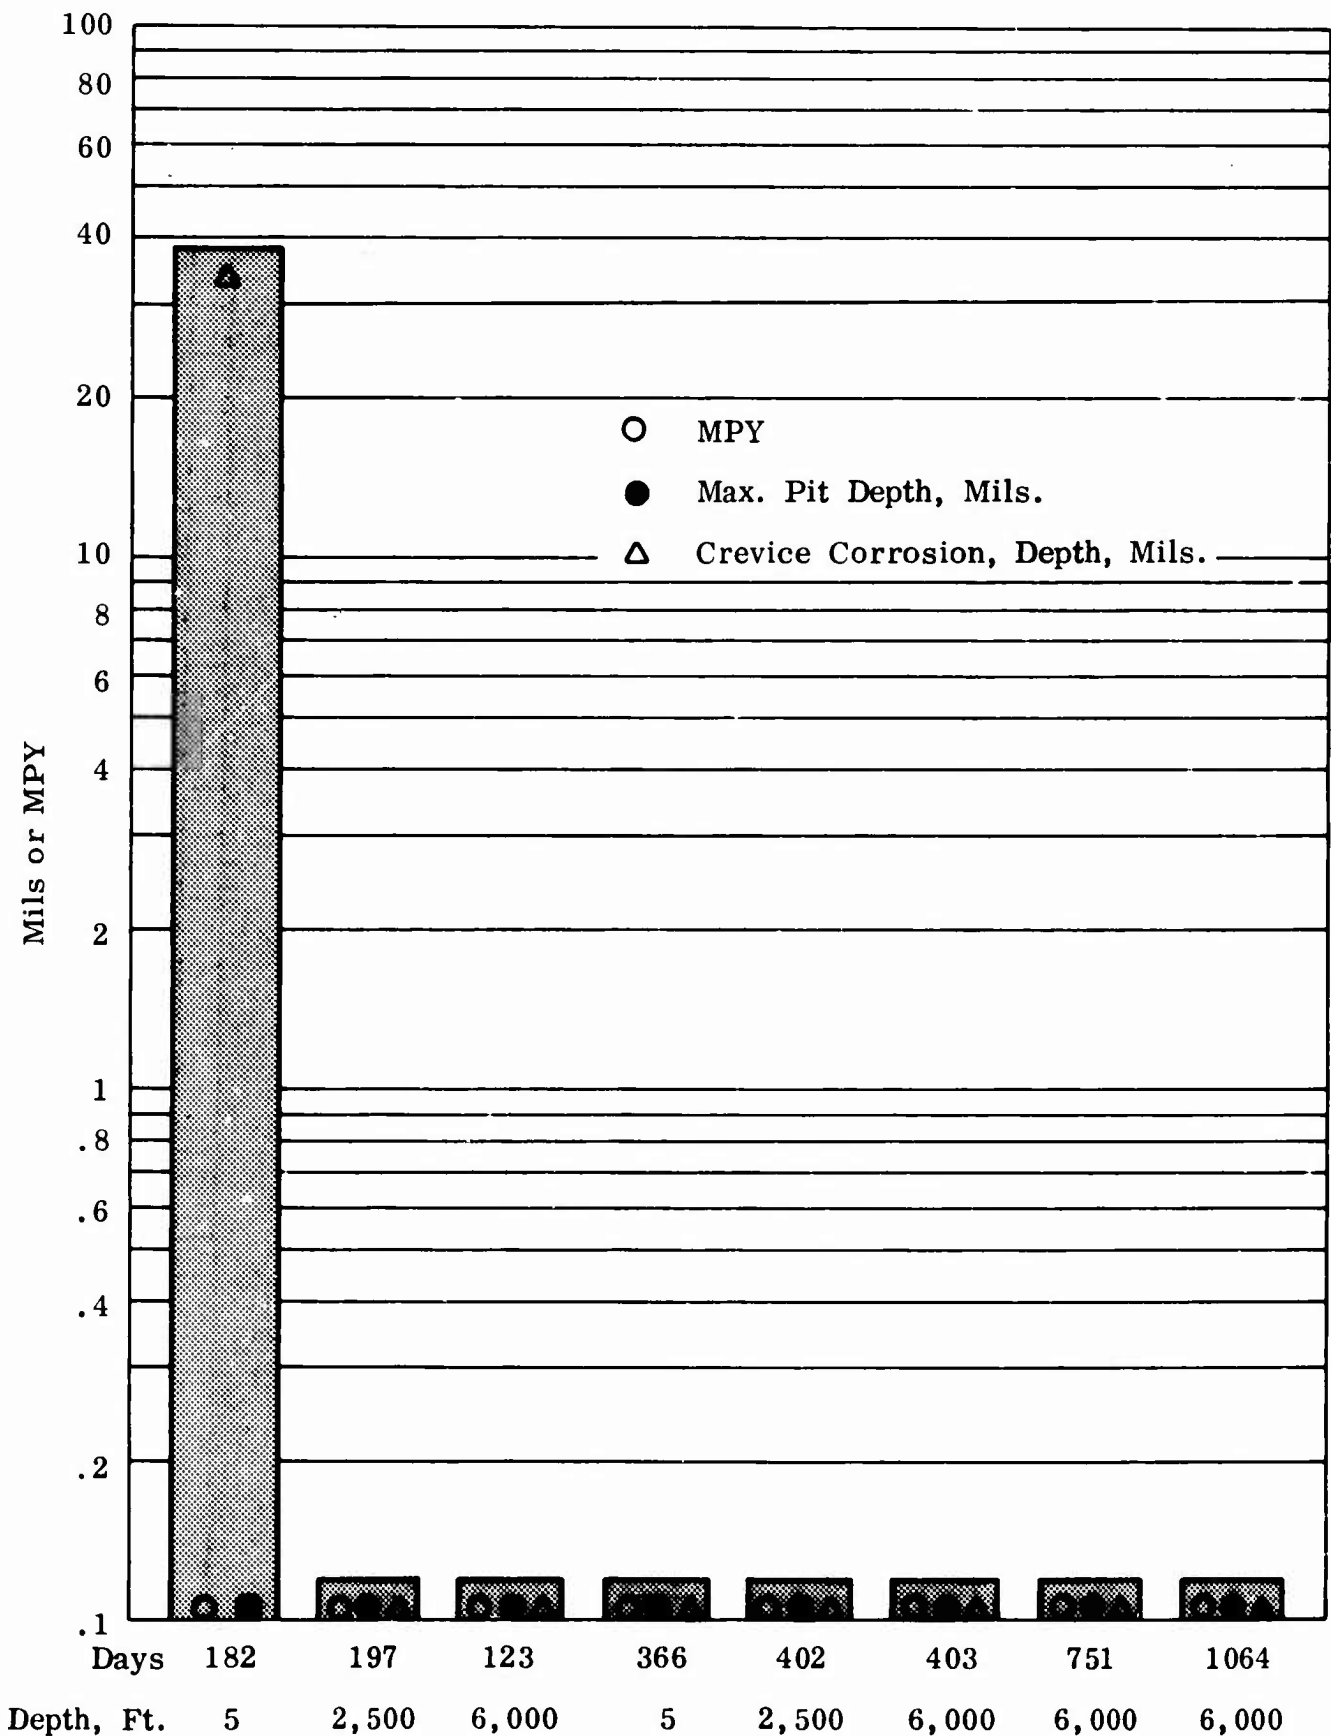
Figure 13. Corrosion rates, maximum pit depths and crevice corrosion of AISI Type 309 stainless steel in seawater at the surface and at depth.

As shown in Figure 13, AISI Type 309 stainless steel was free of pitting during surface exposures and at the 2,500-foot depth for 1 year and at the 6,000-foot depth for exposures as long as 3 years. There was only incipient crevice corrosion of this alloy except after 6 months at the surface where it had penetrated to a depth of 33 mils. The aggressiveness of the bottom sediments was the same as the water above them.

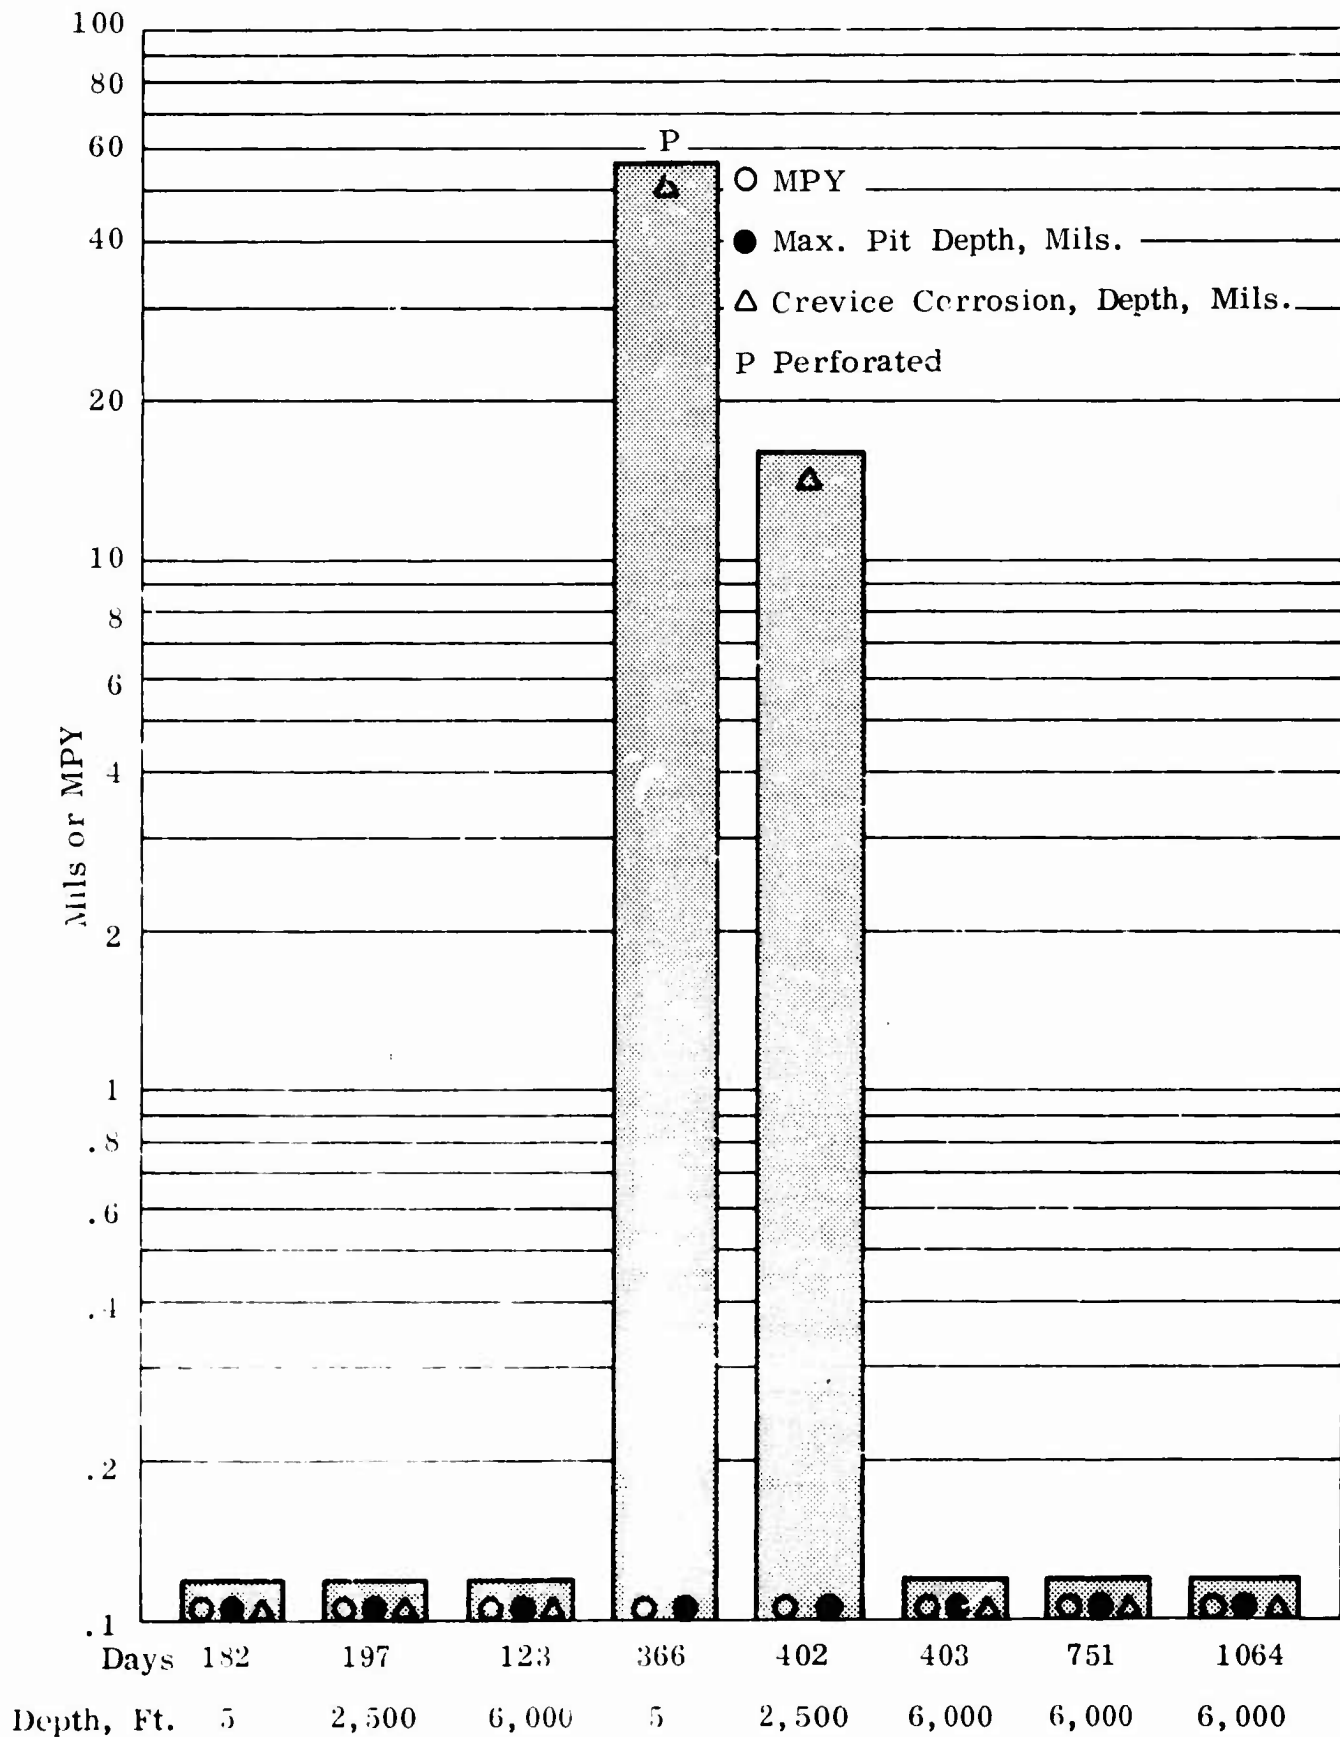
Figure 14. Corrosion rates, maximum pit depths and crevice corrosion of AISI Type 310 stainless steel in seawater at the surface and at depth.

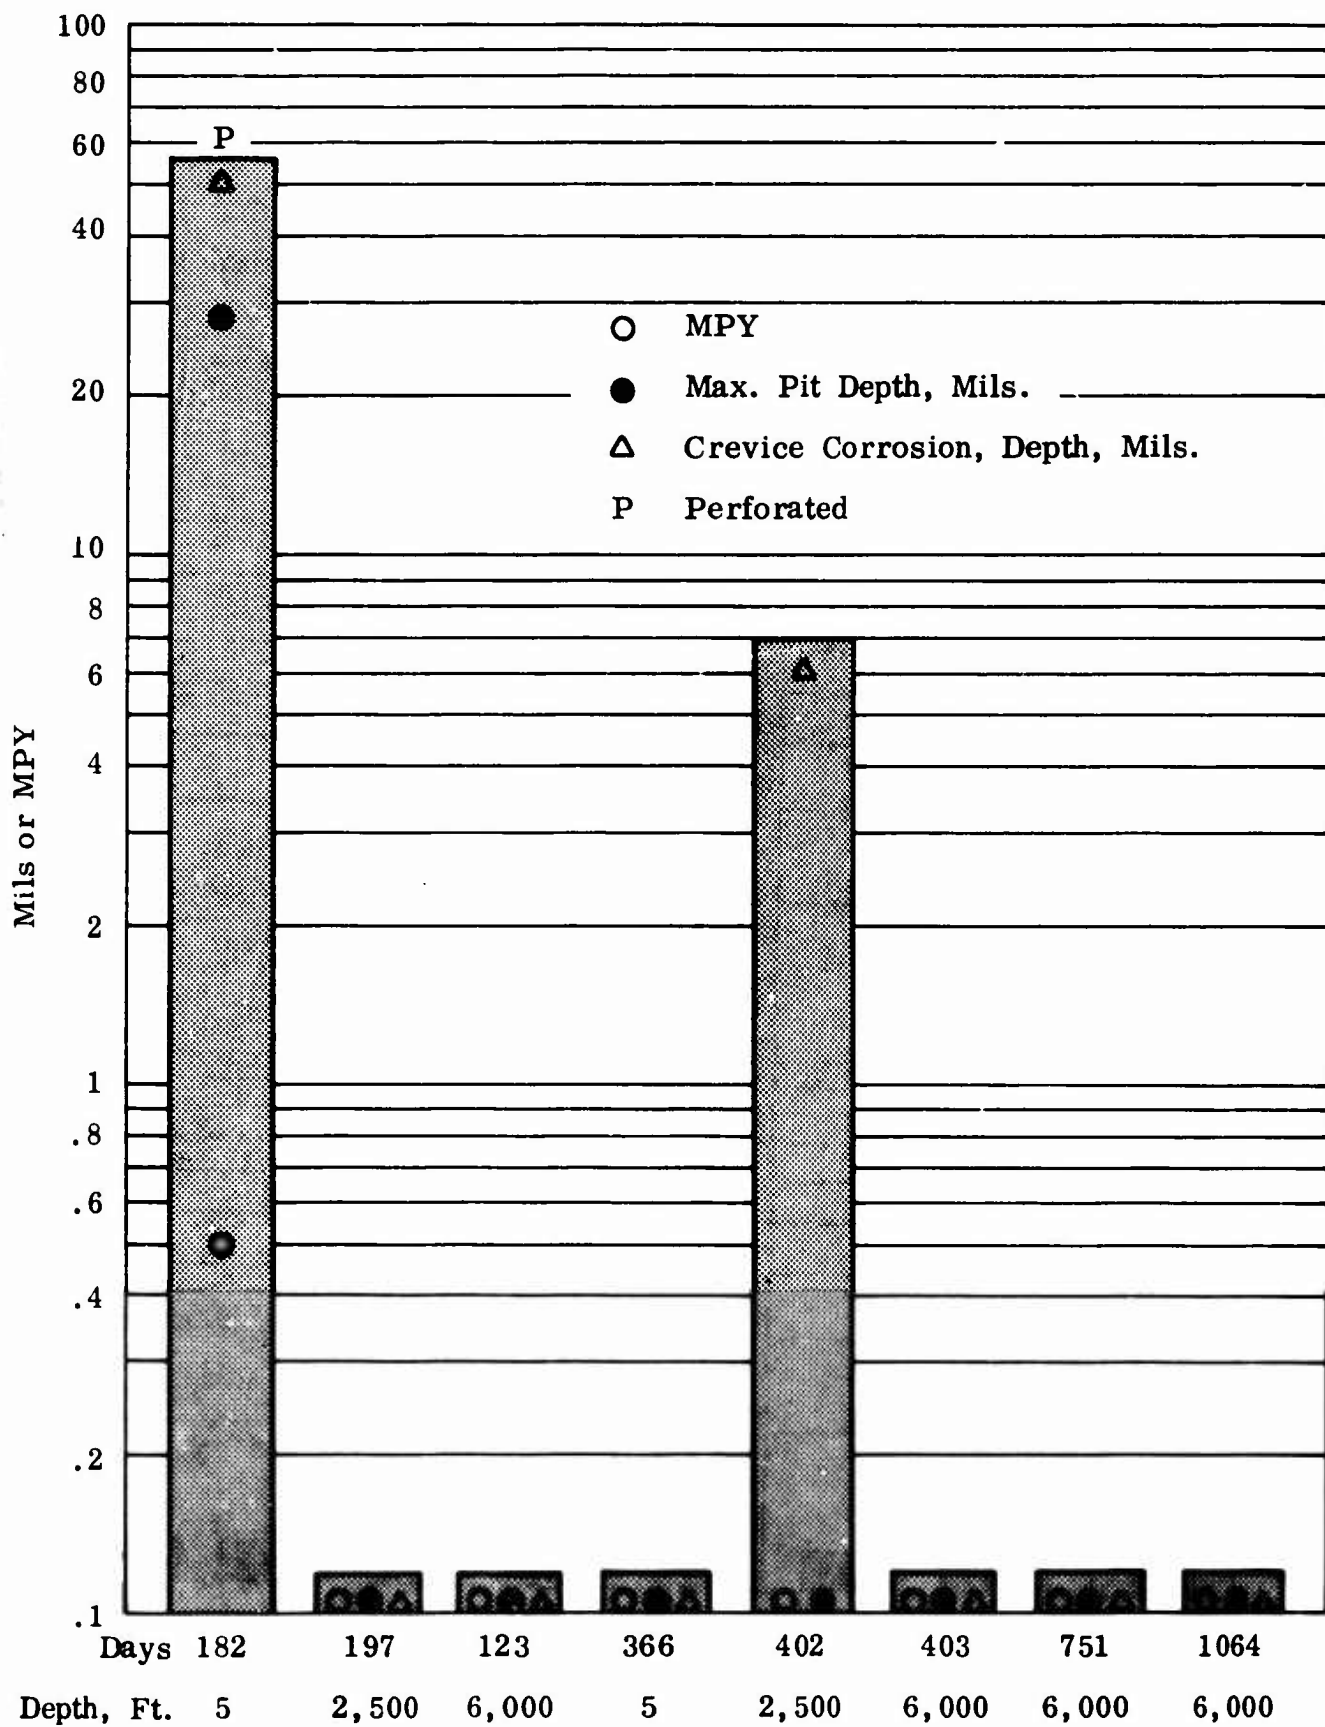
Figure 15. Corrosion rates, maximum pit depths and crevice corrosion of AISI Type 311 stainless steel in seawater at the surface and at depth.

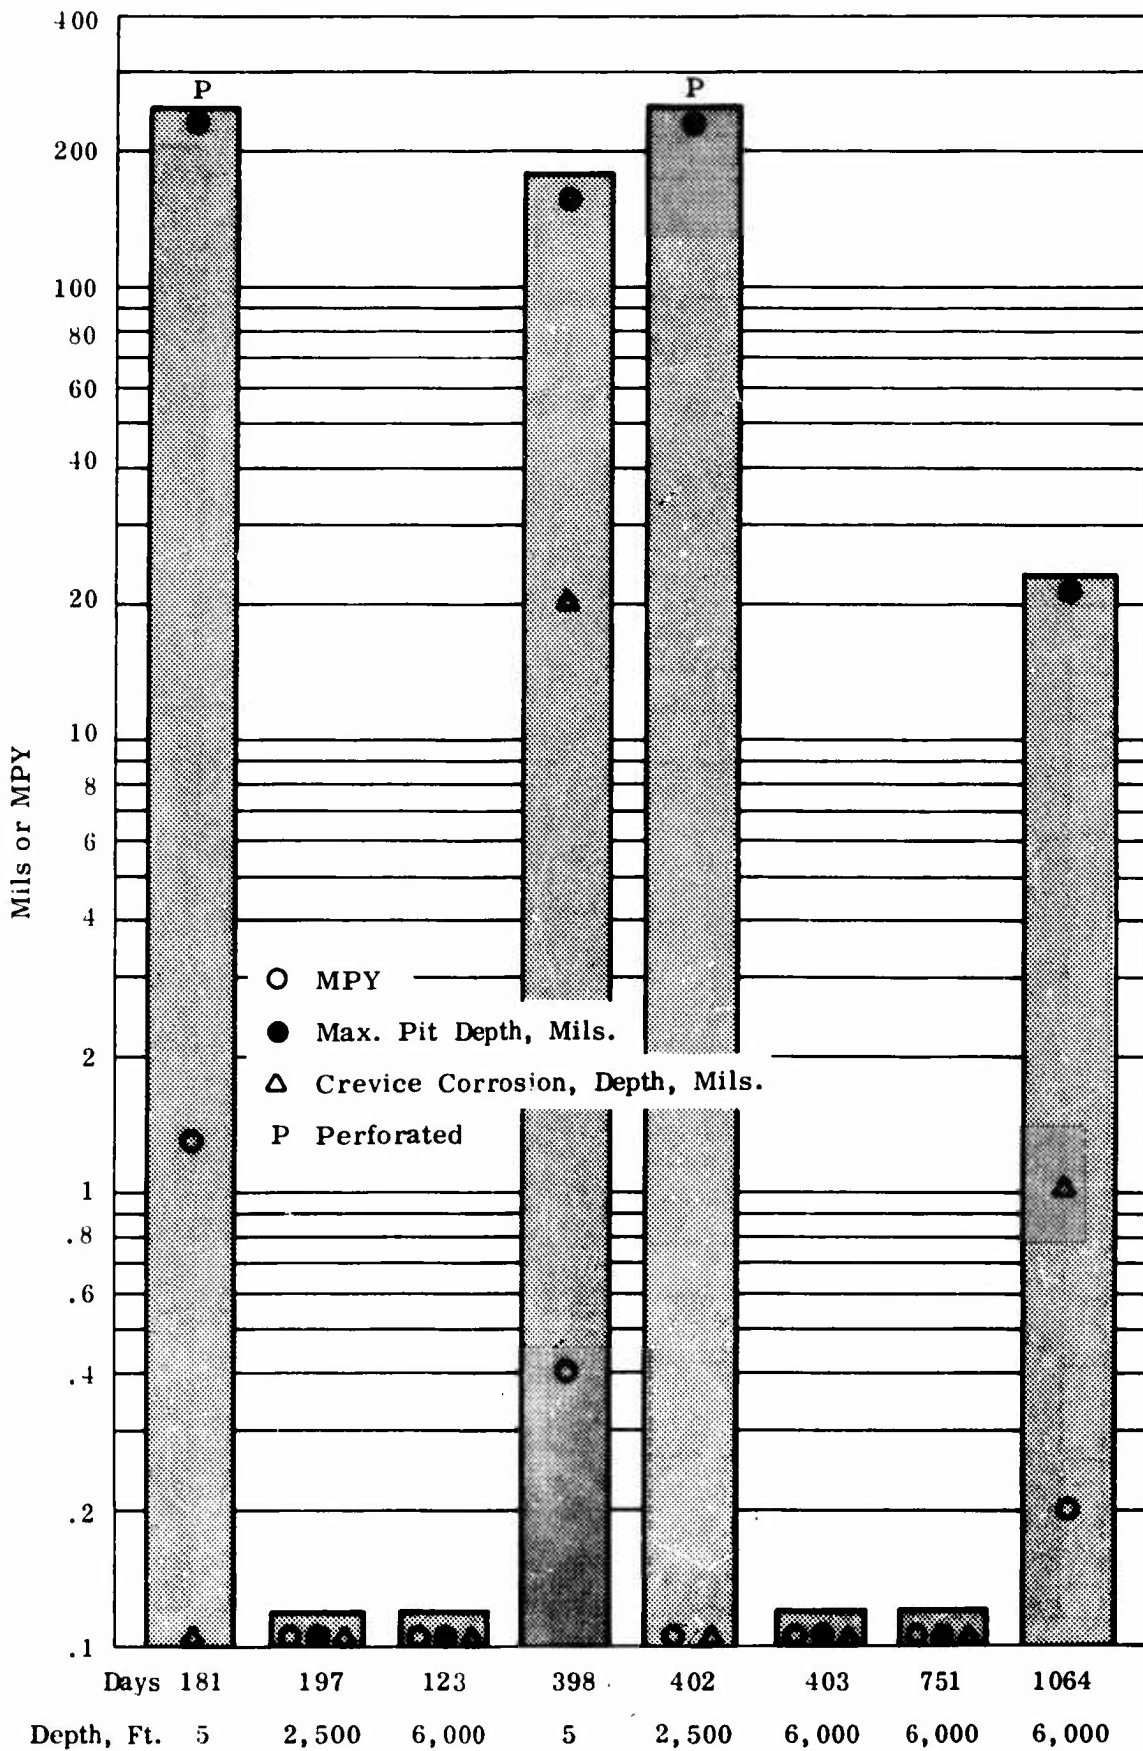
Figure 16. Corrosion rates, maximum pit depths and crevice corrosion of AISI Type 316 stainless steel in seawater at the surface and at depth.

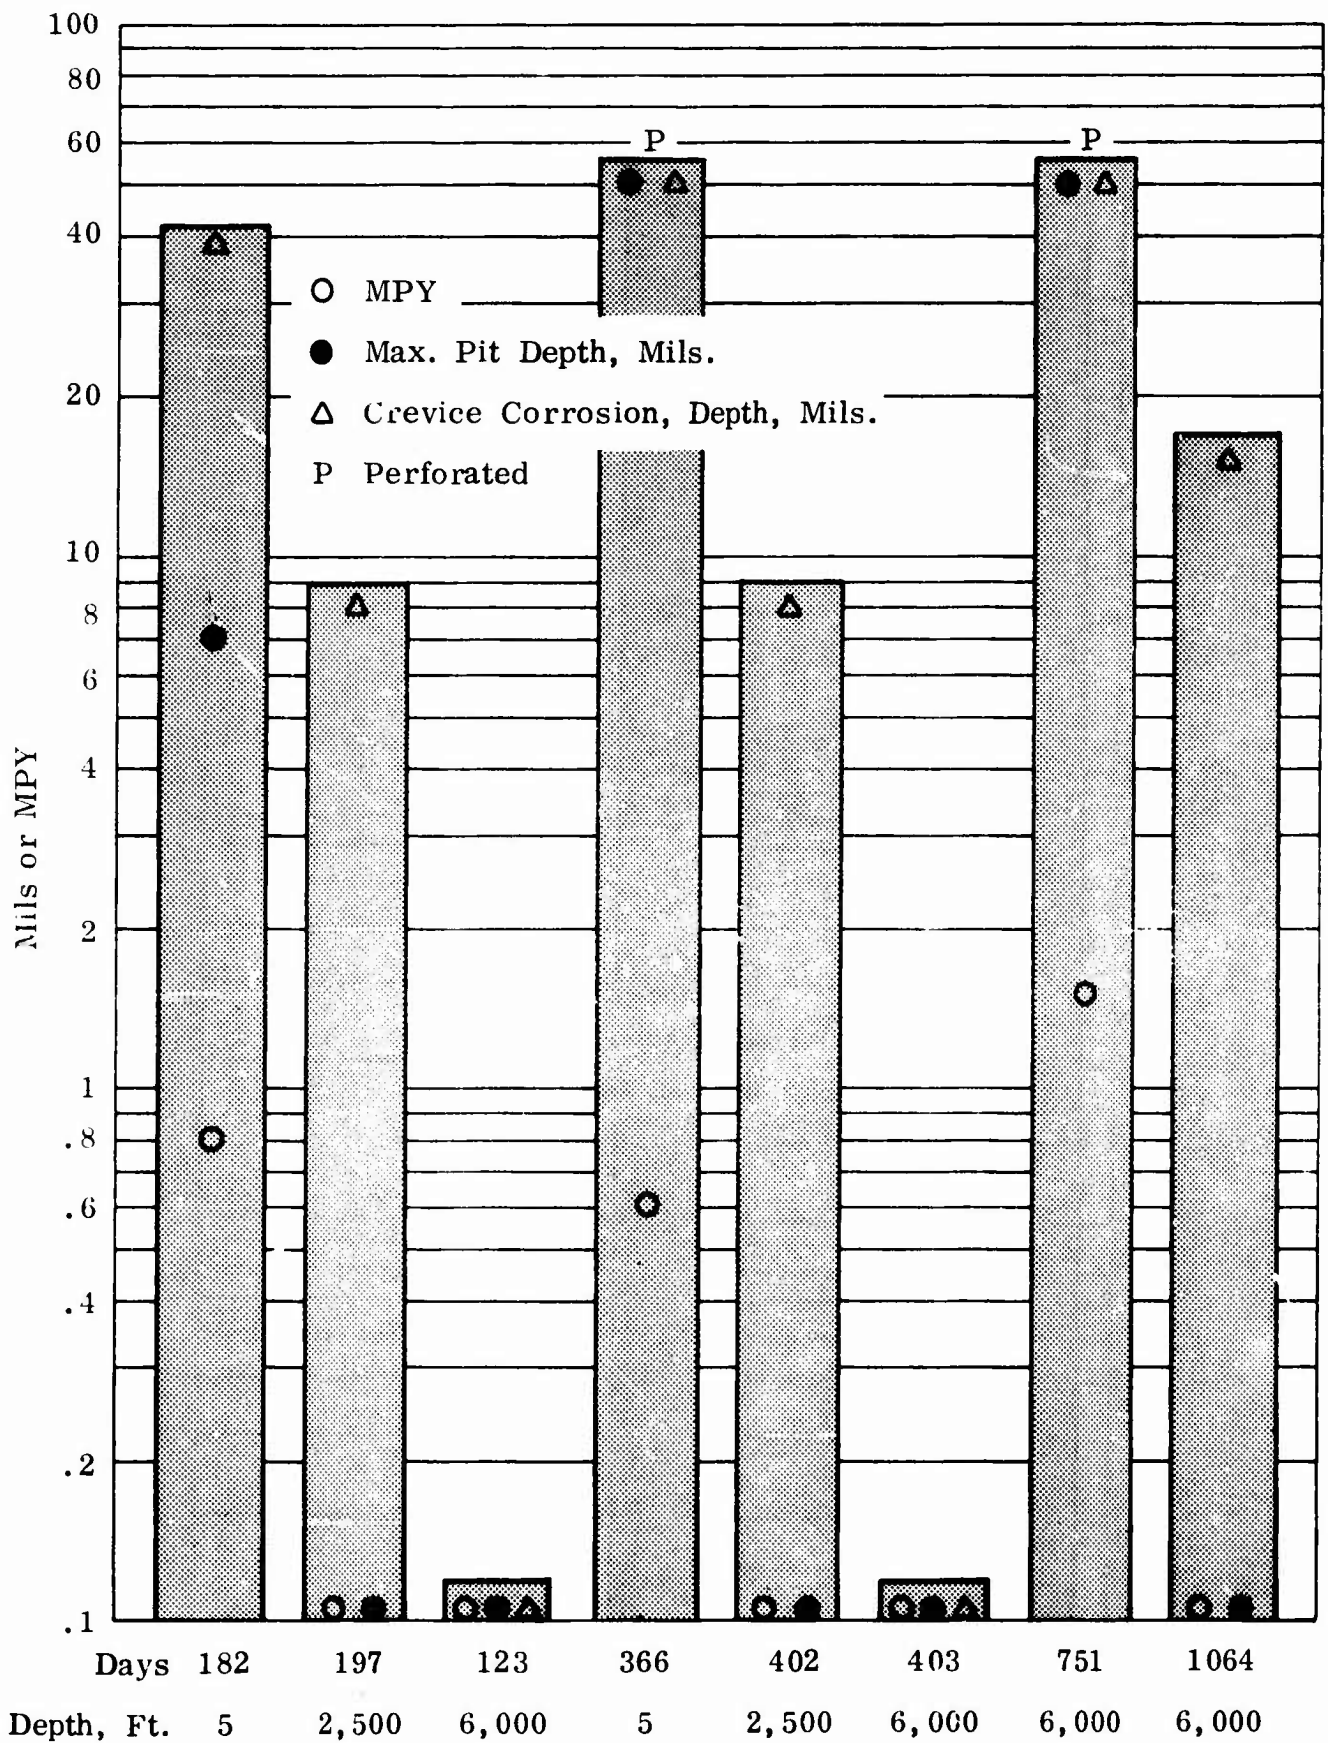
Figure 17. Corrosion rates, maximum pit depths and crevice corrosion of AISI Type 316 (sensitized) stainless steel in seawater at the surface and at depth.

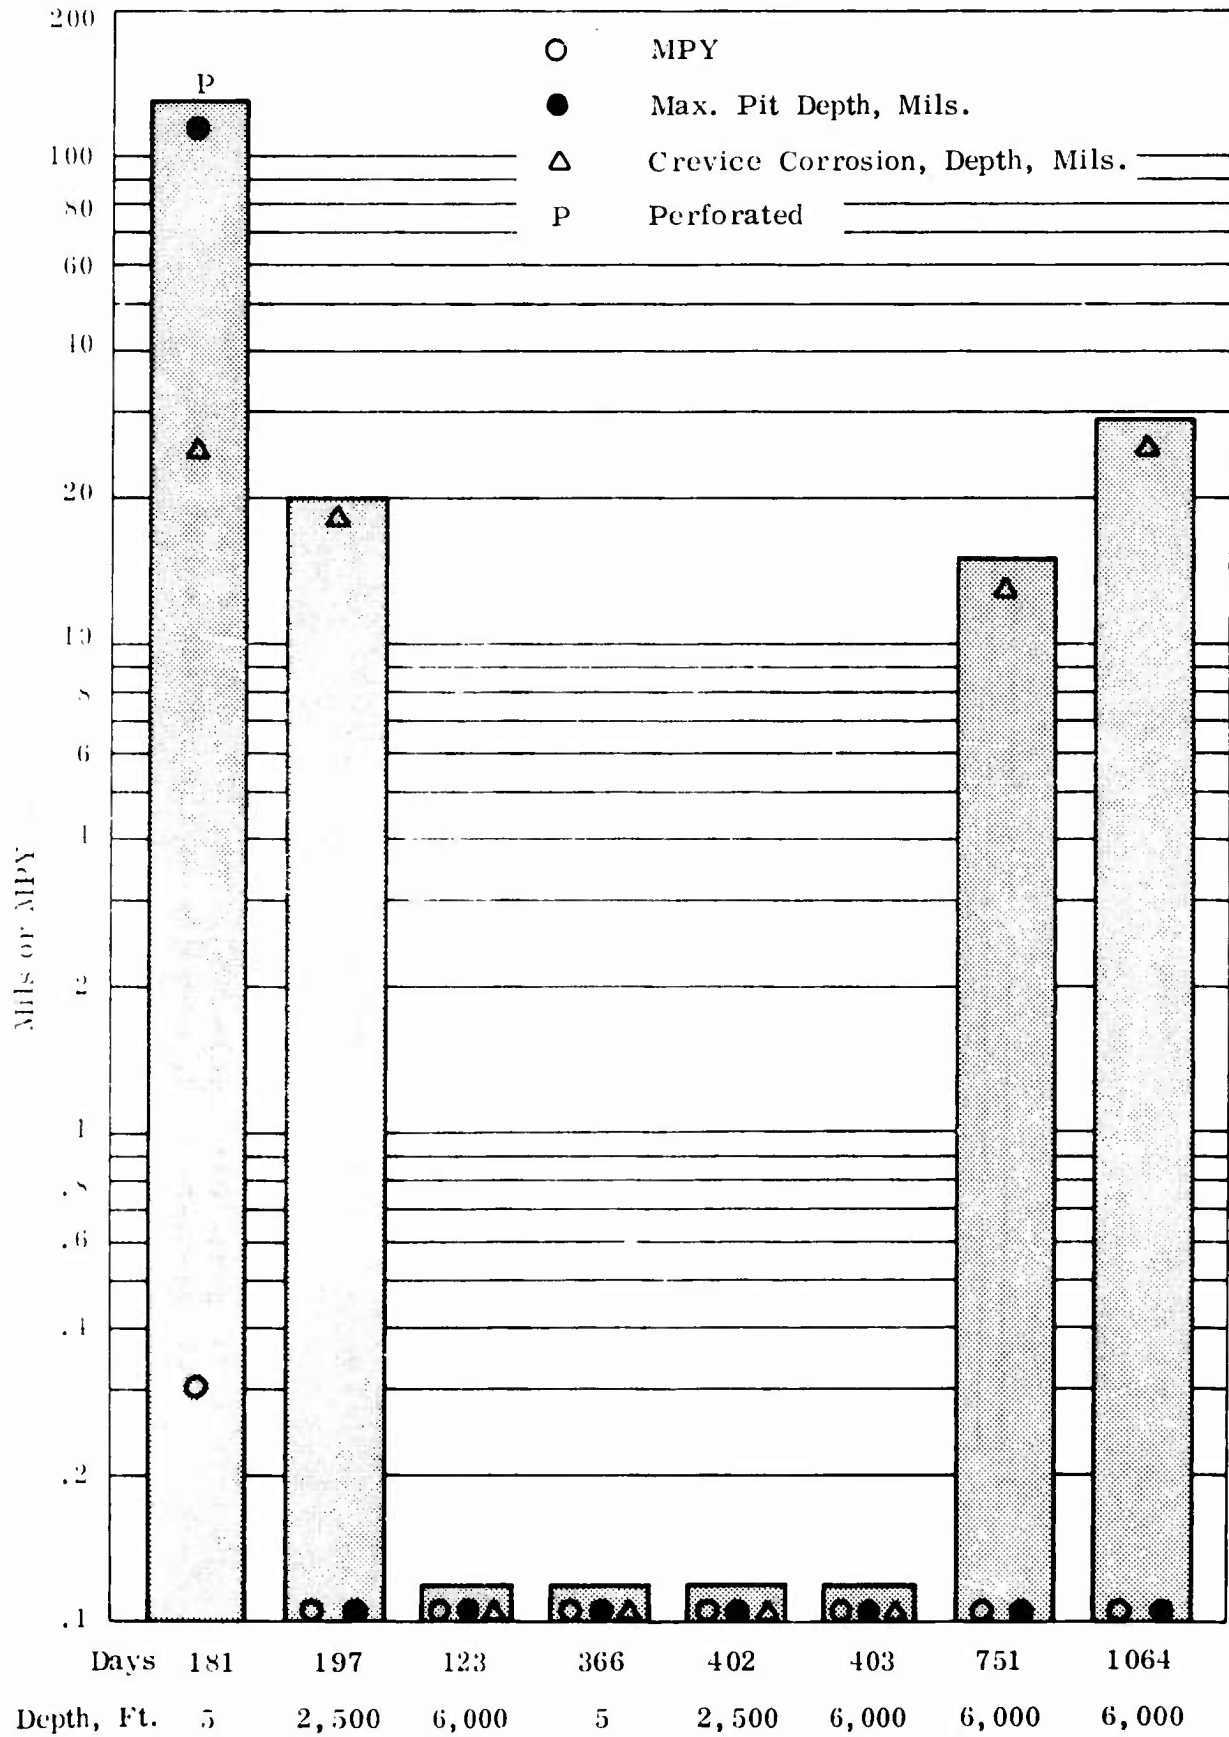
Figure 18. Corrosion rates, maximum pit depths and crevice corrosion of AISI Type 316L stainless steel in seawater at the surface and at depth.

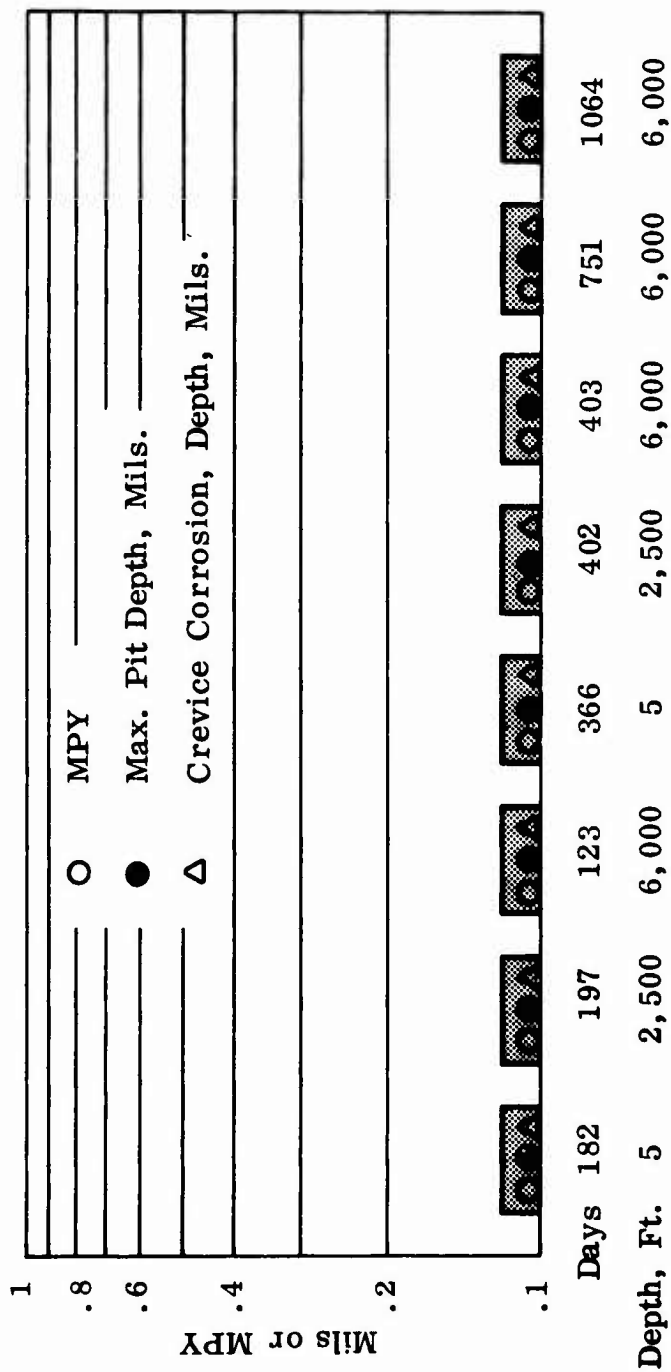
Figure 19. Corrosion rates, maximum pit depths and crevice corrosion of stainless steels AISI Types 317, 239 and 633, alloy 20Cb-3 and Ni-Cr-Mo-Si in seawater at the surface and at depth.

AISI Types 317 and 329 stainless steels were attacked only by incipient crevice corrosion when exposed in seawater at the surface and at a depth of 2,500 feet for 1 year and when exposed at a depth of 6,000 feet for 3 years, Figure 19. The same was true for the bottom sediments.

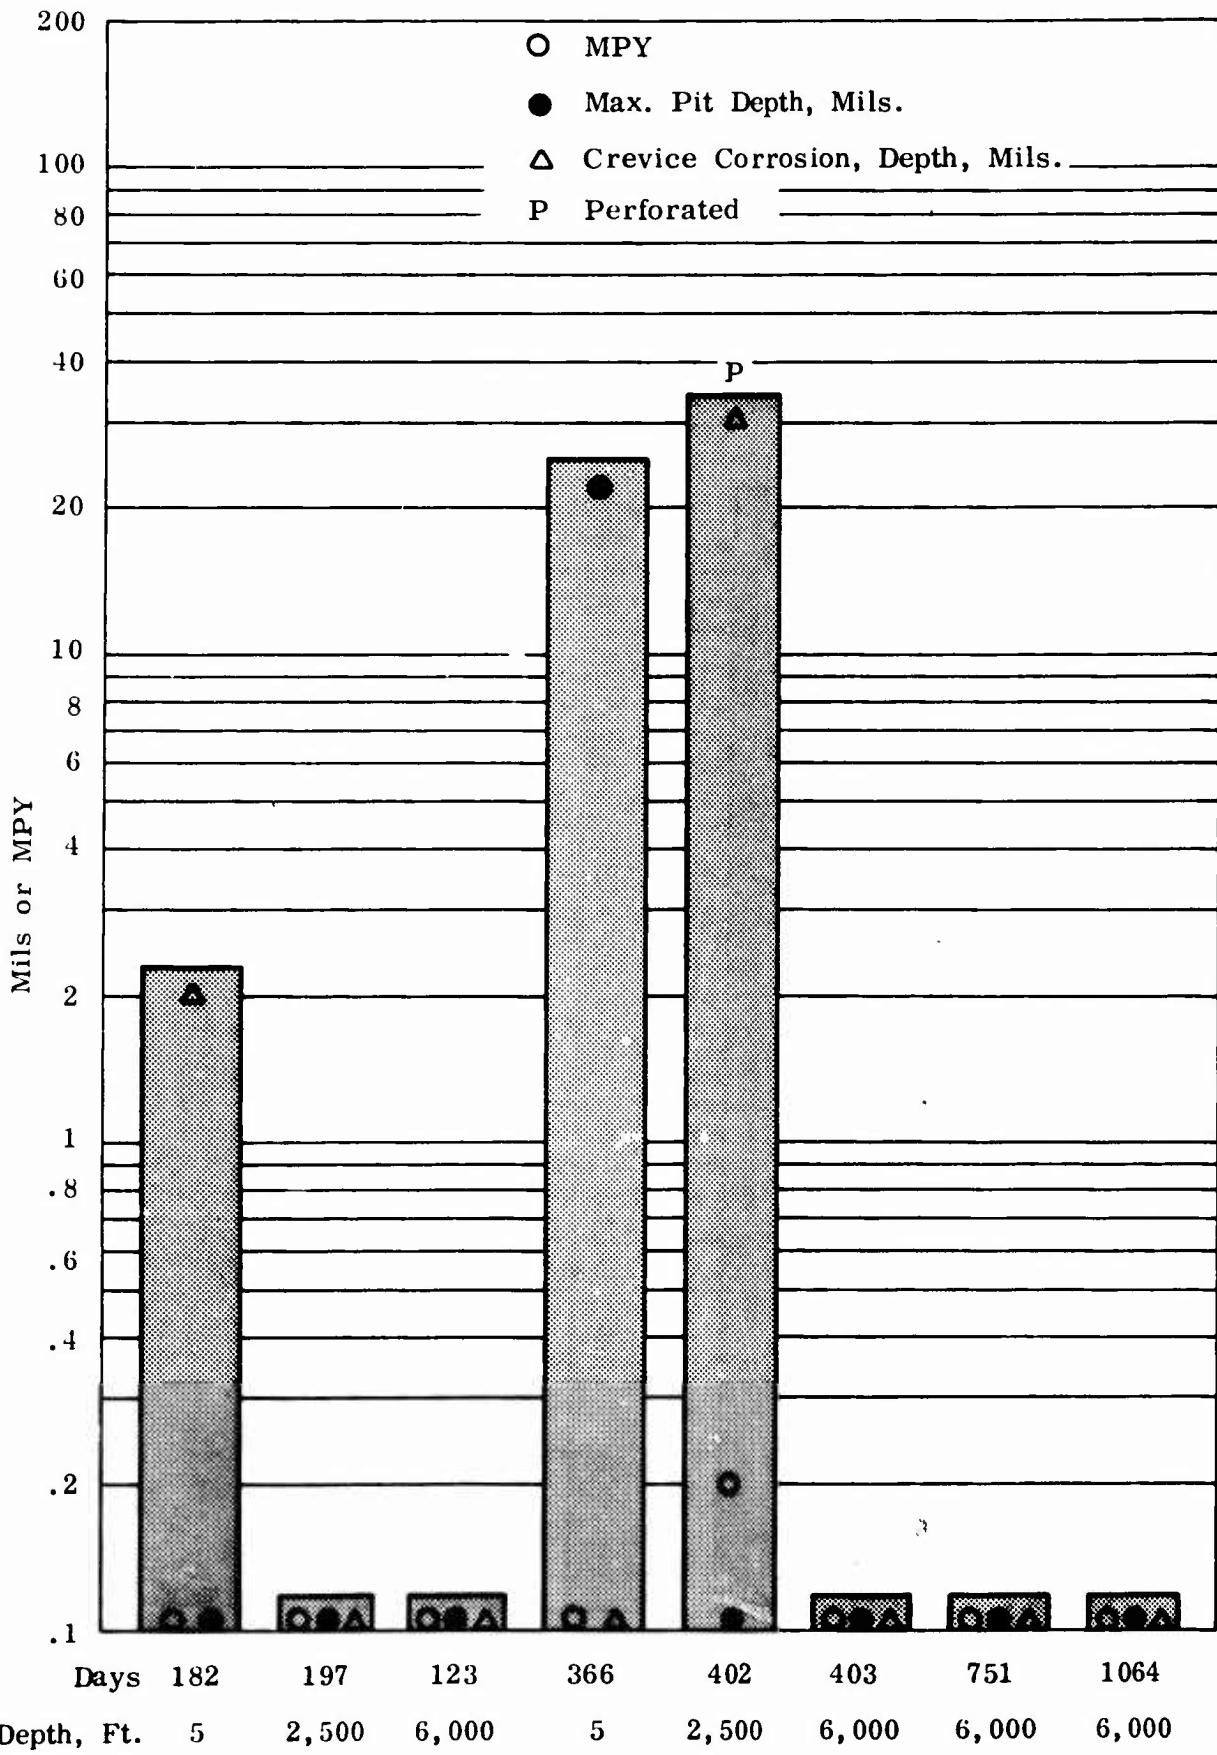
Figure 20. Corrosion rates, maximum pit depths and crevice corrosion of AISI Type 321 stainless steel in seawater at the surface and at depth.

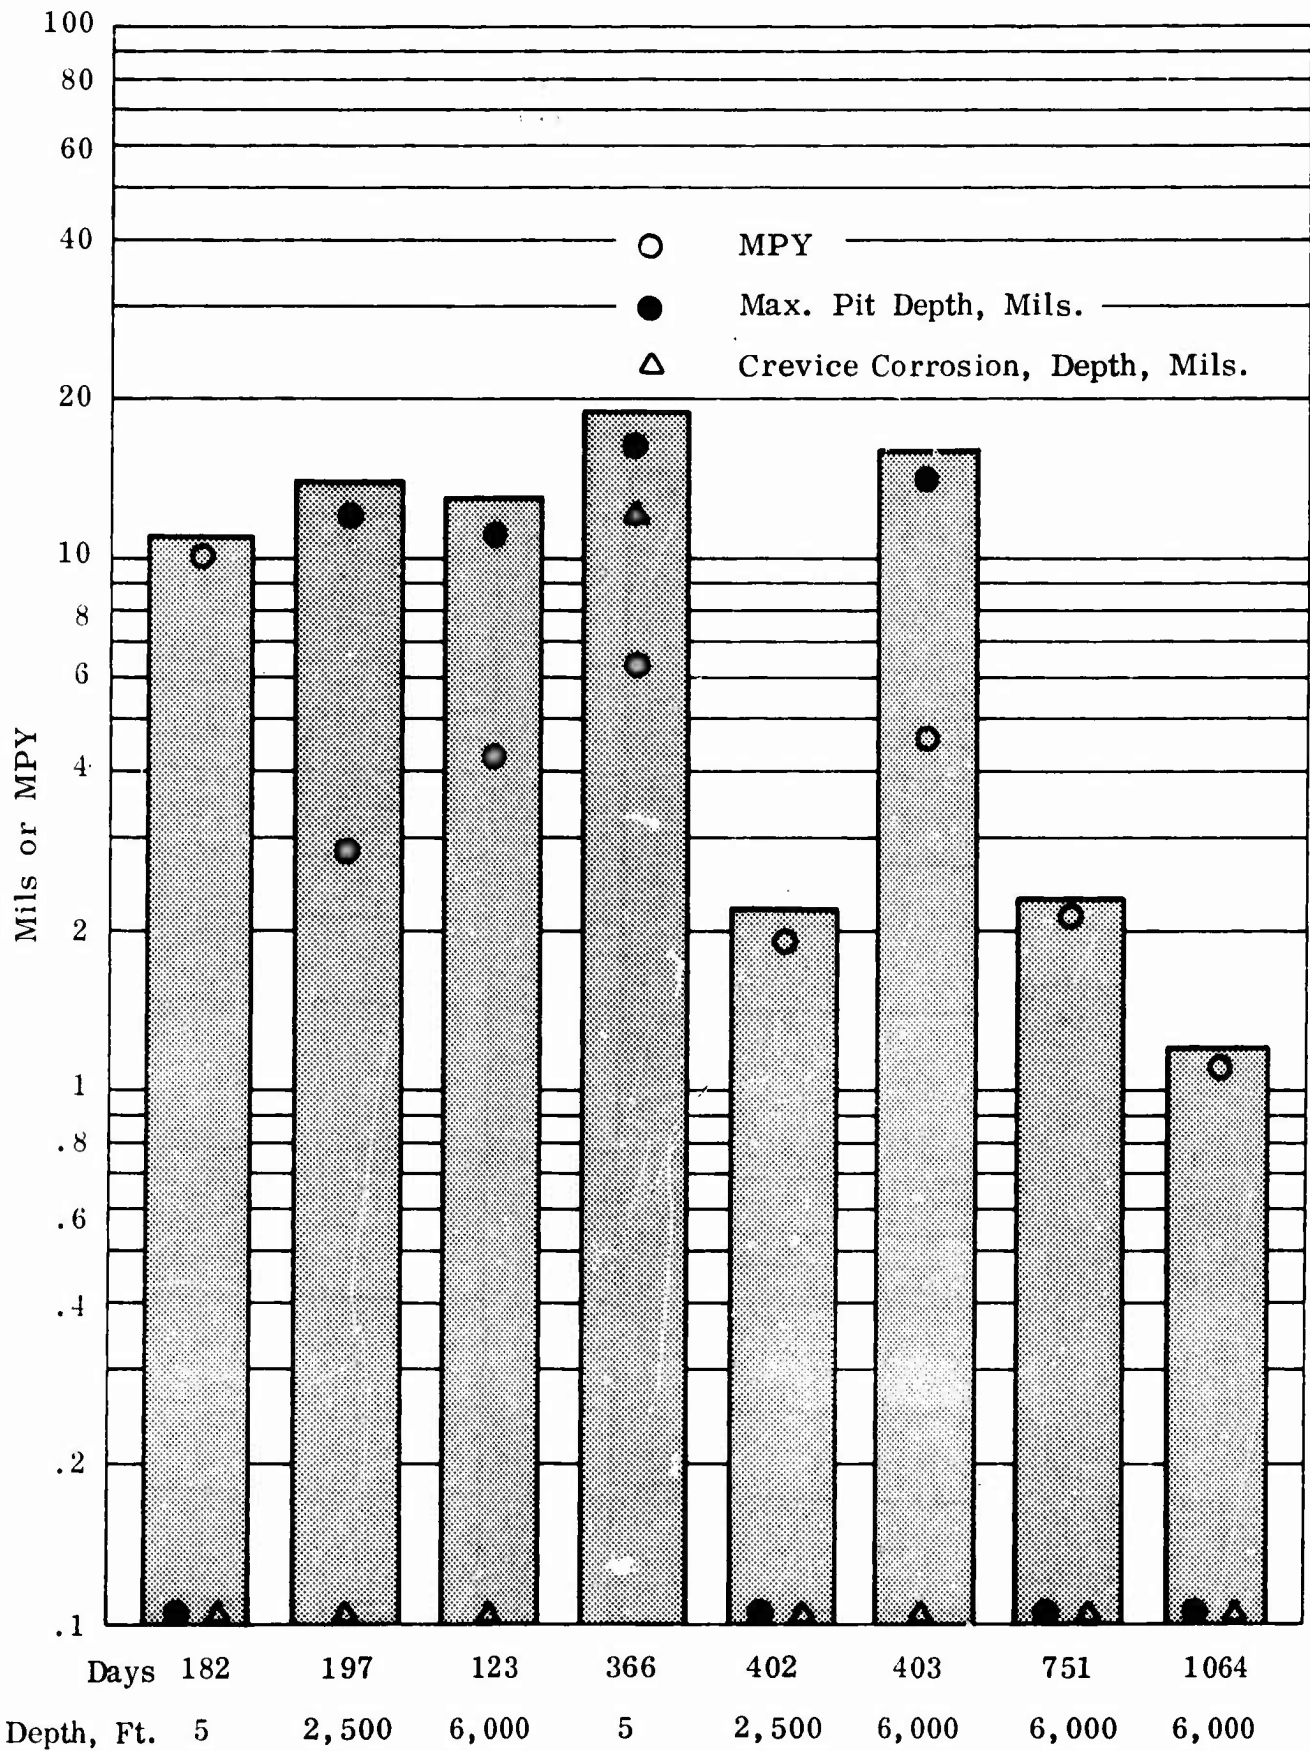
Figure 21. Corrosion rates, maximum pit depths and crevice corrosion of AISI Type 325 stainless steel in seawater at the surface and at depth.
