3. REPORT TITLE  
CORROSION OF MATERIALS IN HYDROSPACE - PART VI - STAINLESS STEELS

5. AUTHOR(S) (First name, middle initial, last name)  
Fred M. Reinhart

NAVAL CIVIL ENGINEERING LABORATORY  
Port Hueneme, California 93043

Technical Note N-1172

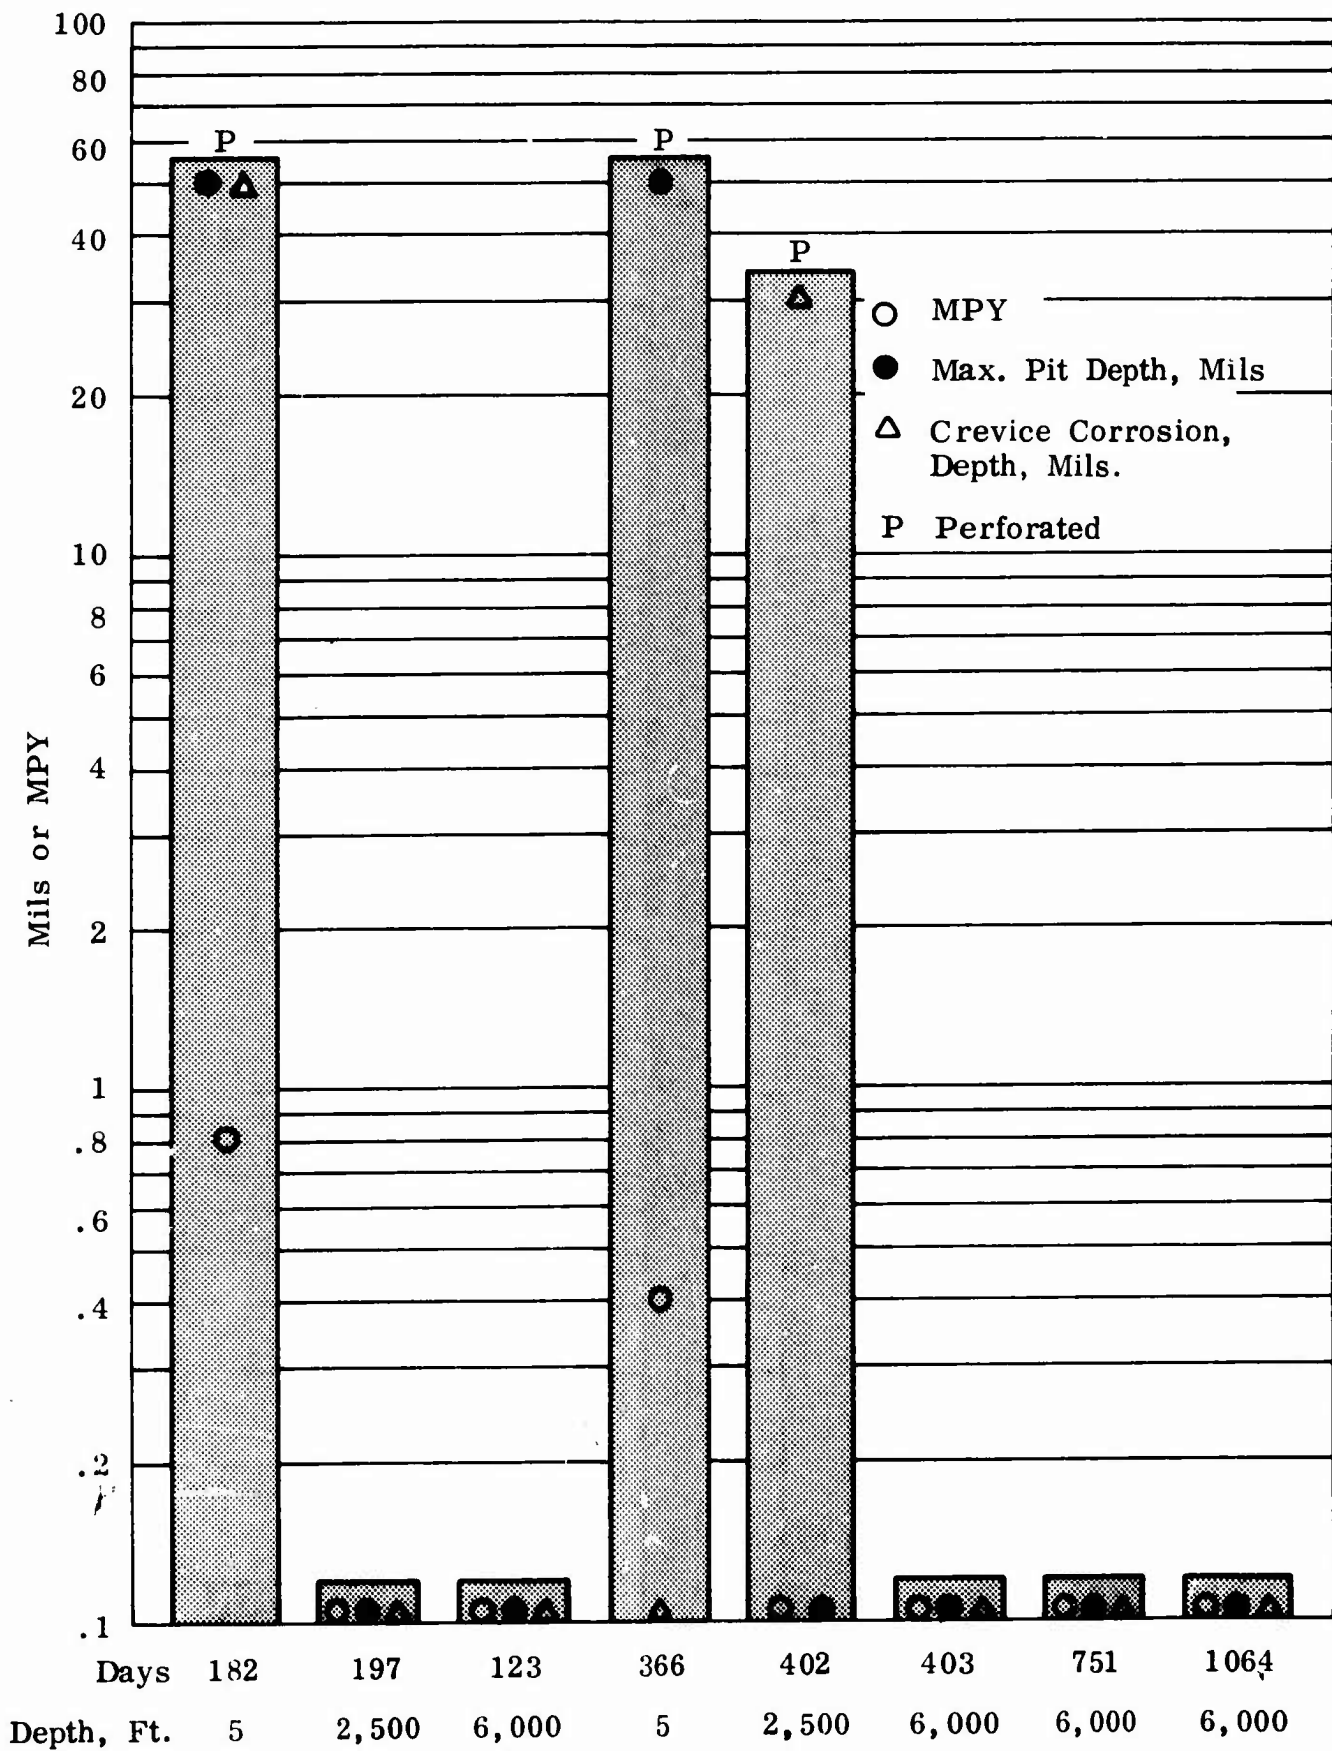
Figure 22. Corrosion rates, maximum pit depths and crevice corrosion of AISI Type 330 stainless steel in seawater at the surface and at depth.

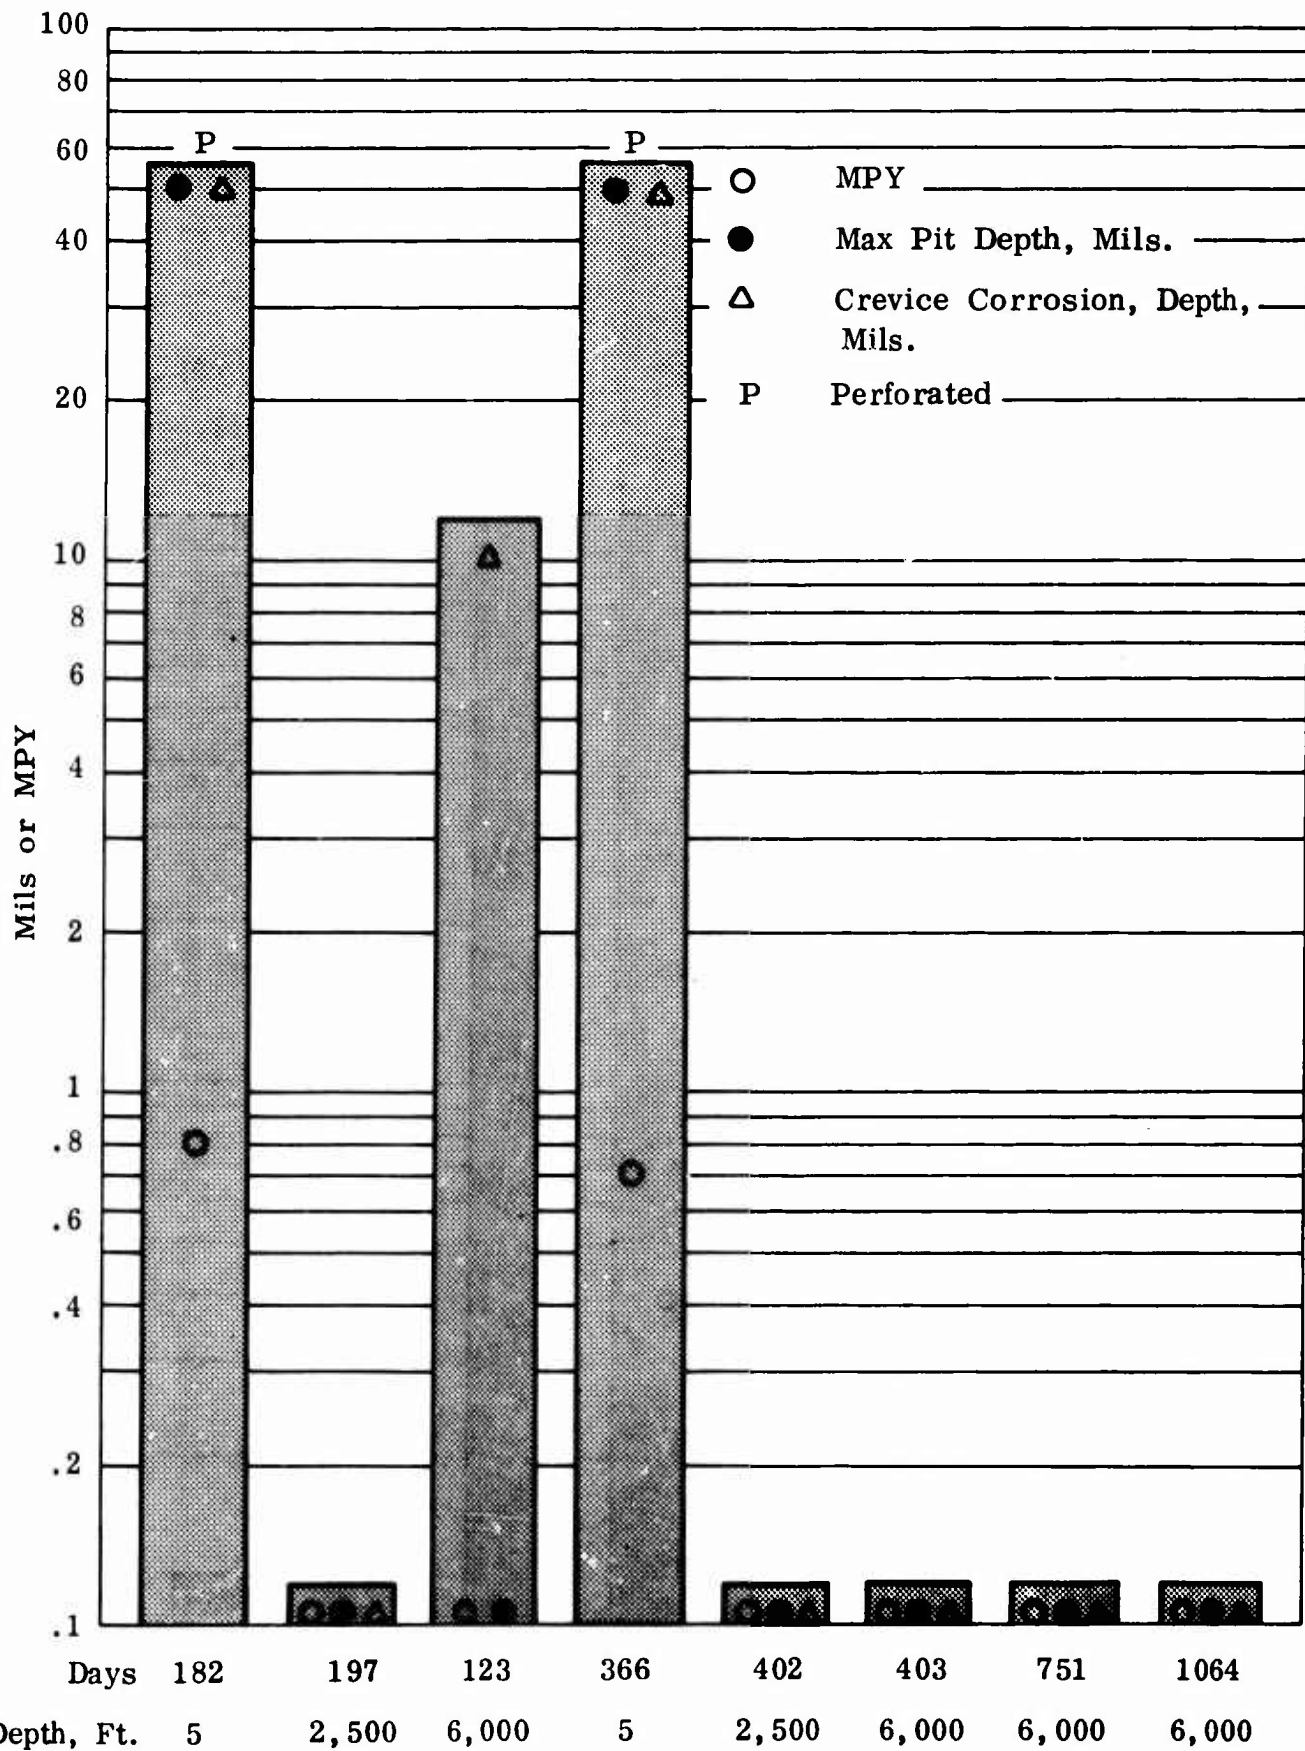
Figure 23. Corrosion rates, maximum pit depths and crevice corrosion of AISI Type 347 stainless steel in seawater at the surface and at depth.

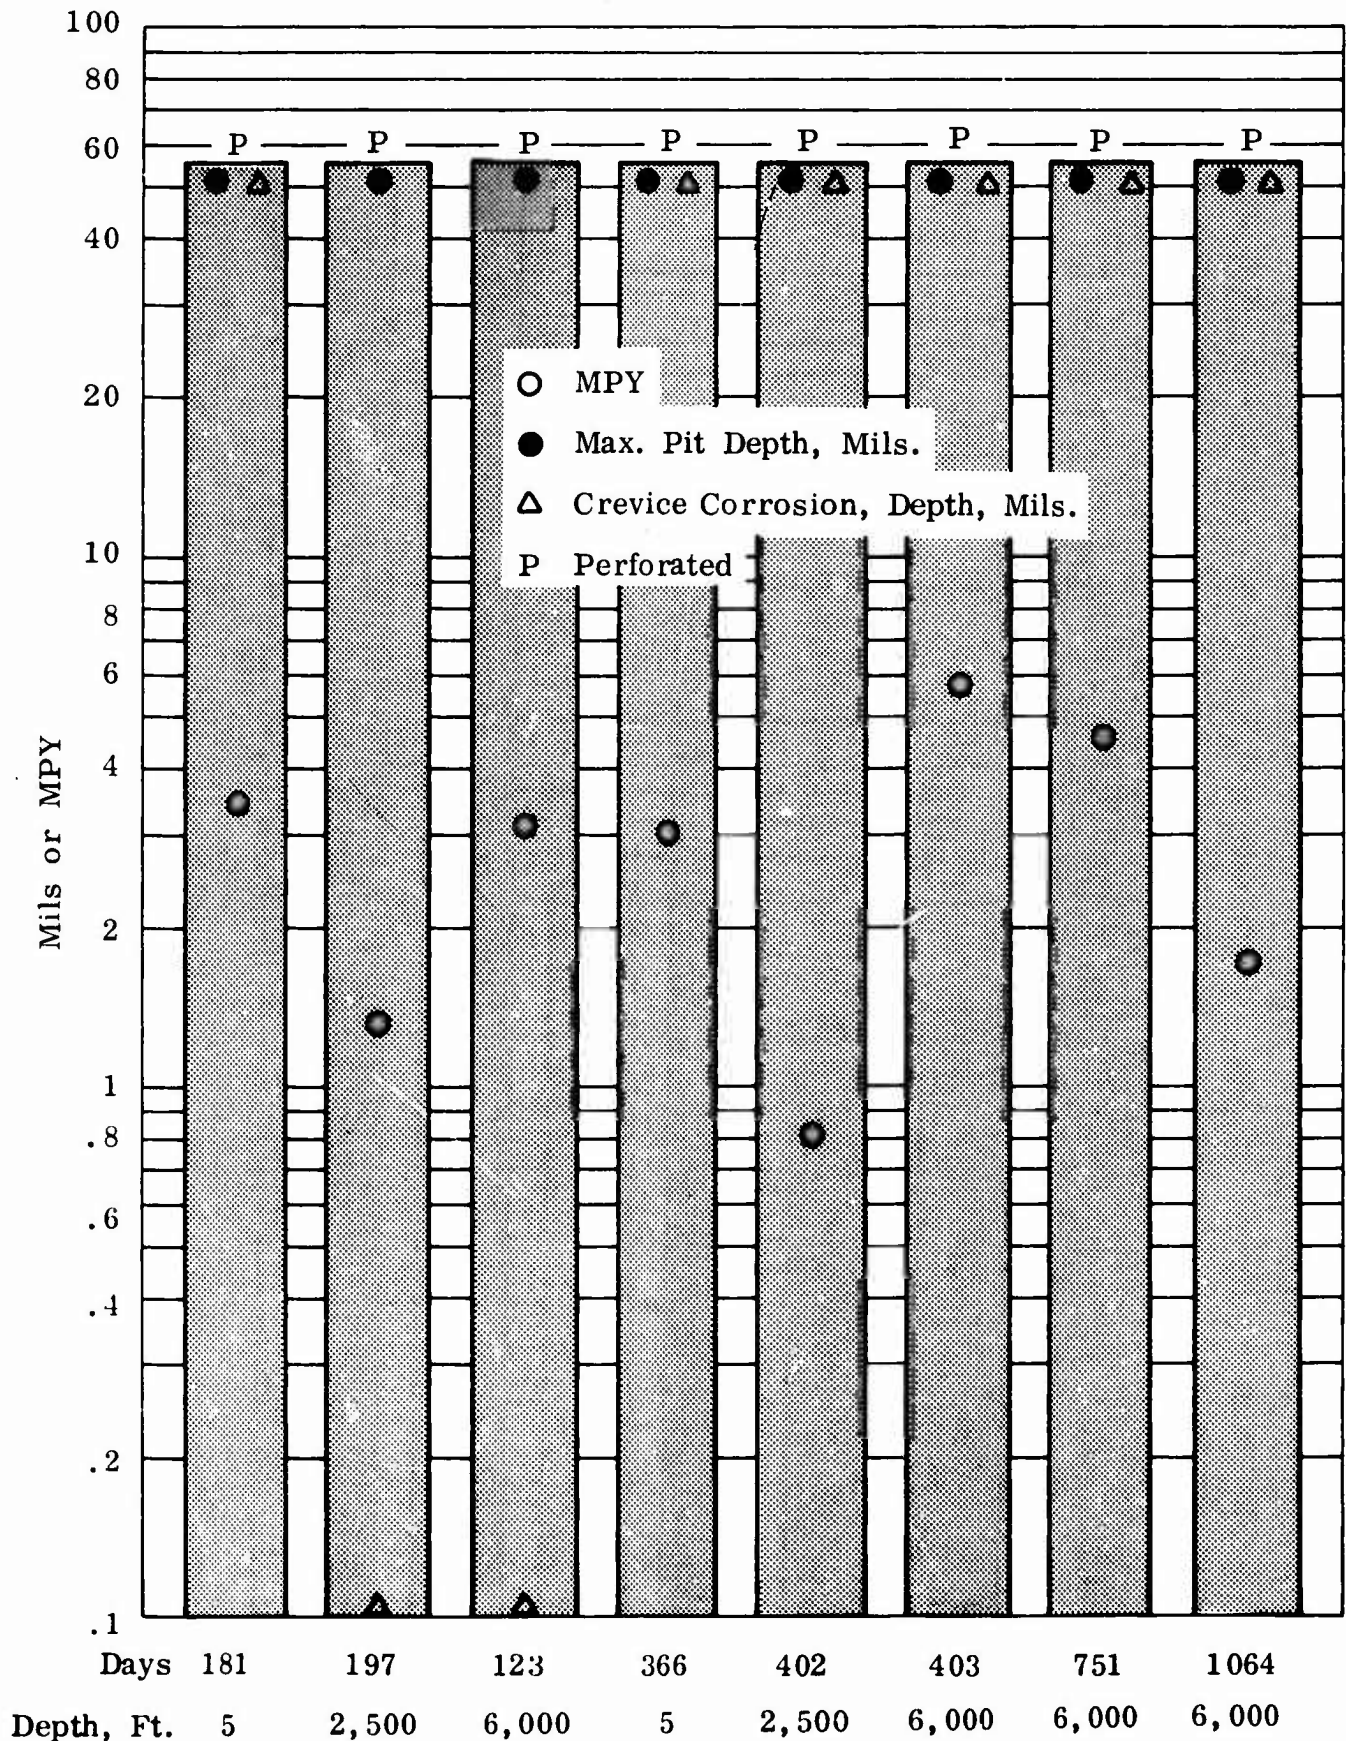
Figure 24. Corrosion rates, maximum pit depths and crevice corrosion of AISI Type 410 stainless steel in seawater at the surface and at depth.

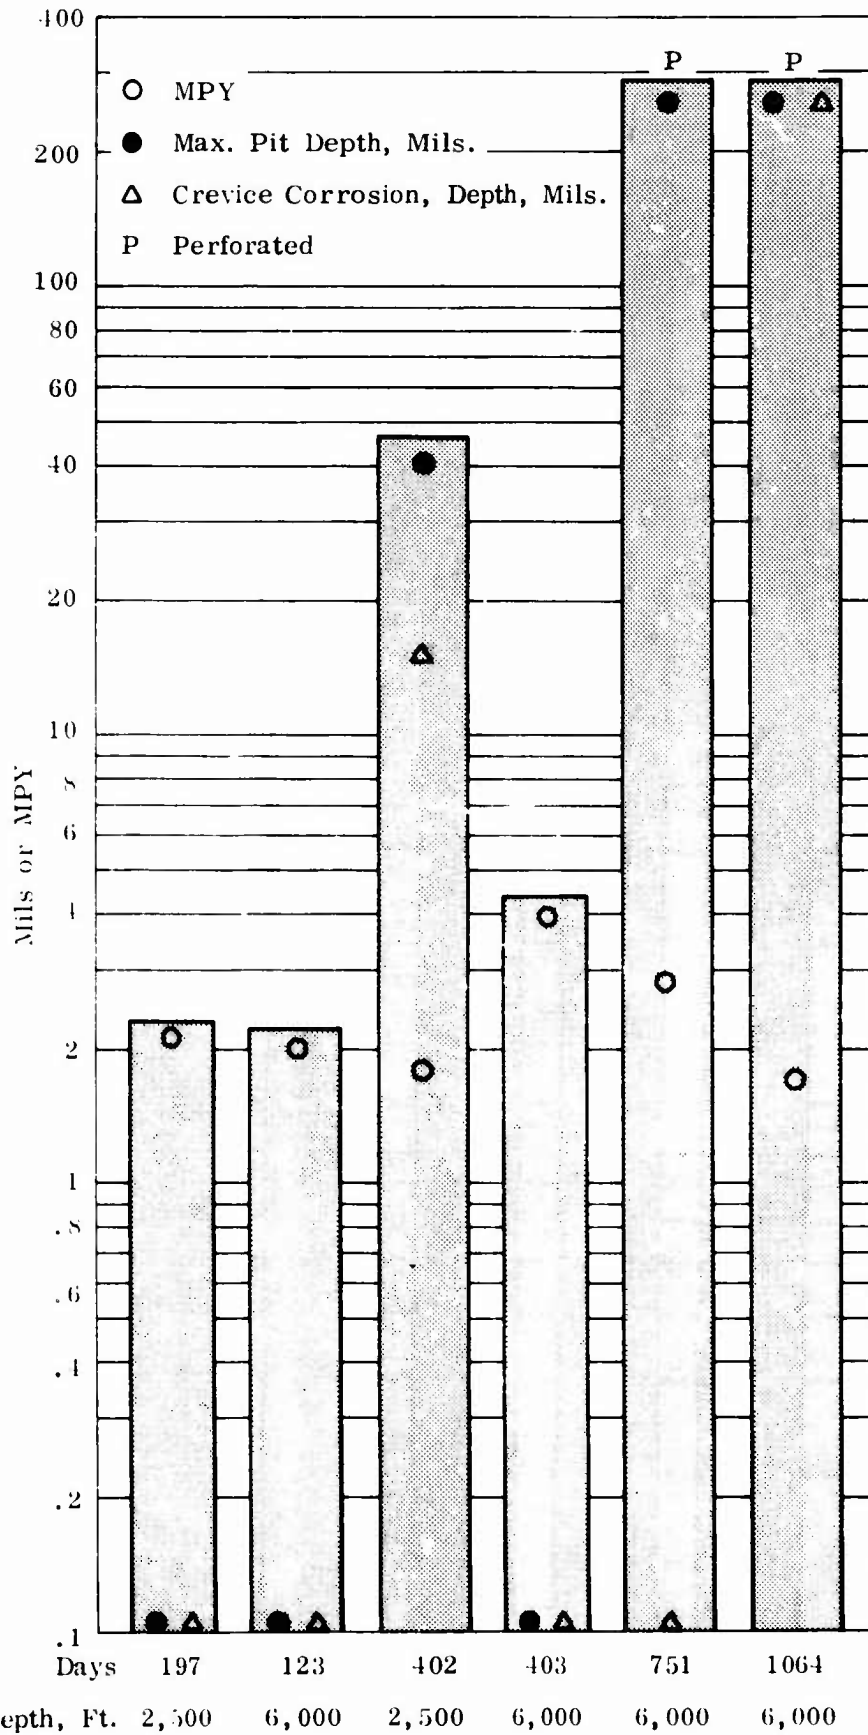
Figure 25. Corrosion rates, maximum pit depths and crevice corrosion of AISI Type 405 stainless steel in seawater at depth in the Pacific Ocean.

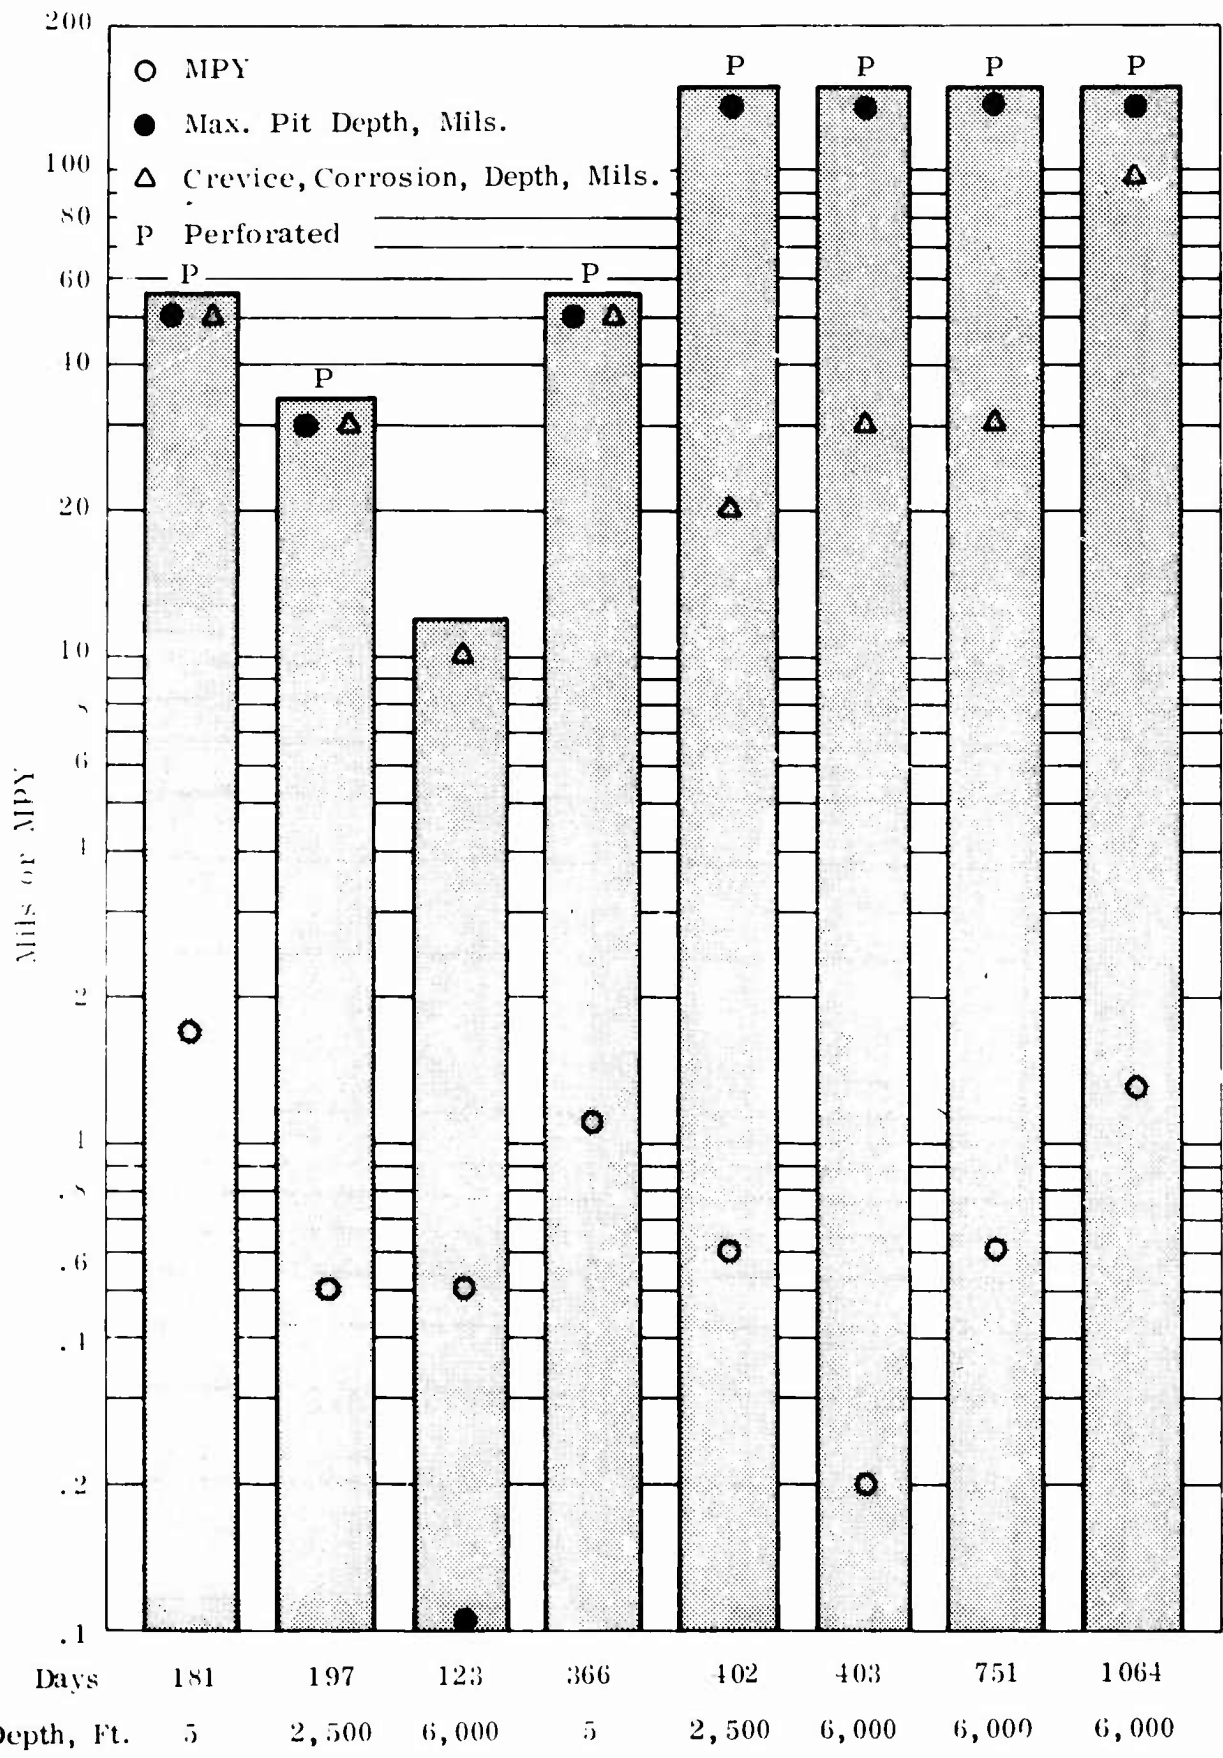
Figure 26. Corrosion rates, maximum pit depths and crevice corrosion of AISI Type 430 stainless steel in seawater at the surface and at depth.

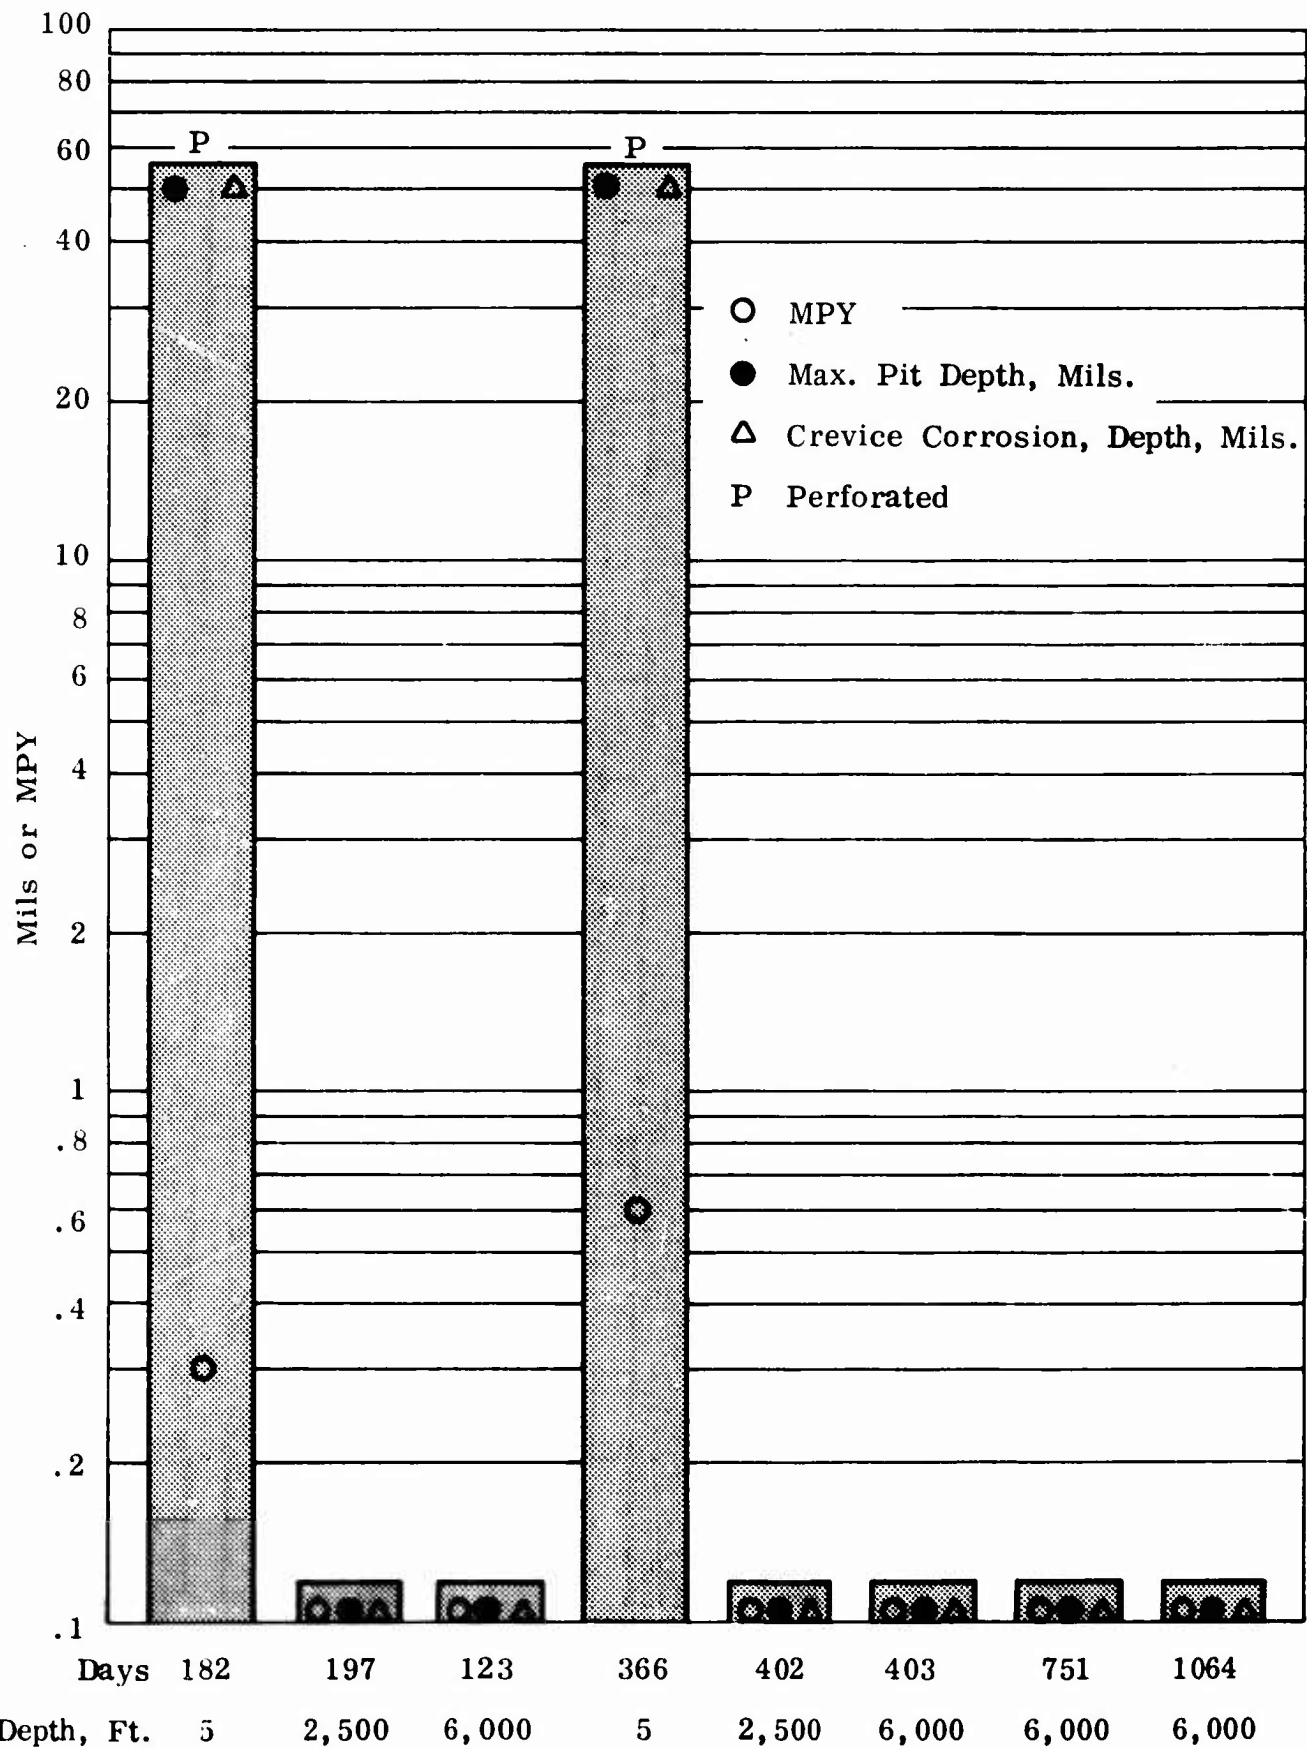
Figure 27. Corrosion rates, maximum pit depths and crevice corrosion of AISI Type 446 stainless steel in seawater at the surface and at depth.

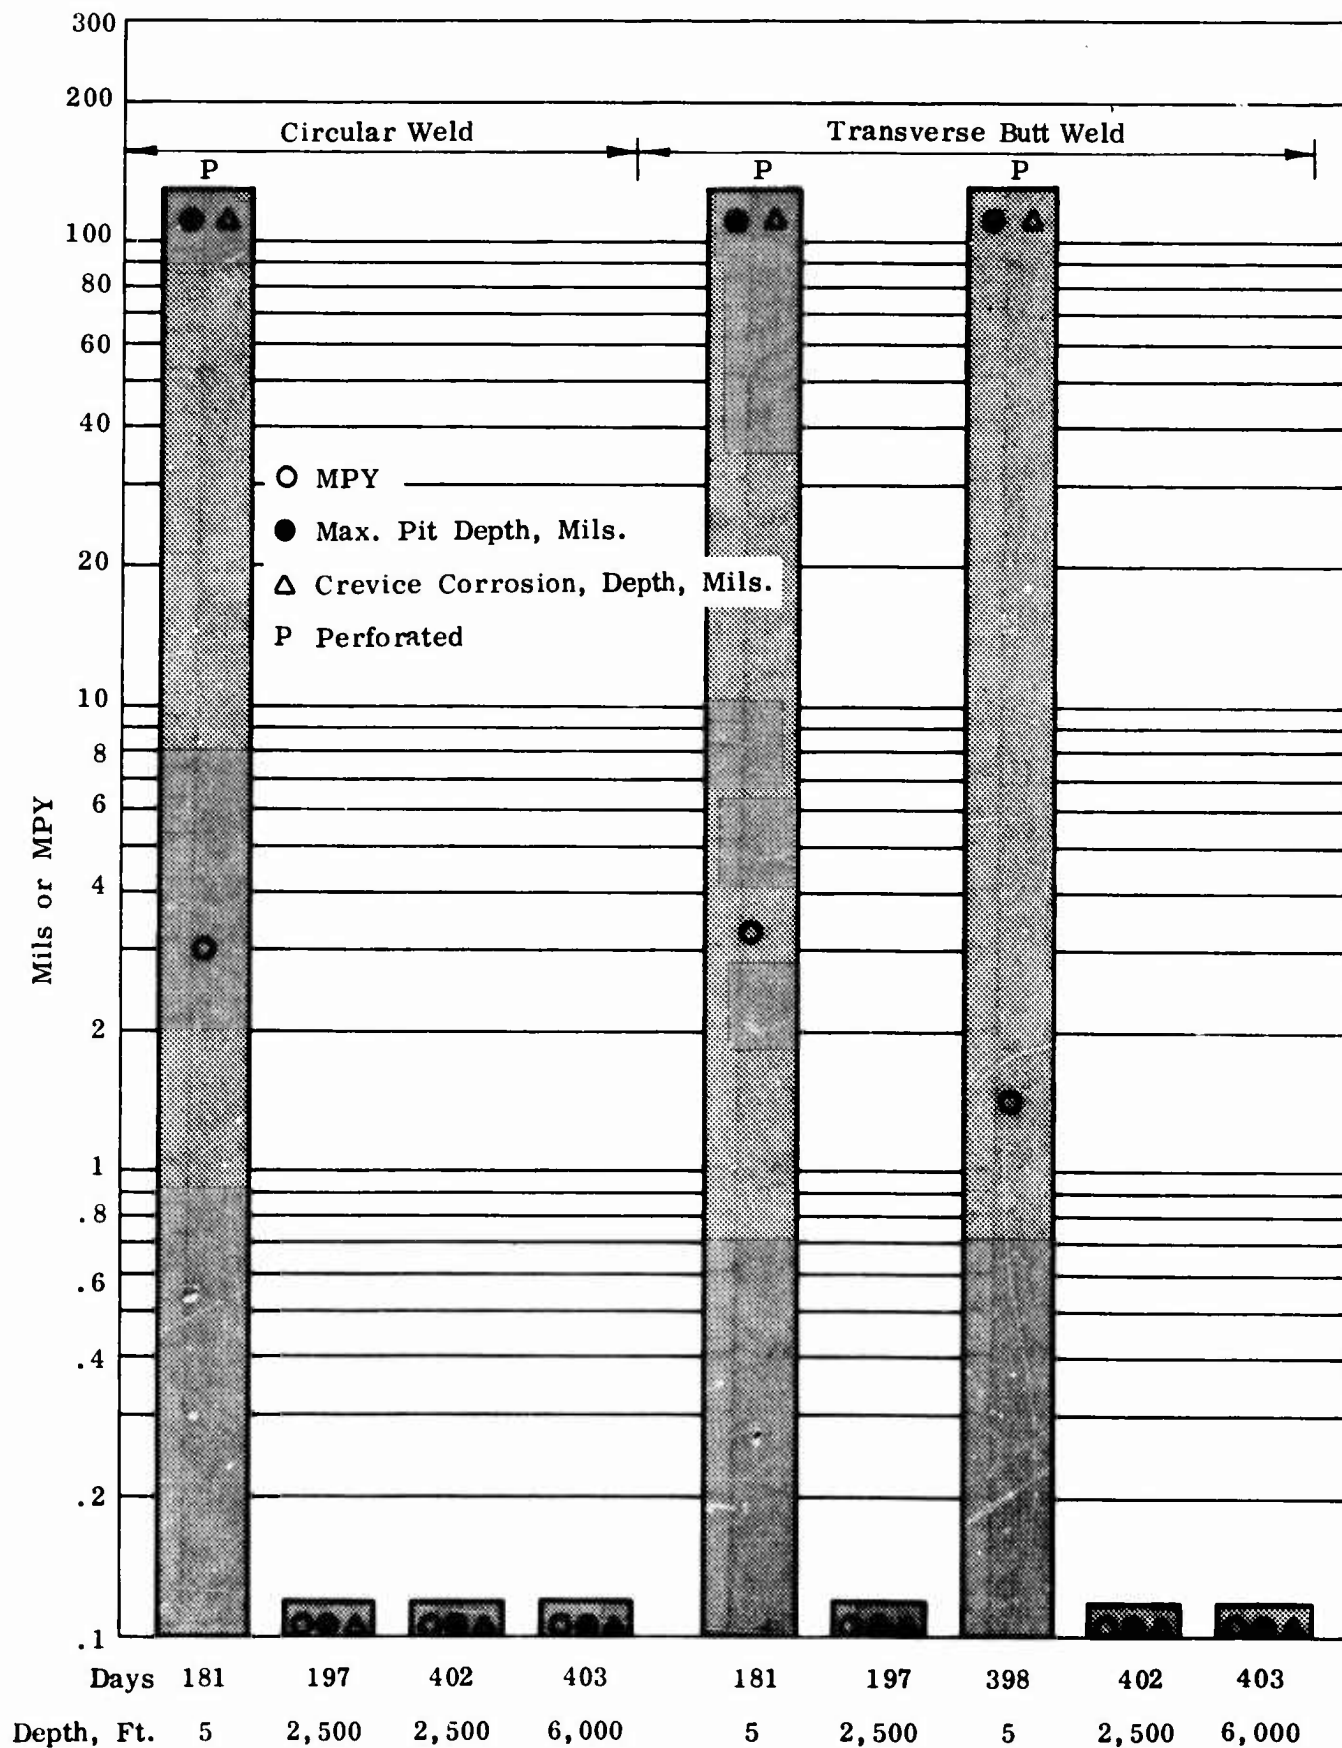
Figure 28. Corrosion rates, maximum pit depths and crevice corrosion of welded AISI Type 630-H925 precipitation hardening stainless steel in seawater at the surface and at depth.

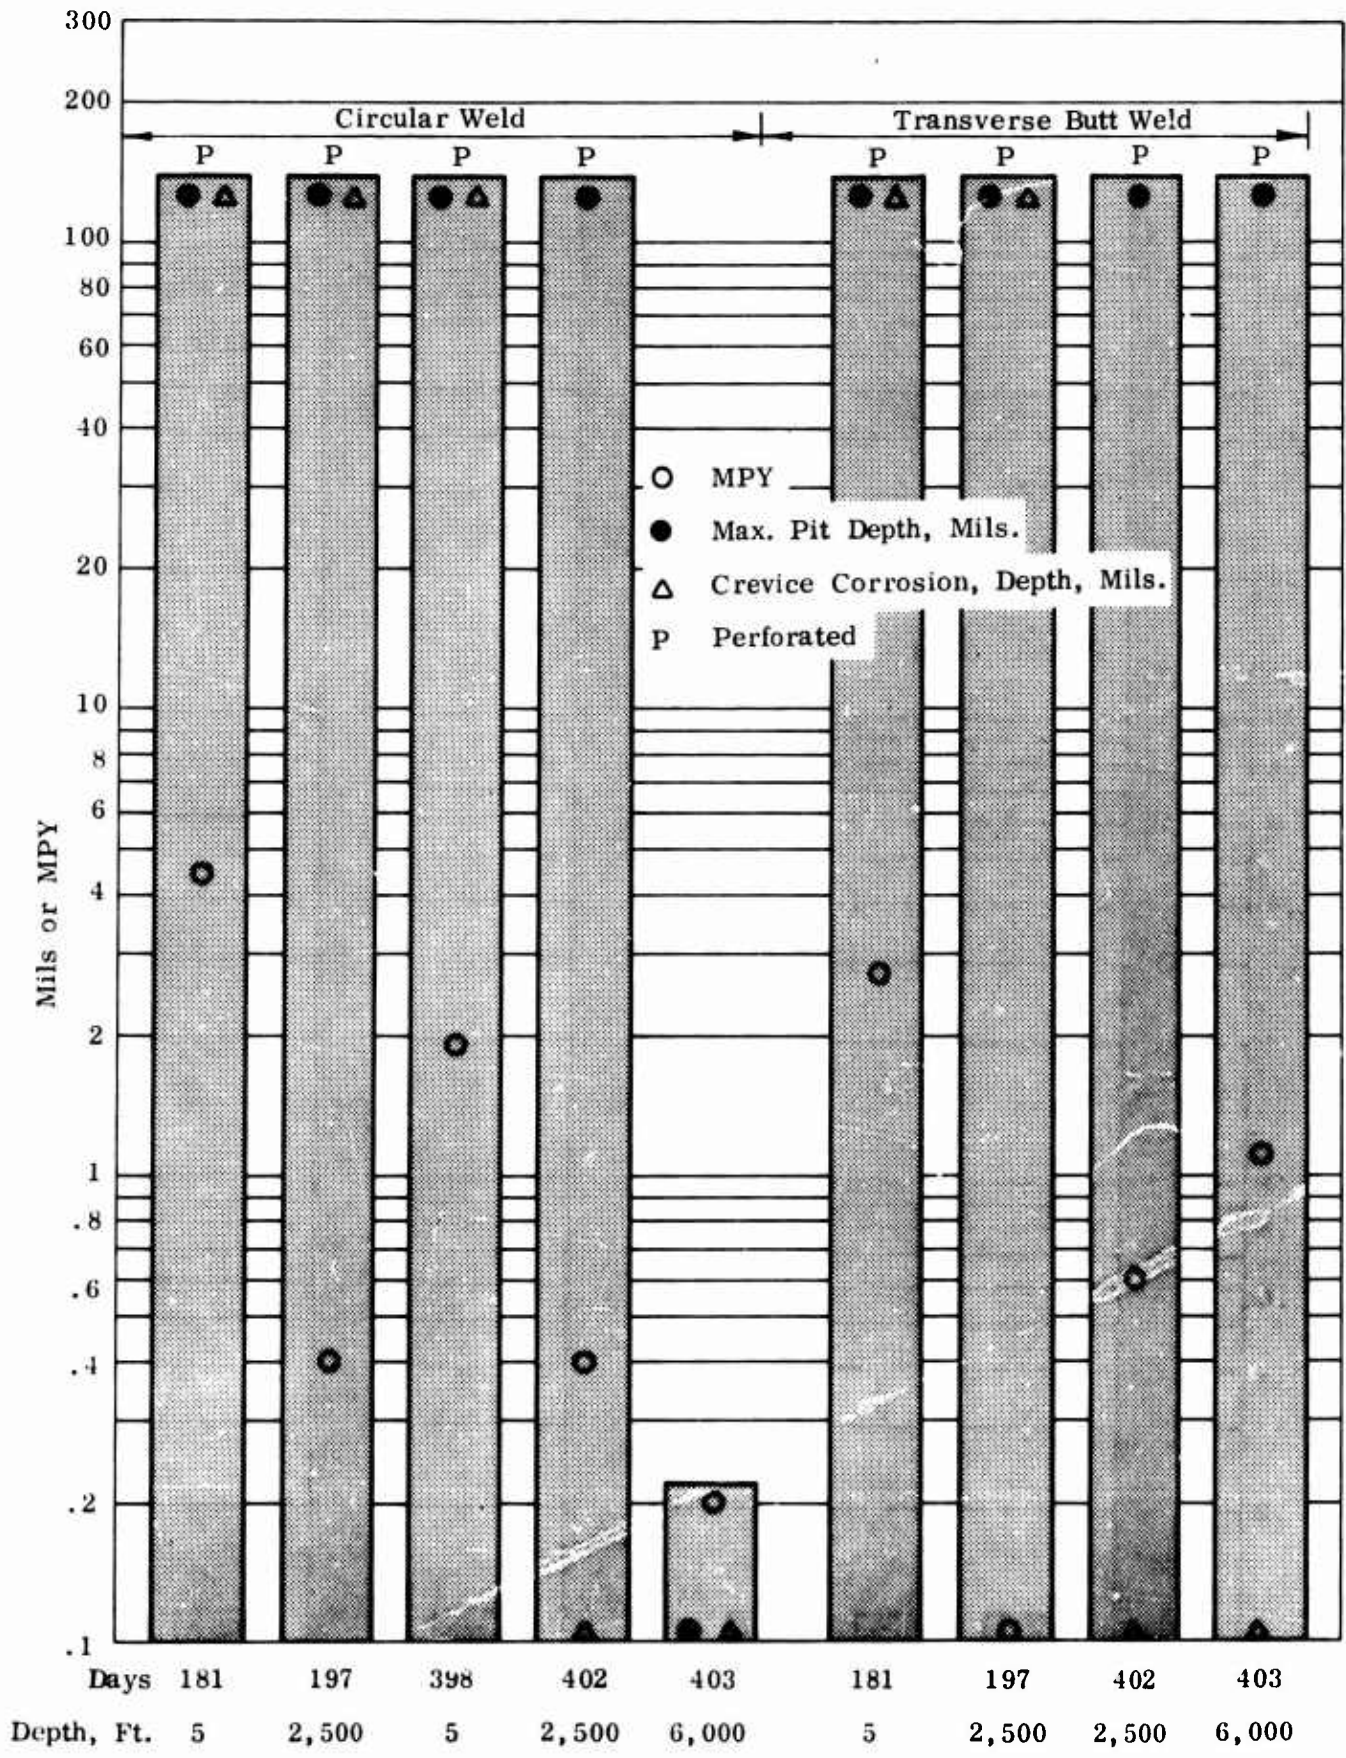
Figure 29. Corrosion rates, maximum pit depths and crevice corrosion of welded AISI Type 631-TH1050 precipitation hardening stainless steel in seawater at the surface and at depth.

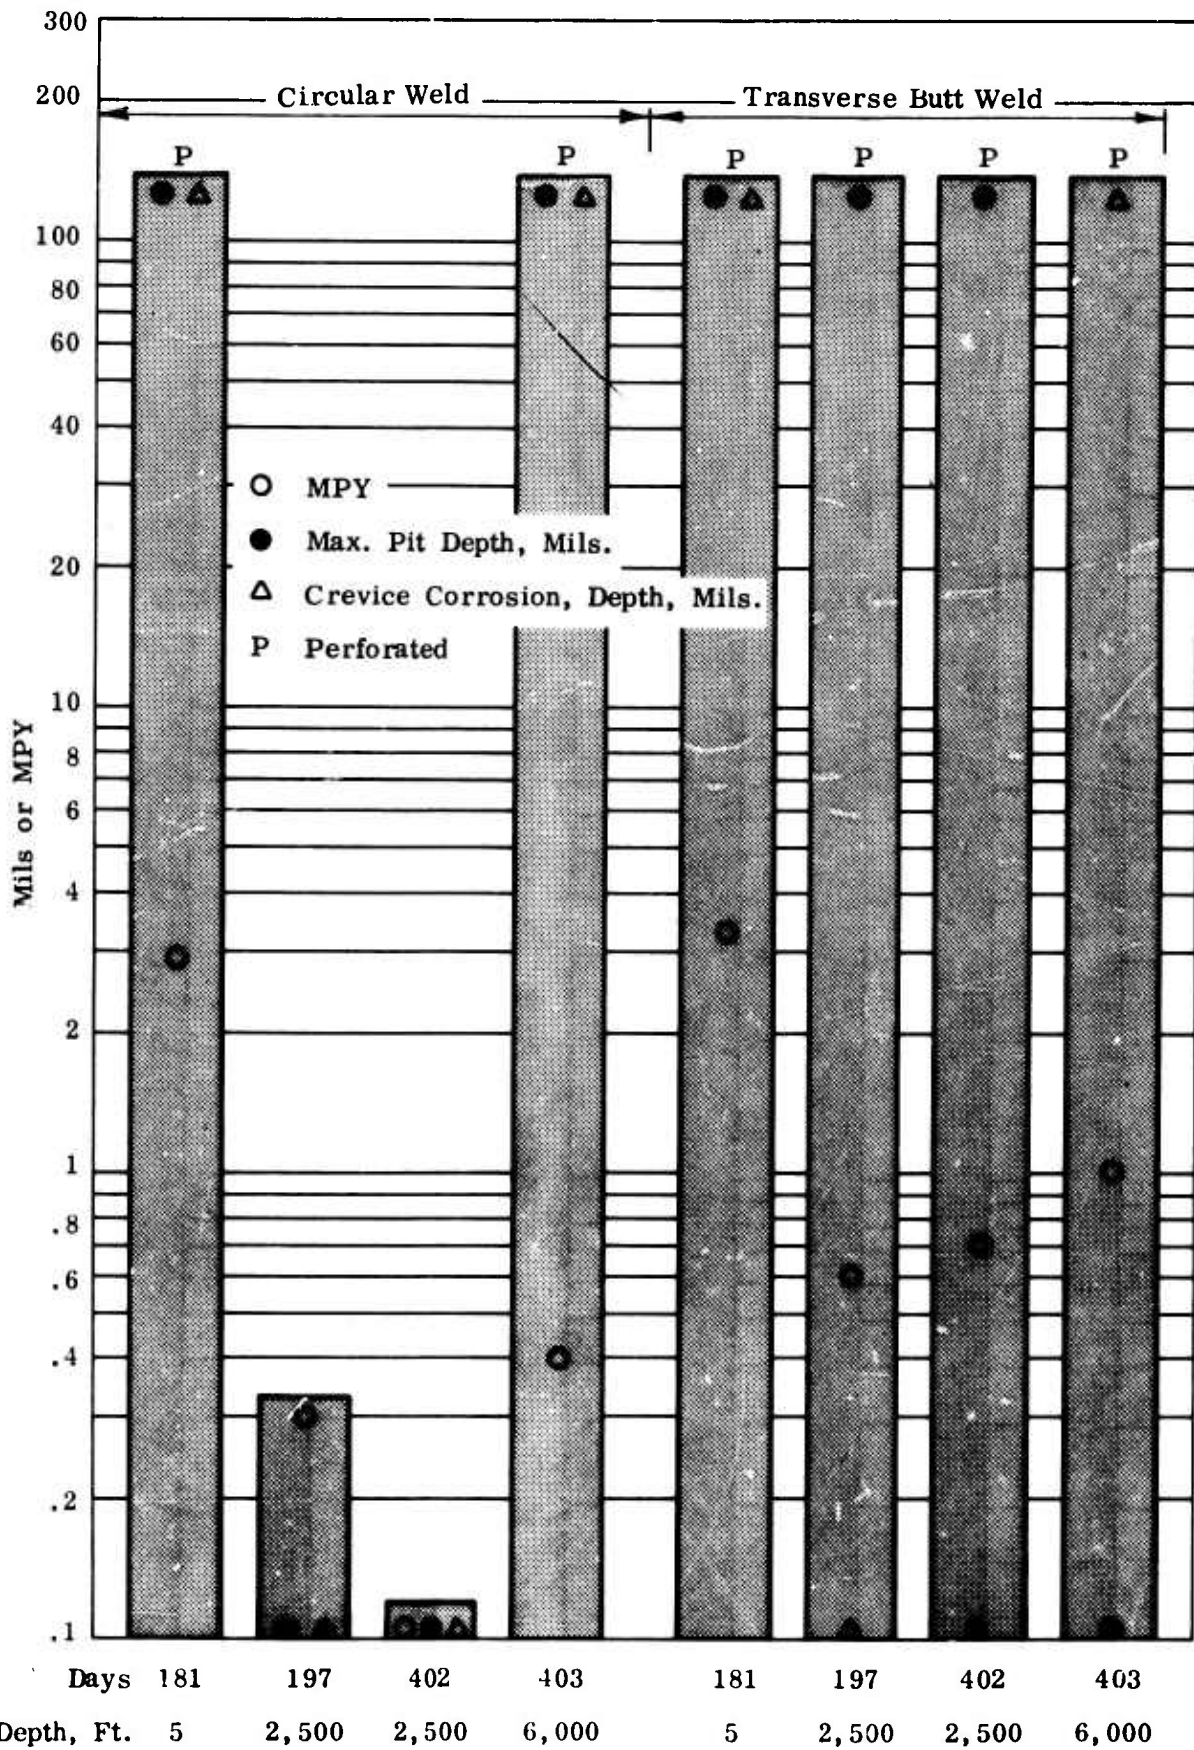
Figure 30. Corrosion rates, maximum pit depths and crevice corrosion of welded AISI Type 631-RH1050 precipitation hardening stainless steel in seawater at the surface and at depth.

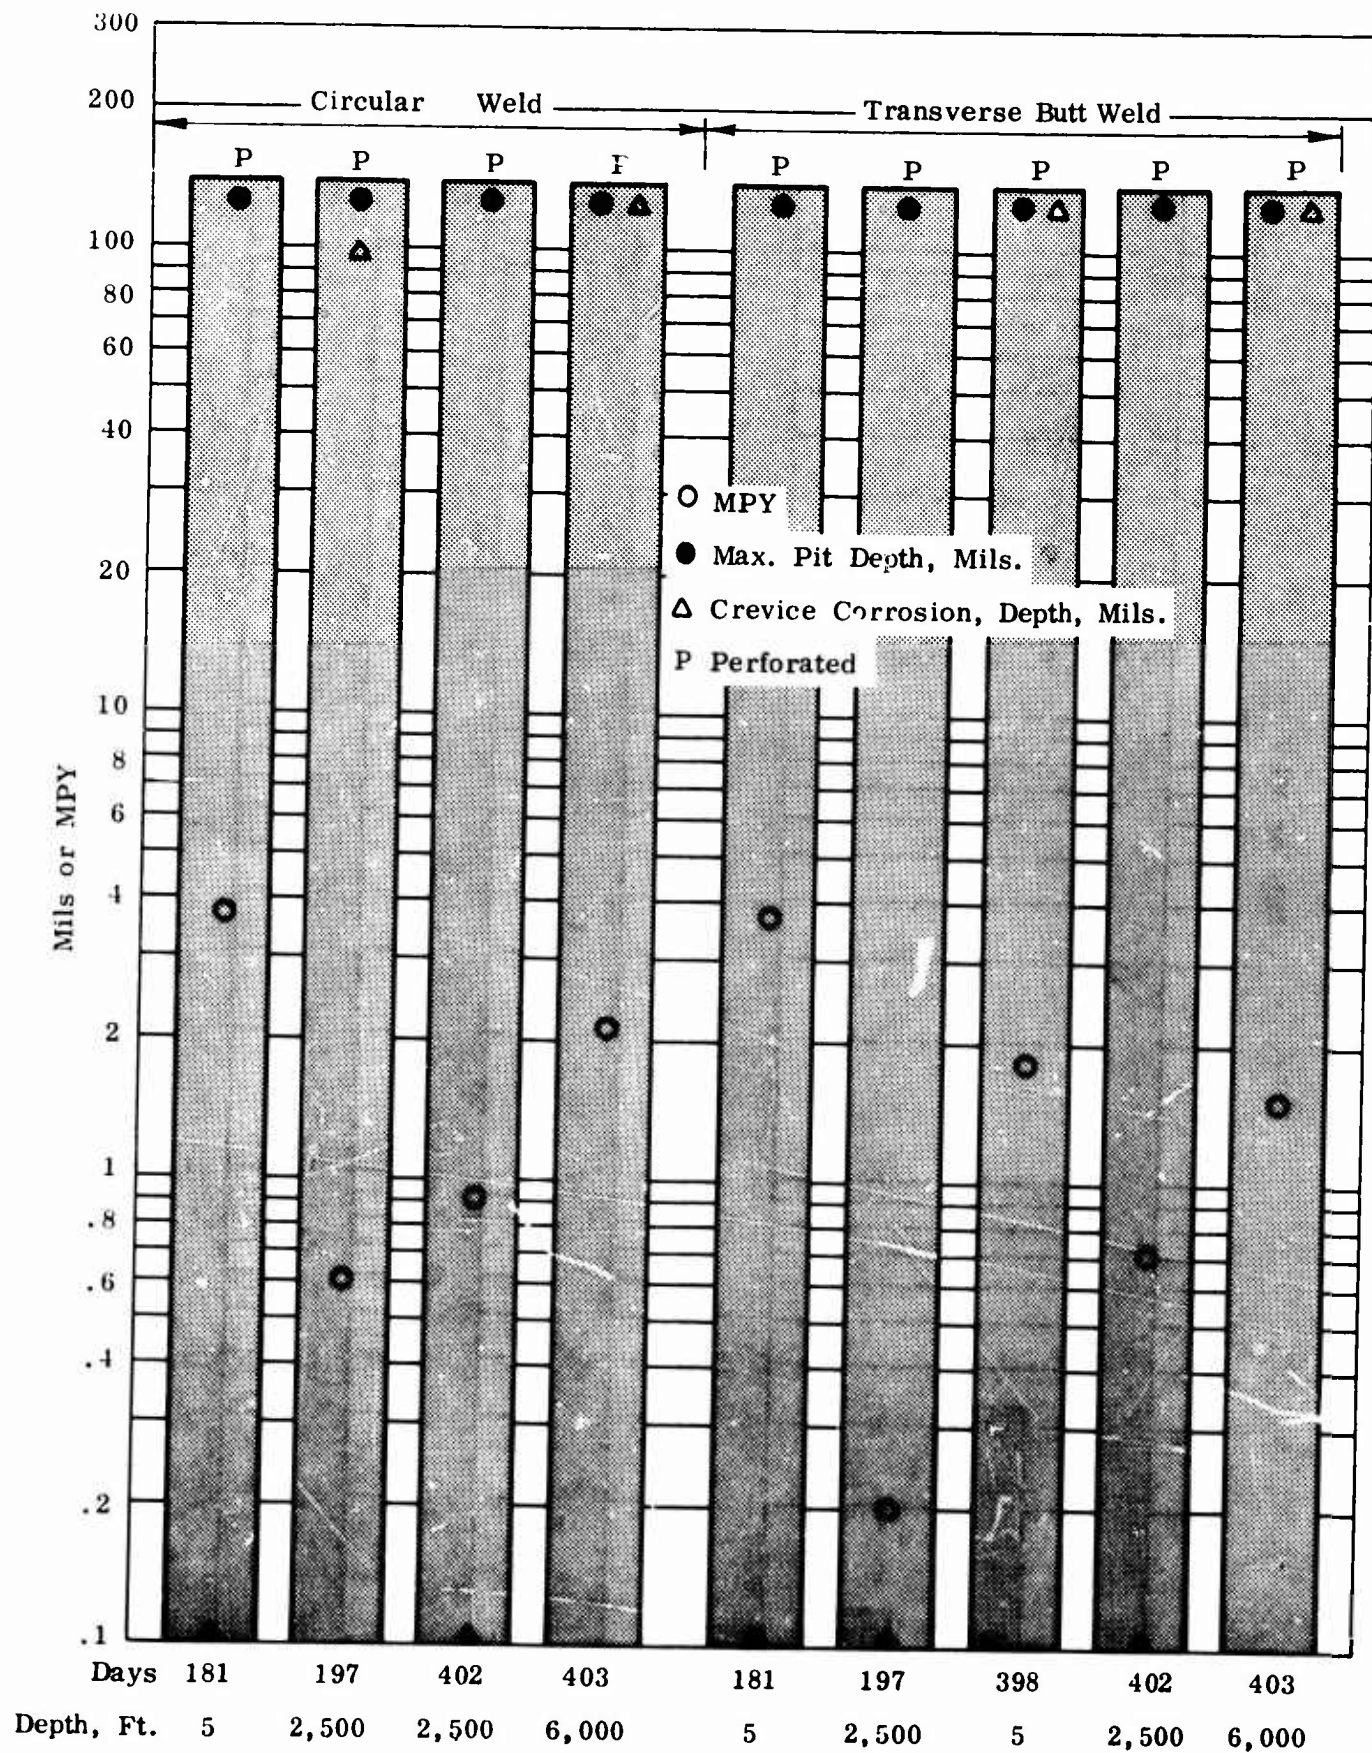
Figure 31. Corrosion rates, maximum pit depths and crevice corrosion of welded AISI Type 632-RH1100 precipitation hardening stainless steel in seawater at the surface and at depth.
