3. REPORT TITLE  
CORROSION OF MATERIALS IN HYDROSPACE - PART VI - STAINLESS STEELS

5. AUTHOR(S) (First name, middle initial, last name)  
Fred M. Reinhart

NAVAL CIVIL ENGINEERING LABORATORY  
Port Hueneme, California 93043

Technical Note N-1172

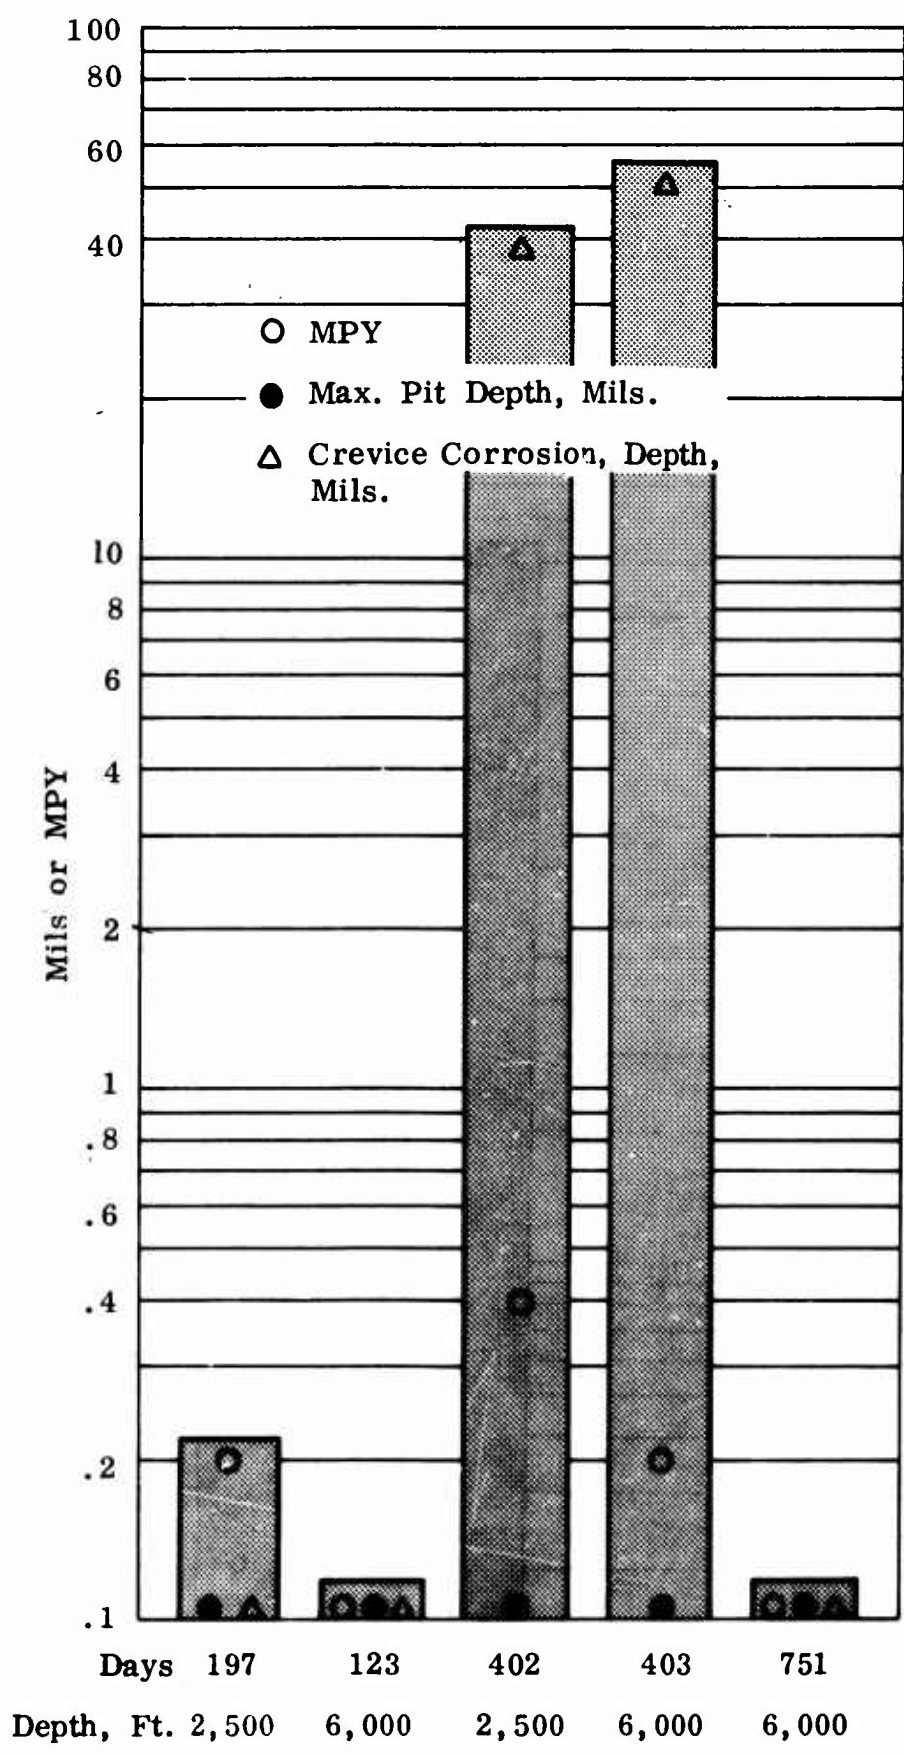
Figure 32. Corrosion rates, maximum pit depths and crevice corrosion of AISI Type 634-CRT precipitation hardening stainless steel in seawater at the surface and at depth.

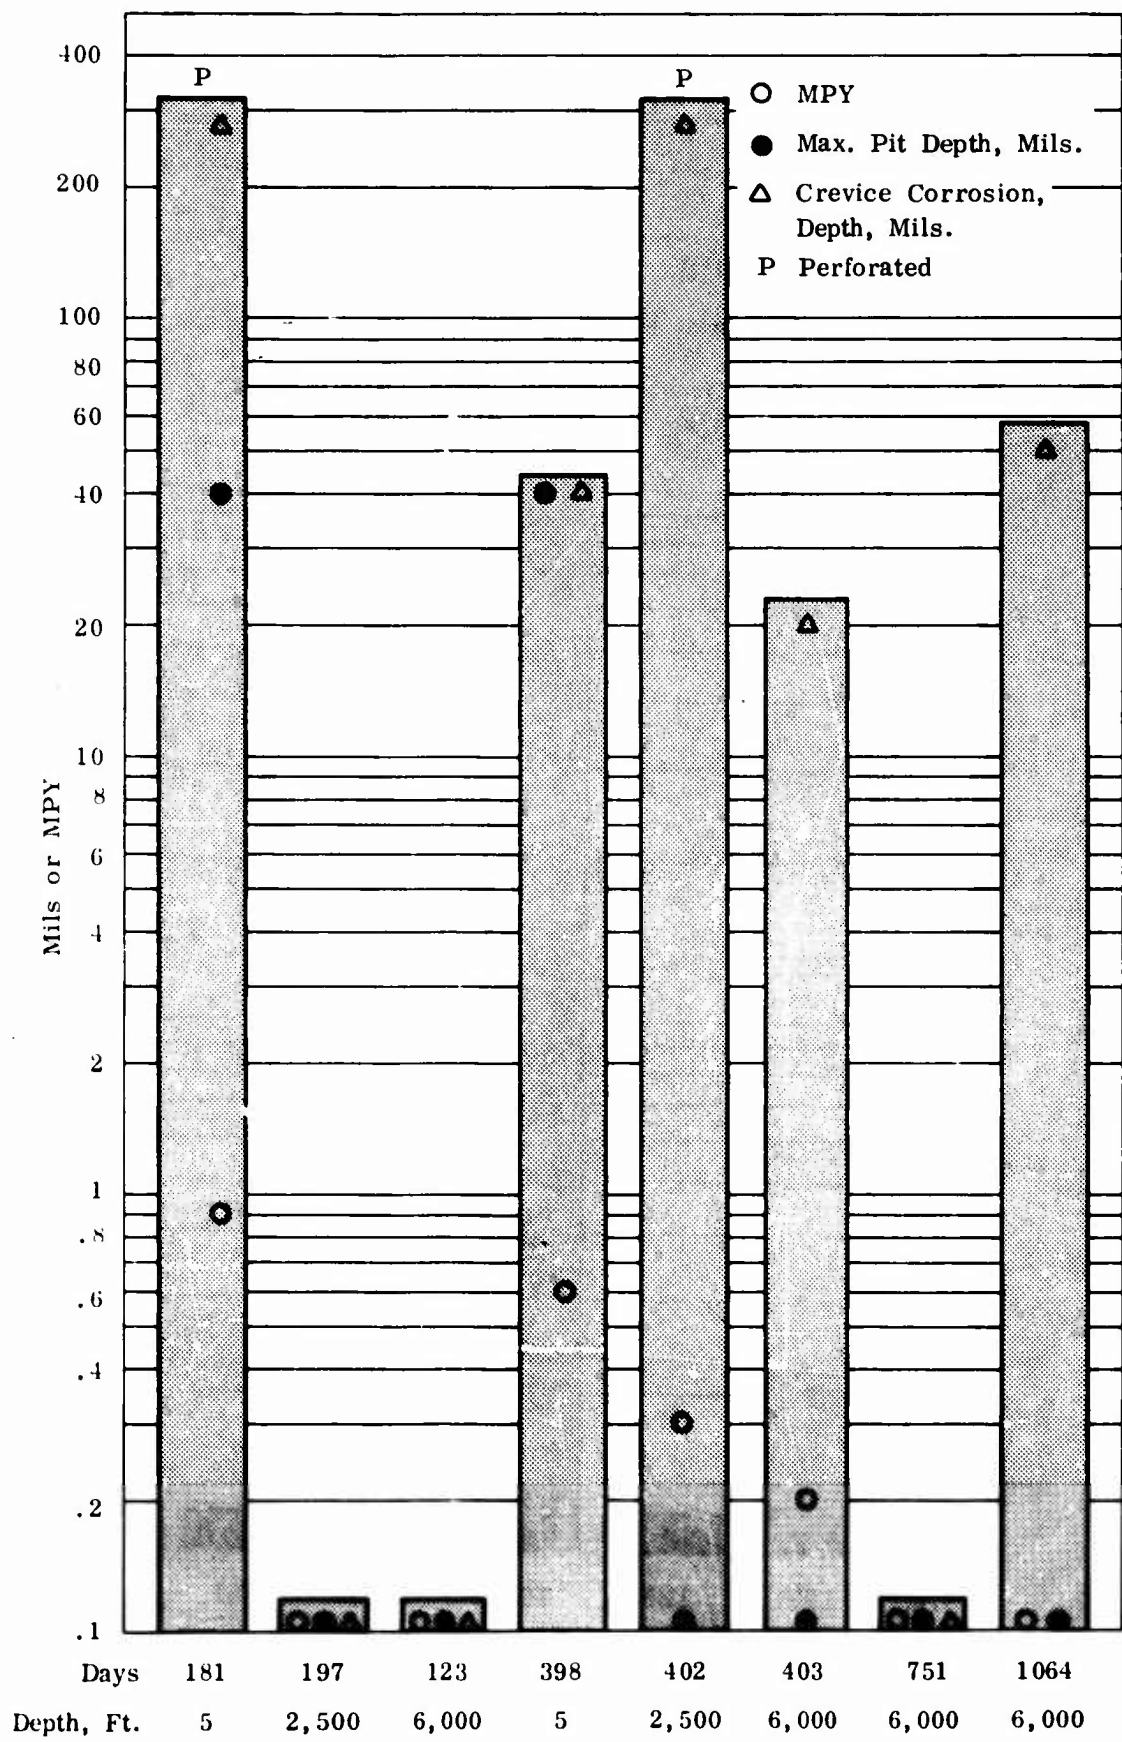
Figure 33. Corrosion rates, maximum pit depths and crevice corrosion of AISI Type 635-TH1000 precipitation hardening stainless steel in seawater at the surface and at depth.

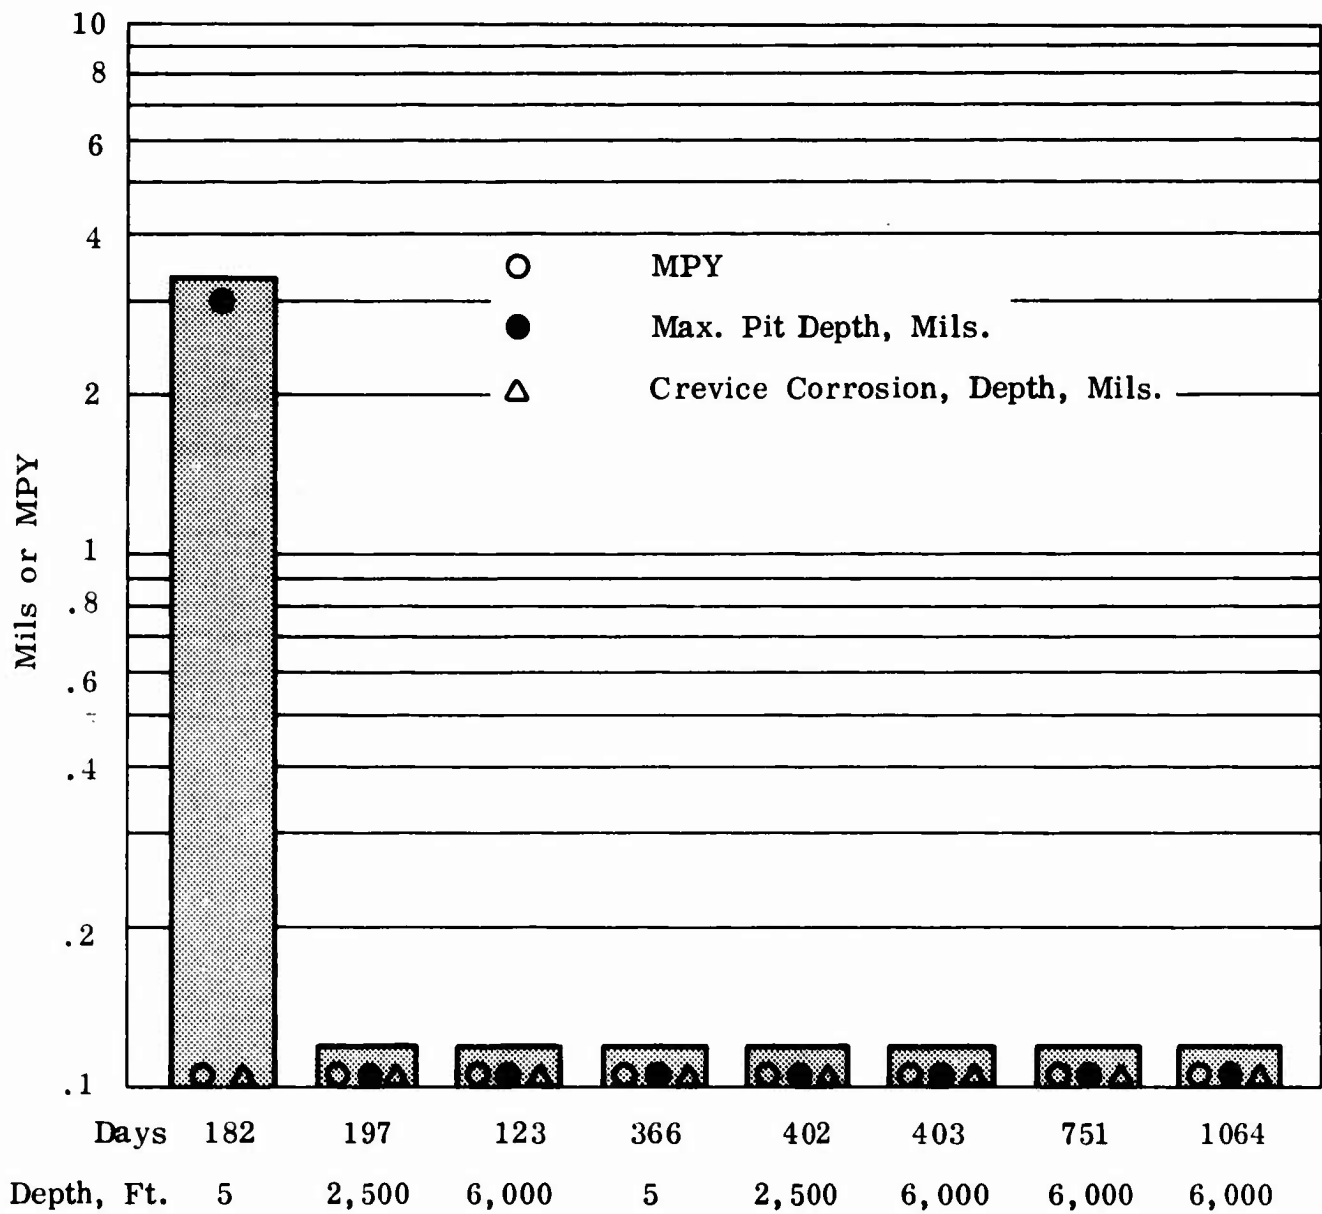
Figure 34. Corrosion rates, maximum pit depths and crevice corrosion 17Cr-14Ni-3Cu-2Mo precipitation hardening stainless steel in seawater at the surface and at depth.

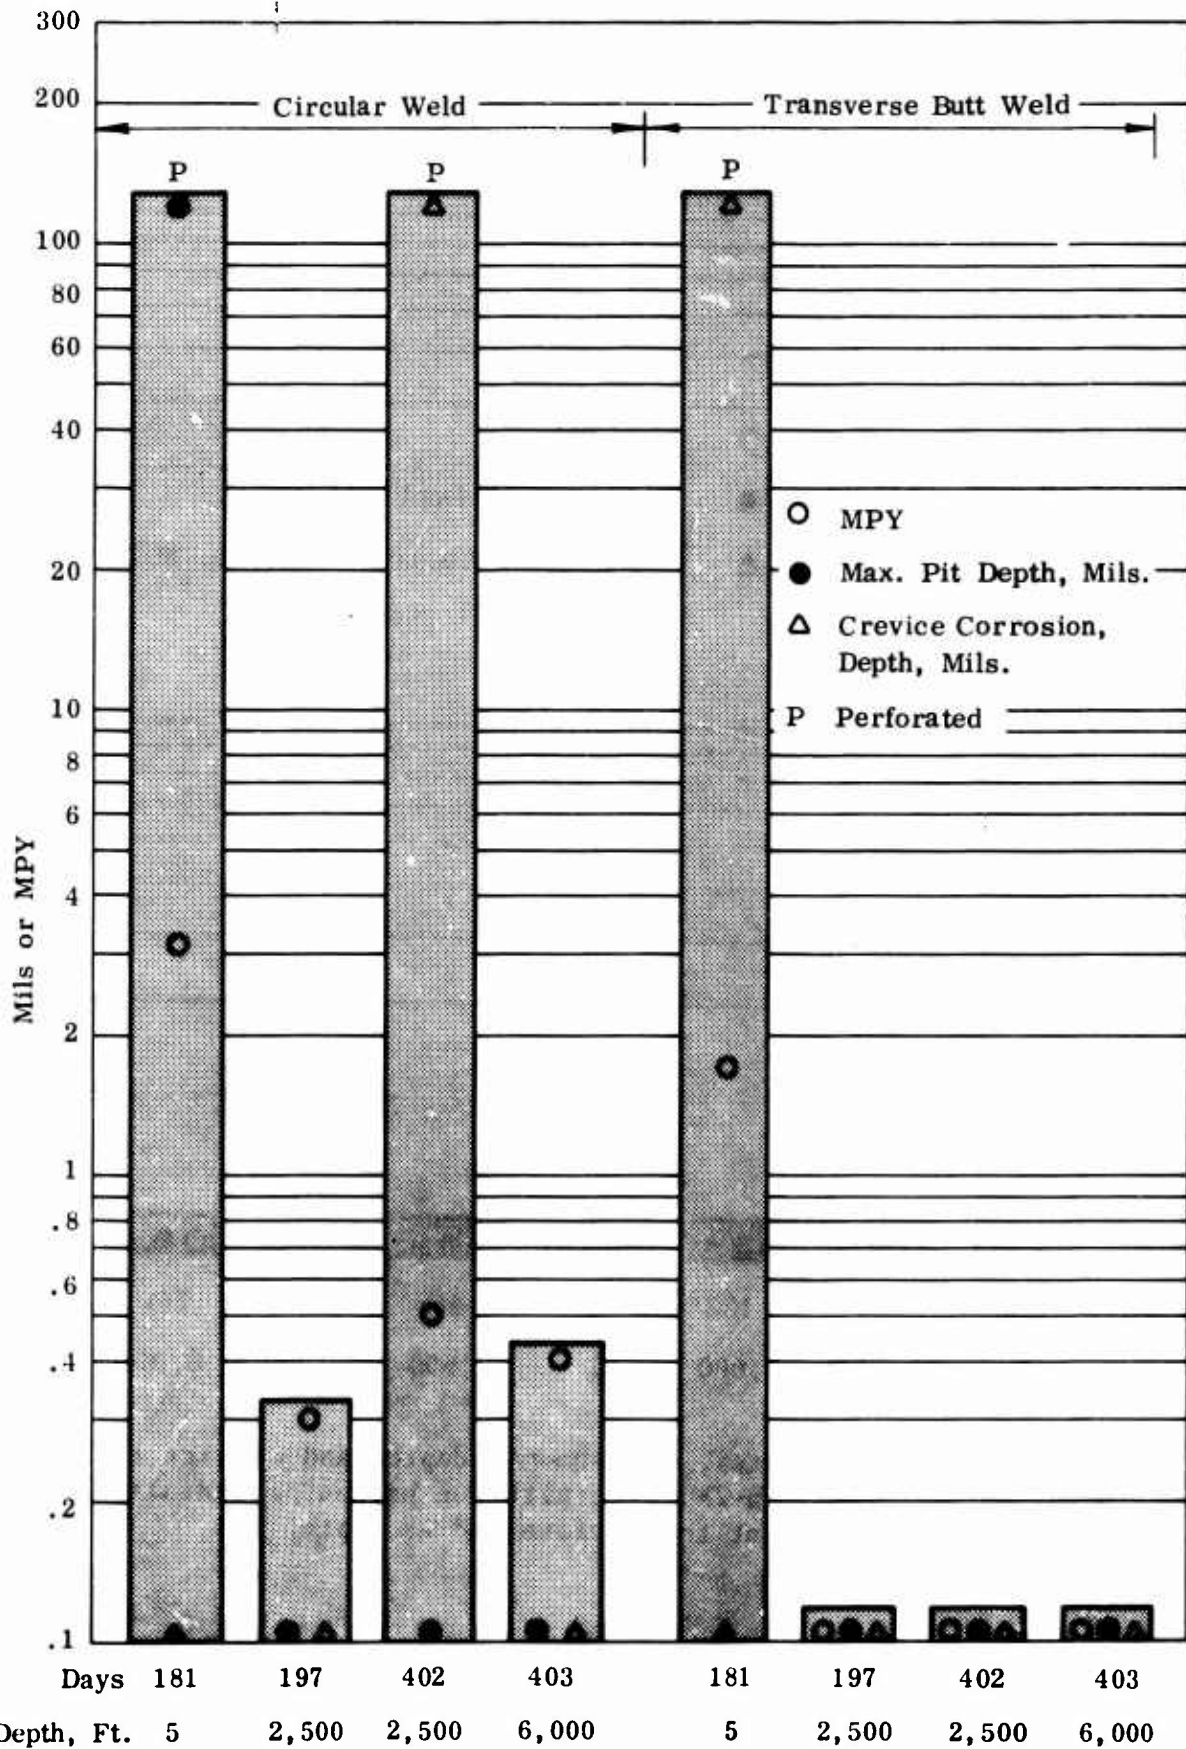
Figure 35. Corrosion rates, maximum pit depths and crevice corrosion of welded PH14-8Mo-SRH950 precipitation hardening stainless steel in seawater at the surface and at depth.

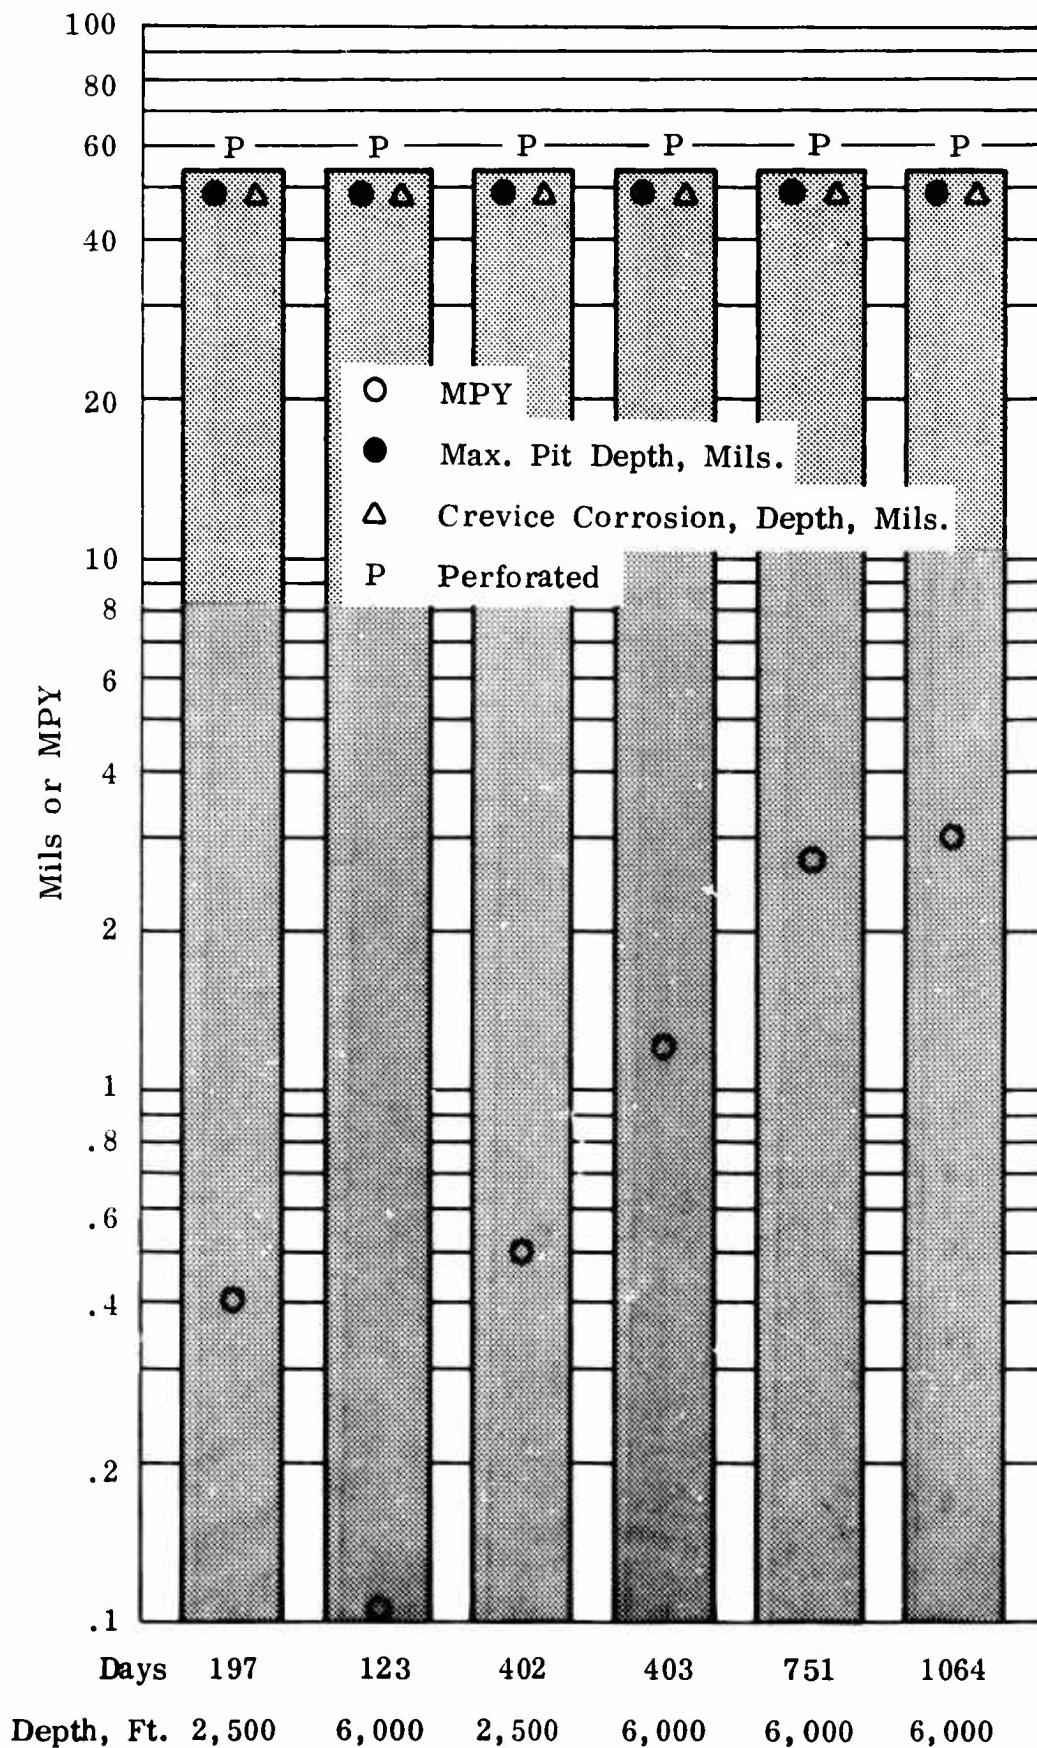
Figure 36. Corrosion rates, maximum pit depths and crevice corrosion of 15-7AMV, annealed precipitation hardening stainless steel in seawater at depth.

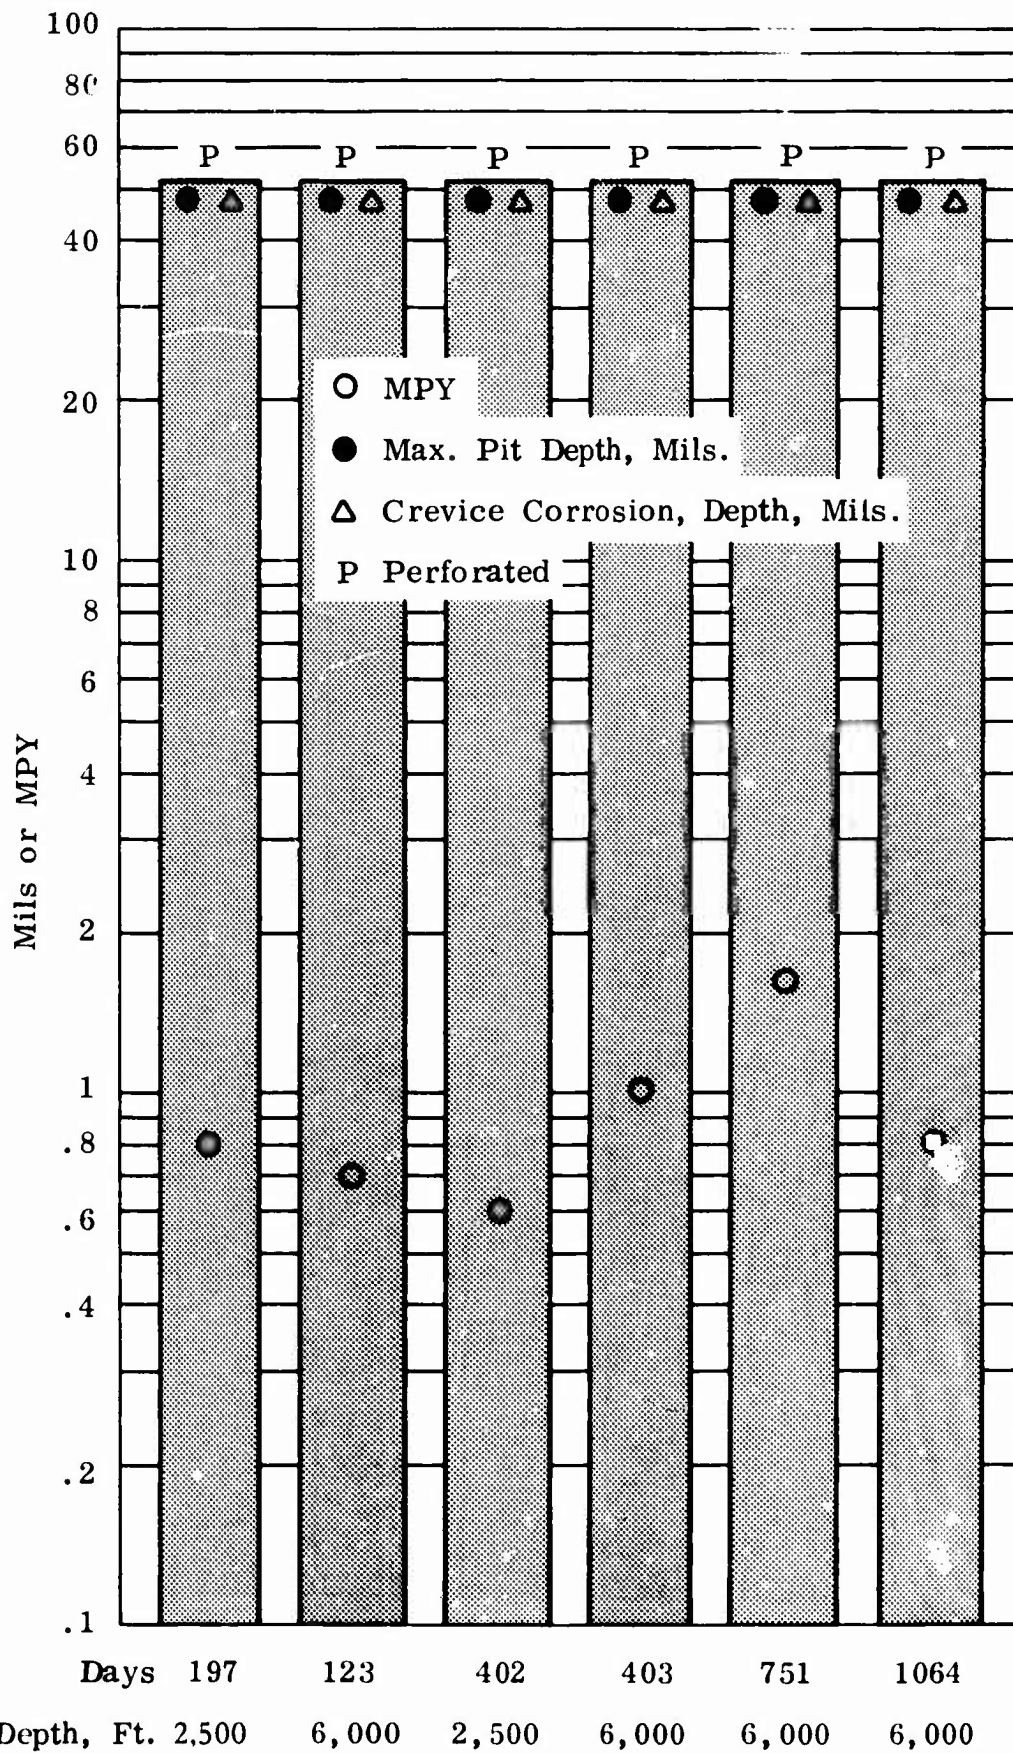
Figure 37. Corrosion rates, maximum pit depths and crevice corrosion of 15-7AMV-RH950 precipitation hardening stainless steel in seawater at depth.

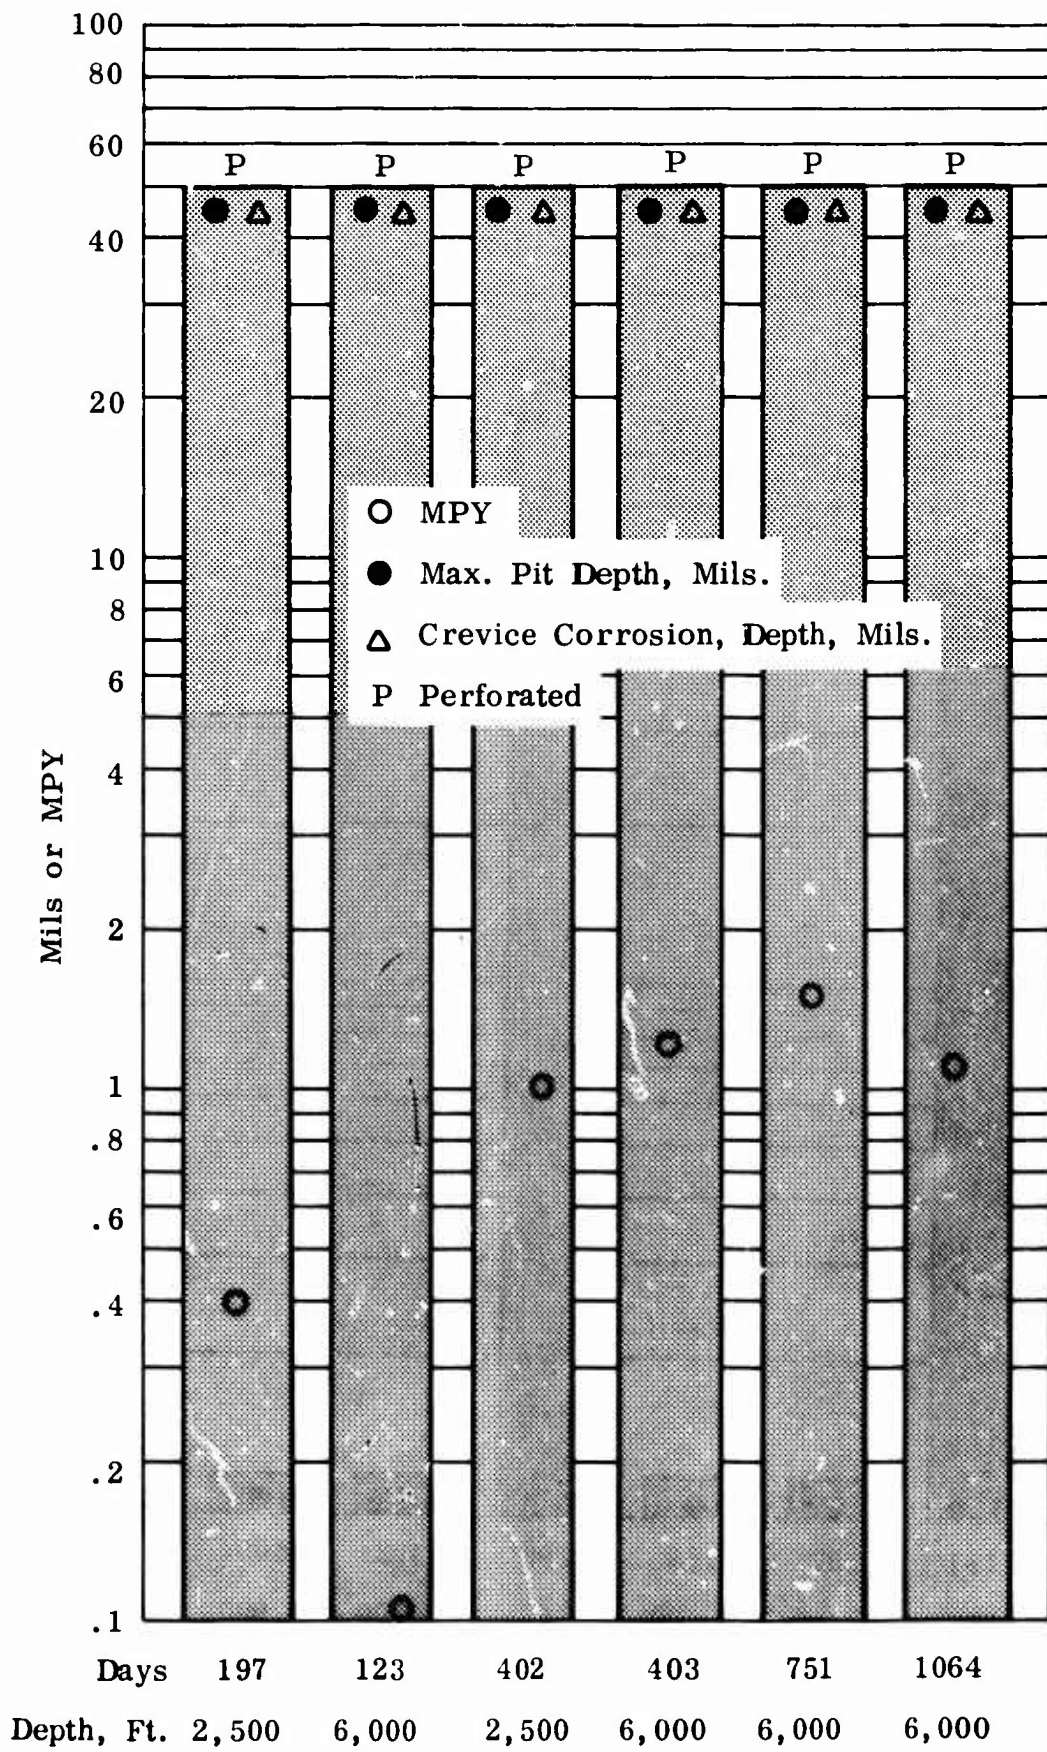
Figure 38. Corrosion rates, maximum pit depths and crevice corrosion of 15-7AMV-RH1150 precipitation hardening stainless steel in seawater at depth.

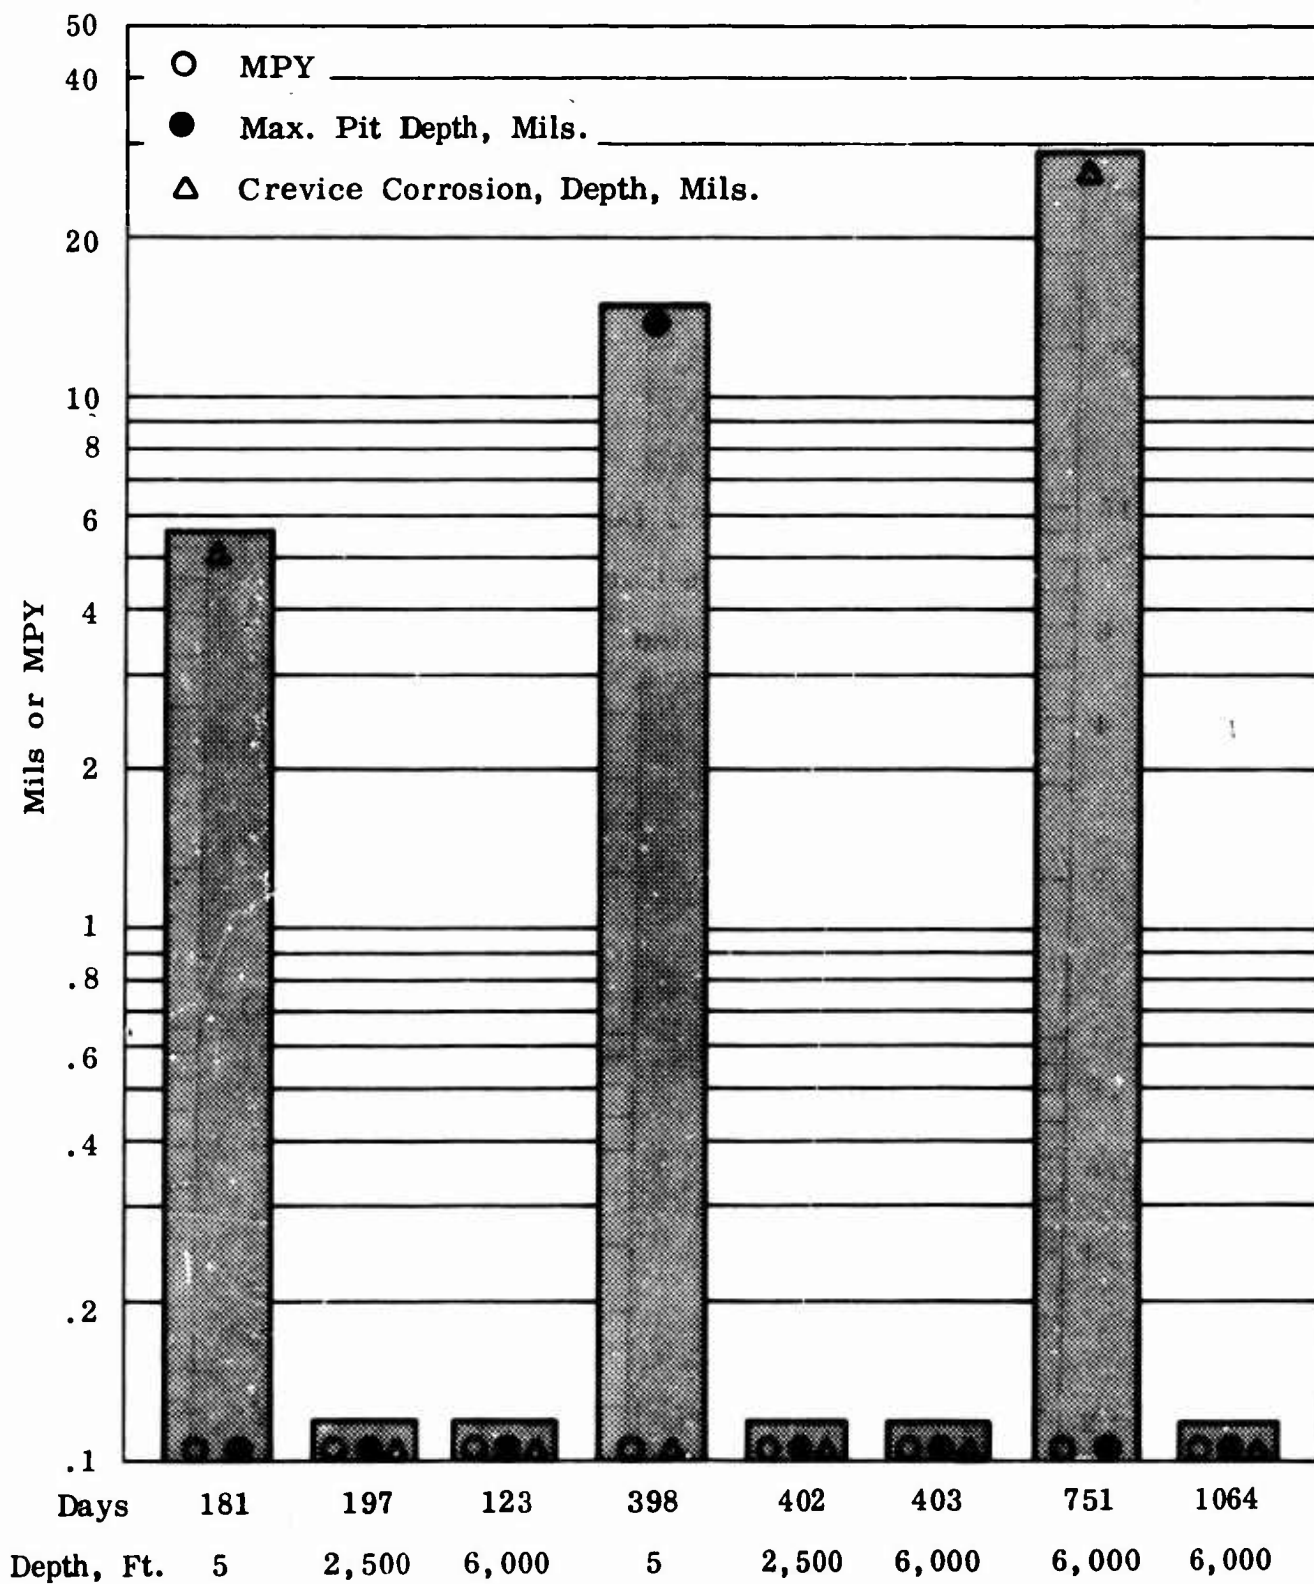
Figure 39. Corrosion rates, maximum pit depths and crevice corrosion of 20Cb stainless steel in seawater at the surface and at depth.

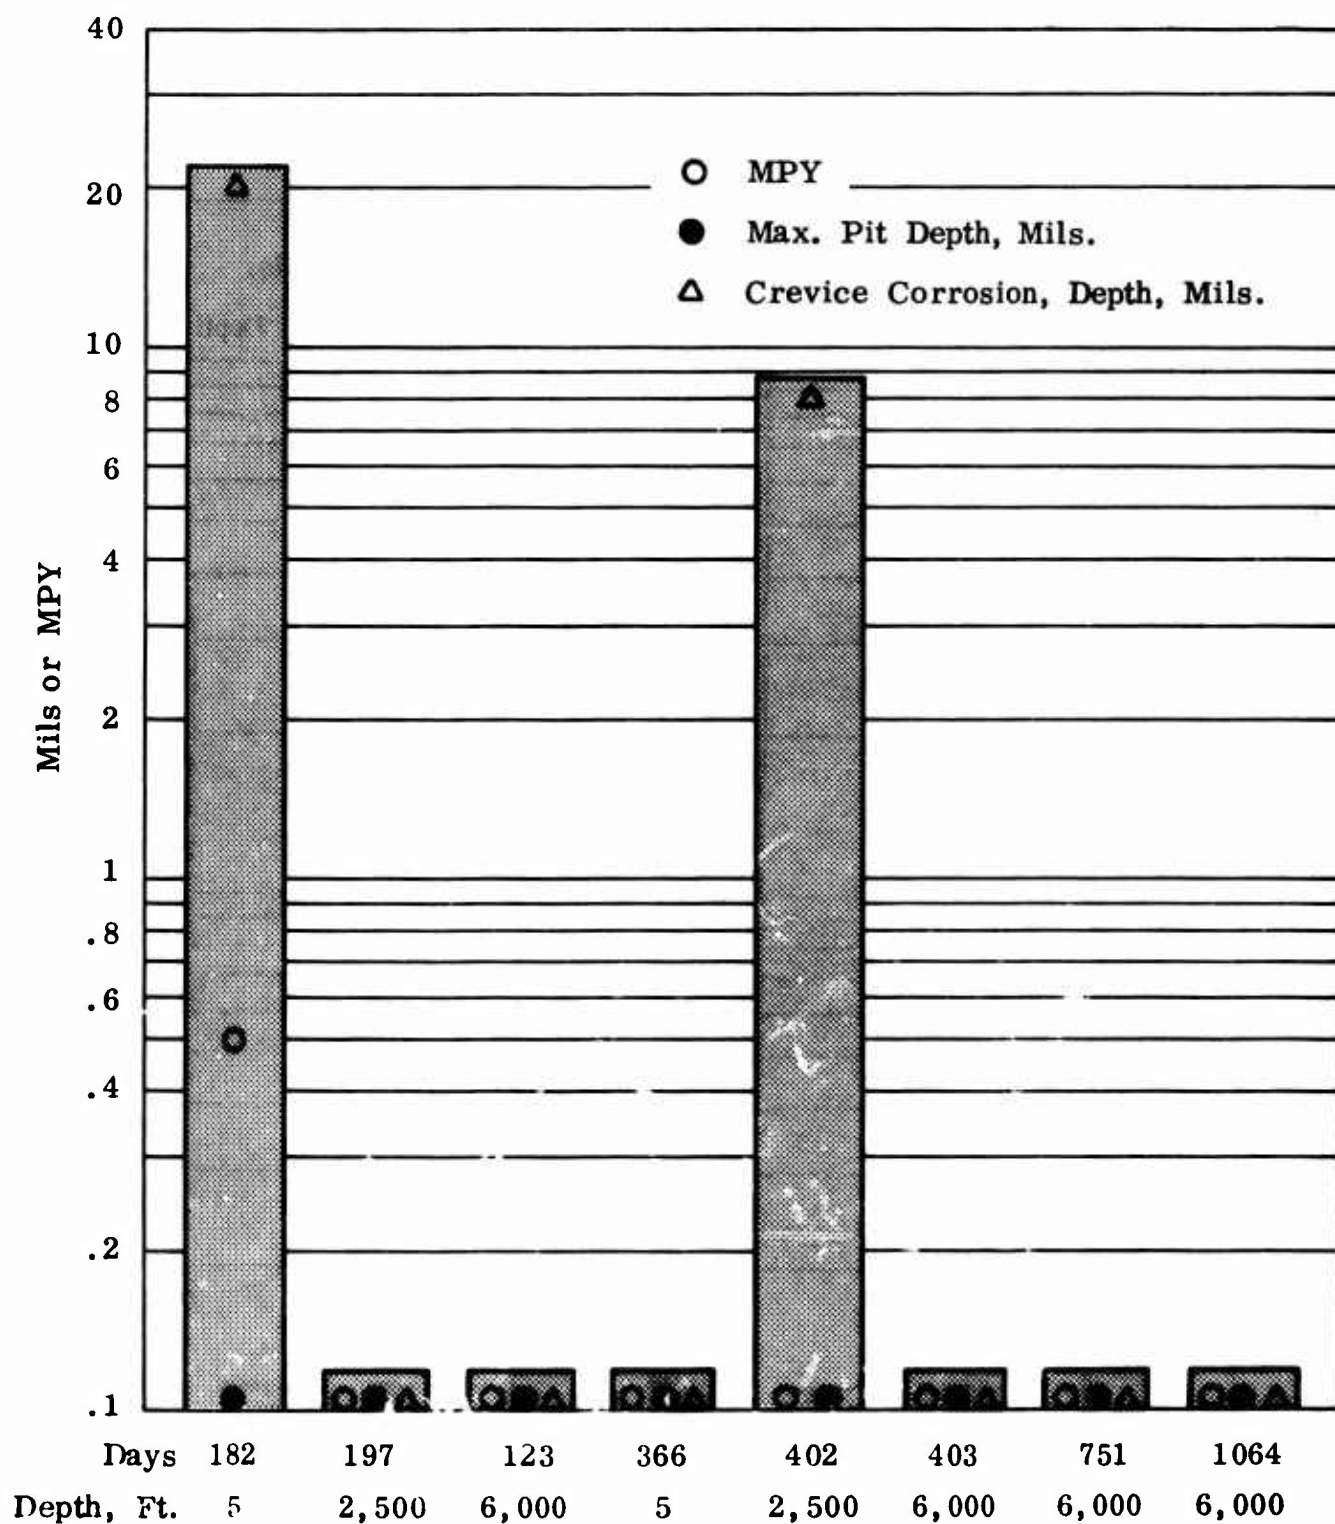
Figure 40. Corrosion rates, maximum pit depths and crevice corrosion of Ni-Cr-Cu-Mo#1 stainless steel in seawater at the surface and at depth.

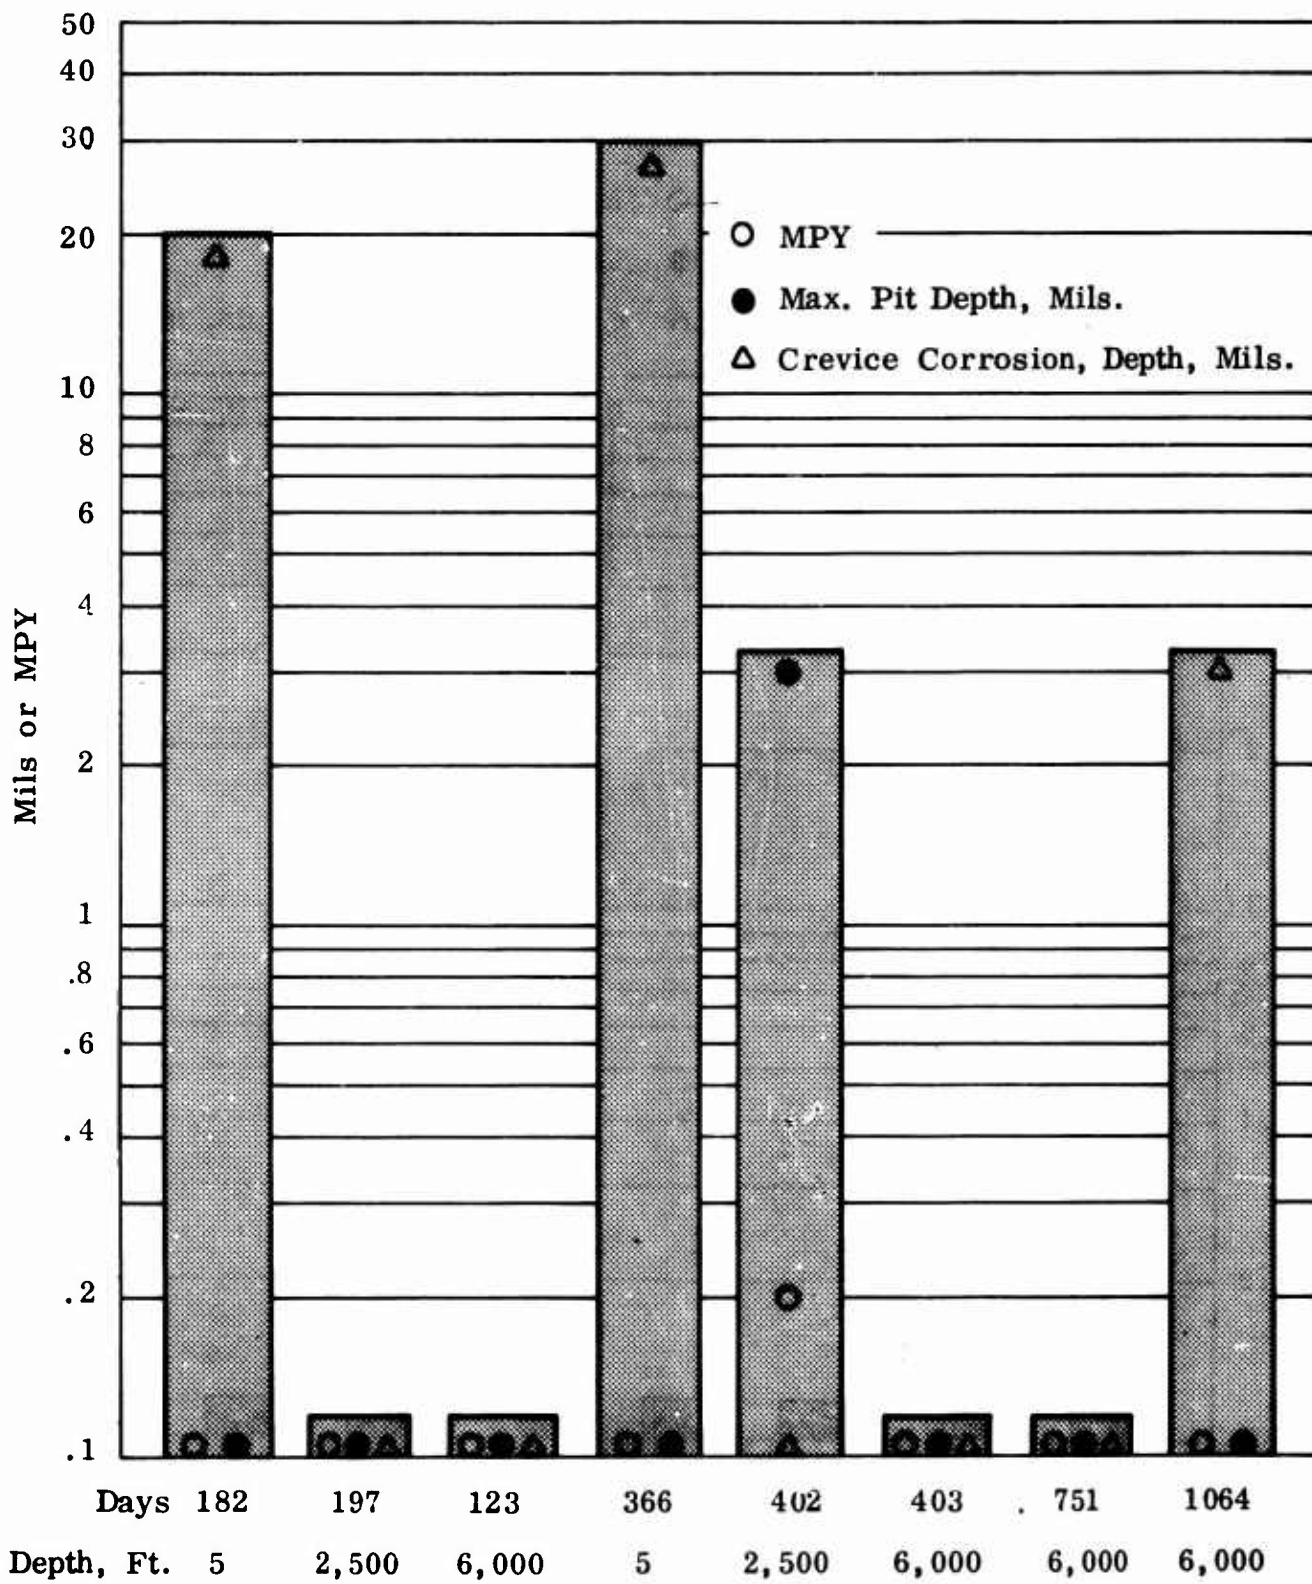
Figure 41. Corrosion rates, maximum pit depths and crevice corrosion of Ni-Cr-Cu-Mo#2 stainless steel in seawater at the surface and at depth.

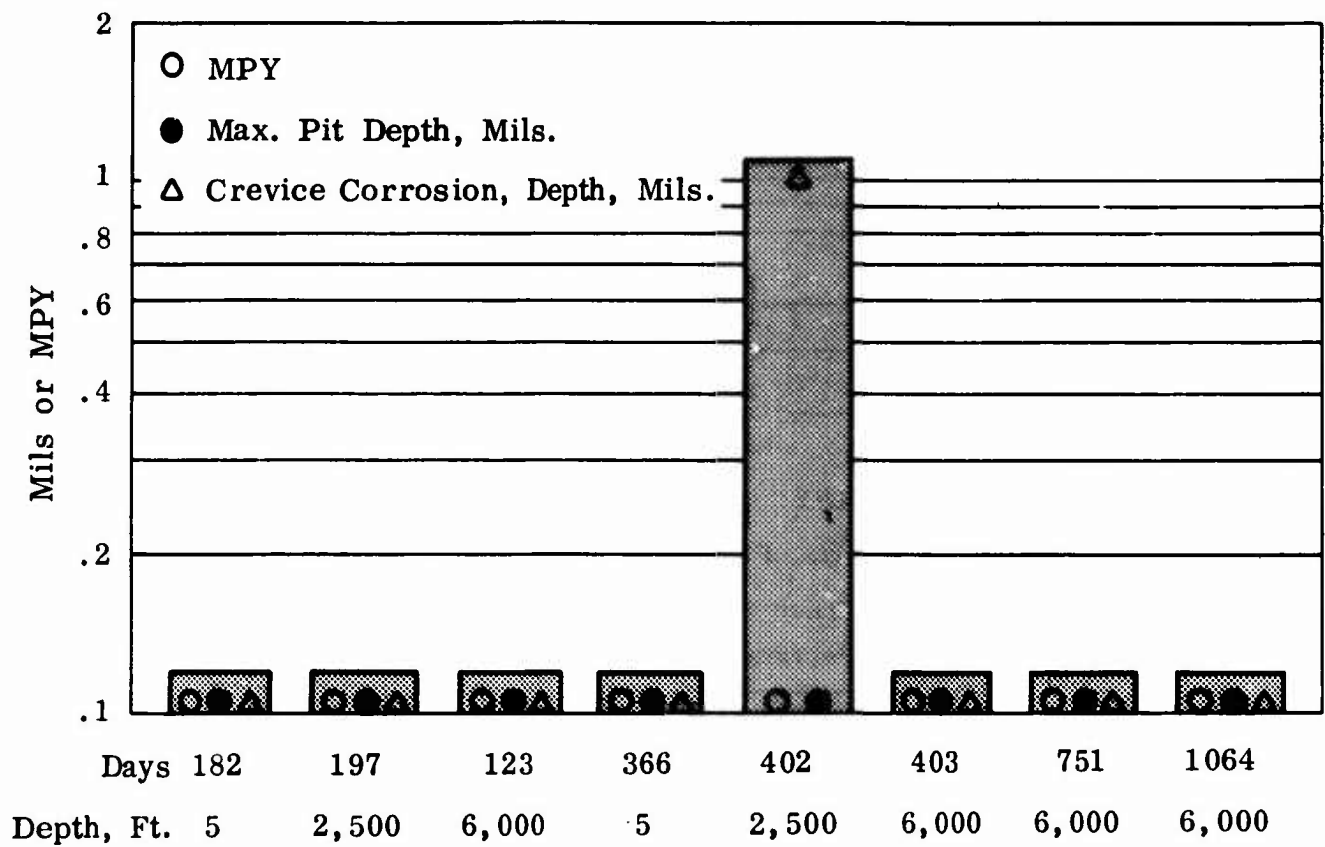
Figure 42. Corrosion rates, maximum pit depths and crevice corrosion of Ni-Cr-Mo stainless steel in seawater at the surface and at depth.

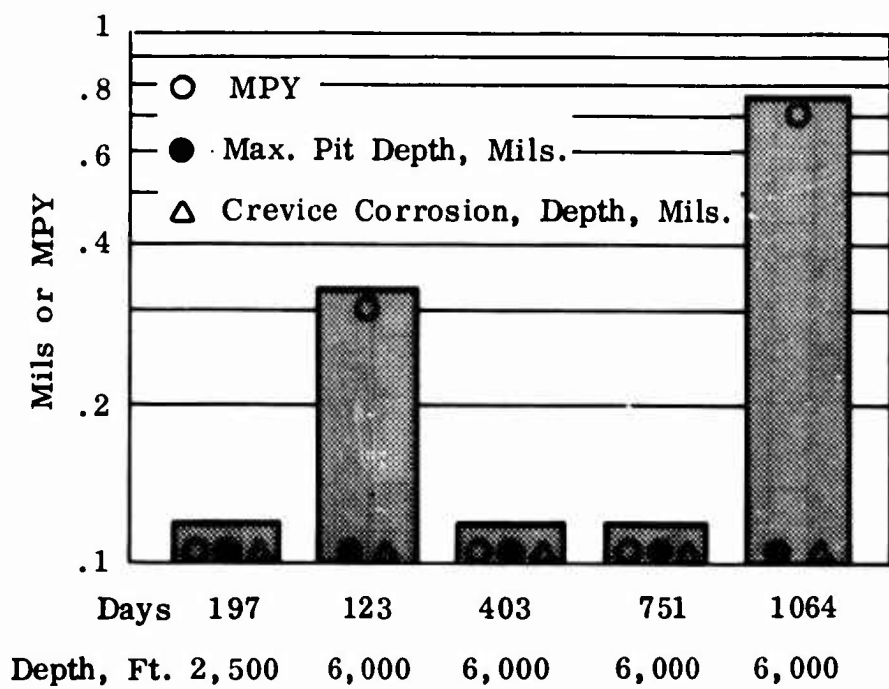
Figure 43. Corrosion rates, maximum pit depths and crevice corrosion of RL-35-100 stainless steel in seawater at depth.

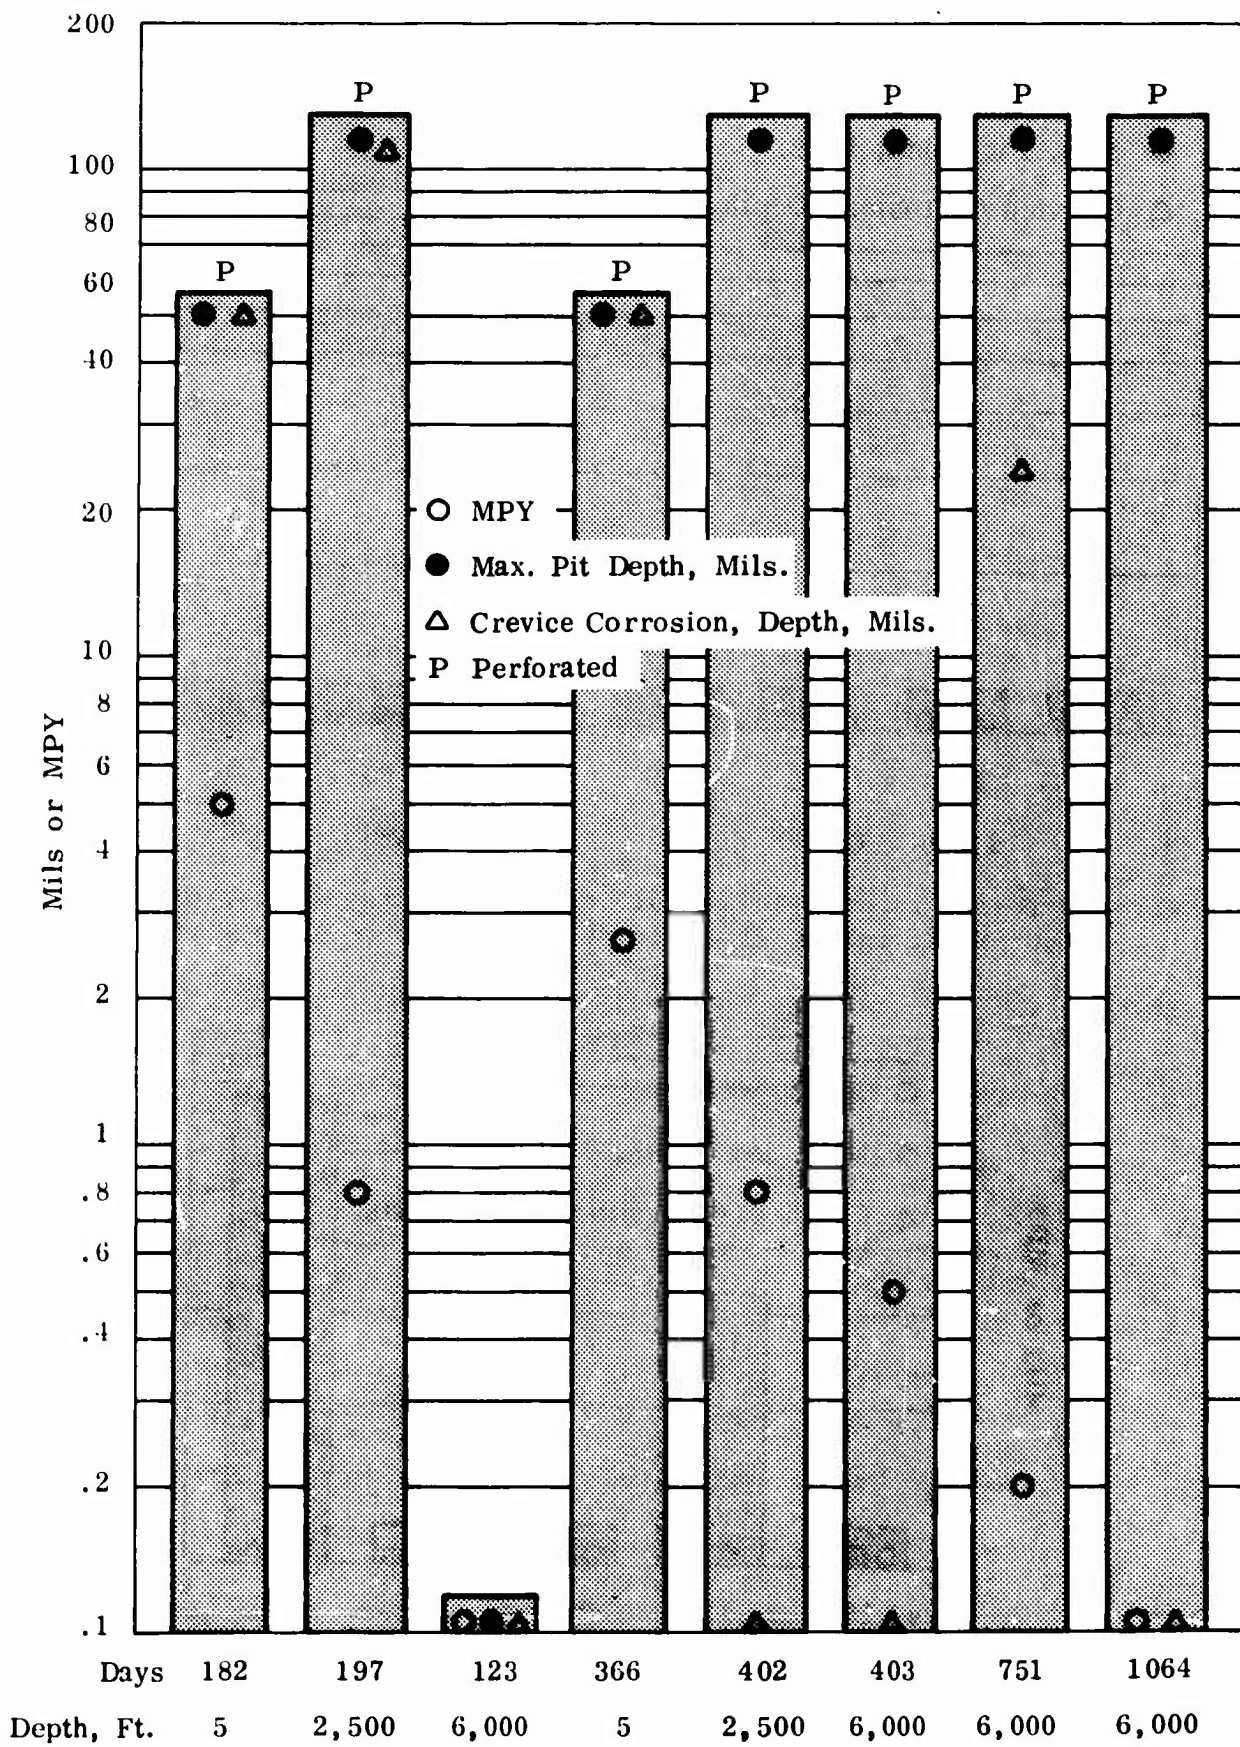
Figure 44. Corrosion rates, maximum pit depths and crevice corrosion of 18Cr-14Mn-0.5N stainless steel in seawater at the surface and at depth.
