## USAAVLABS TECHNICAL REPORT 71-7

# DETERMINATION OF PHYSICAL AND STRUCTURAL PROPERTIES OF MIXED-MODULUS COMPOSITE MATERIALS

**VERTOL DIVISION**

**THE BOEING COMPANY,  
PHILADELPHIA, PENNSYLVANIA**

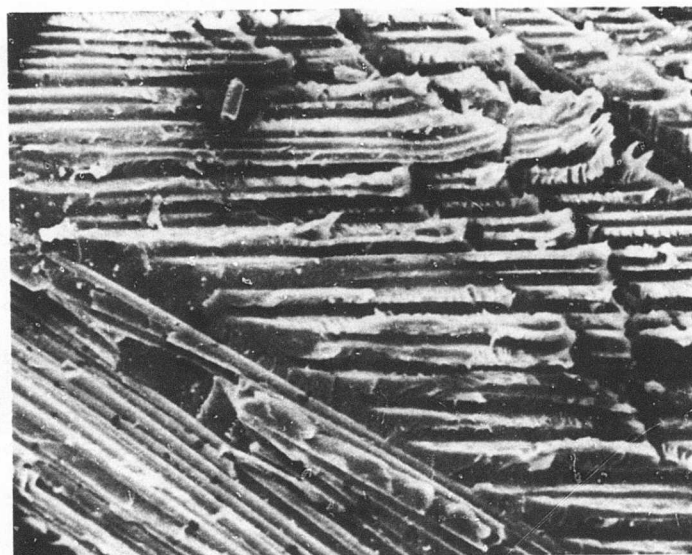
(a) 190X GRAPHITE (—) S-GLASS ( \ )

(b) 200X GRAPHITE (—) S-GLASS ( \ )

Figure 50. Scanning Electron Micrographs of a Failure Surface from a Static Mixed-Modulus Deflection Specimen.

At low optical magnifications, the interface fractures appeared to have isolated patches of the opposing composite's resin and fibers left clinging to the surface. The SEM investigation not only verified this observation (Figures 50a, 50b, and 51b) but also revealed a large number of denuded S-glass and graphite fibers (Figures 50 and 51). A fracture parallel to the interface would naturally result in a large number of exposed fibers. The extent to which the fibers are denuded here indicates that the fiber-resin interface bond was the weak link in both the graphite and glass systems.
