MISCELLANEOUS PAPER NO. 4-829

# FIELD TESTS OF AM3 LANDING MAT

# **FIELD TESTS OF AM3 LANDING MAT**

## SUMMARY

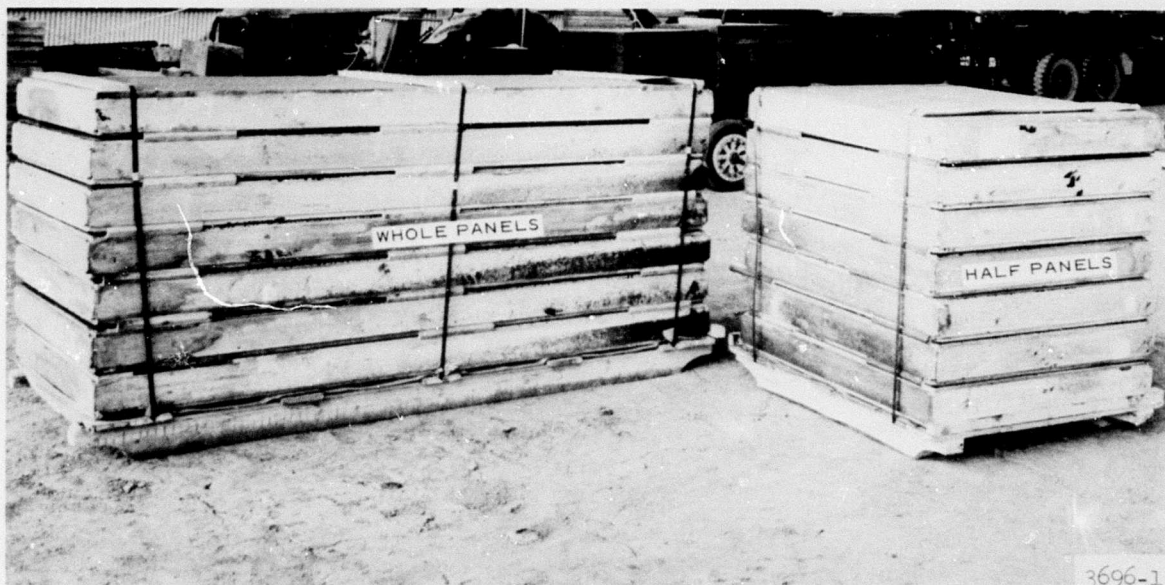
Photograph 1. Bundles of whole and half panels of AM3 mat

4. The mat was shipped in bundles of seven panels each. Full-size panels and half panels were bundled separately (photograph 1). Panels were supported on wooden pallets and were individually separated by wooden wedges placed in the connectors to prevent adhesion between the antiskid surfacing and the bituminous coating on the bottom of panels. Overall bundle dimensions including dunnage were: length, 100.5 in.; width, 40.75 in.; and height, 47.0 in. The bundles were banded with 5/8-in.-wide steel straps. The average weight of a bundle of full-size panels was 1395 lb.

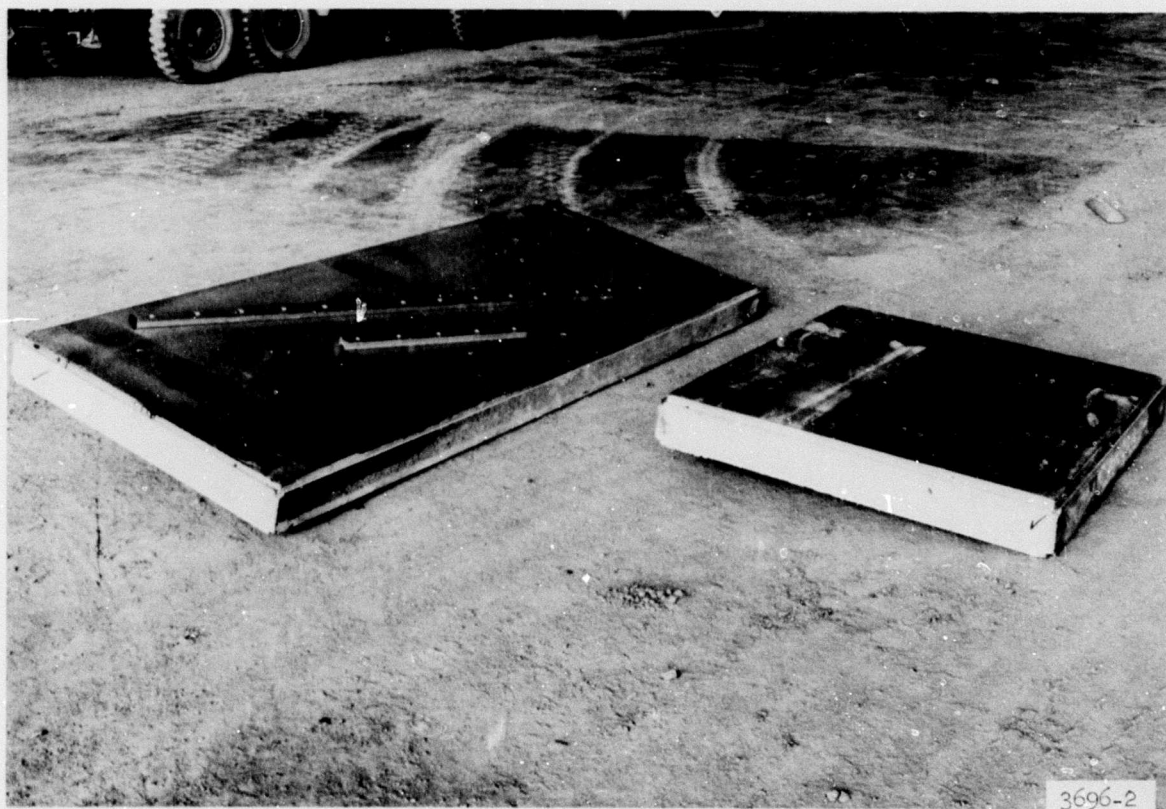
Photograph 2. Whole and half panel of AM3 mat

5. Photograph 2 shows a whole and a half panel of AM3 mat. For this investigation, 237 whole panels and 21 half panels of AM3 mat were furnished. The AM3 mat was made by the Aluminum Corporation of America (ALCOA), New Kensington, Pa., under contract with the Department of the Navy. Overall dimensions of the panels were: length, 97-5/16 in.; width, 39-3/16 in.; and thickness, 5.520 in. The width of the top side of the panels averaged 0.09 in. more than the width of the bottom side. This caused a crown to develop in the pad during the pond tests, as described subsequently in paragraph 10. The average weight of one panel was 183.14 lb without connectors, and 212.64 lb with connectors. The weight of the panel with connectors per square foot of placing area was 7.87 lb. The placing area of one panel with connectors was 27.02 sq ft.

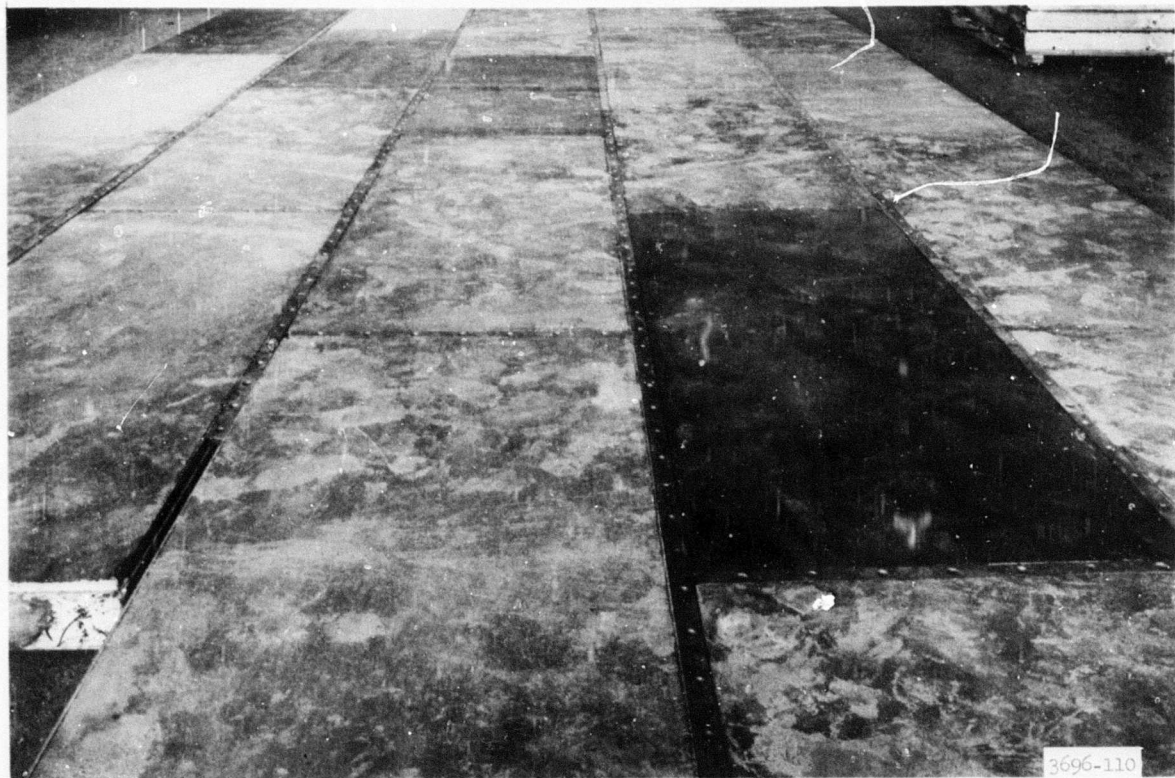
Photograph 4. Odd-size panels (darker colored) intermixed with other panels in pad complex

7. The installation instructions accompanying the AM3 mat noted that the panels were not all of uniform dimension and some panels were not interchangeable due to the prototype nature of initial fabrication. Sixty-four panels in the shipment, marked with yellow coding, were  $1/16$  in. deficient in width. However, these panels were used successfully in both Phase I and Phase II tests with only minor difficulty in assembly. Sixteen additional panels, marked with white coding, contained discrepancies of  $\pm 3/16$  in. in width and were not used in test Phases I and II. These 16 panels were intermixed with other panels in a trial assembly on a flat, hard surface with only minor difficulty. Although the difference in width was visible, no major problems were encountered in placing the nonuniform panels with other panels. The dark-colored panels in photograph 4 are the dimensionally deficient panels assembled in the layout.

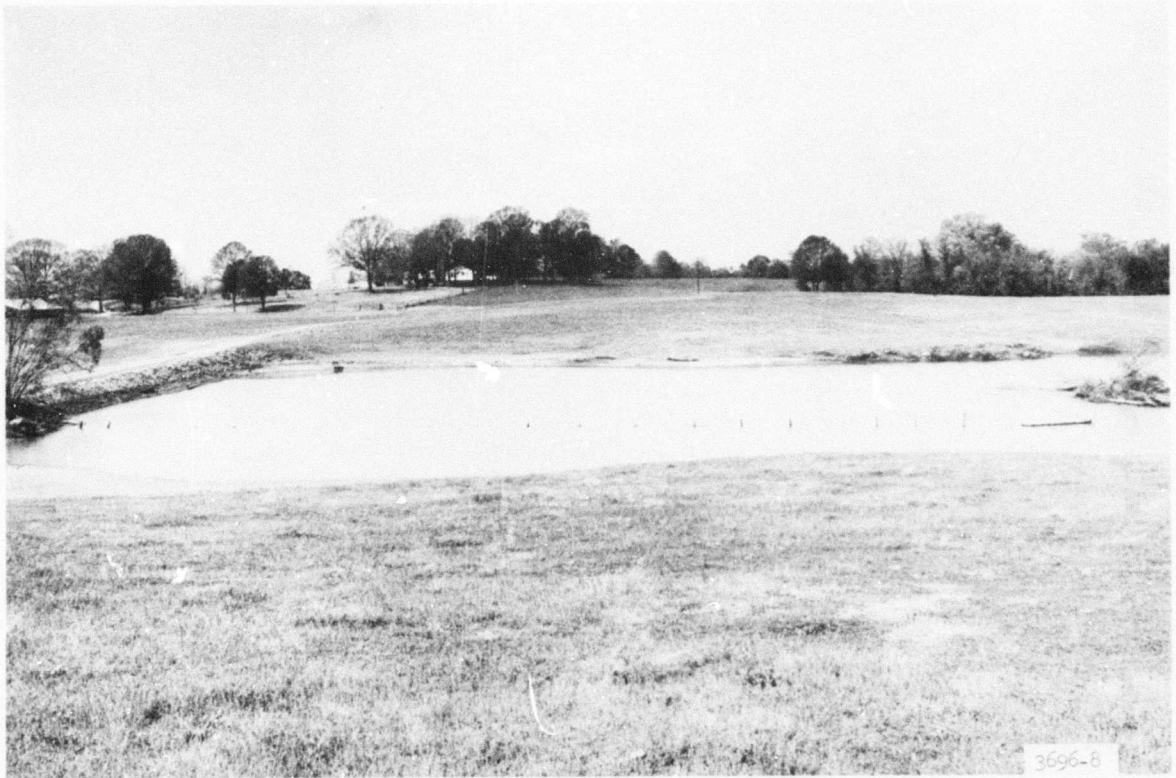
Photograph 5. Site of test Phase I

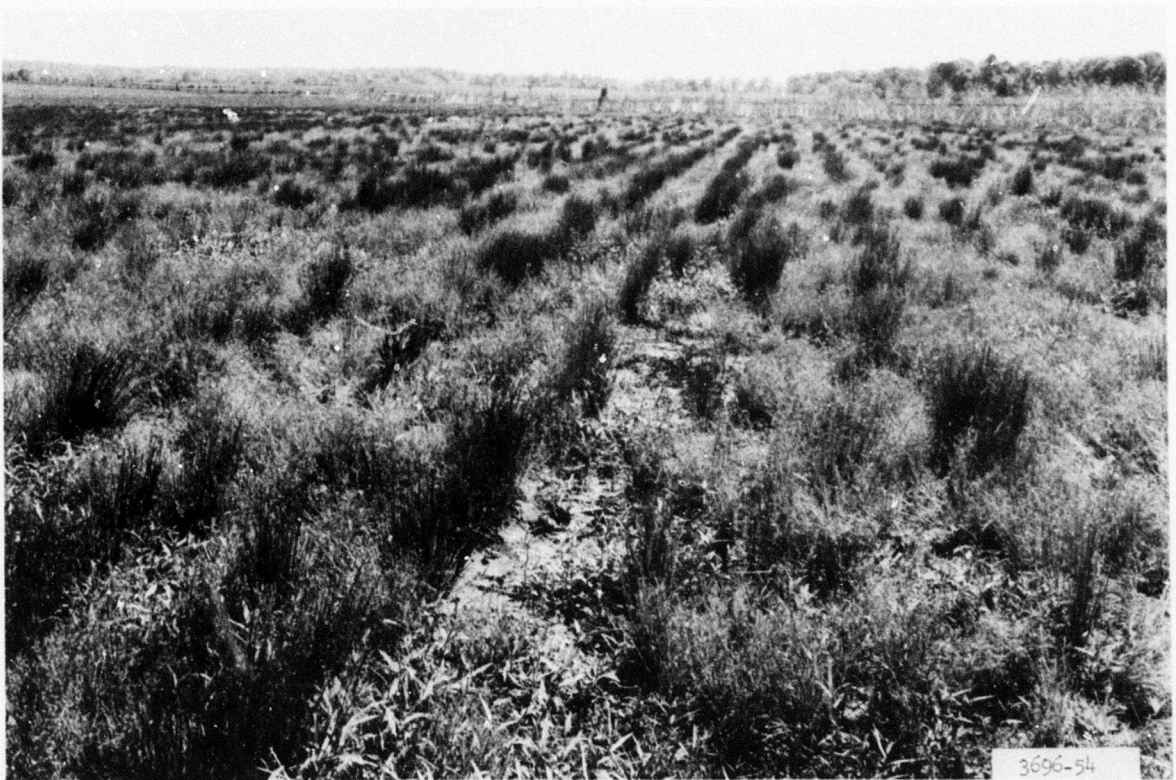
Photograph 6. Site of test Phase II

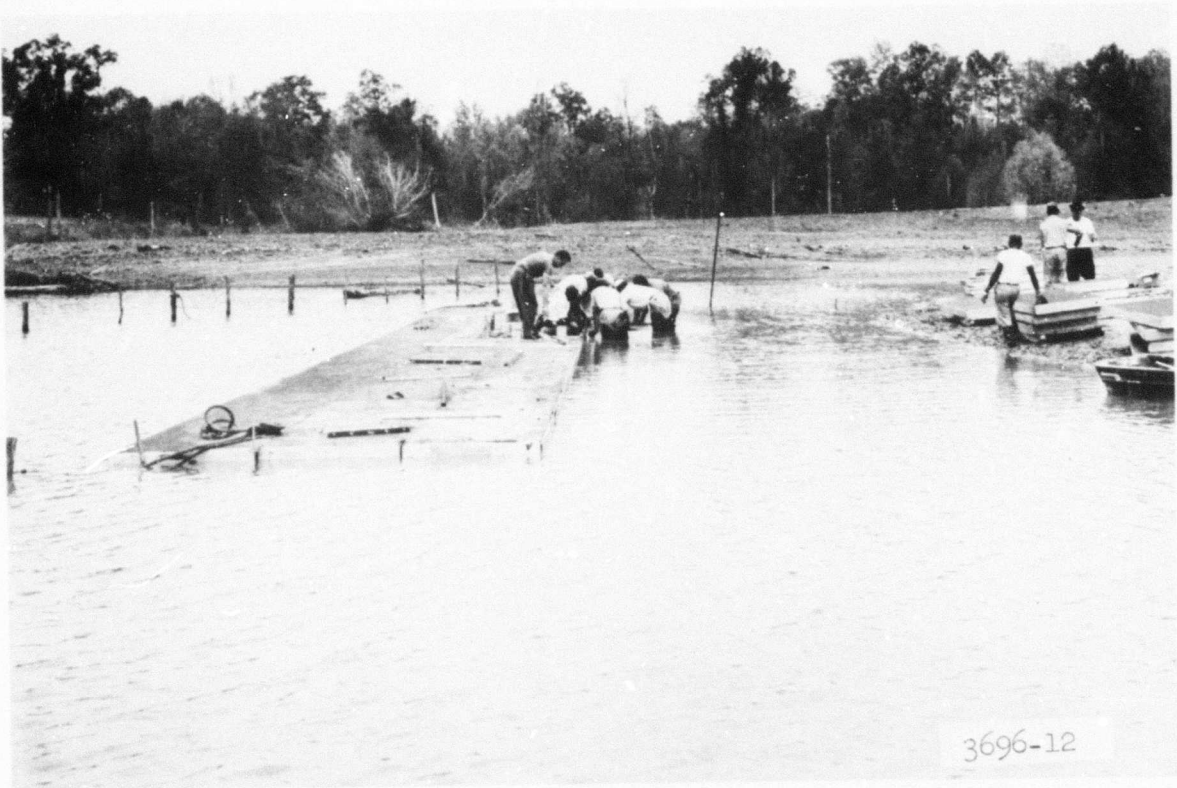
Photograph 7. Assembly of run 4 of pad on pond

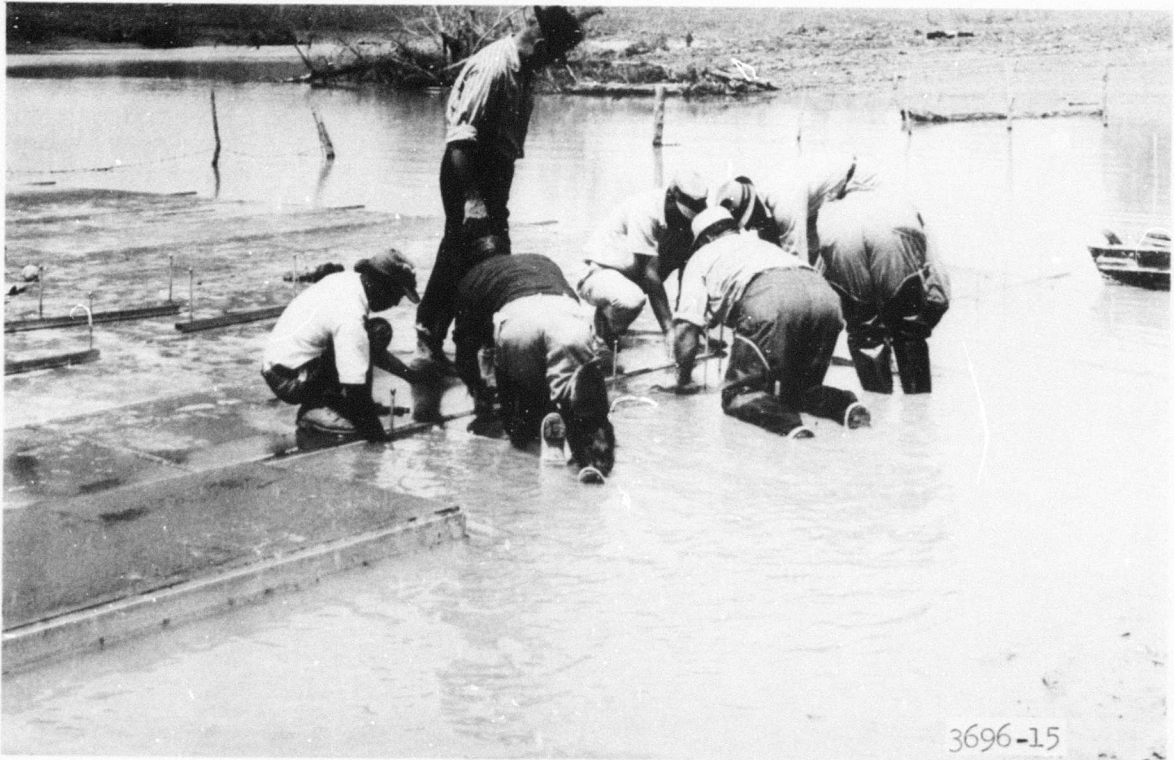
Photograph 9. New panel being forced underwater in order to connect it to pad

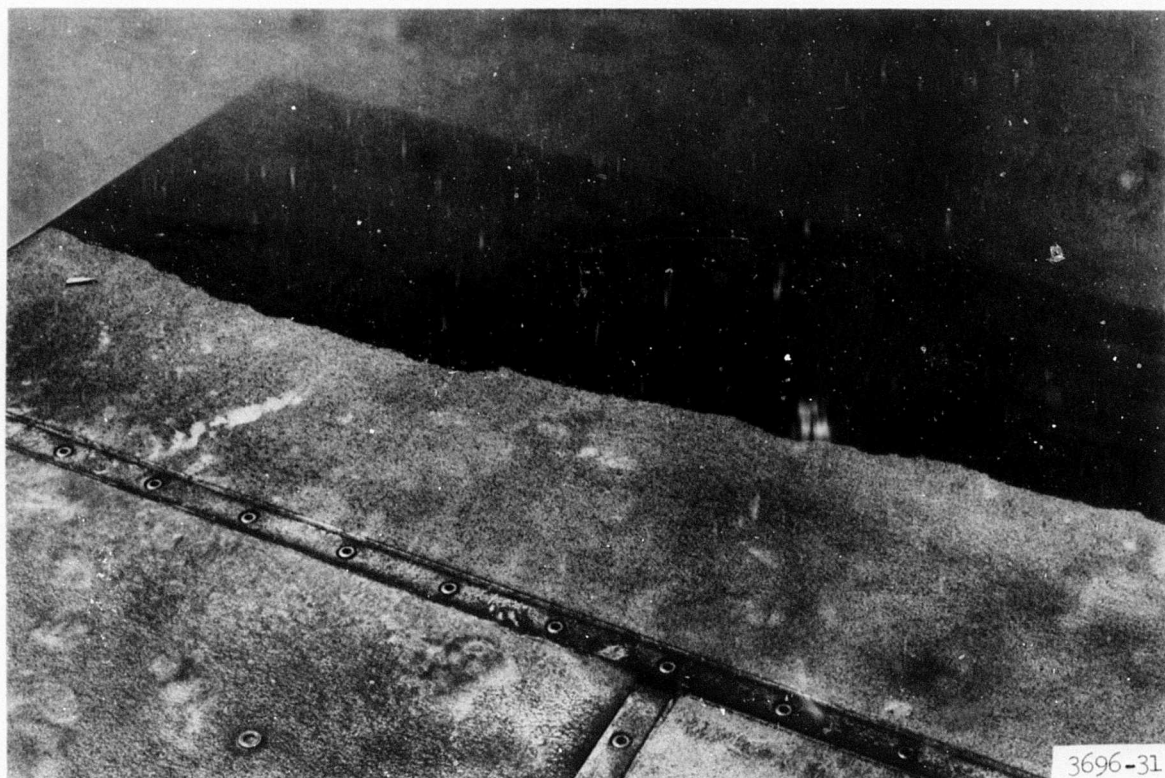
Photograph 12. Closeup of corner of run 1 with edge underwater

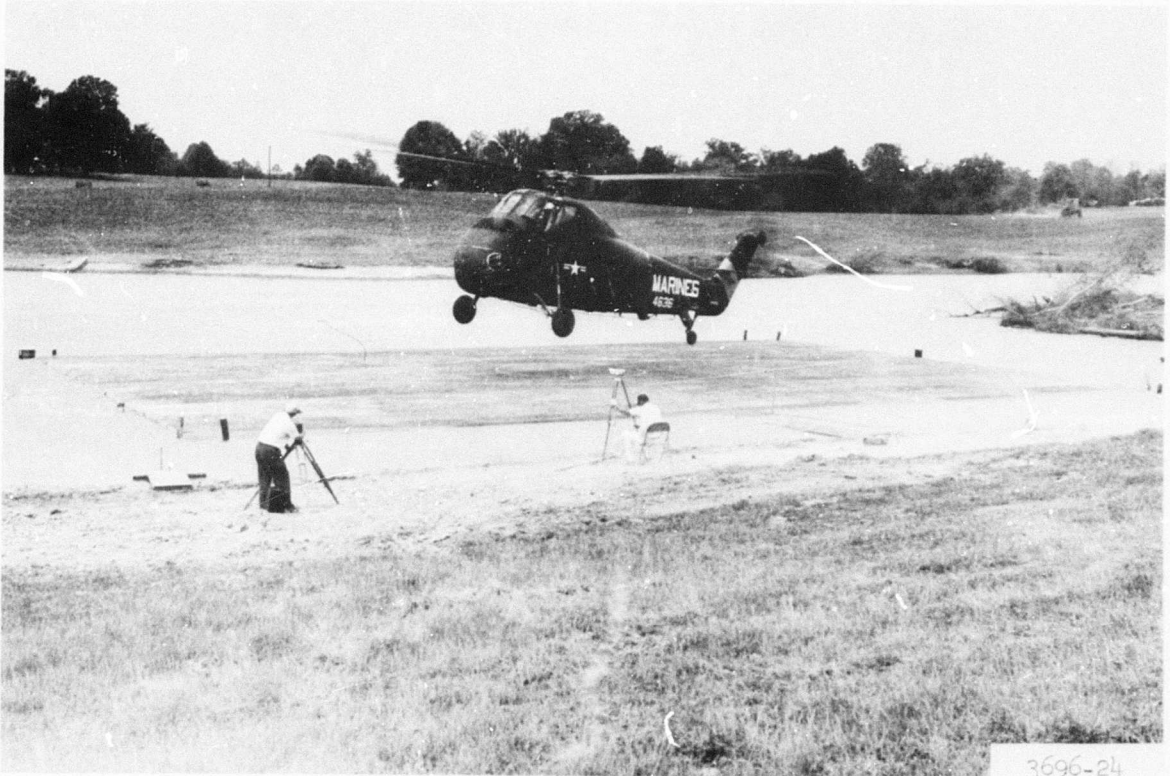
3696-24

Photograph 13. UH-34D helicopter making first landing on pad

13. Photograph 13 shows the UH-34D helicopter making its first approach to the pad. The landing was made very cautiously, with the full weight of the craft being eased down on the pad. Photograph 14 shows the aircraft after its first landing, with approximately 14,000-lb total weight on the pad. Table 2 summarizes the landings, weights, and gravity forces during test Phase I. The initial operations consisted of several landings with gravity forces ranging up to 2.12. The basic weight of the helicopter with maximum fuel load was 10,000 lb. To achieve increased gravity forces, the helicopter dropped from a height of 4 or 5 ft with no power. During these drops, approximately 0.5-in. elevation change was noticed in the two gages recording the pad's elevation on the water. After several drops, the helicopter performed taxiing operations on the entire pad, along the joints, and around the edge with no evidence of any unusual occurrences. Photograph 15 shows the front wheels of the aircraft within 4 ft of the mat edge during taxiing operations. Water can be seen just covering the edge of the mat at this point. No unusual conditions other than minor pumping of water between joints were observed during any of the operations. The pilot indicated that normal landings on the pad were softer than ordinary landings on firm ground.

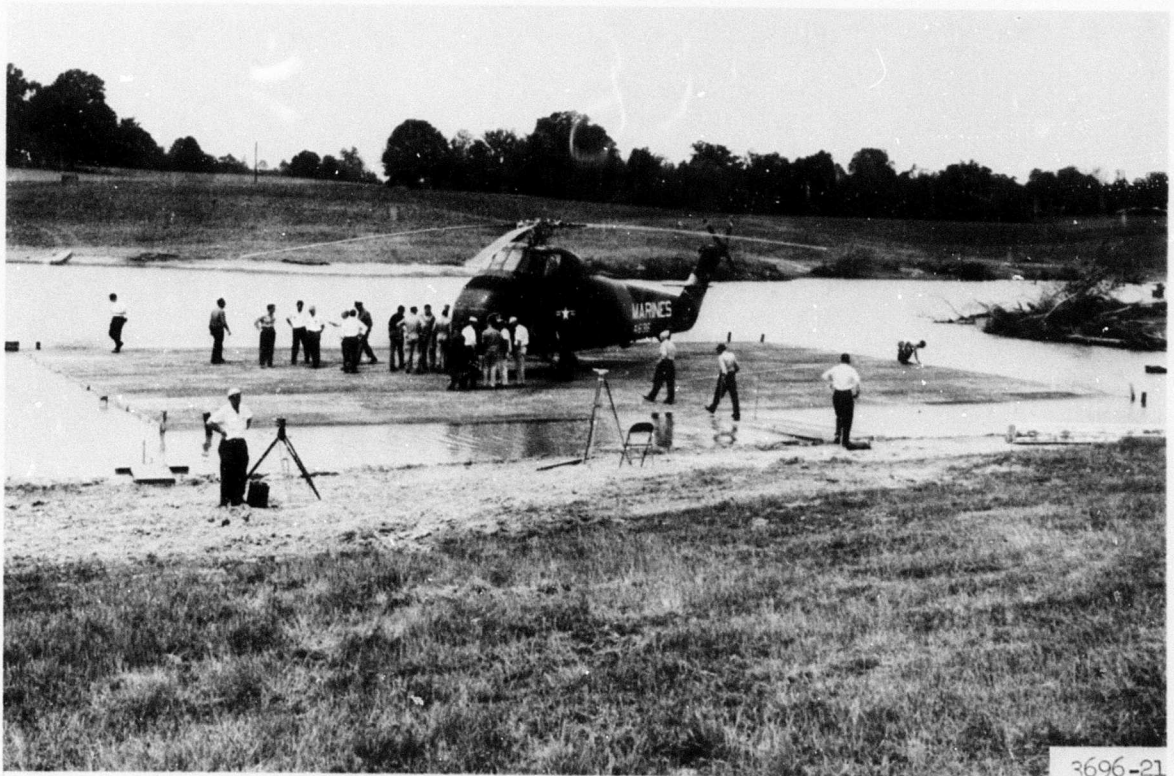
Photograph 14. Pad after first helicopter landing

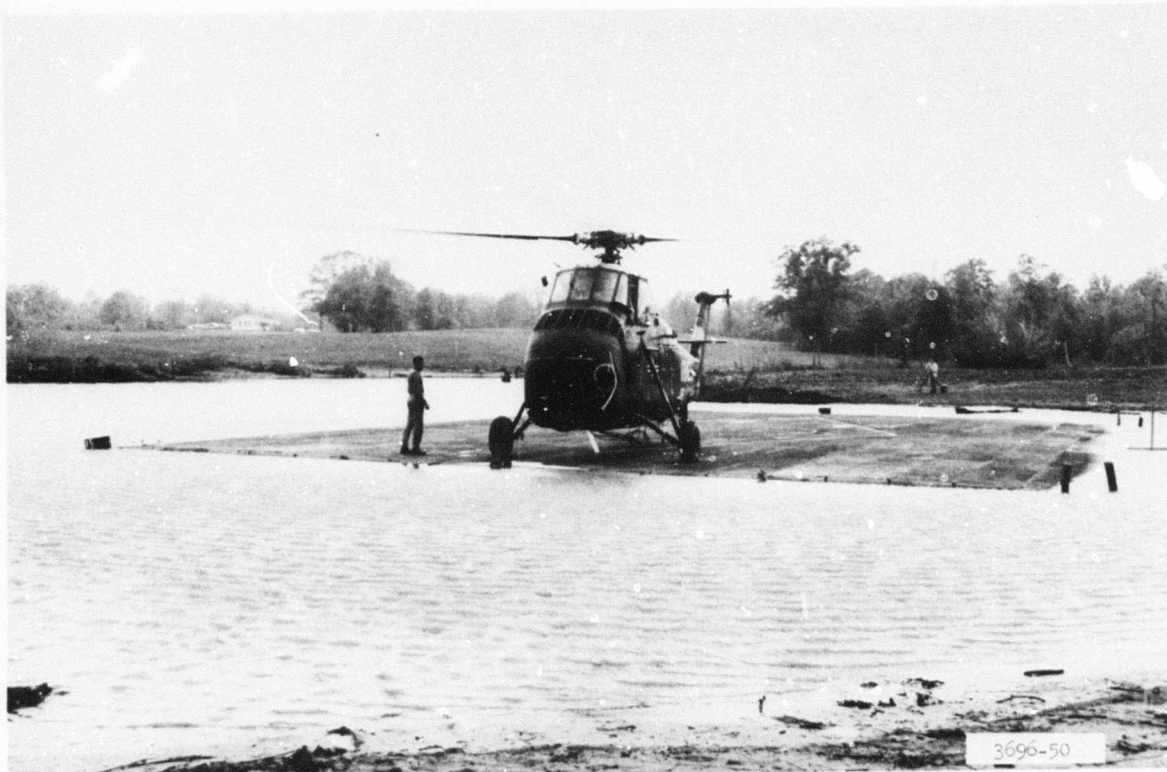
Photograph 15. Taxiing operations with main wheels  
within 4 ft of edge of pad

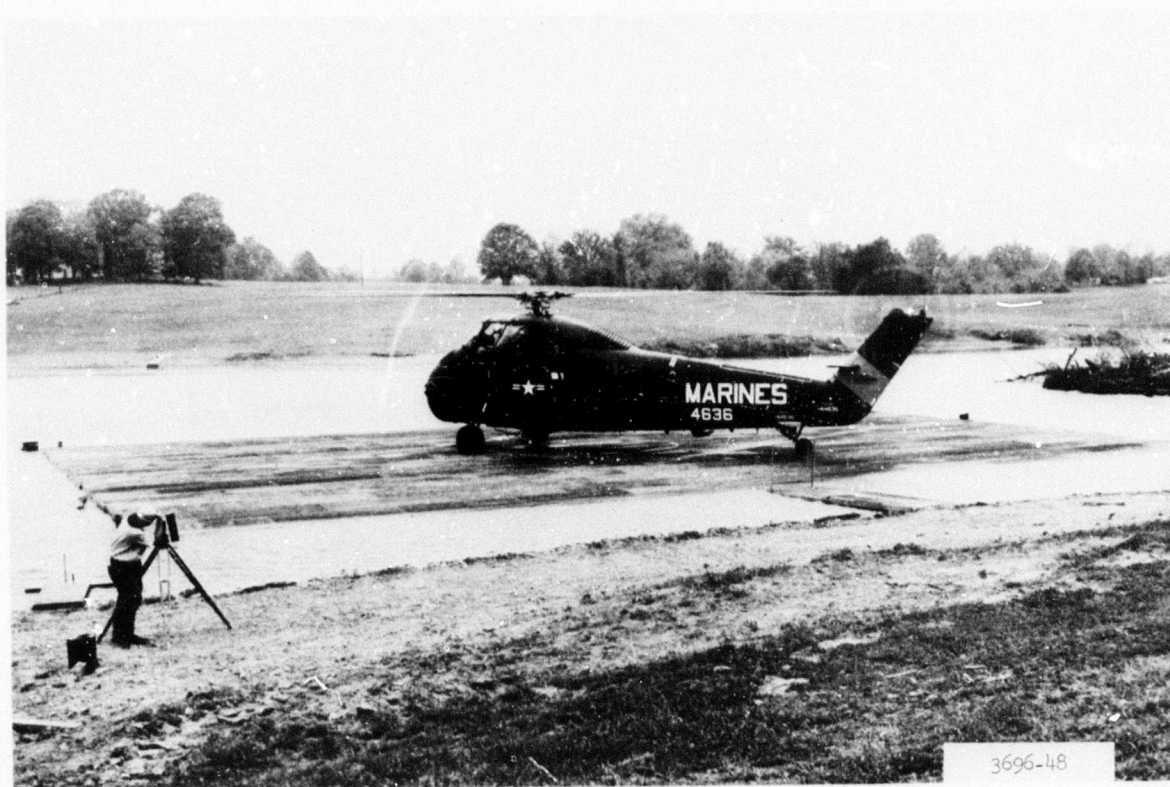
Photograph 16. Operations on pad with maximum  
helicopter load of 13,000 lb

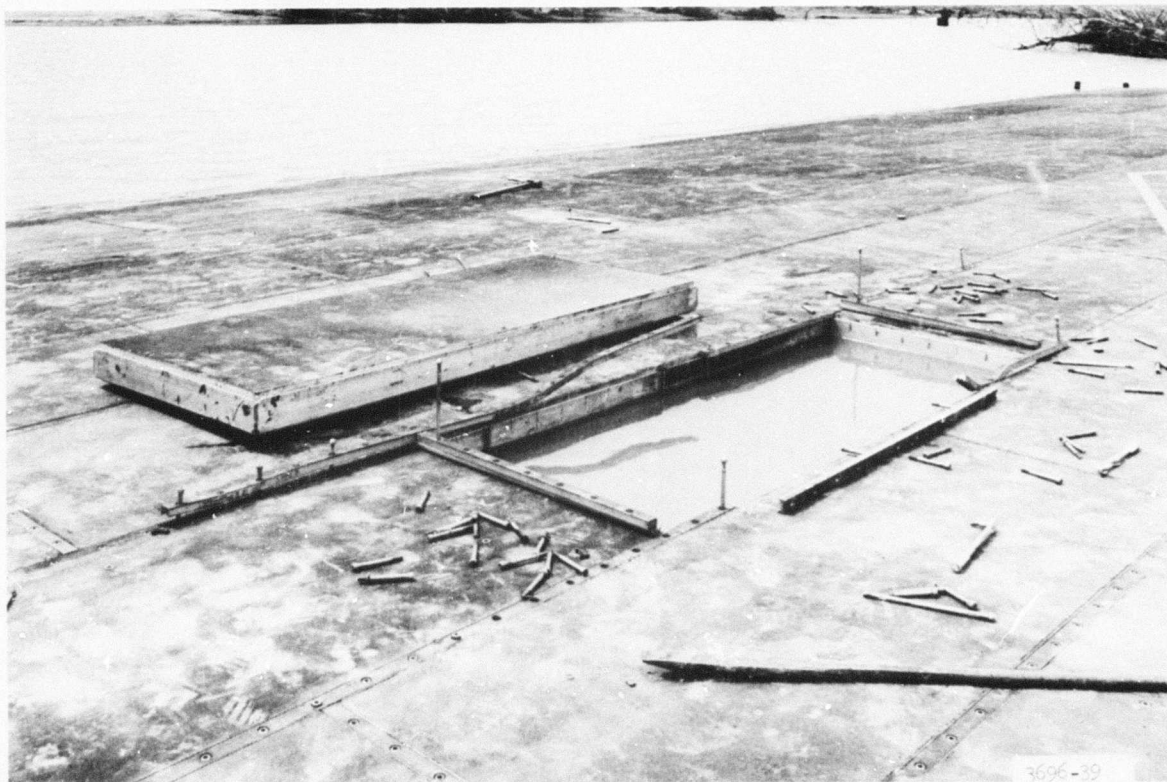
Photograph 17. Panel removed from pad, showing side-connector bars bent and broken during removal

15. One panel located in the middle of the pad was removed to determine the time and effort required to remove and replace a panel. All bolts around the panel were loosened, and the side-connector bars were forced out. One bar was bent out of shape and another was broken during this operation (photograph 17). The time required for eight men to remove the panel was 35 min. Replacing the panel was somewhat more difficult, as the panel had to be pushed down into the water to the level of the pad surface and held in position while the connectors and bolts were replaced. The time required for eight men to replace the panel was 50 min. The total effort required to remove and replace the panel was 11-1/3 man-hours. This first operation was accomplished with an untrained crew, and it is evident that a trained crew could accomplish the operation in less time.

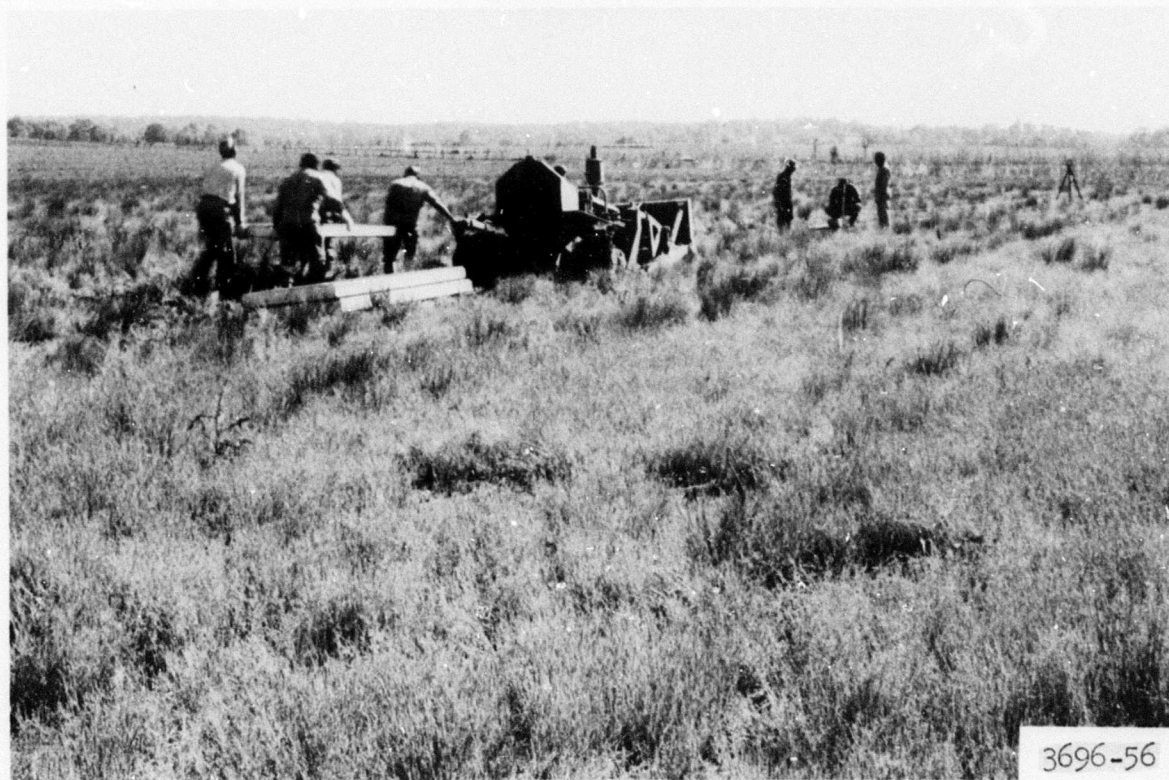
Photograph 18. D4 bulldozer bogged down in marsh near test site

17. The initial work at the marsh site was laying out the test area and attempting to move the bundles of AM3 on skids to the test area. A D4 bulldozer towing the first bundle from the stockpiled area to the center of the marsh was immobilized in the mud. Photograph 18 shows the immobilized bulldozer and the panels being hand-carried to the area.

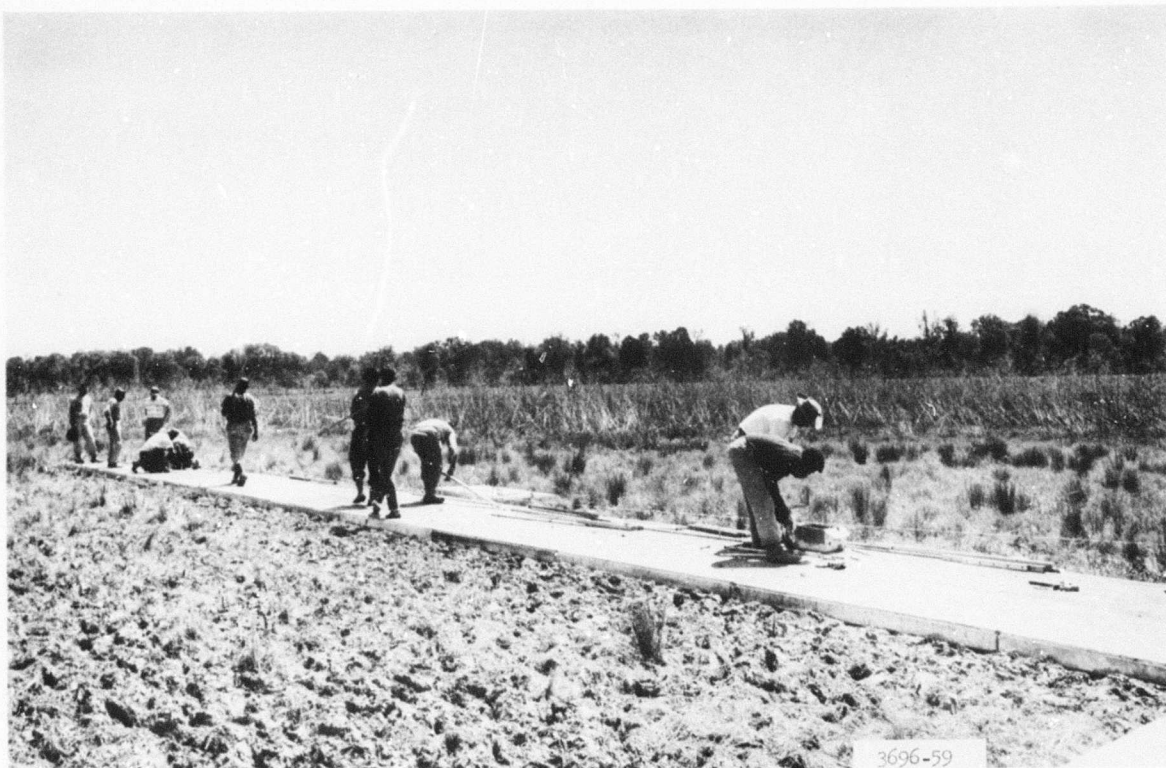
Photograph 19. Test area after placement of two runs of mat.  
Condition of marsh after foot traffic shown in foreground

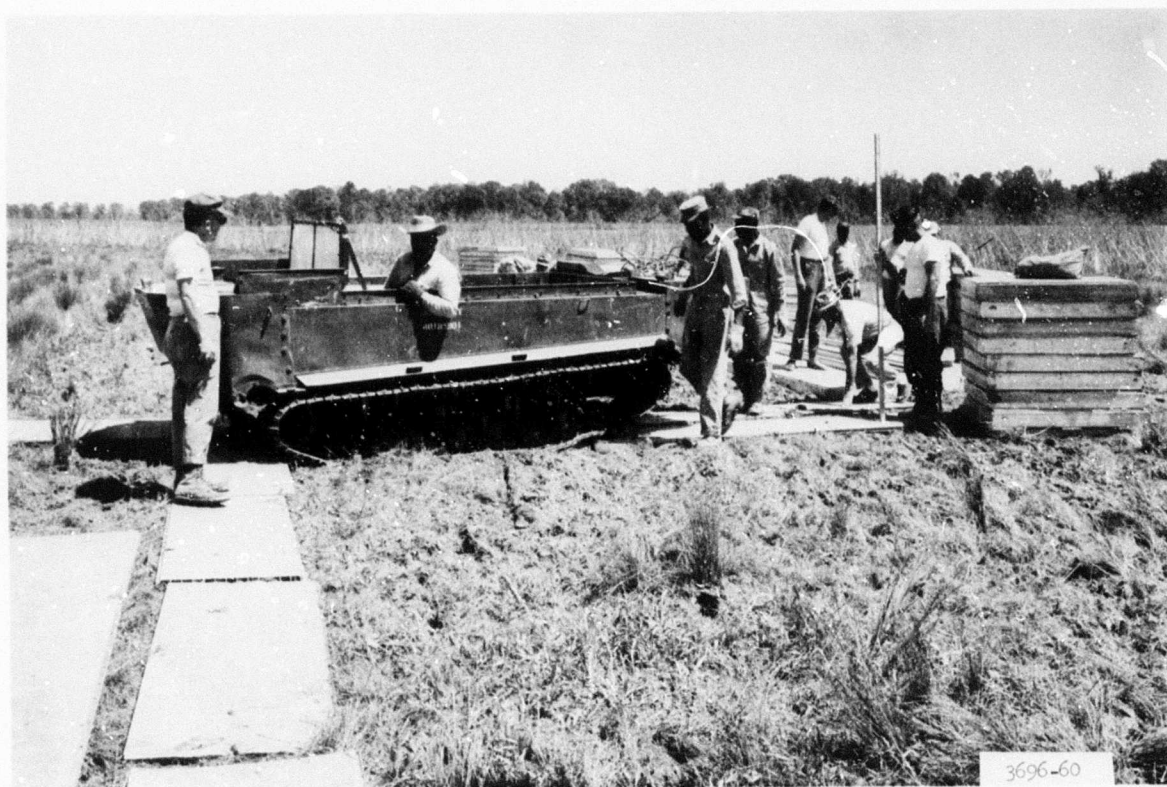
Photograph 20. Tracked vehicle (Weasel) used to tow mat bundles to assembly  
area. Mat from previous investigations (foreground) used for walkway

Because of the increased weight of panels caused by water absorption and the ankle-deep muck, four men were required to carry a panel. No attempt was made to clear or level the area prior to placement of the mat; however, continuous walking in the area during assembly operations pushed the vegetation into the mud and rendered the area relatively level (photograph 19). It was finally decided to use a tracked-amphibian vehicle (Weasel) to tow the mat bundles and position them around the pad site. This vehicle was much lighter than the bulldozer and had wider tracks which enabled it to negotiate the marsh with little or no difficulty (photograph 20).

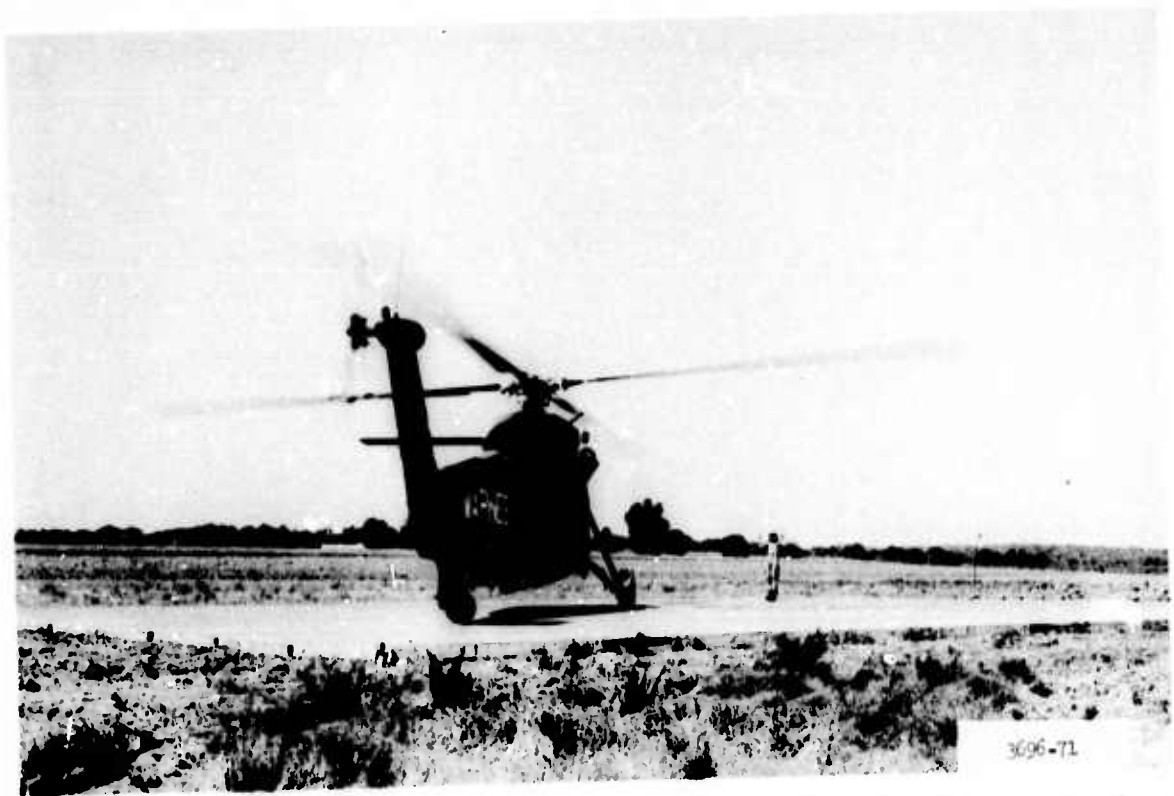
Photograph 24. Taxiing operations on pad; gross aircraft weight, 10,000 lb

22. Prior to any landings being made on the pad, the CBR of the soil was determined at various intervals around the perimeter of the pad. The CBR of the top 18 in. at nine locations averaged 0.20 percent. On its first approach to the pad, the helicopter raised considerable dust as soil particles and other foreign matter were blown from the surface (photograph 23). After that, the surface remained clean; therefore, there was no dust problem during subsequent operations (photograph 24). During the initial tests, the helicopter was loaded to 10,000 lb and 11 landings were made with gravity forces of 1.20 to 2.13 (table 2). The aircraft was taxied over the entire pad, along the joints, and around the edges with no evidence of any unusual occurrences or failures (photograph 24).

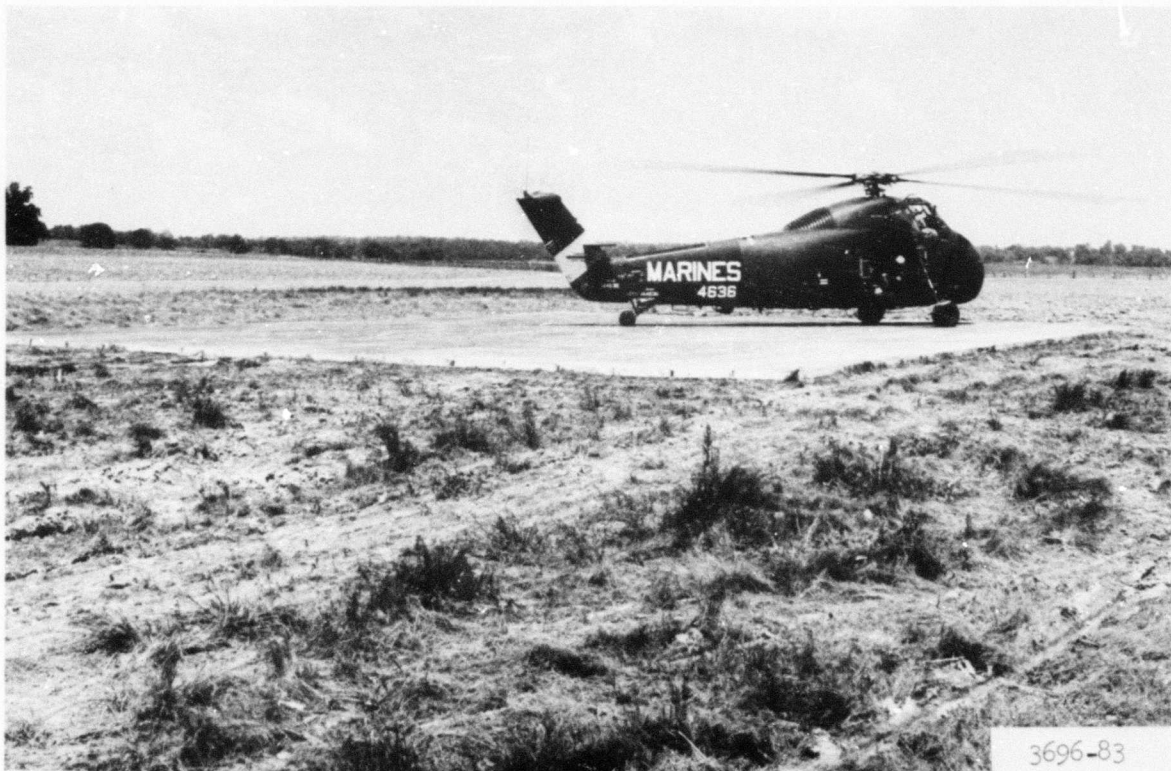
Photograph 25. Helicopter on edge of pad after making a rolling landing across pad; gross aircraft weight, 12,000 lb

these tests with the 12,000-lb load. The helicopter touched down on one corner, taxied to the opposite corner, and halted abruptly at the pad's edge (photograph 25). This simulated a normal landing for a helicopter operating with a maximum cargo load. The craft again taxied over the entire pad, with the main gear wheels coming within inches of the edge (photograph 26). The helicopter also taxied along and across the depressed joint between runs 14 and 15 (paragraph 19). The depressed area was trafficked with the tail wheel (photograph 27) and main gear wheels (photograph 28) with no adverse effects being noted. The only visible damage to the pad was flaked-off antiskid compound. This was particularly evident when one tire was braked and 360-deg turns were made. Loose antiskid compound was observed on 20 panels during and after the tests. It is believed that exposure to water during the pond tests weakened the bond between the antiskid compound and the panels. The CBR was determined at each corner of the pad and also near the center of the pad after one panel was removed. The average CBR in the top 12 in. was 0.26 percent.

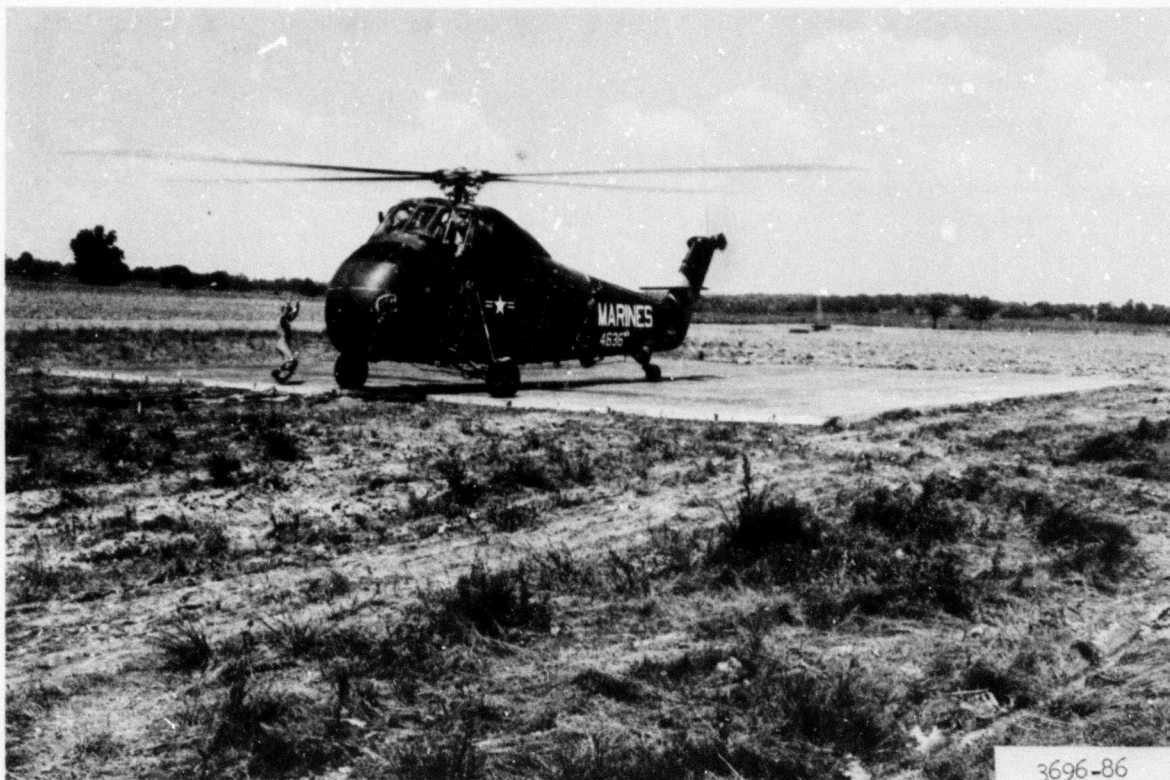
Photograph 26. Taxiing operations with main load wheels approaching edge of pad (gross aircraft weight, 12,000 lb)

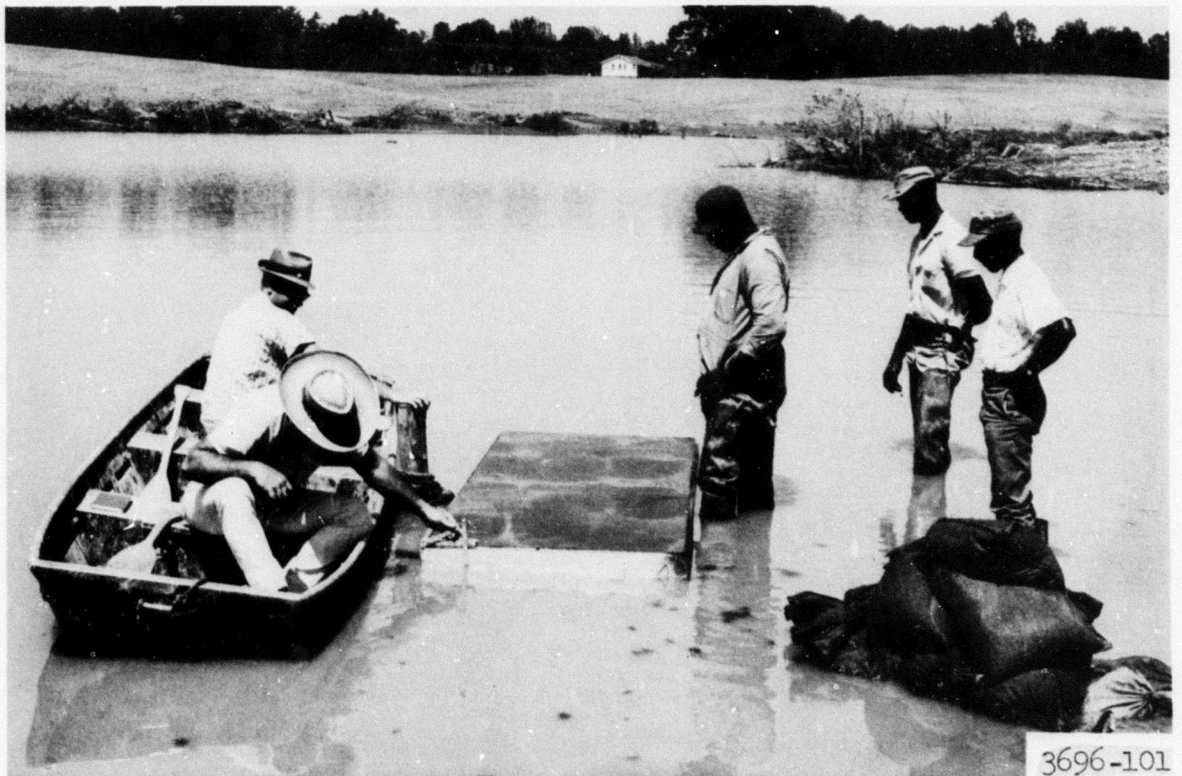
Photograph 30. Panel floating with 3-in. freeboard  
after being submerged for 10 days

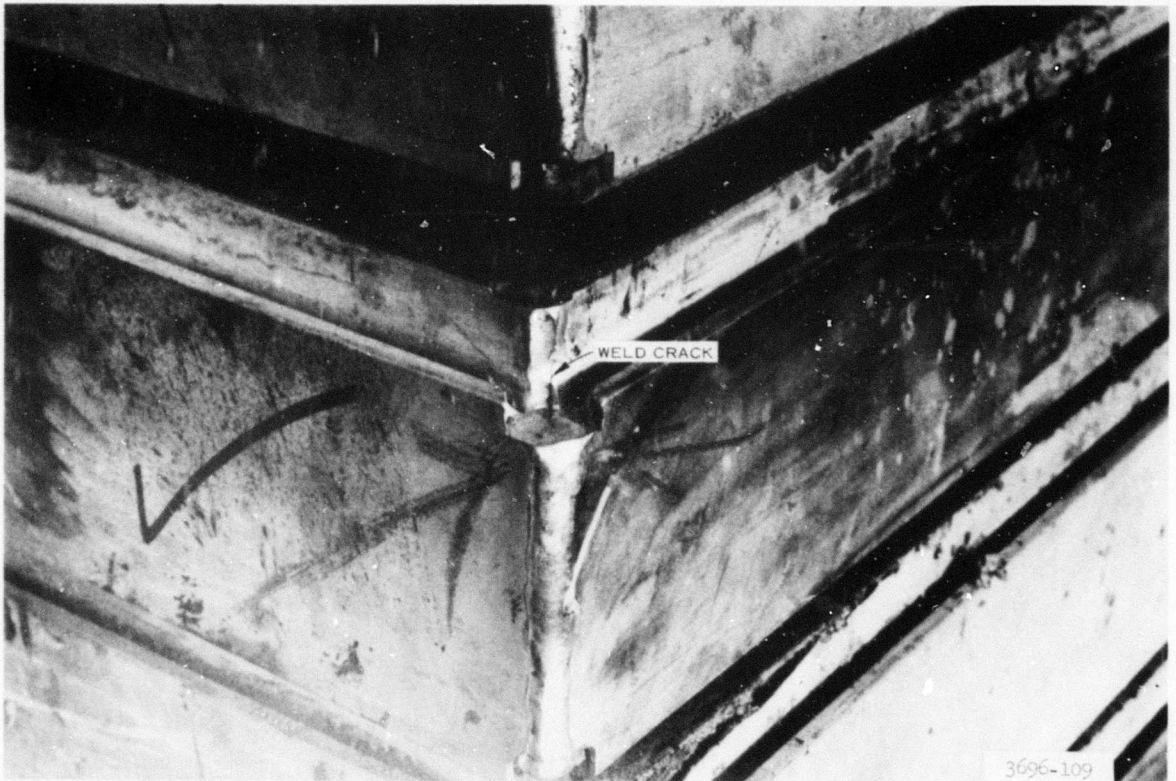
Photograph 31. Hairline crack in upper portion of panel corner which allowed water to enter the core

27. In Phase I tests, it was evident that some of the panels were absorbing water. One panel which weighed 183 lb prior to the test and 267 lb after 7 days on the pond was selected for a submergence test to determine how much additional water it would absorb. This panel was completely submerged with 750 lb of ballast for 10 days. After the ballast was removed, the panel floated to the surface and had an average of 3 in. of freeboard around its edges (photograph 30). Its weight had increased to 292 lb, a gain of 25 lb and a total gain of 109 lb. It is believed that hairline cracks in the corner welds of the panel (photograph 31) allowed water to seep into the core. About 25 to 30 percent of the panels had such cracks; these panels were easily detected as water ran out of the cracks when one end of a panel was elevated.

- d. During helicopter operations in Phase I tests, minor cracks developed in the welded corner joints of the extruded aluminum connectors which permitted an average of 30 lb of water per panel to enter the cores of the panels. Polyurethane foam in the cores somewhat restricted the amount of water absorption and prevented the panel from sinking.

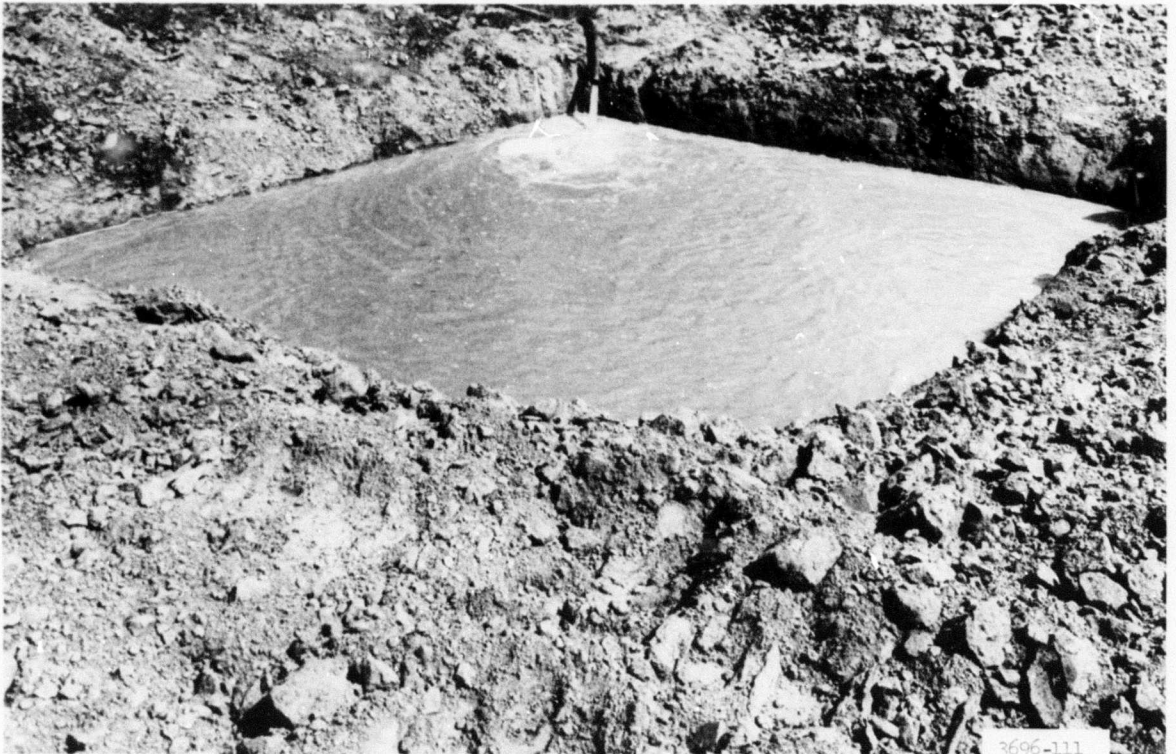
Photograph 32. Pit being flooded in preparation for adhesion tests

28. Adhesion tests were conducted to determine the bond between the bottom of the AM3 panels and the underlying mud. A 12-ft-square pit approximately 3 ft deep was constructed at the WES for this purpose. The soil was a clay (CL) having an average liquid limit of 39 and an average plasticity index of 17 (plate 8). To create the marshy condition desired for the test, the pit was flooded with water and allowed to soak for 2 days (photograph 32). The pit was then backfilled with loose natural clay to create a muck.
