MISCELLANEOUS PAPER NO. 4-829

# FIELD TESTS OF AM3 LANDING MAT

# **FIELD TESTS OF AM3 LANDING MAT**

## SUMMARY

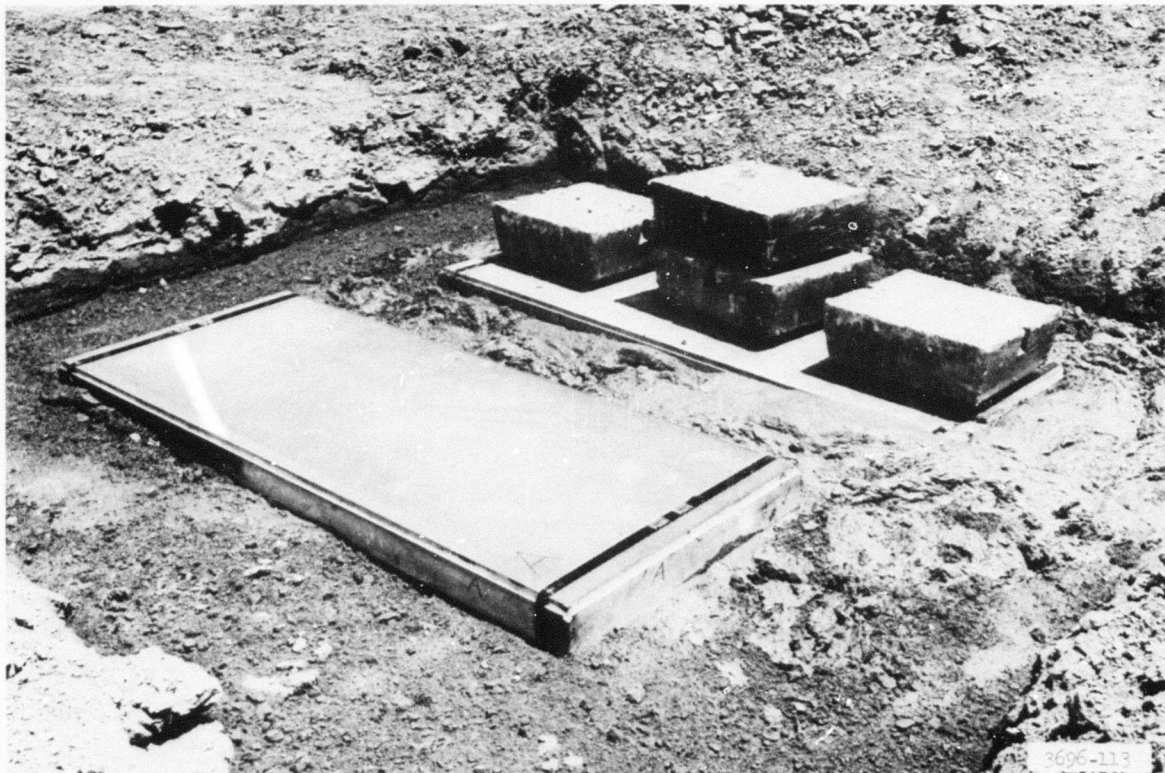
Photograph 33. Panels in marsh pit with 8000-lb load on one panel

29. In the first test, one unloaded panel and one panel loaded to 8000 lb were placed in the pit (photograph 33). After 3 hr, the weight was removed from the loaded panel and an attempt was made to pull the panels from the mud. An overhead crane equipped with a dynamometer measuring the pull was used for the lifting. The unloaded panel was pulled out with a 450-lb pull. On the first attempt to pull the panel which had been loaded, the steel straps around the panel broke at 2000-lb pull without

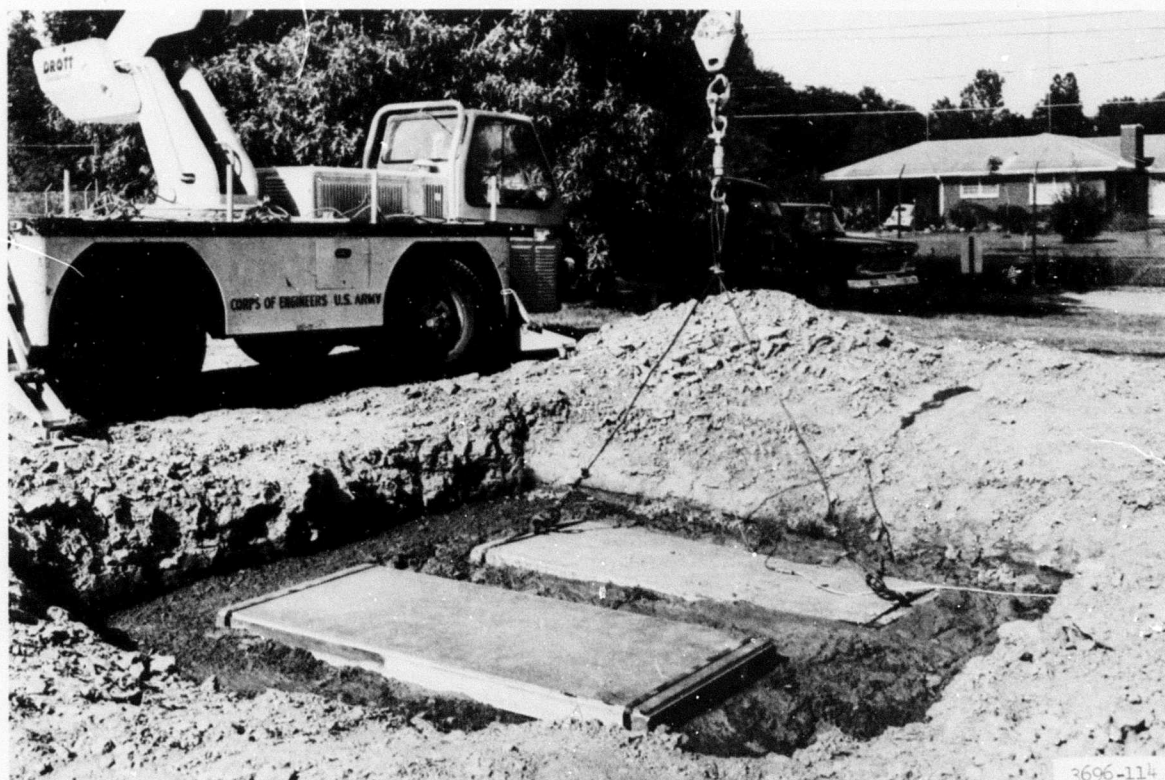
Photograph 34. Attempt being made to remove panel from muck just prior to steel straps breaking

moving the panel (photograph 34). Another attempt was made the next day, and the panel was removed with a 4400-lb pull. The unloaded panel was again placed in the pit; this time a 475-lb pull was required to remove it. A third panel was loaded to 8000 lb for 4 hr and then unloaded. A 1725-lb force was required to pull one end of this panel out of the muck.
