Report 2020

EXPENDABLE, MINE-CLEARING ROLLER

(ENSURE 202.1)

3. REPORT TITLE EXPENDABLE MINE CLEARING ROLLER (ENSURE 202.1)			
4. DESCRIPTIVE NOTES (Type of report and inclusive dates) Final Report: Sept 1969 to August 1971

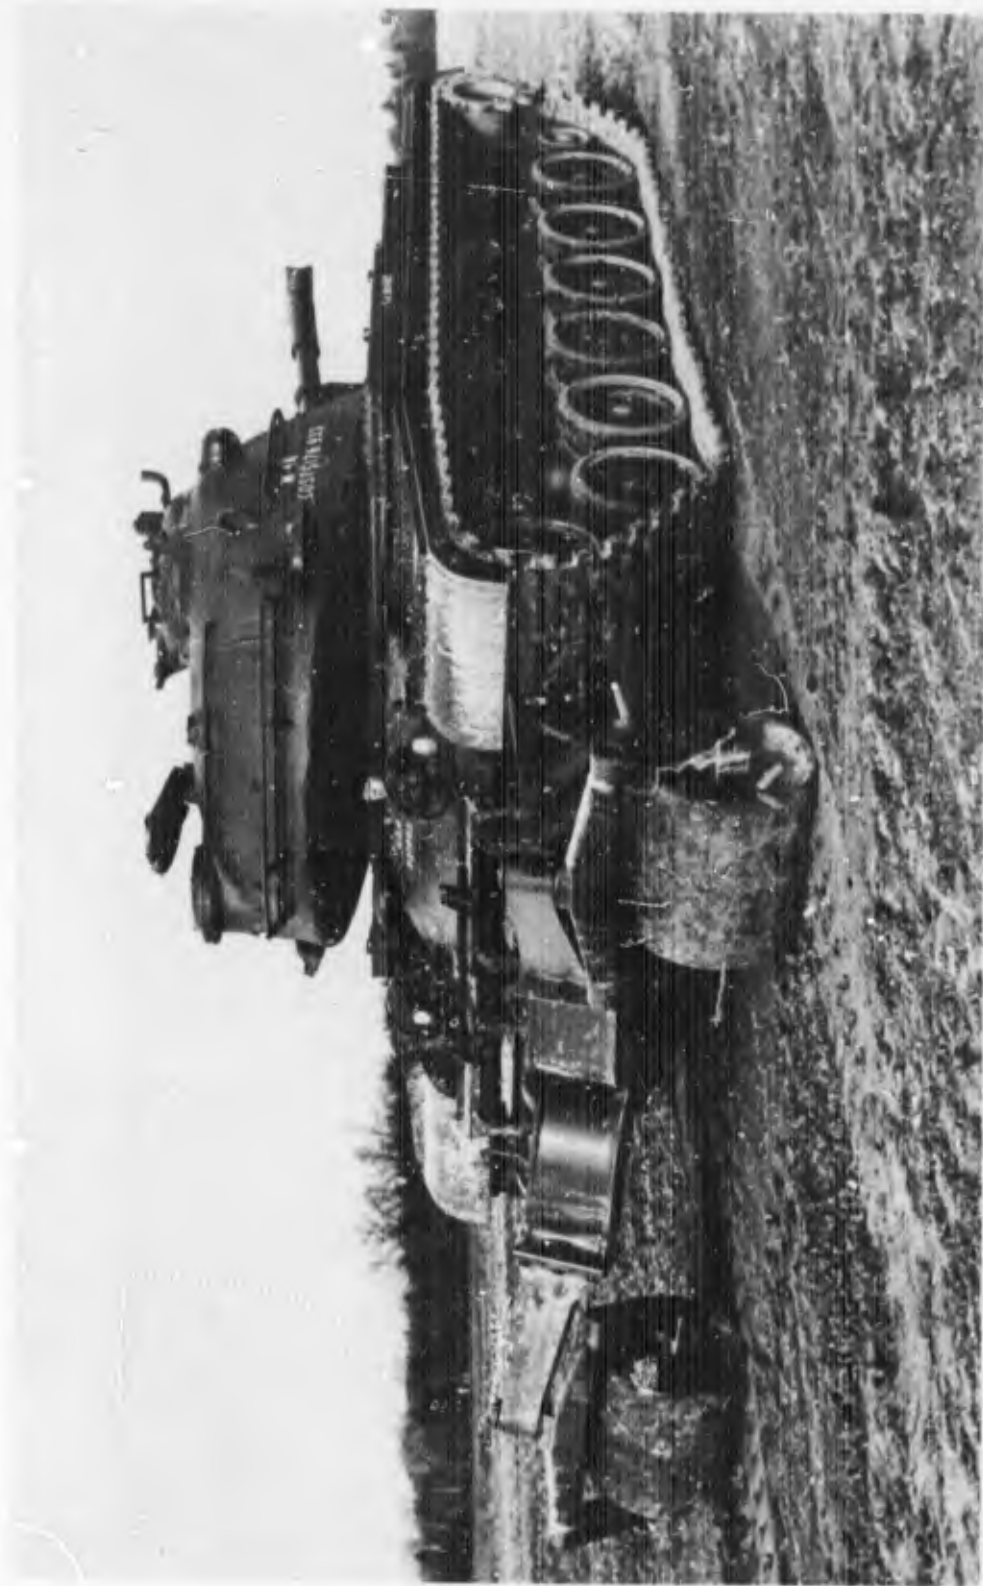
C1706

Fig. 1. The original expendable, mine-clearing roller (Model I).

a. **Field.** The original expendable, mine-clearing roller (Model I) utilized a drum-type roller (Fig. 1). On field testing, these rollers were found to have a too-limited sweep path and also were found to "bridge" or span over potholes and irregularities in the terrain. A new alternative was devised whereby six tank road wheels are mounted on a central axle (Fig. 2). Each wheel is individually capable of vertical articulation. Also, the wheels are linked by a cable system which distributes the load equally under each wheel regardless of its relative vertical position (Model Ia).

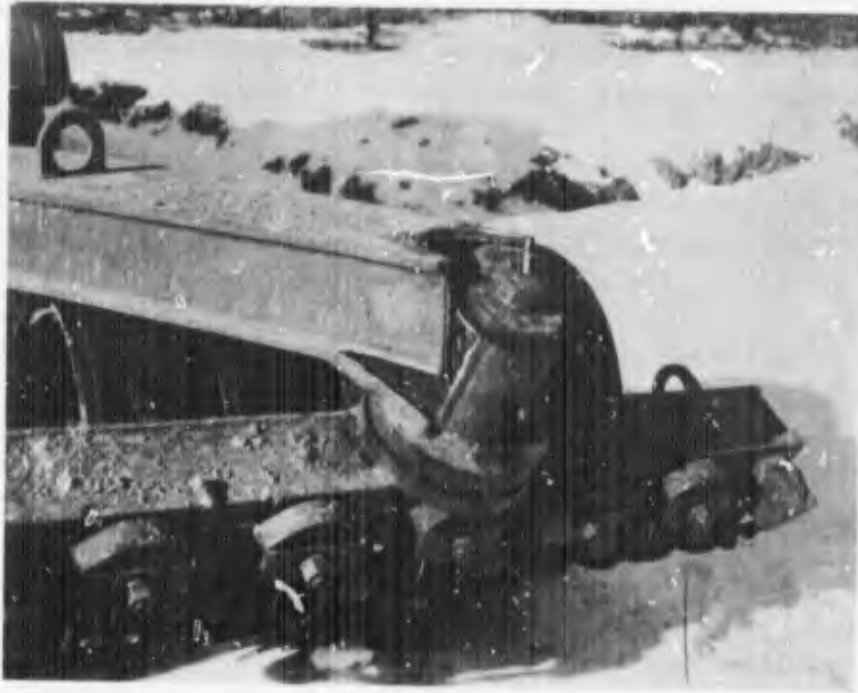
Weld failures occurred at two similar locations (at the extremity of each of the extension arms), and this proved to be a design deficiency (Fig. 3). This deficiency was corrected by instructing the fabricator to increase the size of the weld in the critical areas and to supplement the weld with internal gusset plates.

Fig. 3. Weld failure at the extremity of the extension arm.

The rough-terrain, or "torture," testing brought out several latent defects in the welding design of the frame of the roller. The ends of the extension arms broke several times, and it was obvious that the welds were underdesigned. The pinning of the attach points (between roller frame and tank hull) was inadequate when the torture course produced a "racking" movement to the roller. The roller keys sheared and the pins fell out. The broken welds were repaired

and reinforced on the spot on this first-production model and an Engineering Change Proposal (ECP) was prepared providing an adequate weld design. With the implementation of this ECP, there has been no further indication of this being an inherent weak area in the design of the roller. An ECP redesigning the method of locking the pins in place has also been incorporated in the Technical Data Package (TDP) and no reoccurrence of this problem has been experienced.

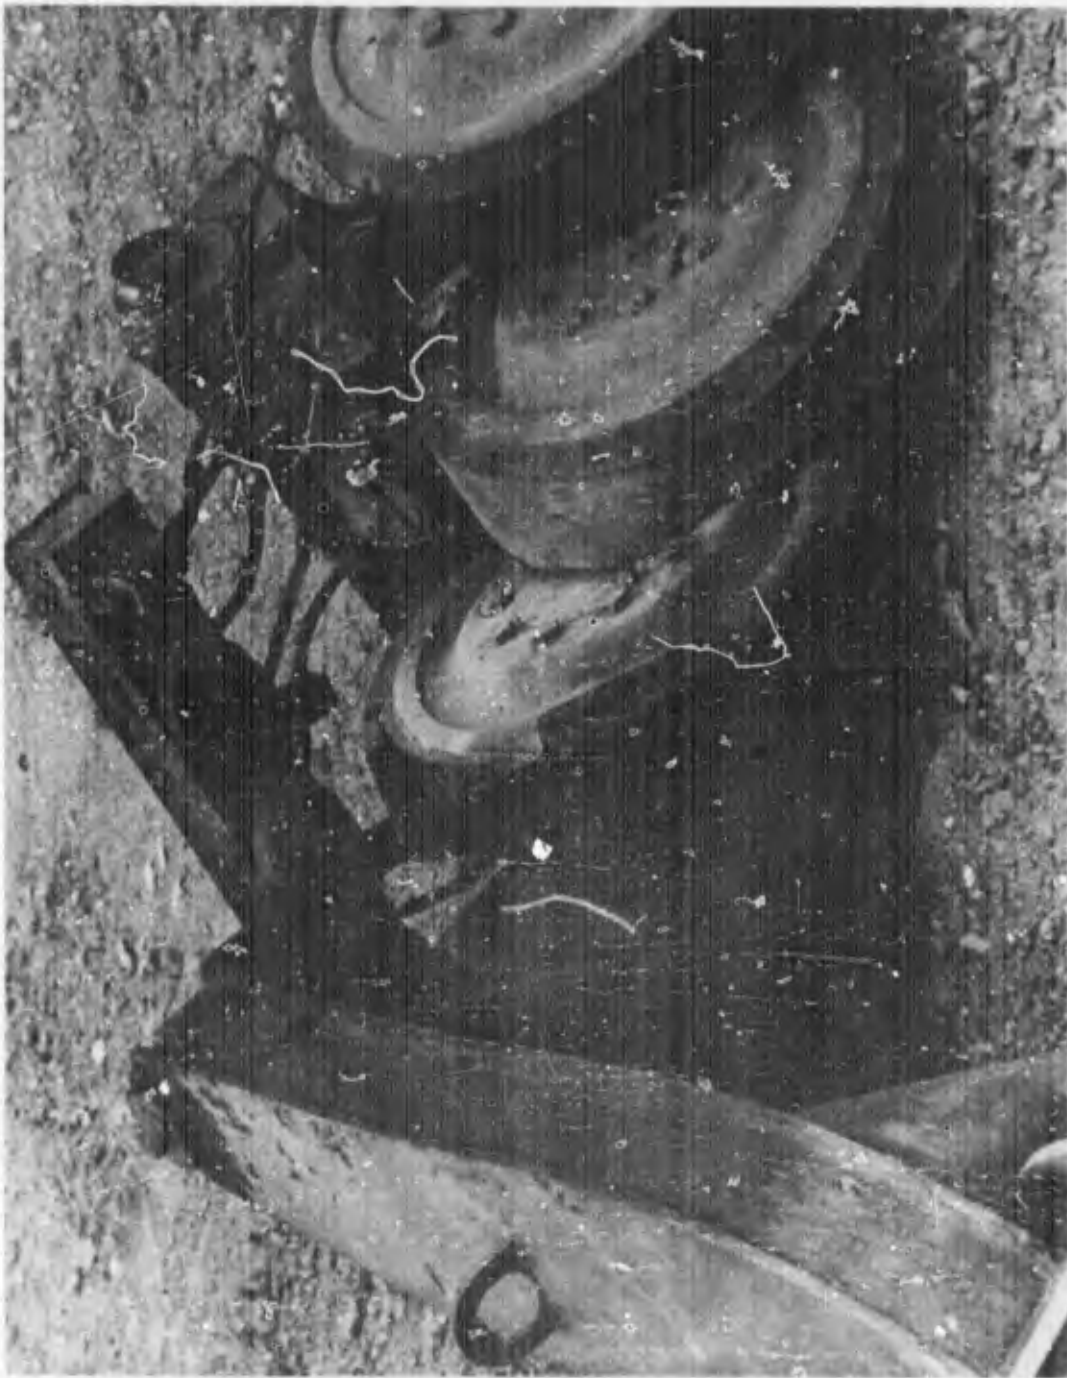
Fig. 10. Typical damage to wheel arm assembly from mine encounter.

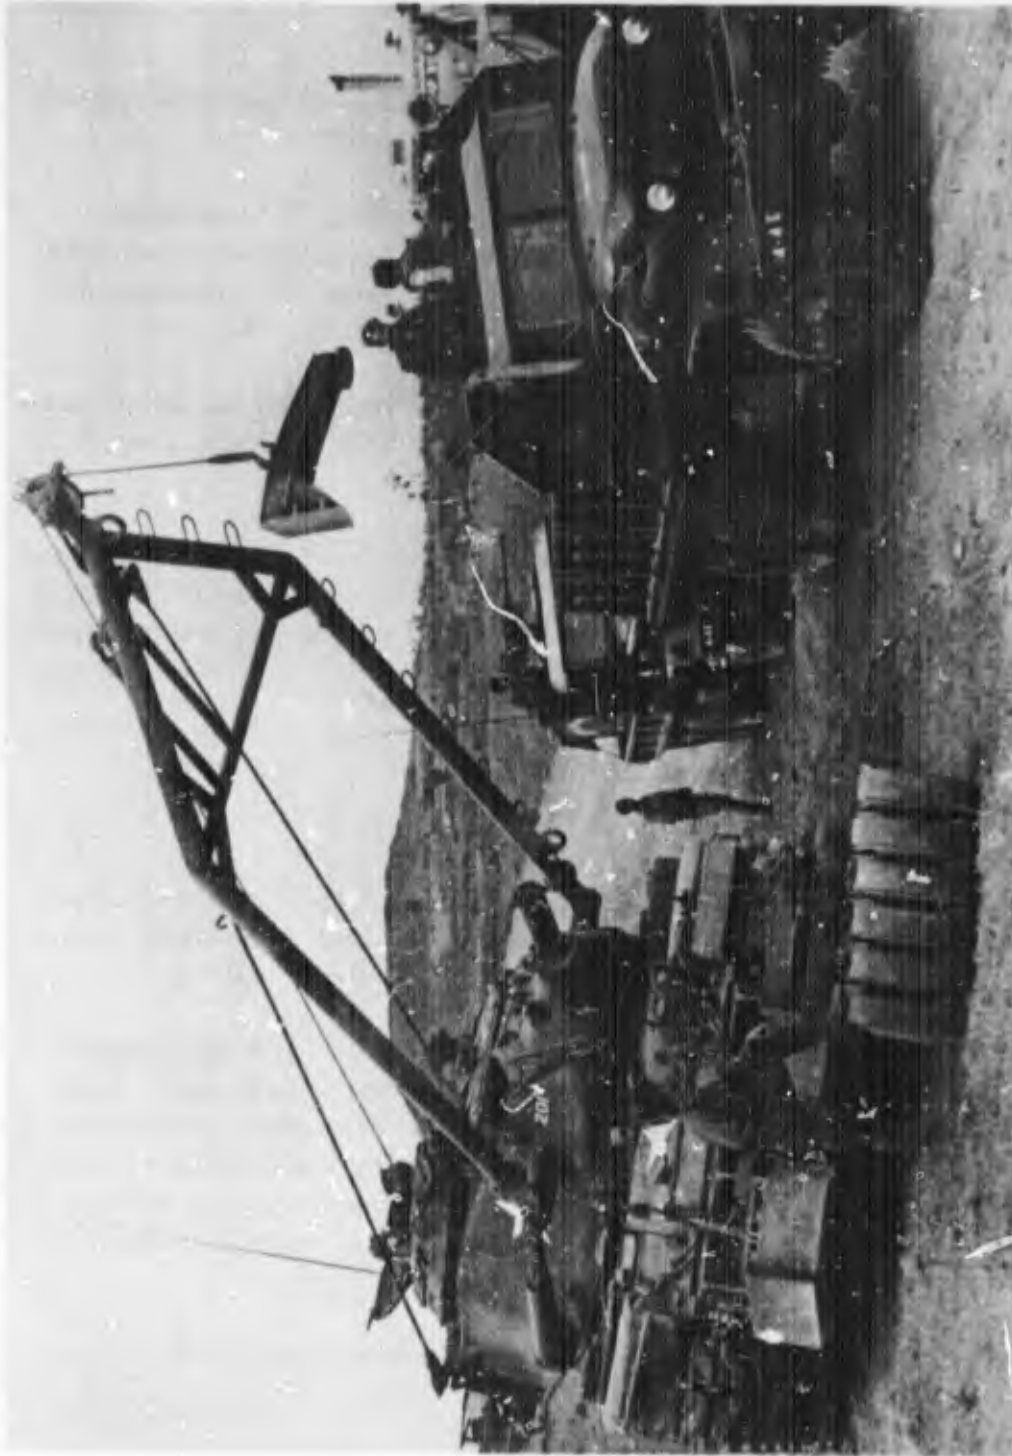
Fig. 11. Self-help capability of the CEV.

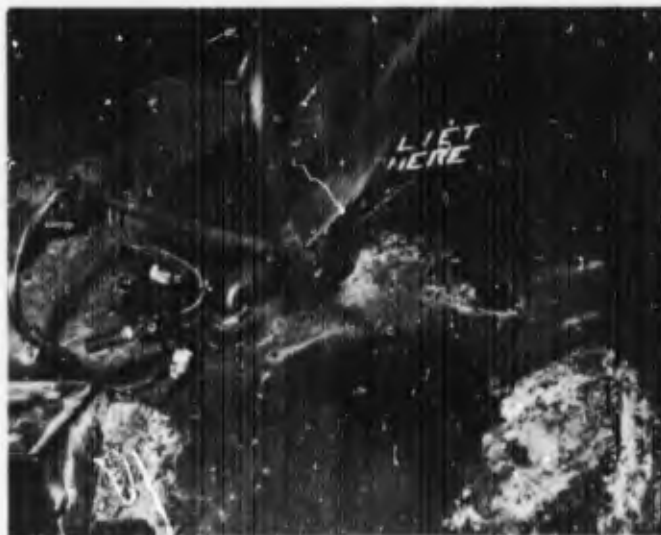
Figure C

STEP 2. Disconnect head lights and cut off mounting brackets.

STEP 3. Remove towing hooks from cast-in-place towing eyes.

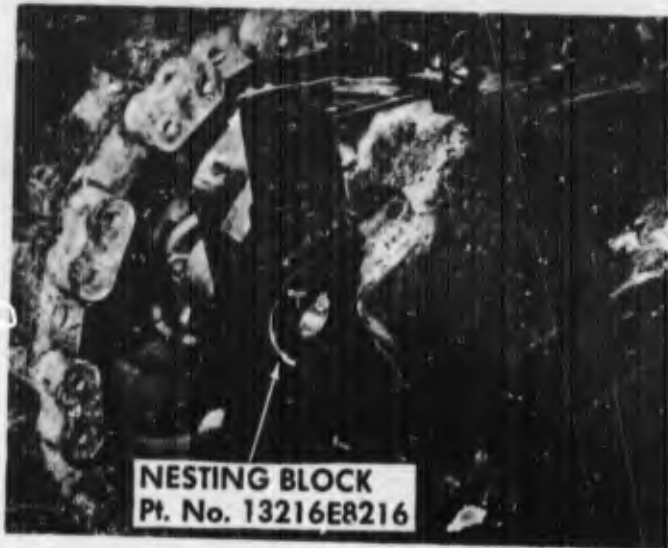
Figure D

STEP 1. Weld nesting block (part number 13216E 8216) to tank hull.
NOTE: Tack Weld, 1/4" long x 4 places, only.

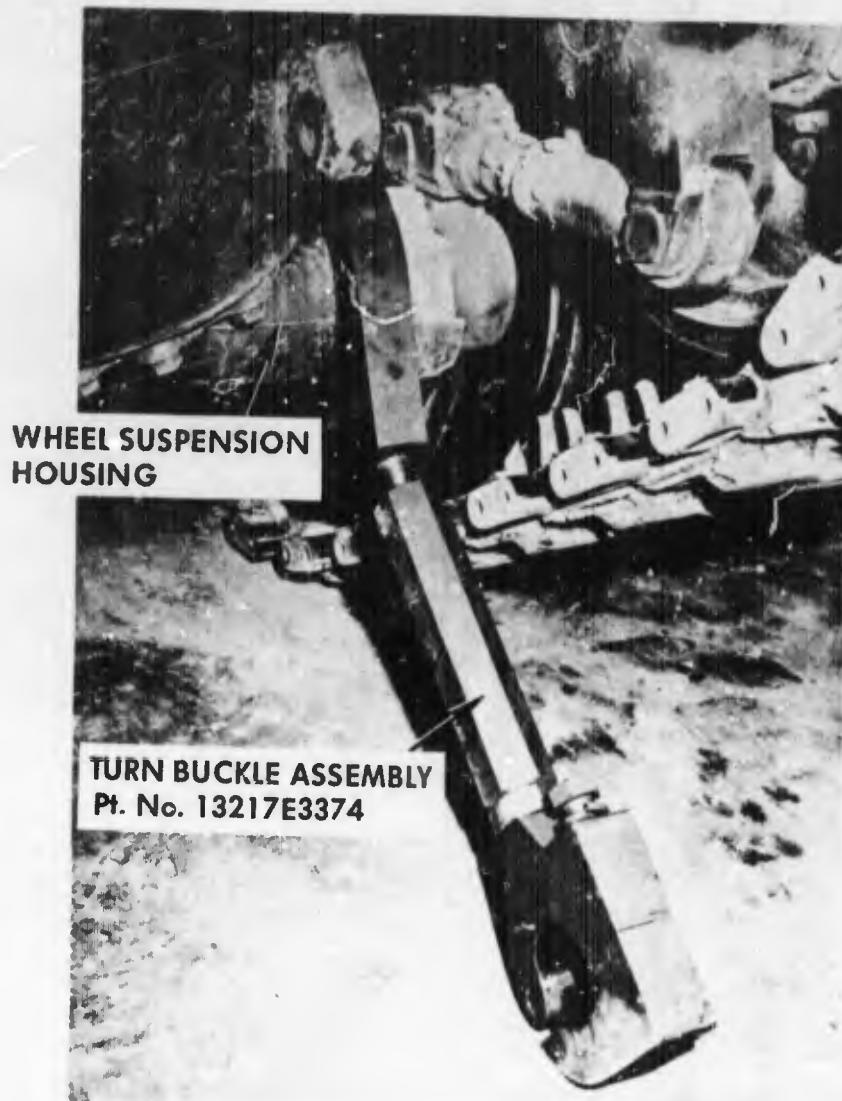
Figure G

Connect turnbuckle, part number 13217E 3374, to tank idler wheel suspension housing as shown in Figure G. Be careful to position the pivot hinge upward on the large turnbuckle end.

The pivot hinge pin is positioned downward on the small, or main frame, connecting end.

Before tightening turnbuckle locknut, see FIGURE N, rotate the turnbuckle body until the large end of turnbuckle is in contact with the back side of wheel suspension housing. SEE FIGURE G, PAGE 29. This operation will cause the main frame, and frame, structural, to be drawn toward the tank hull. SEE FIGURE W, PAGE 43.

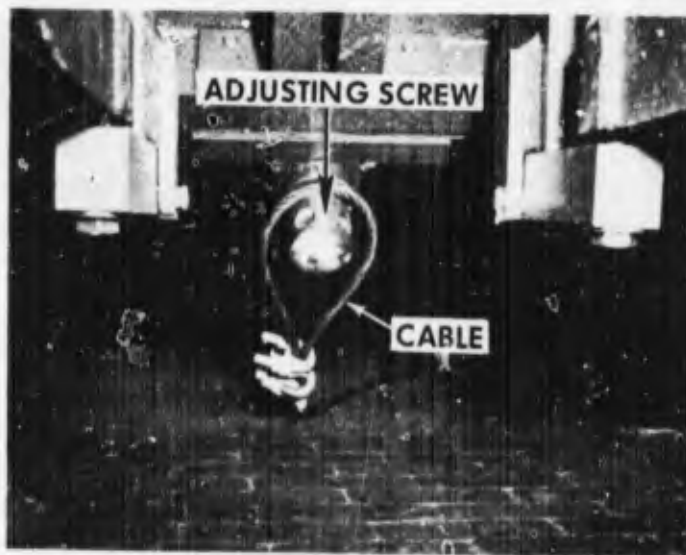
Figure I

ATTACH CABLE TO ADJUSTING SCREW ON BOTTOM OF STRUCTURAL FRAME AND PASS UNDER TANK; ATTACH TO ANY VEHICLE AND PULL STRUCTURAL FRAME TO TANK HULL.

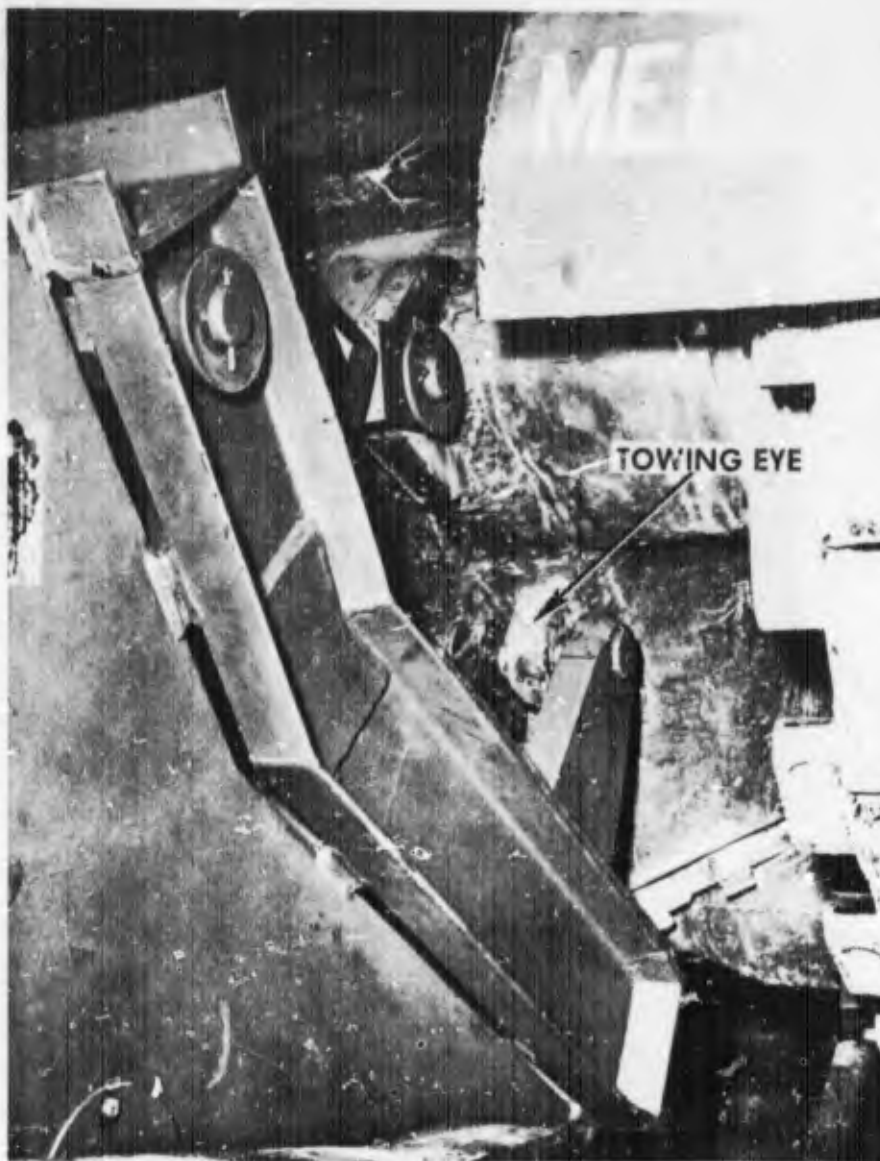
Figure J

Using the headed pins, flat washers, and cotter pins provided with the hardware kit, attach frame, structural, to the tank hull at towing eyes and nesting blocks. SEE FIGURE J.

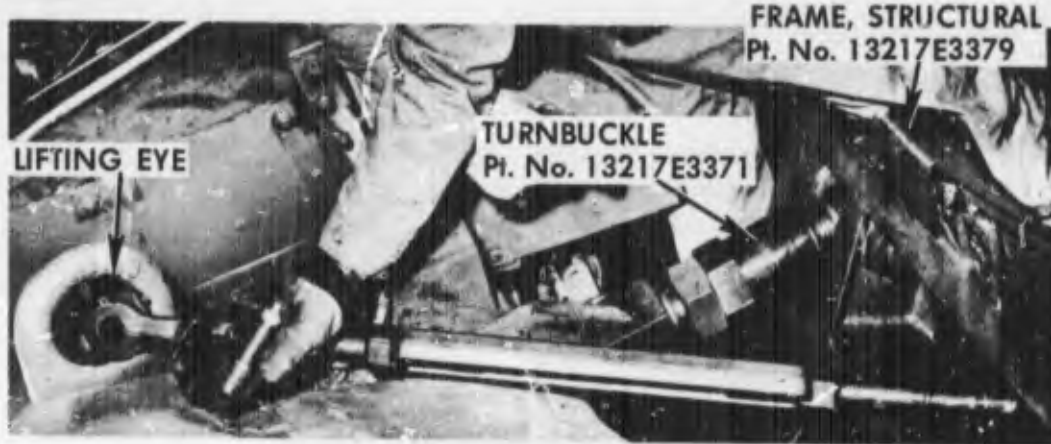
Figure K

Pass rounded end of turnbuckle through slot provided in frame, structural. The opposite end of this turnbuckle is secured to tank lifting eye with a headed pin, washer, and cotter key. SEE FIGURE K, above.

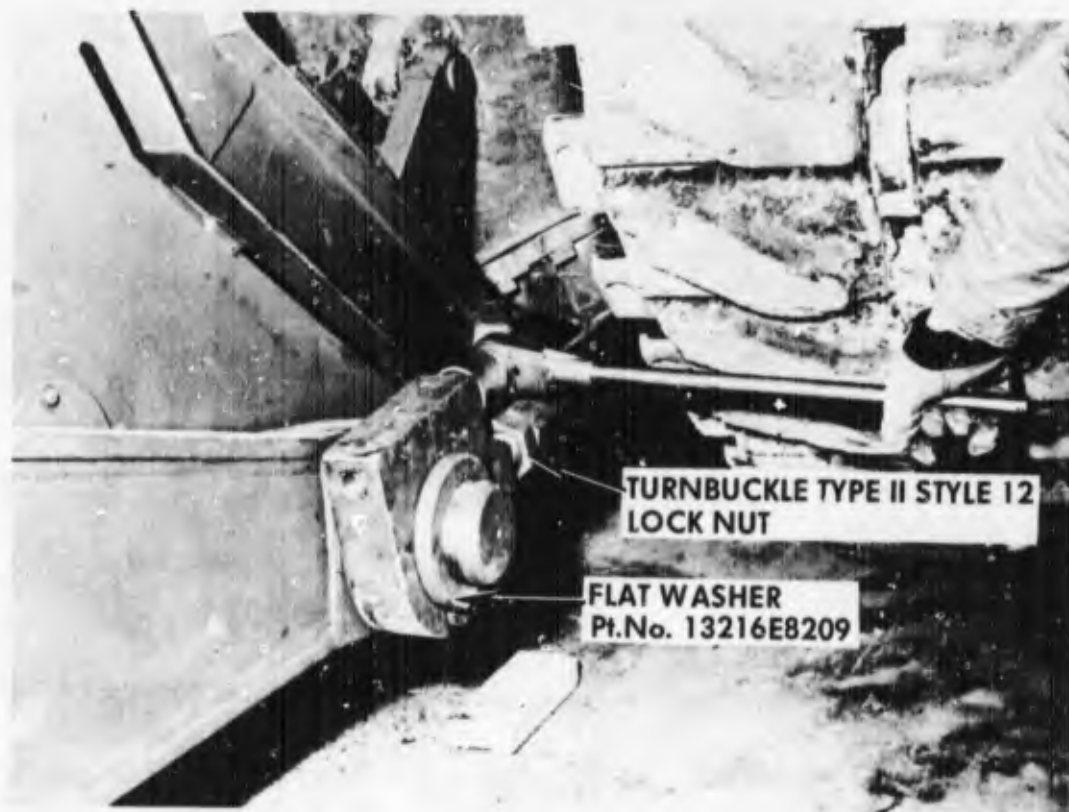
Figure N

Close turnbuckle hinge around pivot shaft end and tighten 1-1/4-7 threaded cap screw as shown in FIGURE N.

Place a second flat washer between turnbuckle and end of pivot shaft end. Secure with 5 inch long cotter pin inserted through hole in the end of pivot shaft.

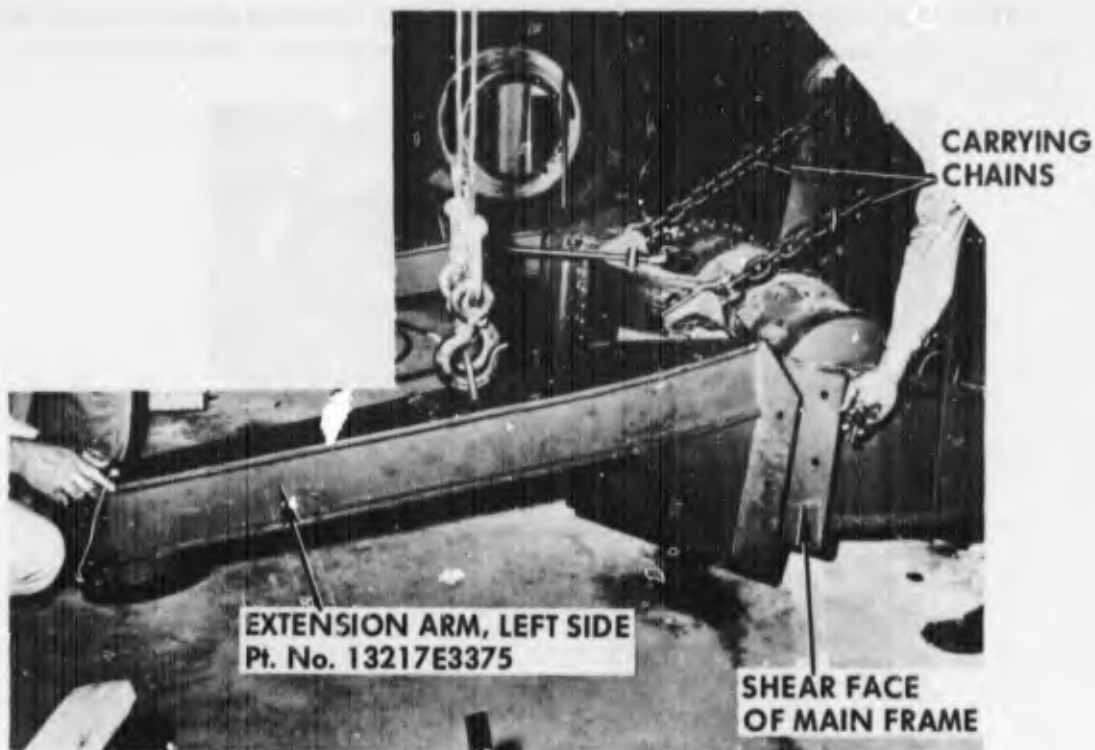
Figure P

The main frame must be held high enough to allow the extension arm to be positioned against the shear face of main frame. SEE FIGURE P, PAGE 37.

Align the six (6) holes in the shear face of the main frame with six (6) corresponding holes in the extension arm.

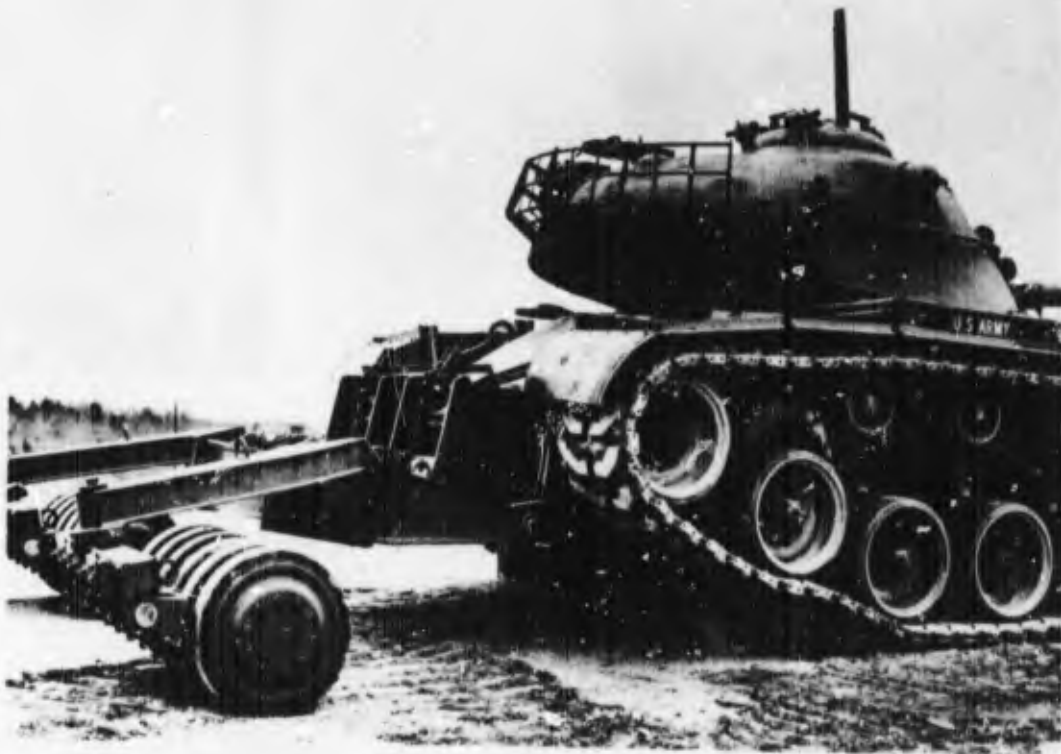
Figure T

If heavy timber blocking is available, either in the field or at a repair shop location, the M-48 tank can be moved forward upon the blocks until the idler wheel and first bogie are raised. **BOTH TANK TRACKS MUST BE RAISED AT THE SAME TIME.**

SEE FIGURE T ON PAGE 40.

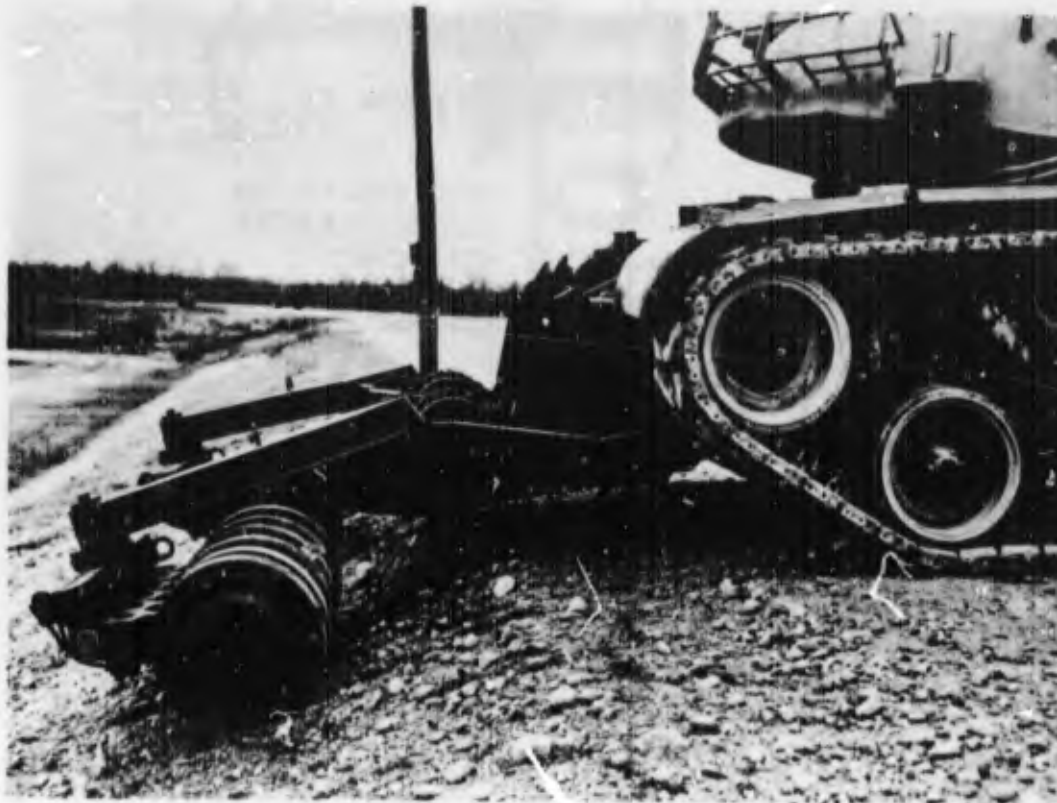
Figure U

In the absence of blocking, the same results may be obtained by driving the expendable wheel and yoke assembly down an incline, allowing the tank tracks to remain on level ground. SEE FIGURE U, PAGE 41.

NOTE: SEE PAGE 41, FIGURE U. The described method is also suitable for disconnecting the roller chains.

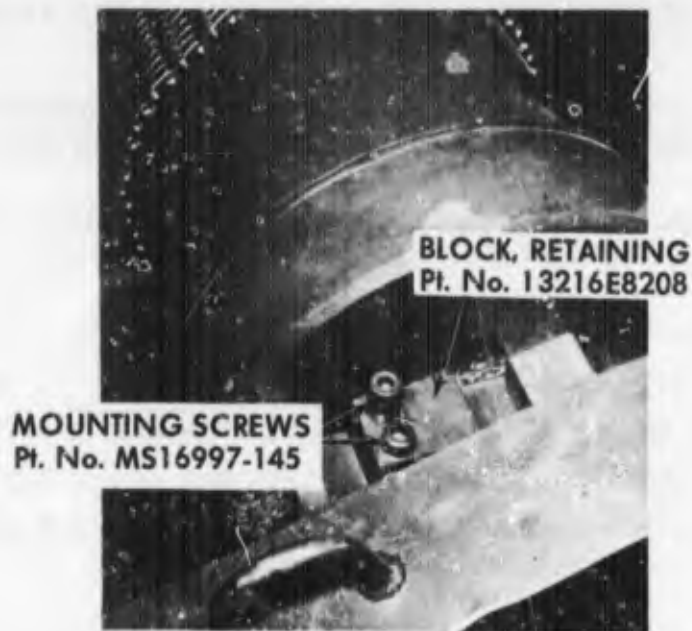
Figure BB

STEP 2.

RECHECK SPRING LUG POSITION.

NOTE: The square portion of the shafts on the front spring assemblies are 3/4 inches longer than the ones used with the back torsion spring assemblies described on PAGES 44 and 45, FIGURES X and Z.

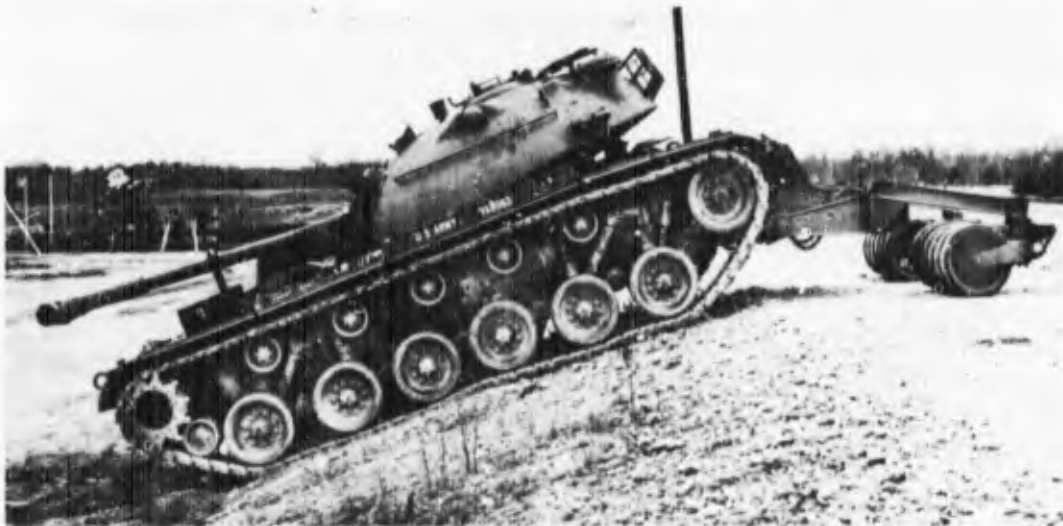
Figure CC

To relieve tension on the torsion spring assemblies, the M-48 tank is driven up an incline. At this point, the roller chains may be disconnected from the torsion spring lugs.

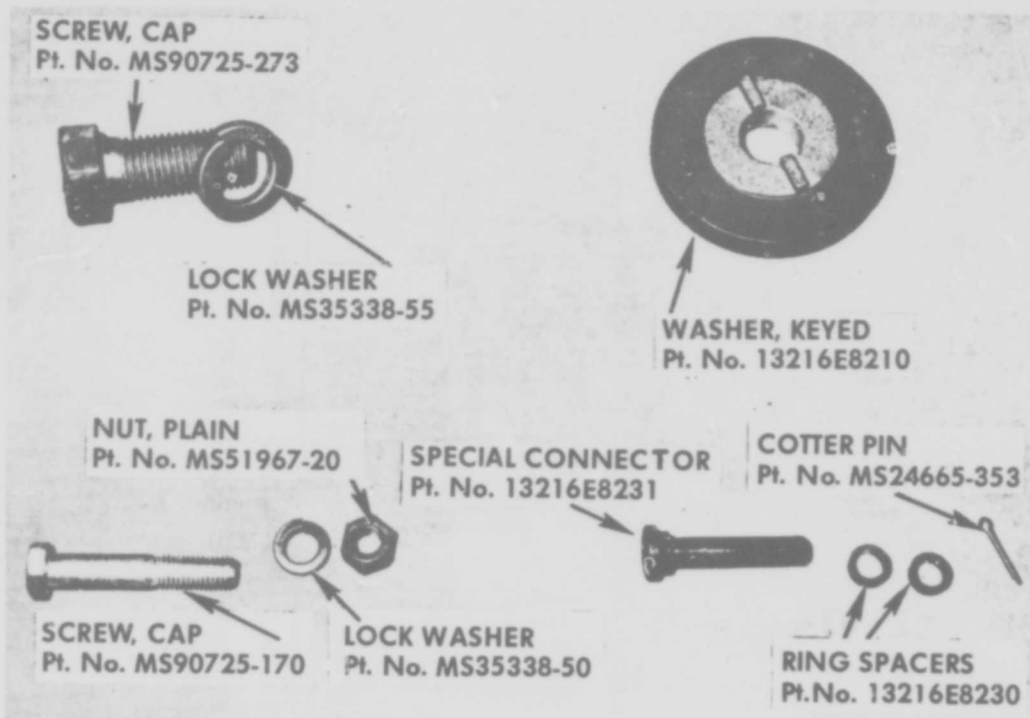
Figure FF

The above parts, FIGURE FF, PAGE 62, are contained in a separate package to be found with the Expendable Wheel and Yoke Assembly shipping skid.
