AMMRC CR 70-5 (F)

**FEASIBILITY STUDY  
OF COLUMBIUM ALLOY CASTINGS**

**R. J. BEAUREGARD**  
**Avco Lycoming Division**  
**Stratford, Connecticut 06497**

FINAL REPORT — CONTRACT NUMBER DAAG46-69-C-0163

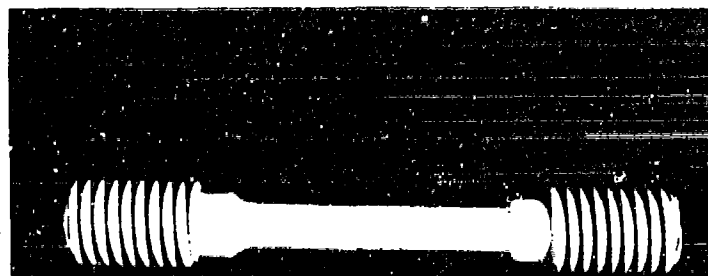
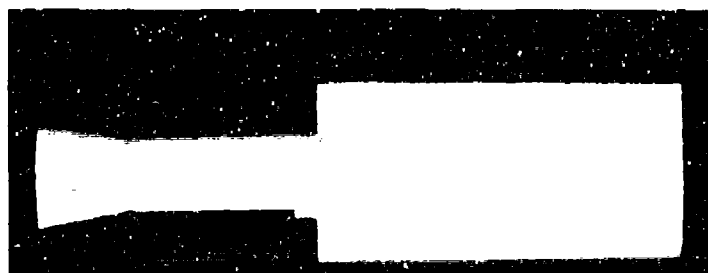
Tensile Specimen

Oxidation/Thermal Fatigue Test Paddle

Figure 4. Wax Patterns of Test Specimens.

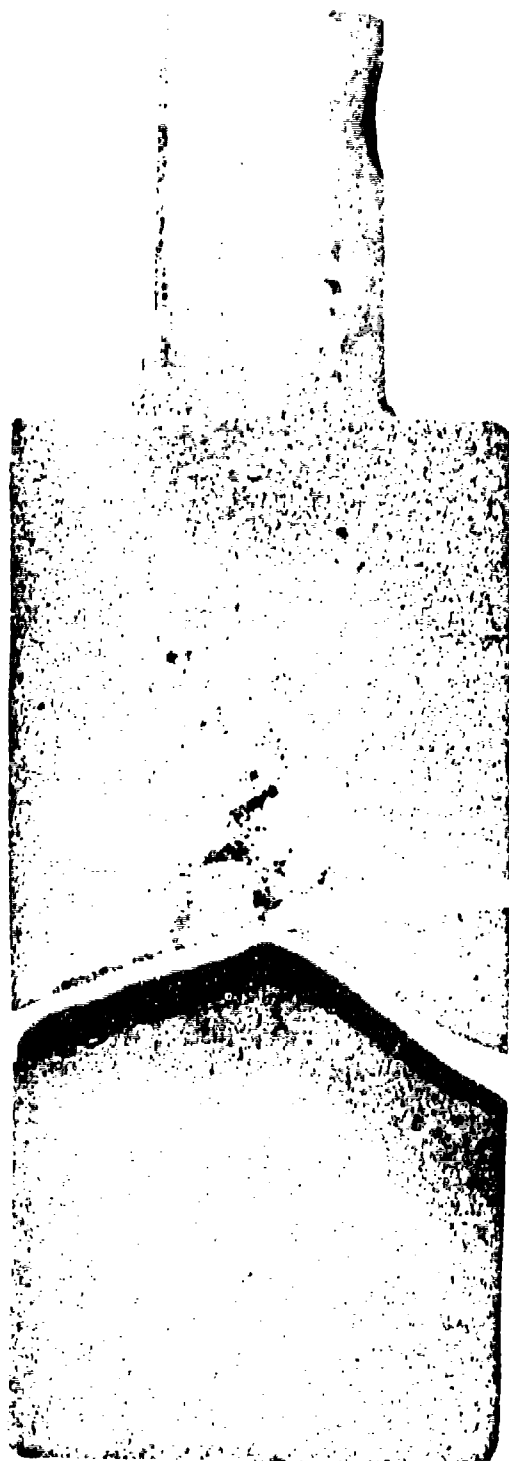
Figure 10. Coated C-3015 Paddle Showing Ballistically Impacted Area.

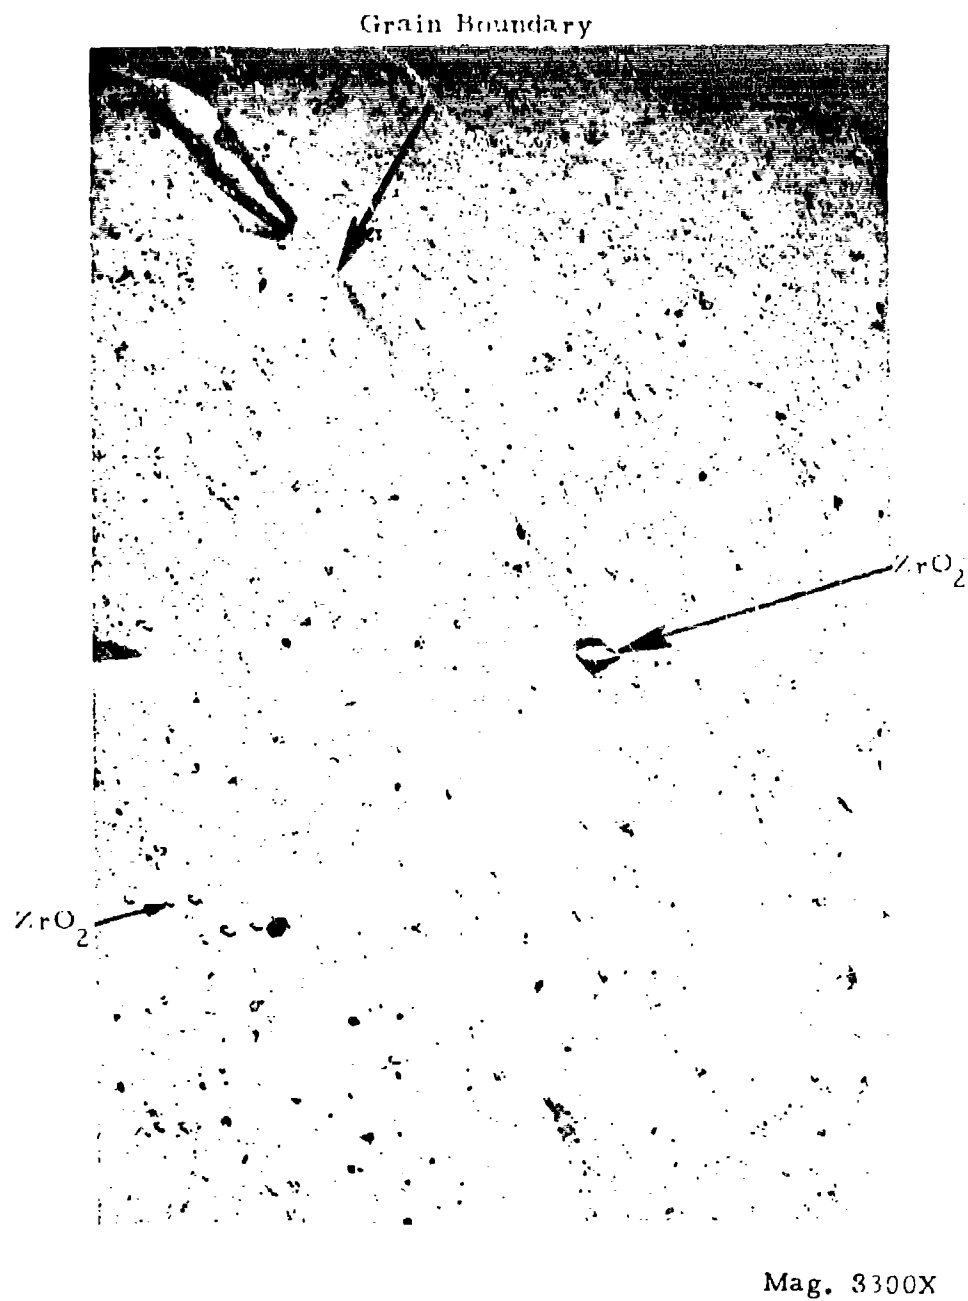
Figure 31. Electron Photomicrograph of Cast B-6 Alloy.
