CHARACTERIZATION OF IR WINDOWS

First Quarterly Technical Report

ARTHUR D. LITTLE, INC.

MARCH 1972

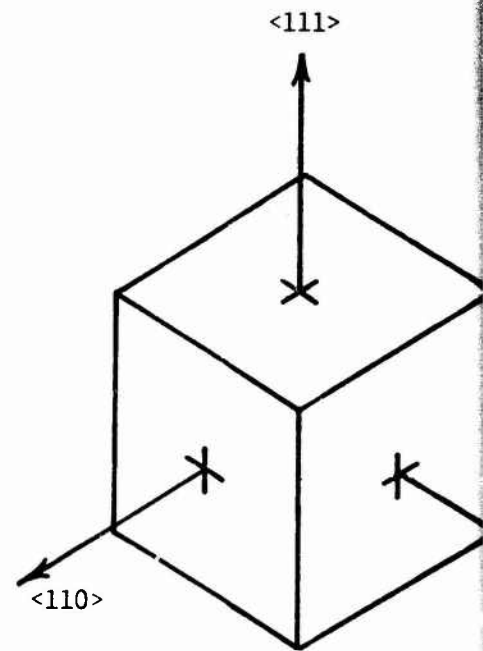
FIGURE 13 (422) REFLECTION TOPOGRAPHS
OF 1 CM CUBE OF GaAs FROM
COMMERCIAL SOURCE A, 10X

A series of (422) reflection topographs were obtained from (111), (110), and (211) as-cut faces of the two GaAs cubes obtained commercially. These topographs are presented in Figures 13 and 14. The cube from Commercial Source A produces generally uniform topographs. The sample appears to have good perfection, with only slight evidence of residual saw damage, evident on the (111) face. The chip on the corner resulted from dropping the crystal. In contrast, the sample from Commercial Source B reveals considerable structure which we attribute to massive damage from high speed sawing. As a result of this extensive damage, it is not possible to comment on the sample's crystallographic and microstructural quality. It is evident that the damage induced during the initial sawing extends deep into the crystal. Many of the Bell & Howell crystals exhibit similar residual damage of this type on polished surfaces.

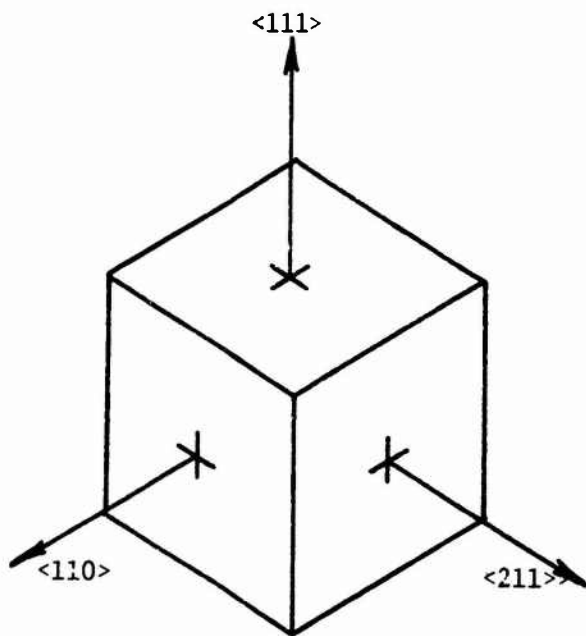
FIGURE 14 (422) REFLECTION TOPOGRAPHS
OF 1 CM CUBE OF GaAs FROM
COMMERCIAL SOURCE B, 10X
