SEA FLOOR TECHNOLOGY  
 REPORT No. 2

ORB - RUM OPERATIONS  
 MARCH THROUGH AUGUST 1970

Victor C. Anderson  
 Daniel K. Gibson

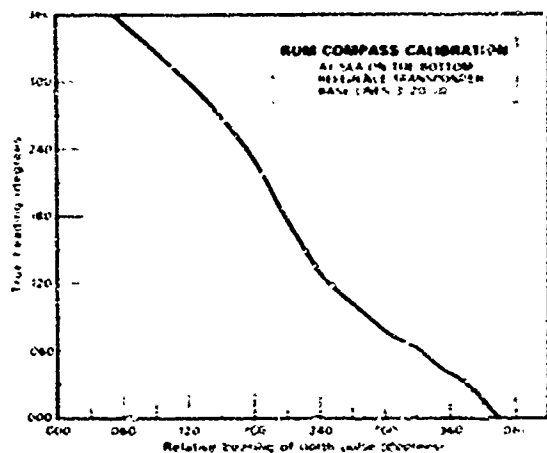
Fig. 2. Compass calibration

tained by drawing a line through the plotted start and finish positions. The compass calibration obtained by drawing a smooth curve through these  $22.5^\circ$  data points is shown in Figure 2. Distance traveled as indicated by track turns counts on the vehicle, agreed very well with distance between plotted positions. All errors were less than 5%.

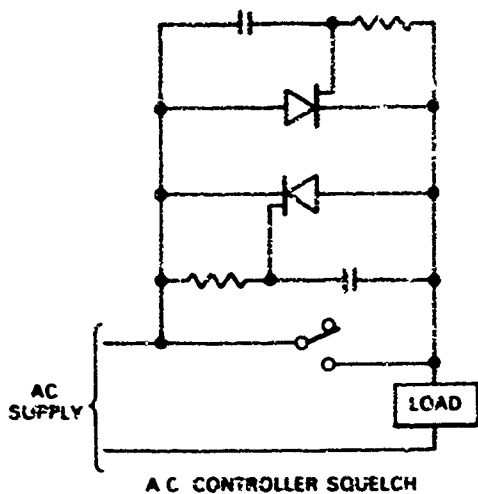
Fig. 8. Test circuits for squelch of contact arcing in power control contactors.

The first, using solid state devices to provide a dynamic squelch across breaking contacts is shown in principle in the simplified schematics of Figure 8. The basic principle of operation is the same for the dc or ac controller. When switch S opens, the rapid voltage rise across it,  $(dv/dt)$ , is coupled into the base of transistor T through capacitor C in the case of the dc circuit, or into the gate of SCR<sub>1</sub> or SCR<sub>2</sub> in the case of the ac circuit. The transistor or SCR is driven "on" (into a conducting state) thereby momentarily maintaining near zero voltage across the opening contacts preventing the occurrence of an arc. In actual practice current limiting to base or gate should be provided. An rf filter to prevent line transients from firing the SCR circuit is also advisable. Both circuits were built and tested across contacts of standard contactors operating at full rated voltage and current in MIL-L-6081C turbine oil at 0 to 5000 psi. Unsquelched

contacts, in both ac and dc contactors, invariably failed in less than 10 cycles at any pressure above 500 psi while the squelched contacts operated perfectly at all pressures and showed only a very faint discoloration on the contact surfaces after several thousand cycles at maximum pressure of 5000 psi. Inductive as well as resistive loads were used in the tests.

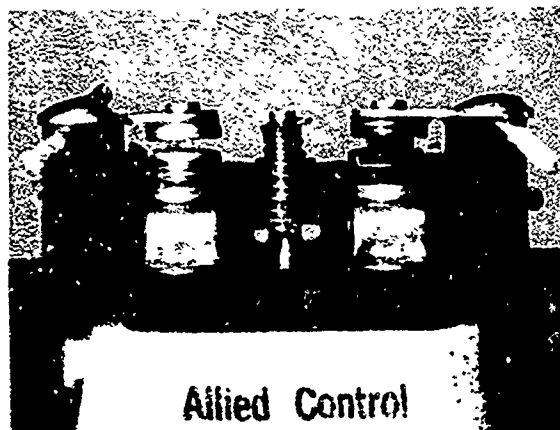
Fig. 9. Test relay contacts.

In the photo of Figure 9, a test relay is shown. Both sets of contacts were wired to identical 4 A inductive loads. The power supply was 120 V 60 Hz. The test was conducted at 2000 psi. The unsquelched set of contacts on the right failed during the first 5 make-break cycles, so power was removed from this pair only. The other (SCR squelched) pair of contacts on the left are in perfect condition after more than 2000 make-break cycles under load.
