TECHNICAL REPORT

72-59-CE

**ENGINEERING EVALUATION OF AGE LIFE EXTENSION,  
T-10 HARNESES, RISERS AND  
T-10 TROOP CHEST RESERVE PARACHUTE CANOPIES**

March 1972

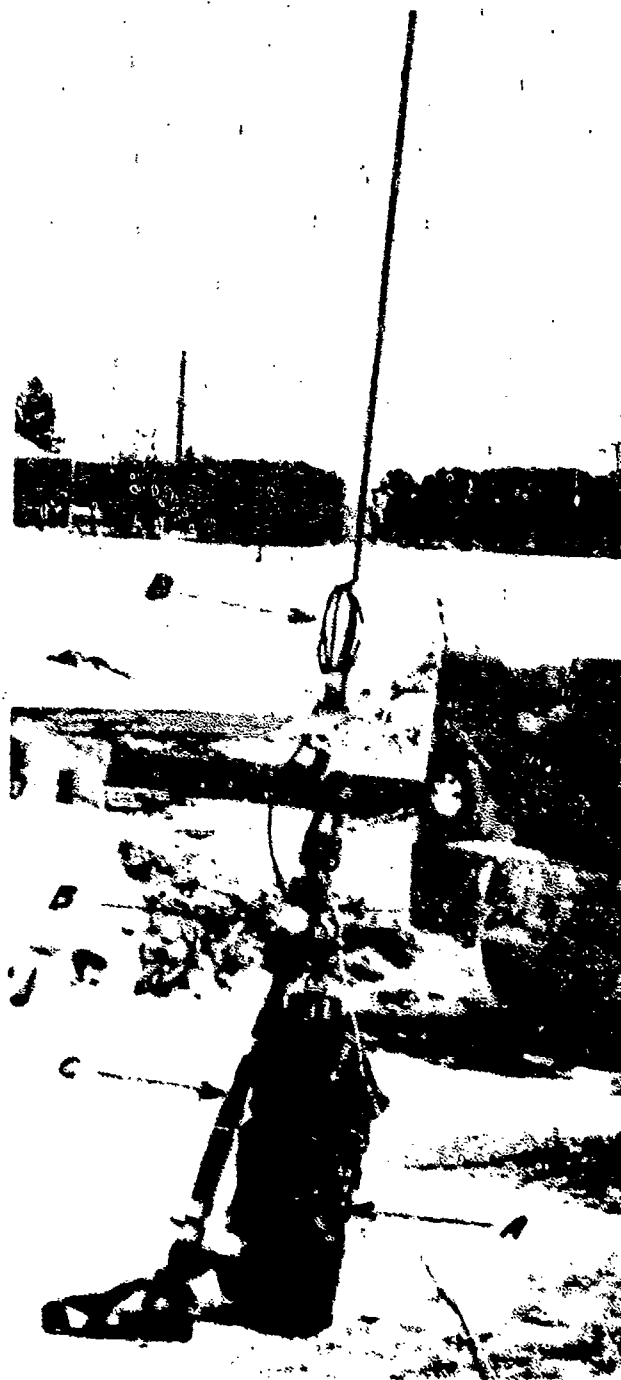
PHOTO 1  
T-10 Troop Type Parachute Harness Rigged on 250  
LB Torso Dummy

- a. Harness
- b. Load Cell and Wiring
- c. Drop Line
- e. Manual Release

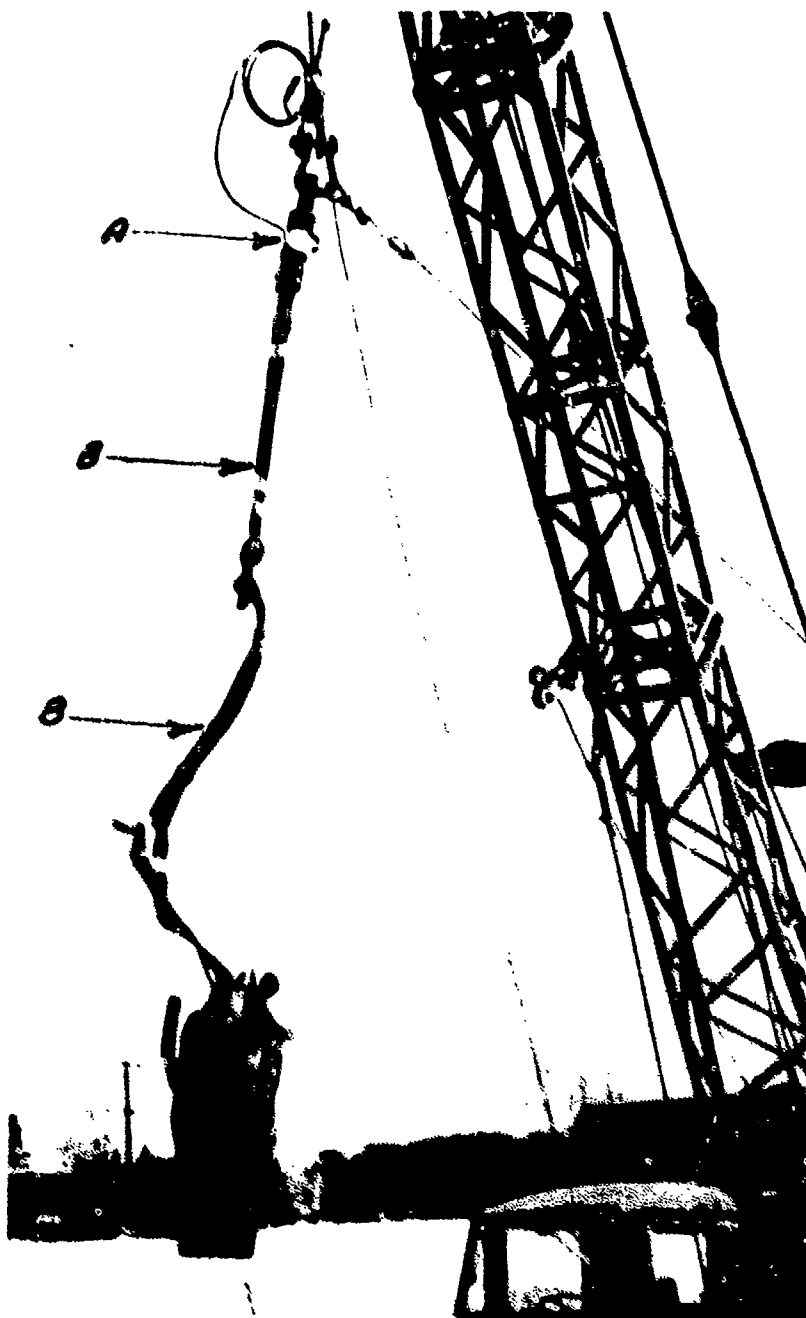
PHOTO 3

Harness and Dummy During Drop Prior to Impact

a. Load Cell

b. Drop Line
