Report No. R-981

BOSSLER COUPLING EXPERIMENTAL FLIGHT TEST

FINAL REPORT

KAMAN AEROSPACE
CORPORATION
OLD WINDSOR ROAD, BLOOMFIELD, CONNECTICUT 06002

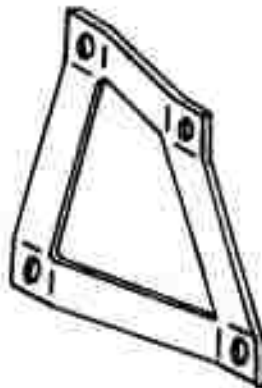
BOSSLER COUPLING

The Bossler coupling is a new flexible driveshaft coupling. It transmits torque through axially-loaded straight elements. It is structurally very efficient. Deformations resulting from shaft misalignments and changes in length are distributed among the many slender straight elements that comprise the coupling. The coupling geometry is illustrated on the following page.

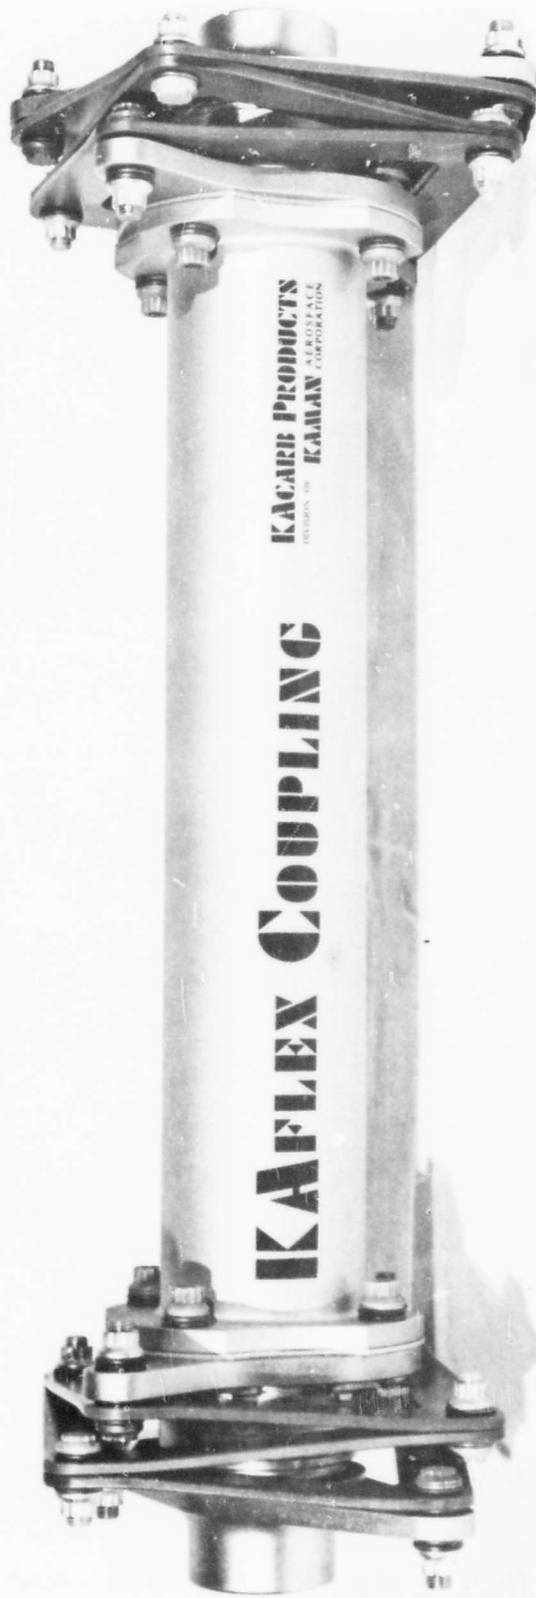
Figure 1. Driveshaft Assembly

The driveshaft assembly is shown in Figure 1. The component parts are identified on the schematic sketch, below.

It was observed that all the coupling plate failures originated in the contact areas where the end plate is bolted against the bushing face of a shaft hub, see Figures 1, 2, and 3.

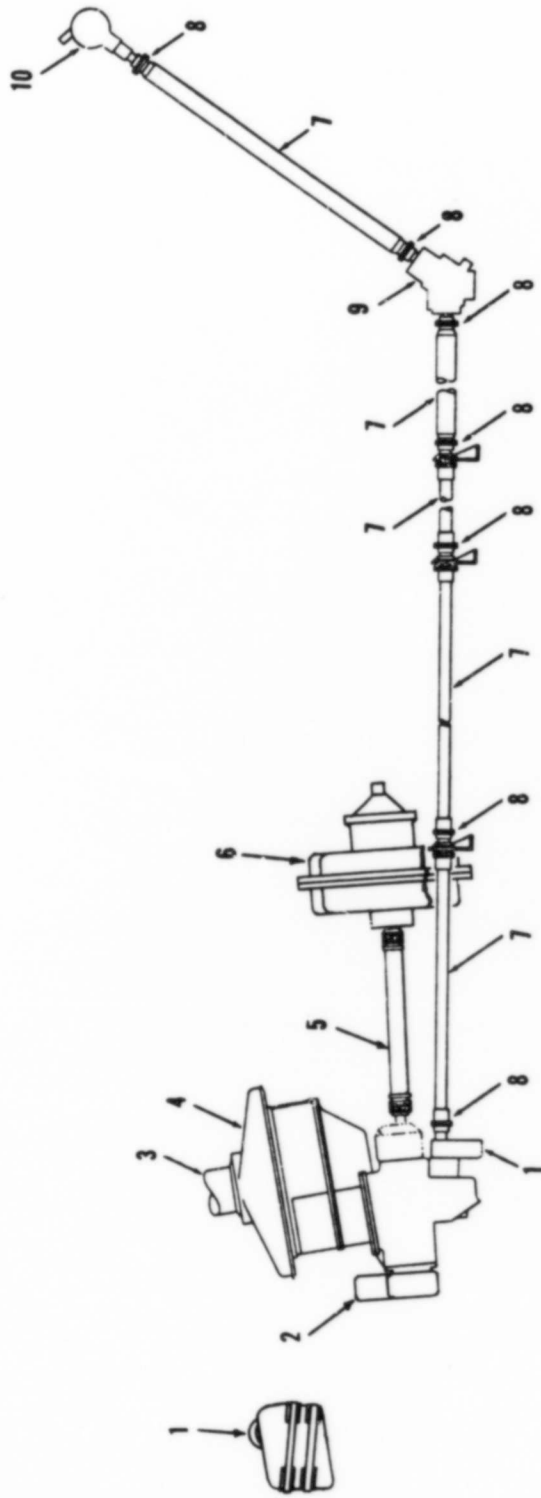
Figure 10. Transmission System

| 1. Oil supply system | 6. Combining gearbox |
| 5. Main drive shaft | 10. Tail rotor gearbox |
