# CHARACTERIZATION OF IR WINDOWS SEMIANNUAL TECHNICAL REPORT

J. S. HAGGERTY, E. T. PETERS

JULY 1972

Arthur D Little, Inc

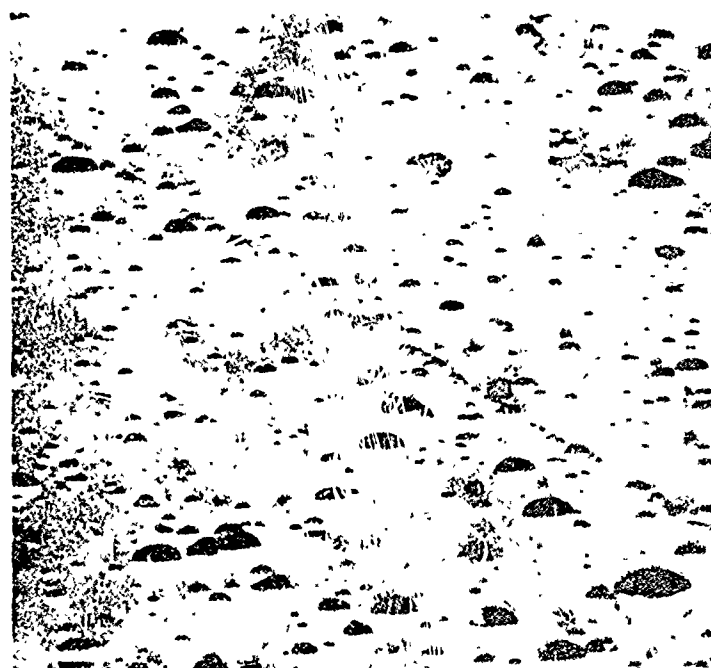
FIGURE 3 PHOTOGRAPHS OF GaAs SURFACE AFTER ION THINNING  
(a) OPTICAL MICROSCOPY (b) SCANNING ELECTRON  
MICROSCOPY

Initial characterization included visual examination of the surfaces by optical and scanning electron microscopy. In all cases, the ion thinned samples contained numerous shallow craters of varying diameter, as shown in Figure 3. Impingement of craters occurred frequently; in some cases, impingement was limited to two or three adjacent craters (labeled A in Figure 3); whereas in other cases, impingement was strung out along a line (labeled B). These same features are shown at higher magnification in Figure 4a. The edge of the sample, shown in Figure 4b, is apparently influenced by deposition and resputtering of copper from the heat sink substrate, resulting in the characteristic cone structures. Occasionally cones were observed in craters away from the sample edge.

At present, we have no understanding of why craters form. They are apparently the result of preferential sputtering at specific points, which then widen spherically. They become evident (25X optical microscopy) only after approximately 8 $\mu$ m of material has been sputtered off. One can speculate that craters originate at point defects, i.e., regions of high strain (such as dislocation cores) or chemical inhomogeneity (precipitates). Were this the case, the largest craters would be expected to be the earliest formed (that is, nearest to the original surface). However, the linear arrays of craters, which are reminiscent of polishing scratches on the original surface, are generally formed from fairly small diameter craters. Rather than pursue a thorough understanding of the ion thinning process at this time, we intend to compare the distribution of surface craters to other structural features that are observed by X-ray topography, infrared microscopy and electron microscopy. Consequently, surface photographs of crater distributions were obtained from three of the thinned GaAs slices at several magnifications. These photographs will be presented together with the X-ray topographic data.

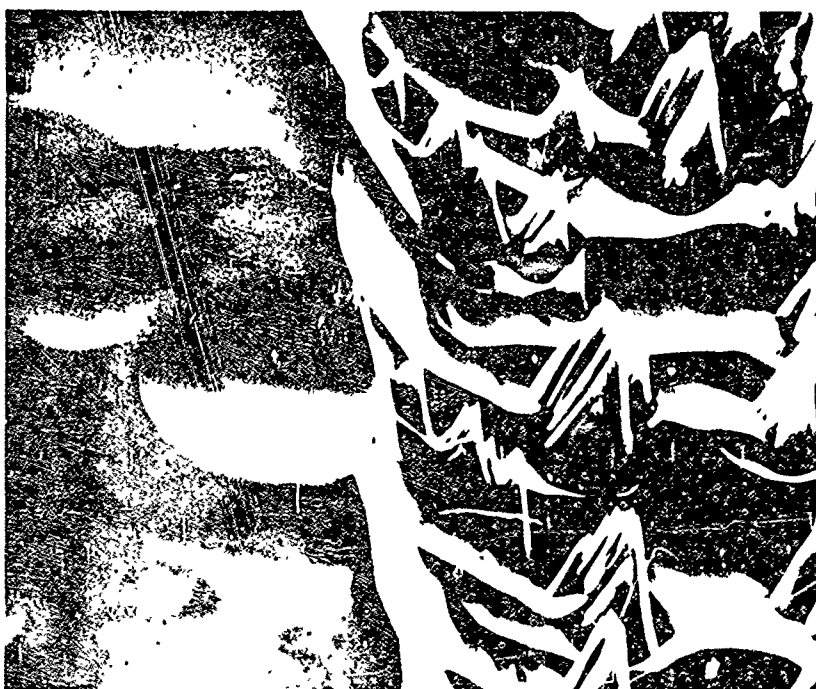
FIGURE 4 SCANNING ELECTRON MICROGRAPHS OF GaAs SURFACE  
AFTER ION THINNING (a) CENTER OF SAMPLE  
(b) EDGE OF SAMPLE
