# THE EFFECT OF AGING TIME ON SPALLATION OF 2024-T6 ALUMINUM

ROBERT B. HERRING and GREGORY B. OLSON  
METALS DIVISION

December 1971

AMMRC TR 71-61

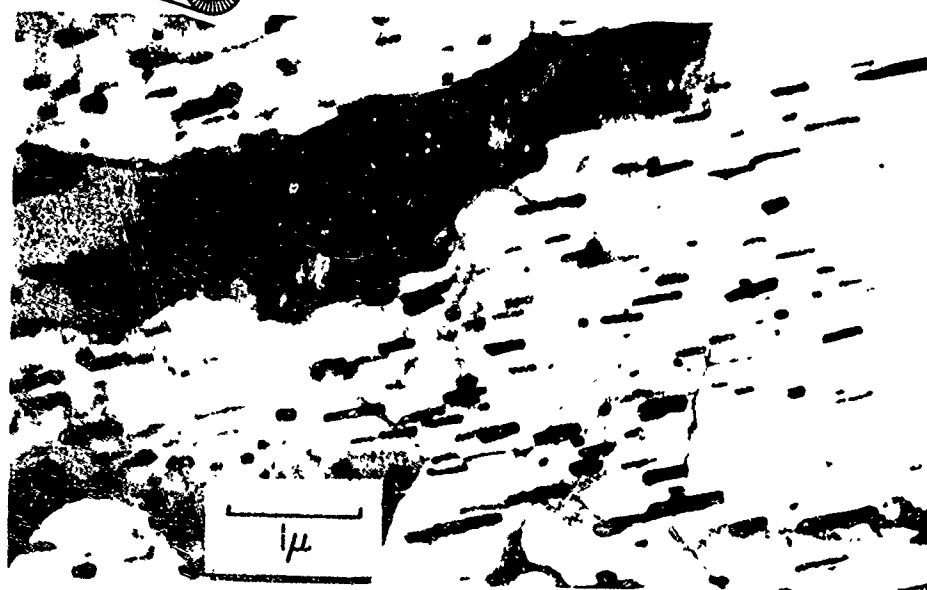
Figure 12. Set I Material Cut Longitudinal to the Rolling Direction  
Showing the Distribution of Dispersoid Particles and  
Subgrain Structure

A second class of noncoherent particles, such as those shown in Figure 12, was also present. Those particles were smaller, 0.5  $\mu$  to 1.0  $\mu$  long and 0.1 to 0.2  $\mu$  thick, and they were also elongated in the original plate rolling direction. They were rather uniformly distributed at particle spacings of

0.5 to 1.0 $\mu$ . Those smaller, noncoherent particles, sometimes called dispersoid particles, have been identified<sup>11</sup> as complex intermetallic compounds containing aluminum, manganese, magnesium, iron, and silicon. In a high purity Al-0.6% Mn alloy, they have been identified as Al<sub>6</sub>Mn. The chief function in the alloy of those dispersoid particles appears to be the control of grain growth during the solution treatments which mainly affect the copper rich precipitate phase.

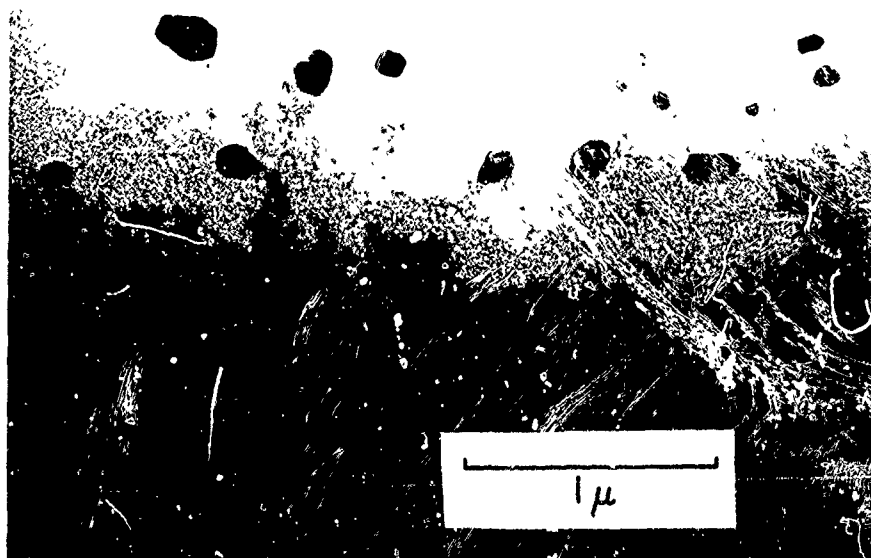
Figure 13. Set I Material Cut Transverse to the Rolling Direction. The Al-Cu-Mg Hardening Precipitate is not Resolved but Contributes the Speckled Background

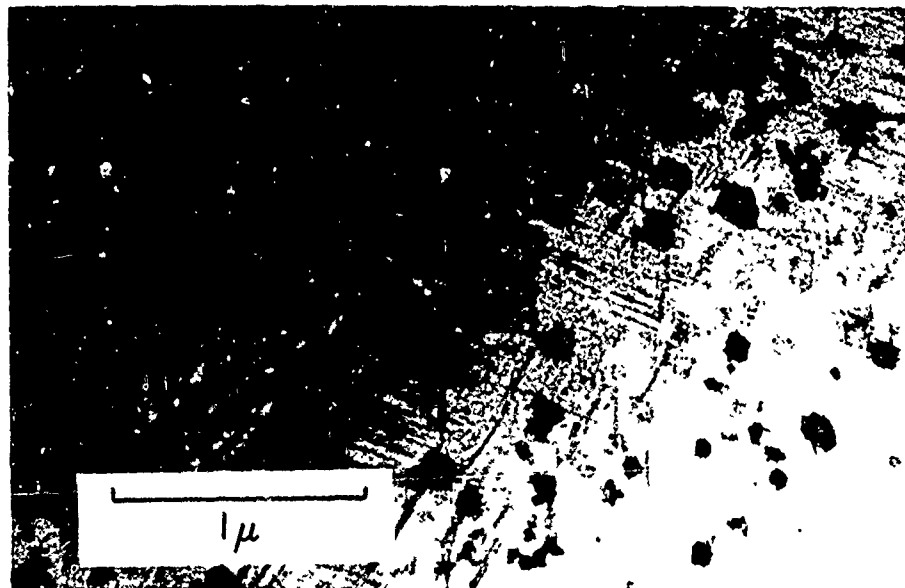
Figure 15. Set II Material Unshocked – After 12 Hr Aging at 190C, the Hardening Precipitate is Resolved as Sets of Fine Parallel Laths

Figure 15 shows a transverse section of set II (peak hardness) material in the unshocked condition. In that condition, the hardening precipitate is resolved as two sets of fine parallel laths which appear almost at right angles in this orientation. In Al-Cu-Mg alloys, the final aging product has been identified as Al<sub>2</sub>CuMg, commonly referred to as S phase, which has been determined by Perlitz and Westgren<sup>12</sup> to be orthorhombic with lattice parameters of  $a = 4.00$ ,  $b = 9.23$ , and  $c = 7.14\text{\AA}$ . The formation of the S phase has been studied by Silcock<sup>13</sup> who reported the precipitation to occur by a series of steps represented by
