**INVESTIGATION OF THE PROPERTIES OF  
CARBON-CARBON COMPOSITES  
AND THEIR RELATIONSHIP TO  
NONDESTRUCTIVE TEST MEASUREMENTS**

*McDONNELL DOUGLAS ASTRONAUTICS COMPANY*

TECHNICAL REPORT AFML-TR-70-213, PART II

AUGUST, 1971

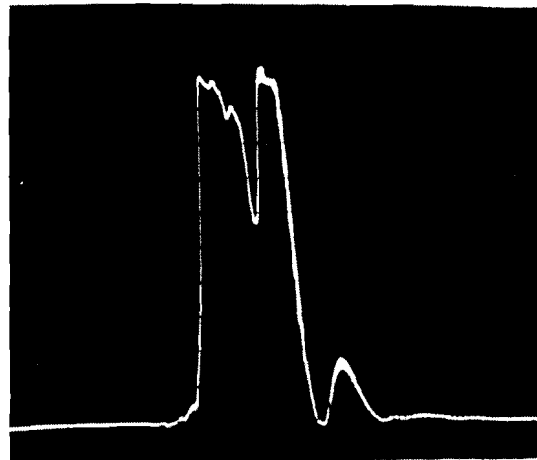
Front and Back Surface  
Indications for No-  
Intentional-Defect  
Area using 3/8-Inch  
Focused Transducer

3/16-Inch Flat-Bottom  
Hole Defect Response  
Using 3/8-Inch Focused  
Transducer

3/16-Inch Flat-Bottom  
Hole Defect Response  
Using 3/8-Inch Flat  
Transducer
