DESIGN AND TESTING OF A BLAST-RESISTANT  
REINFORCED CONCRETE SLAB SYSTEM

Marvin E. Criswell

TECHNICAL REPORT N-72-10

Conducted by **U. S. Army Engineer Waterways Experiment Station**  
**Weapons Effects Laboratory**  
**Vicksburg, Mississippi**

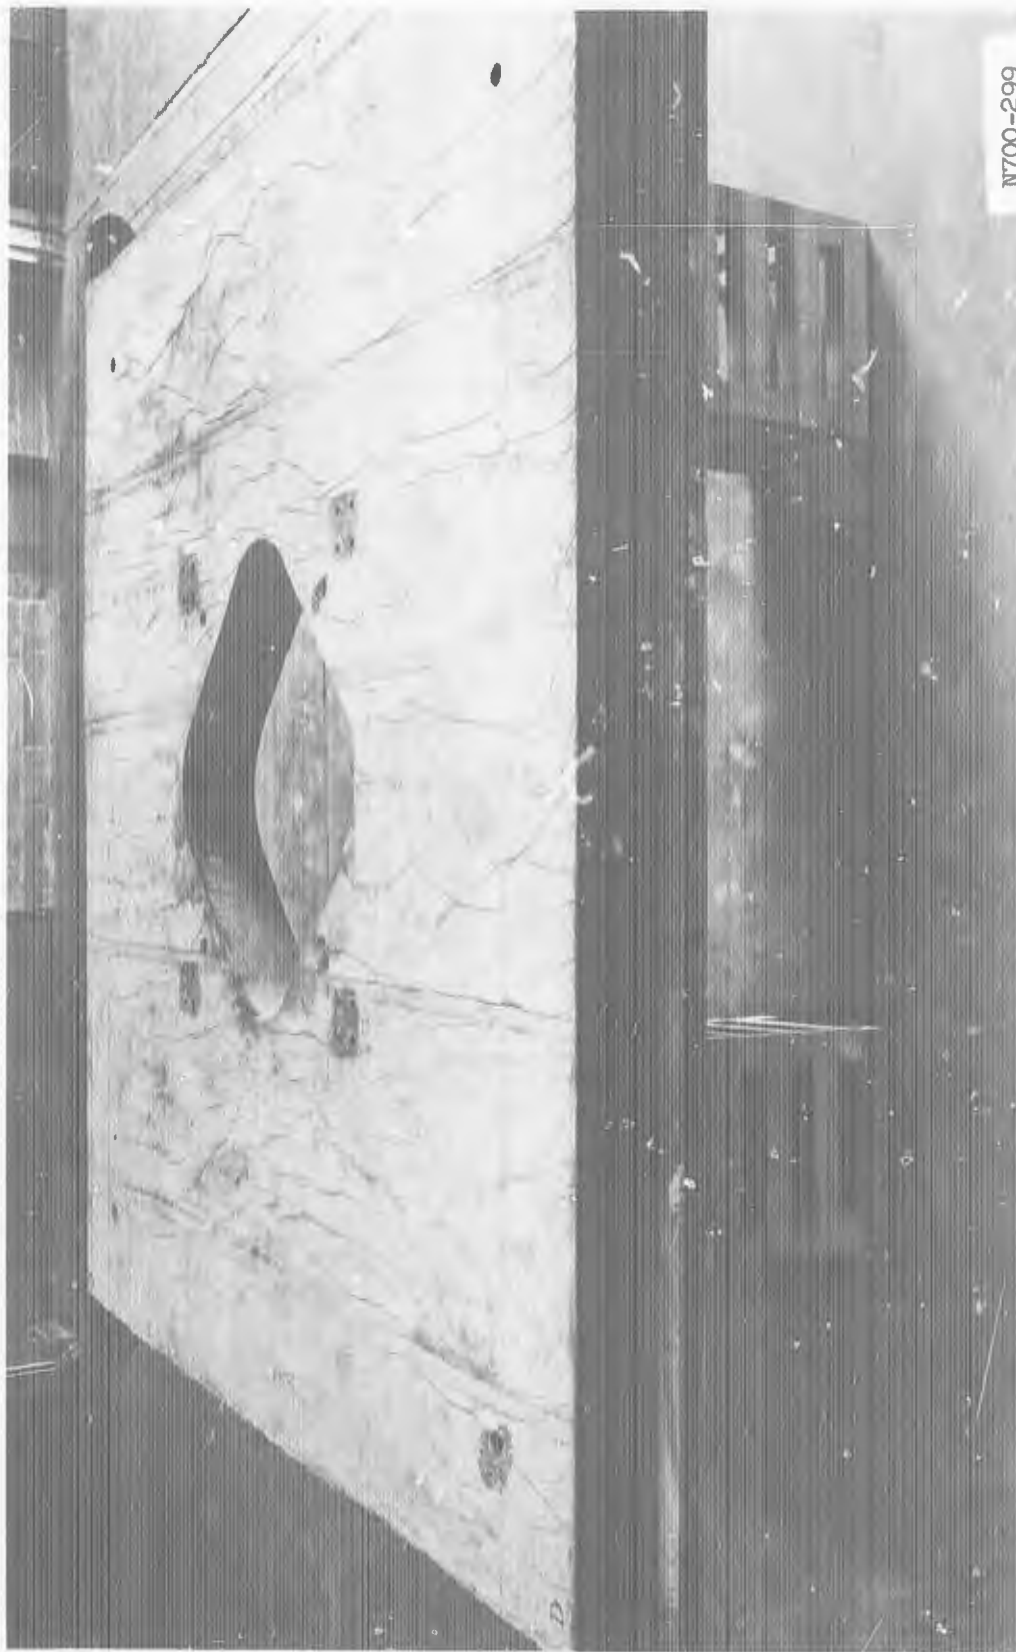
Figure 3.4 Base slab ready for start of model formwork construction.

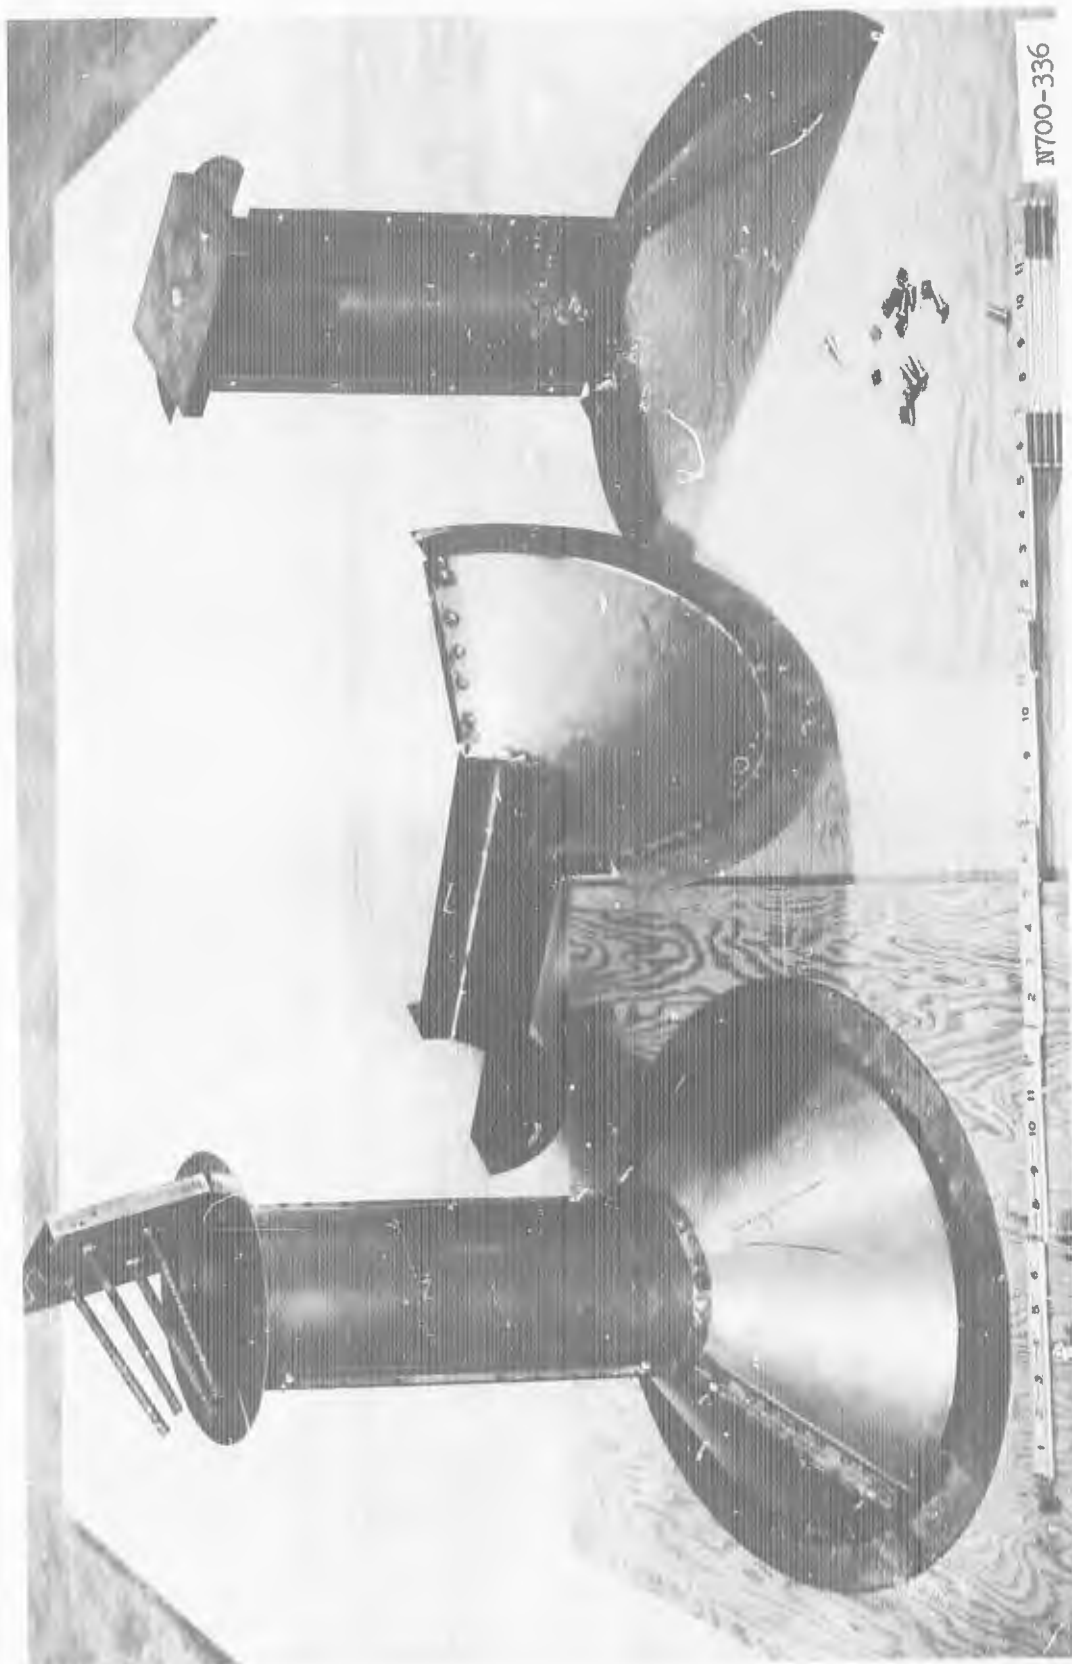
Figure 3.10 Column and capital forms and column base plates.

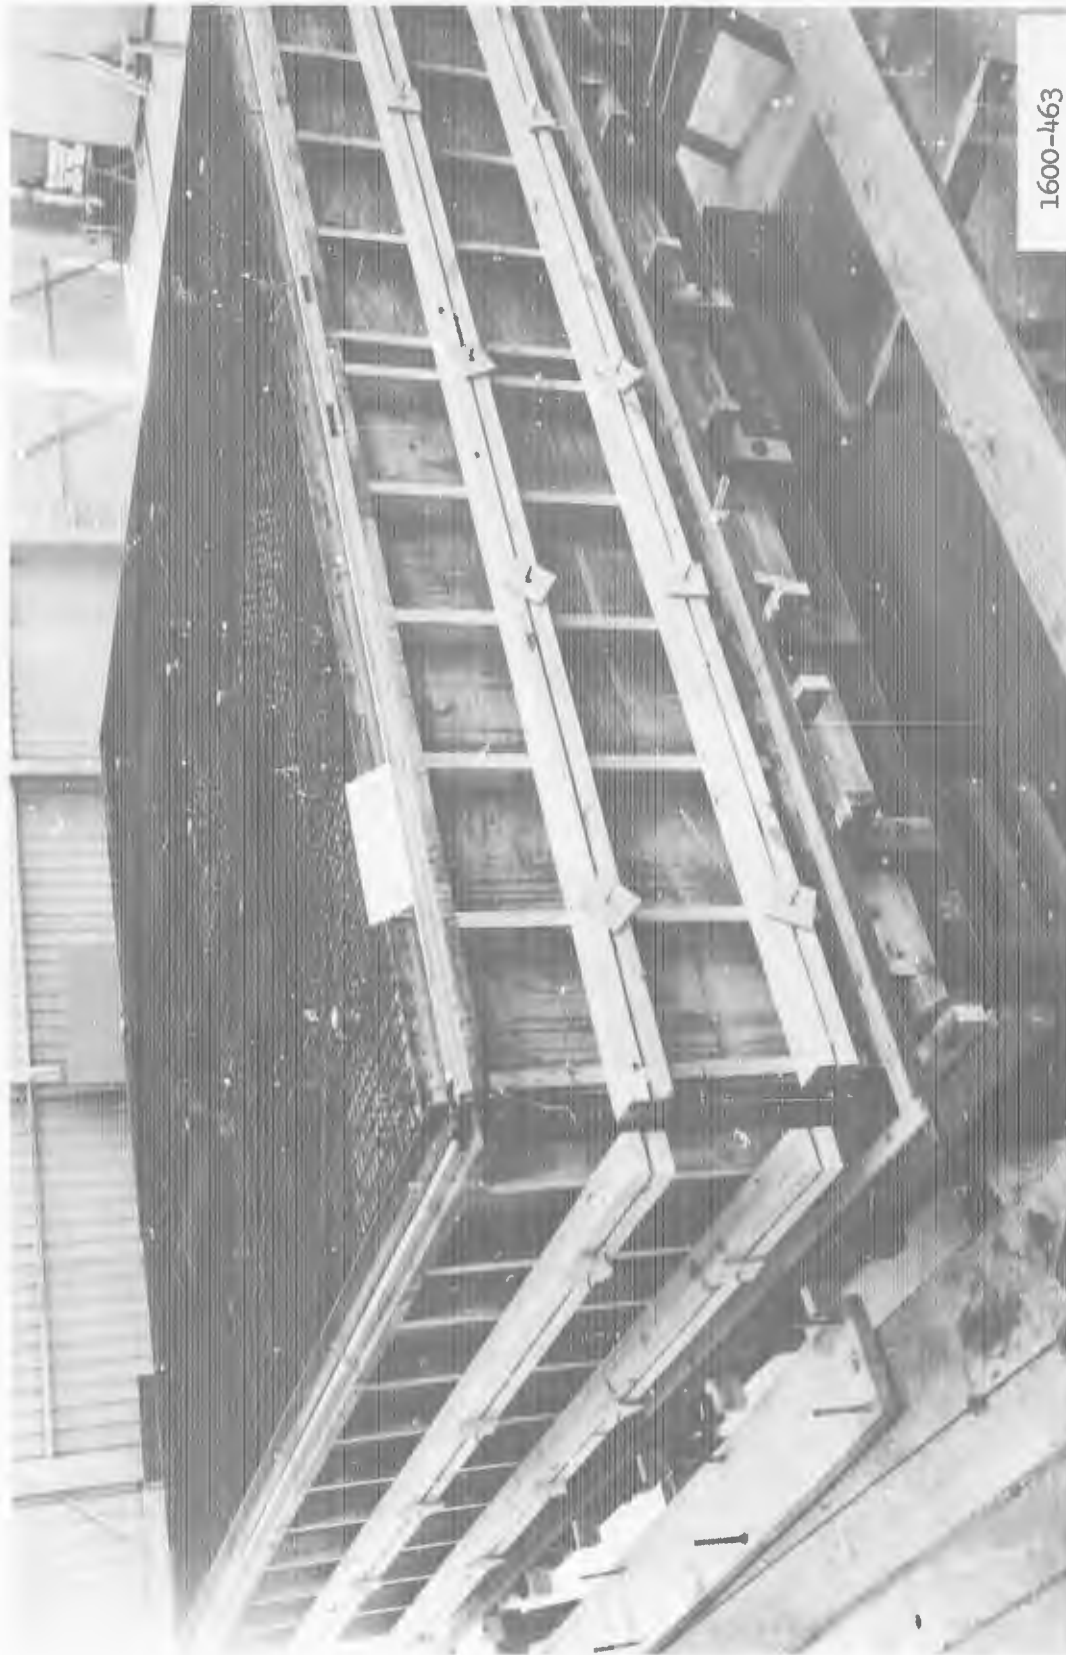
Figure 3.26 Slab model and formwork ready for casting of concrete.

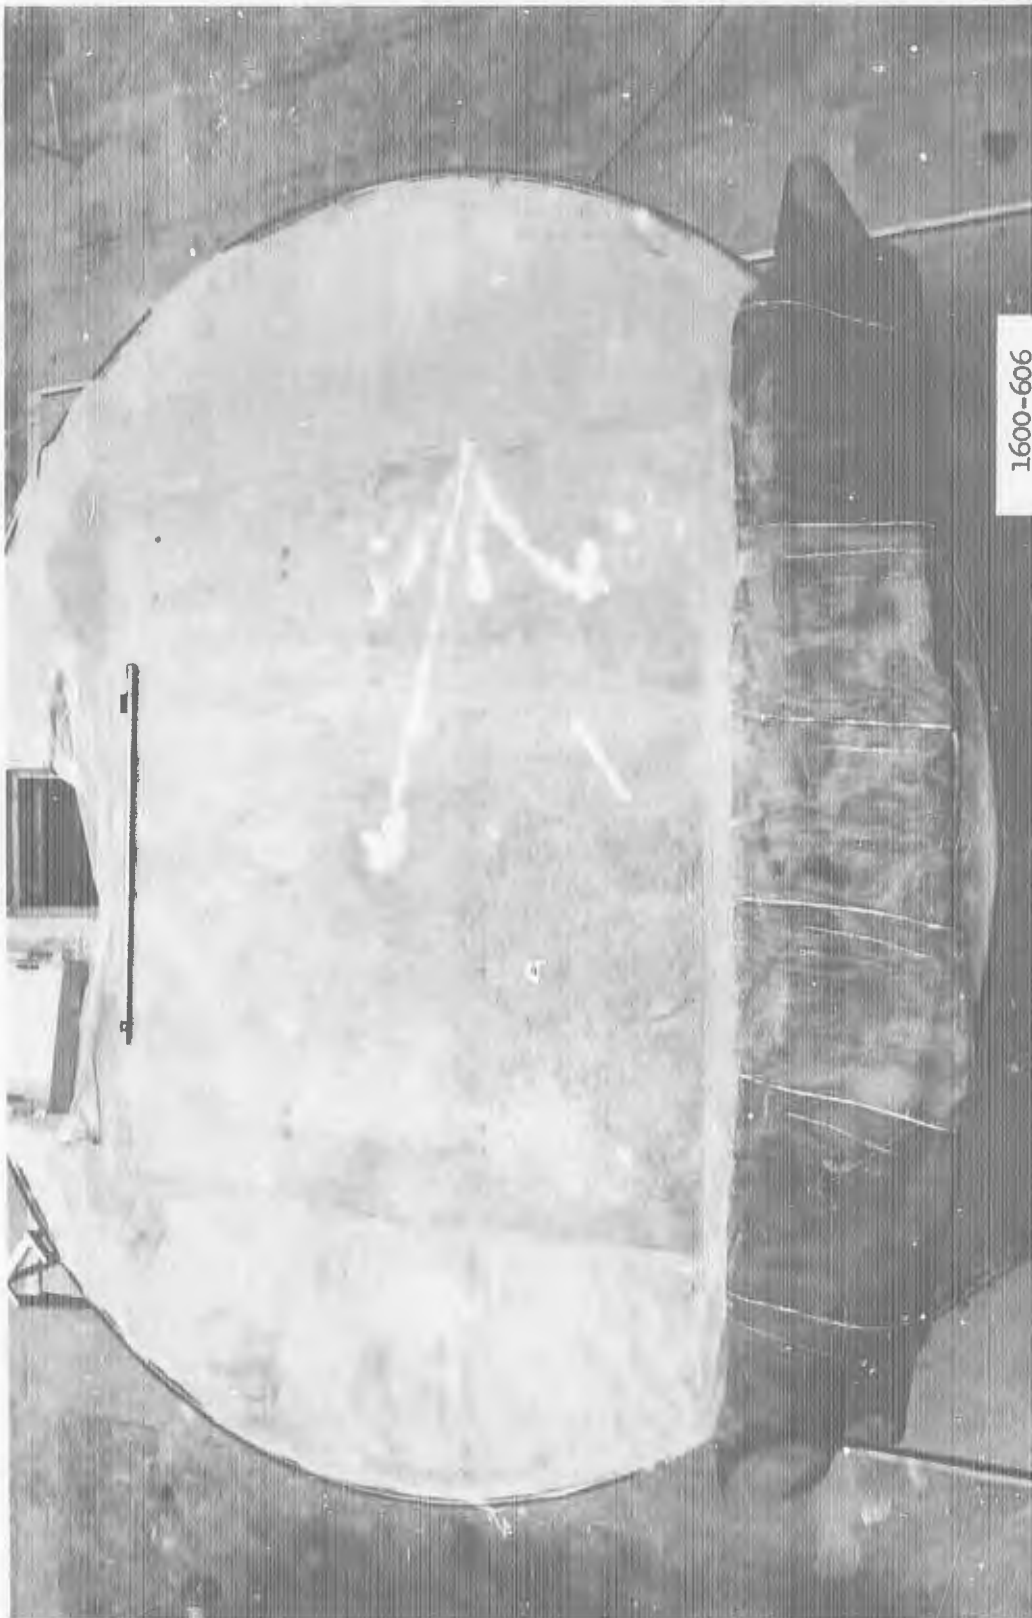
Figure 4.15 Slab surface after Dynamic Test I.

The first loading of the dynamically tested model was at an overpressure of 19.7 psi and a rise time of 8-1/2 msec. The model sustained very little damage and performed largely within its elastic range. Cracking and some yielding of the reinforcement occurred at the negative moment section of the slab over the inner face of the wall. Minor cracking along the centers of some panels occurred on the underside of the slab.

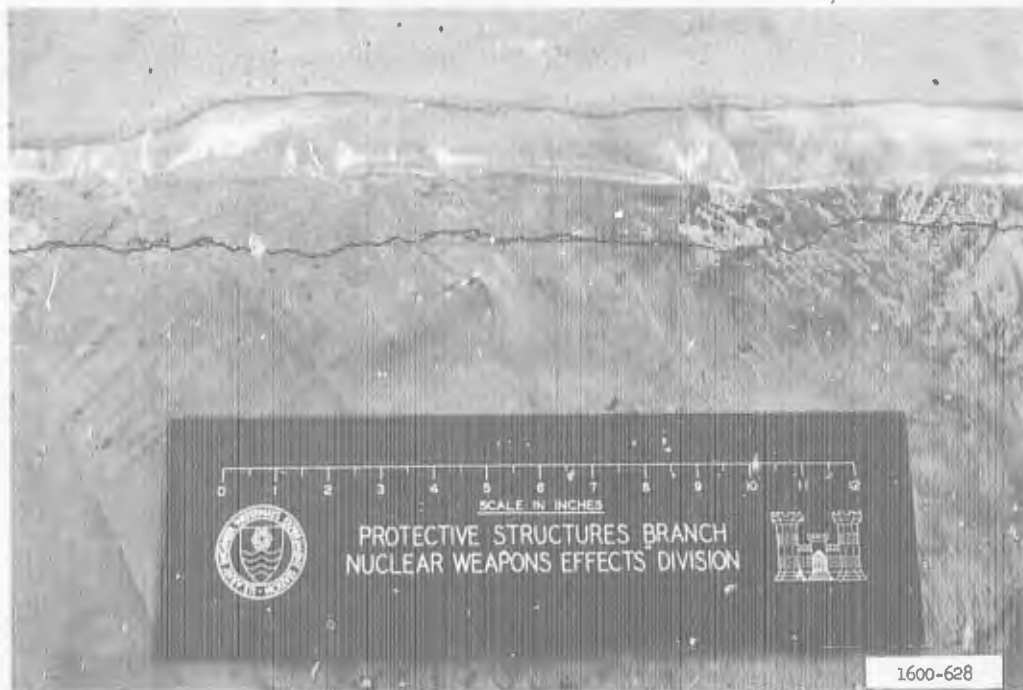
Figure 4.16 Crack over inner wall face, north side of specimen after Dynamic Test I.

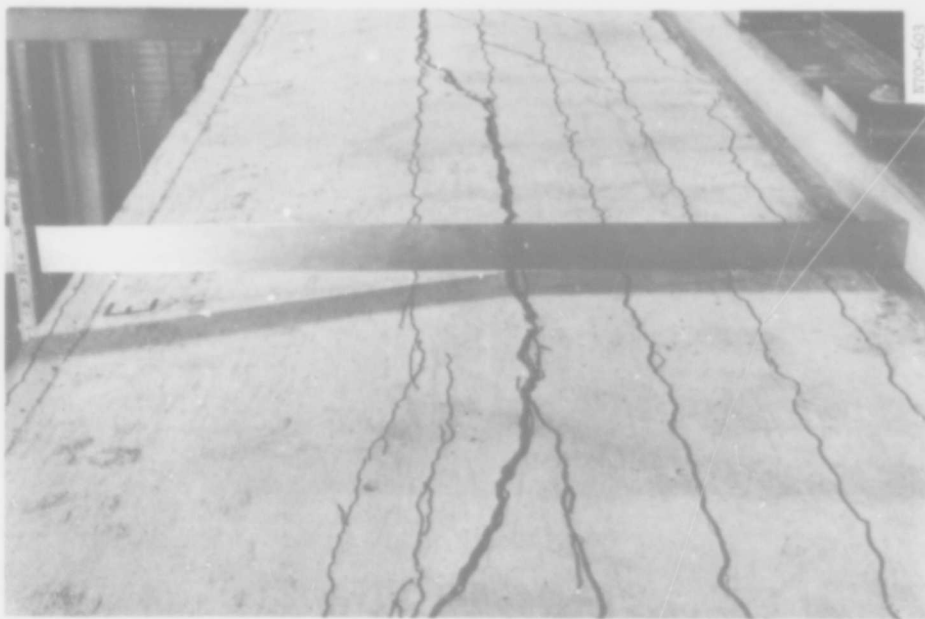
Figure 4.29 Rotation at east wall midheight after Dynamic Test II.
