EVALUATION OF MODIFICATIONS OF AM2 AND
XM18 LANDING MAT

MISCELLANEOUS PAPER S-70-5

Sponsored by Naval Air Engineering Center, Philadelphia, Pennsylvania

Conducted by U. S. Army Engineer Waterways Experiment Station, Vicksburg, Mississippi

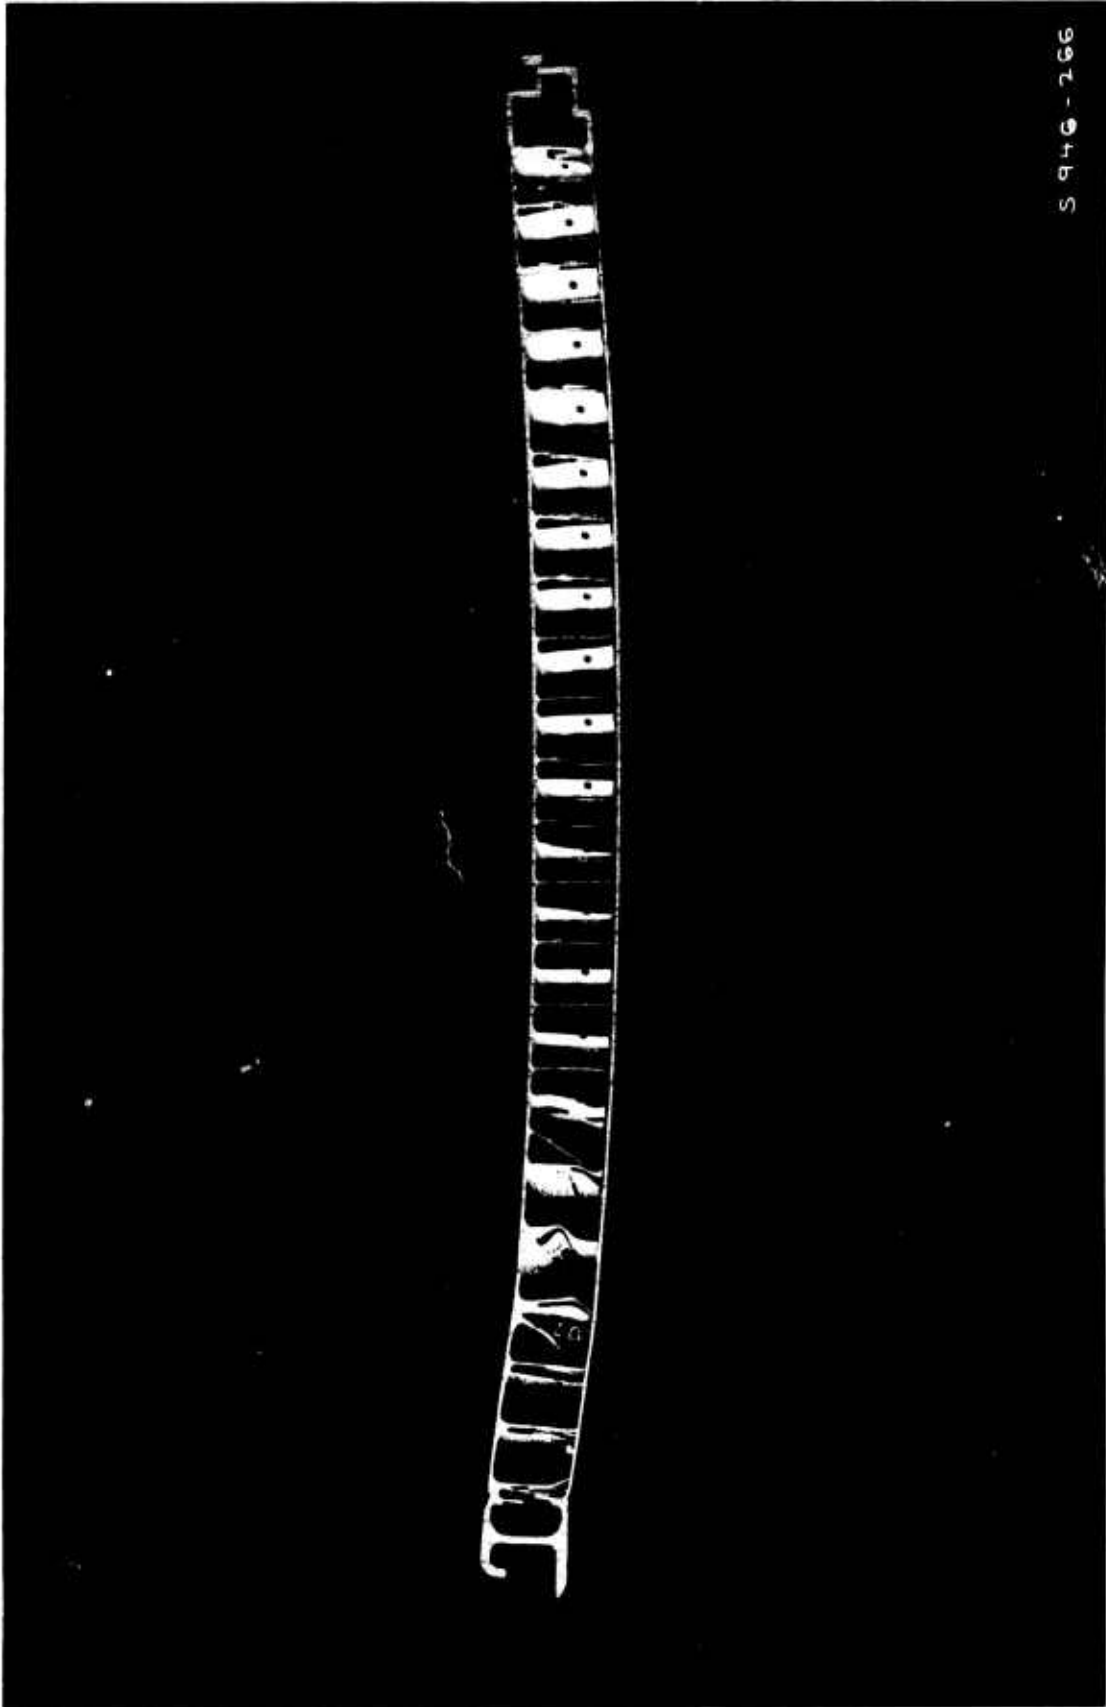
Photograph 5. Cross section of AM2 mat panel 6 after failure at six coverages.
Damaged plank removed from test section and cut for inspection

27. Test item 1 (Alcoa AM2) sustained 72 coverages of traffic before failure. A total of eight panels were failed due to excessive dishing. A cross-sectional view of a failed panel is shown in photograph 5. It can be seen in the photograph that the core has separated from the bottom skin. This separation in turn led to the buckling of the core (dishing) with increased traffic. Small end-joint weld cracks were observed in three panels at failure; however, the weld cracks did not present a tire hazard and did not contribute to the failure of the test item. Soil strength of the subgrade for item 1 during the period of traffic was rated at 4.3 CBR.

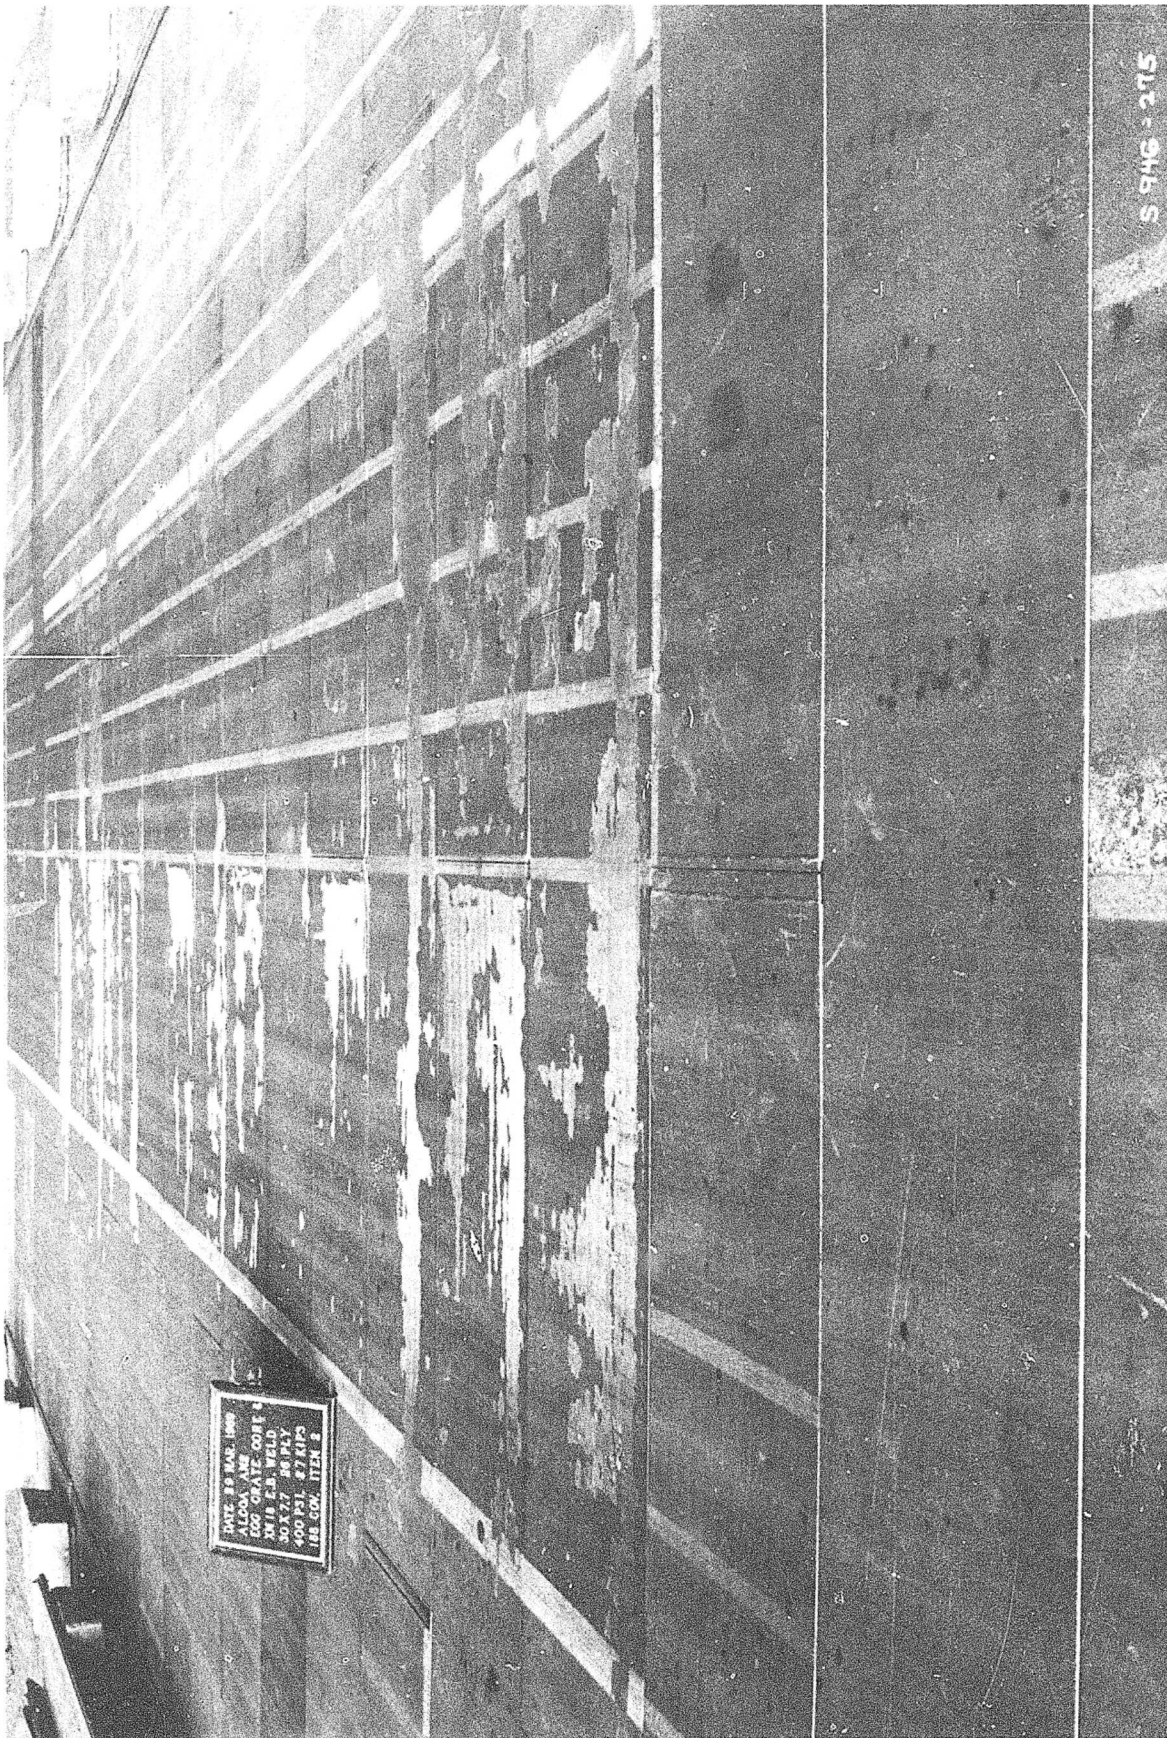
Photograph 14. Item 2 at failure after 188 coverages

of nine panels were failed throughout the traffic period. An overall view of item 2 at failure is shown in photograph 14.

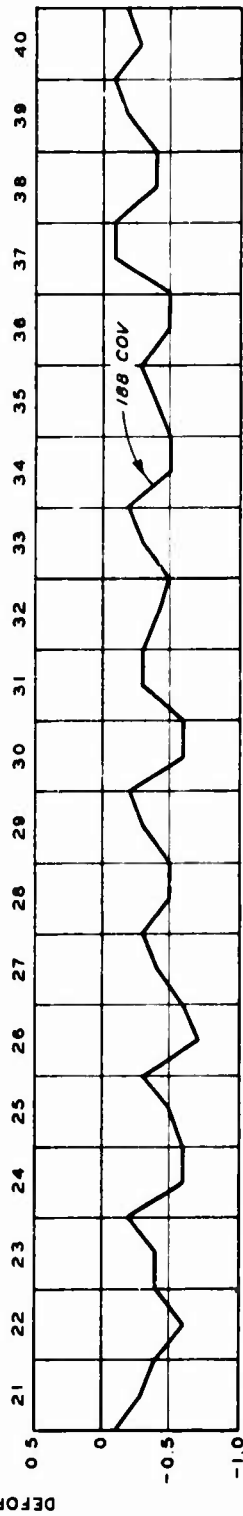
CENTER-LINE PROFILES

23. Plots showing permanent deformation as determined from level readings taken prior to and at failure of the test items are shown in plate 5. Cross sections were taken at several locations, and the results shown in plate 5 are averages of all the readings. The maximum deformation for items 1 and 2 was 0.4 and 0.7, respectively. A plot of deformation along the center line of the traffic lane is shown in plate 6.
