EXPLOSIVE CLADDING MAJOR CALIBER GUN  
BARRELS. FEASIBILITY STUDY

REPORT NO. MT 012

# EXPLOSIVE CLADDING MAJOR CALIBER GUN BARRELS

FEASIBILITY STUDY

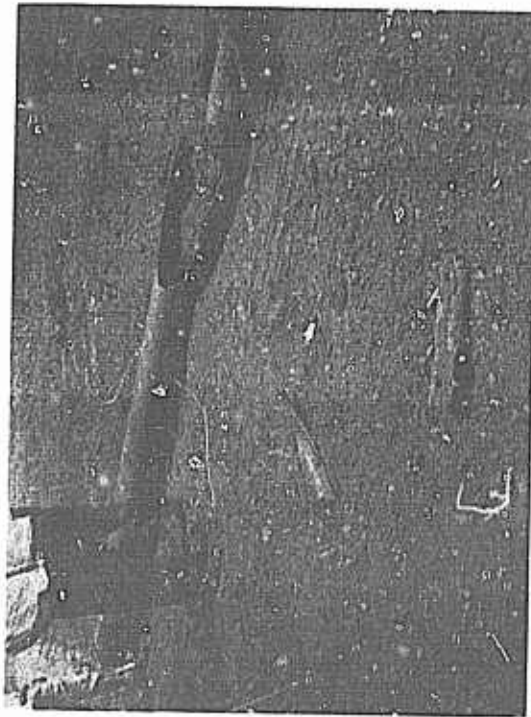
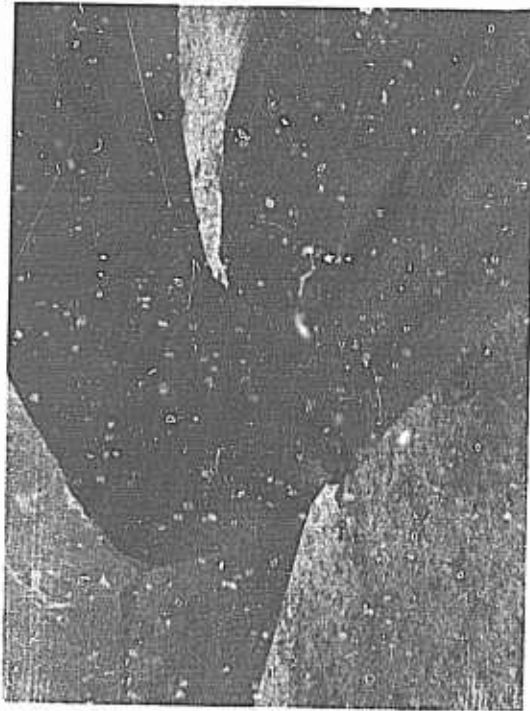
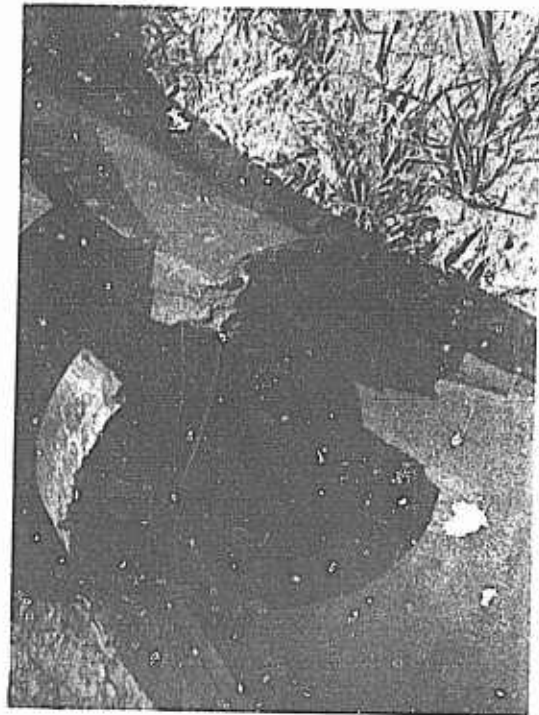
FIGURE 5

A. FIRST TRIAL AT CLADDING

B. RUPTURED 5" GUN BARREL & LINER

C. 5" BARREL & LINER WITH 8" RESTRAINT

D. 8" RESTRAINT & 5" BARREL

The experiment with sample S6 resulted in the barrel rupturing approximately 84 inches in length, originating about 30 inches from the muzzle end. The restraint failed in approximately half of its length. The consensus was with adequate restraint, cladding would have been successful; it appeared that the remainder of the barrel had been clad. (See photographs Figure 5).

Subsequent inspection indicated that very little cladding occurred and it was believed that when rupture occurred the effective pressure was reduced to the point where little or no useful energy remained.
