# DEVELOPMENT OF COMPOSITE CONSTRUCTIONS WITH IMPROVED RAIN EROSION RESISTANCE

BY  
BOYCE G. KIMMEL  
HUGHES AIRCRAFT COMPANY  
AEROSPACE GROUP

FINAL SUMMARY REPORT

Prepared Under  
Naval Air Systems Command  
Contract No. N00019-72-C-0257  
Materials and Processes Branch  
Washington, D.C. 20360

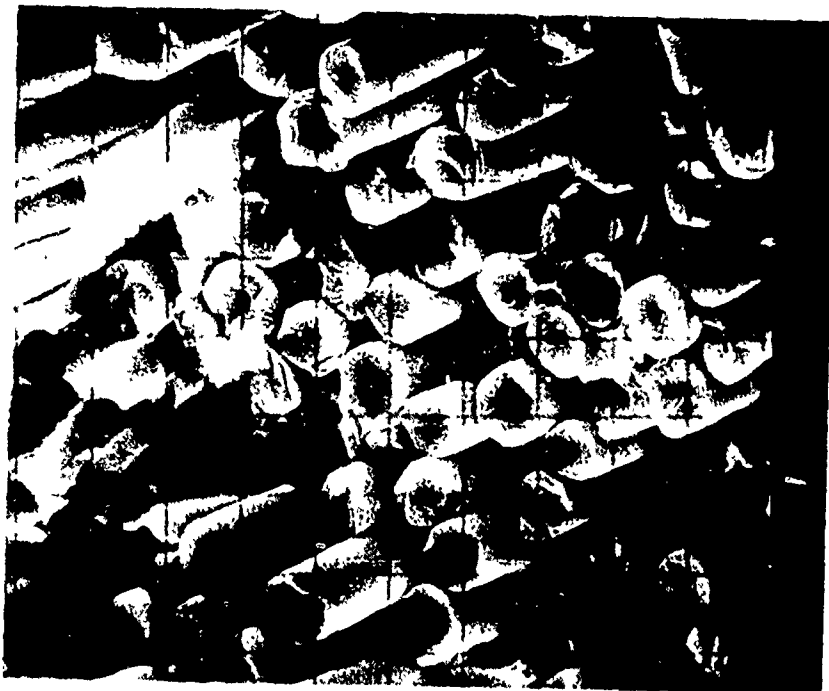
Erosion in pitNEG IDENT A15

Figure 8. Scanning electron Micrographs of specimen EP-9A  
(cont) (ECG-Epon 825/Versamid 140, 55/45, end-oriented)

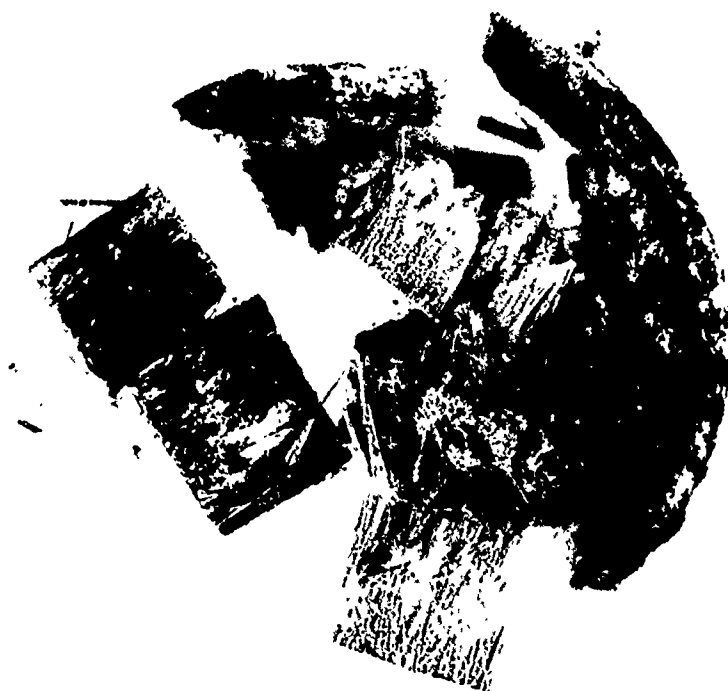
a. Specimen No. PO-2B, 10 seconds  
at 333 meters/second

Figure 14. ECG Glass Roving-534-801 Polyphenylene Oxide Cross-Lined with Benzenetrisulfonyl Chloride, end-oriented (Reinforcement Content = 79.1 volume-percent)

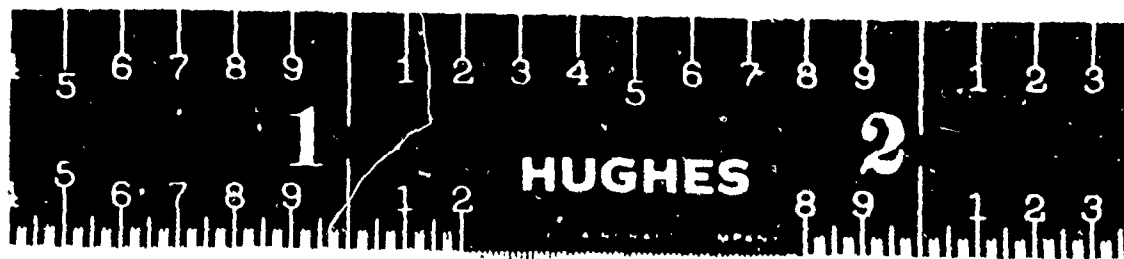
b. SPECIMEN NO. N-16E, 60 SECONDS AT 333 METERS/SECOND

c. SPECIMEN NO. N-16H, 120 SECONDS AT 333 METERS/SECOND

Figure 49. Nomex 1200 denier yarn (plasma-treated) - Epon 828/MPDA, end-oriented (reinforcement content = +1.2 volume-percent).

Previously, it was concluded from weight loss data only that higher fiber loadings were desirable. However, examination of the exposed specimens shows an increased tendency to crack with increased fiber loadings. The results seemed to indicate poor bonding between the matrix and the Nomex fibers. The same effect was observed, however, for Nomex-epoxy composites made from Nomex which had been plasma-treated to increase adhesion to the matrix.

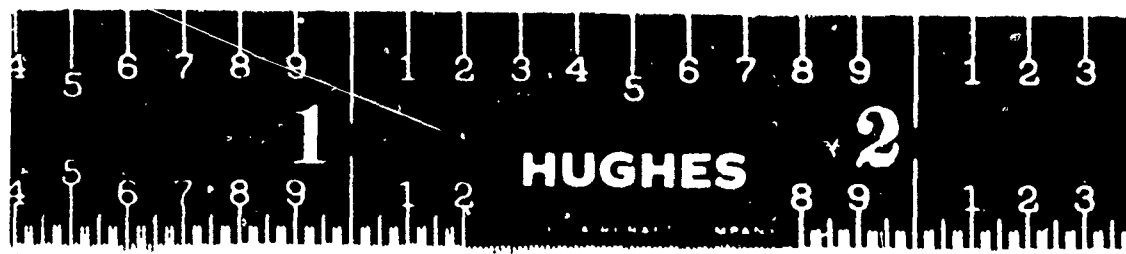
c. SPECIMEN NO. N-15H, 120  
SECONDS AT 333 METERS/  
SECOND

Figure 50. Nomex 1200 denier yarn (plasma-treated) - Epon 828/  
MPDA, end-oriented (reinforcement content =  
76.8 volume-percent).
