FLIGHT TEST EVALUATION OF FOLDING  
SIDEWALL EXPANDABLE TIRES ON THE  
C-131B AIRCRAFT

Aeronautical Systems Division  
Wright-Patterson Air Force Base, Ohio

January 1973

14  
ASD-TR-73-1

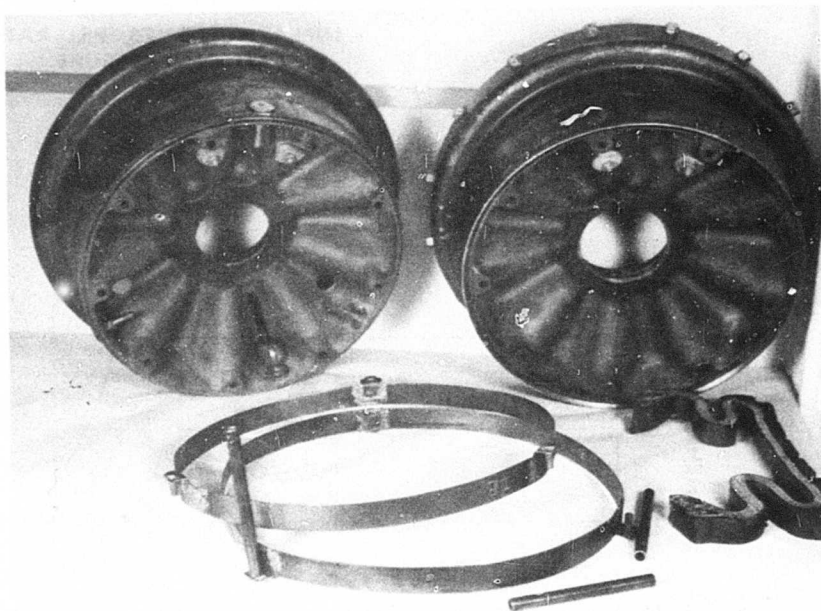
Figure 9a. Wheel and Bead Spacer Components.

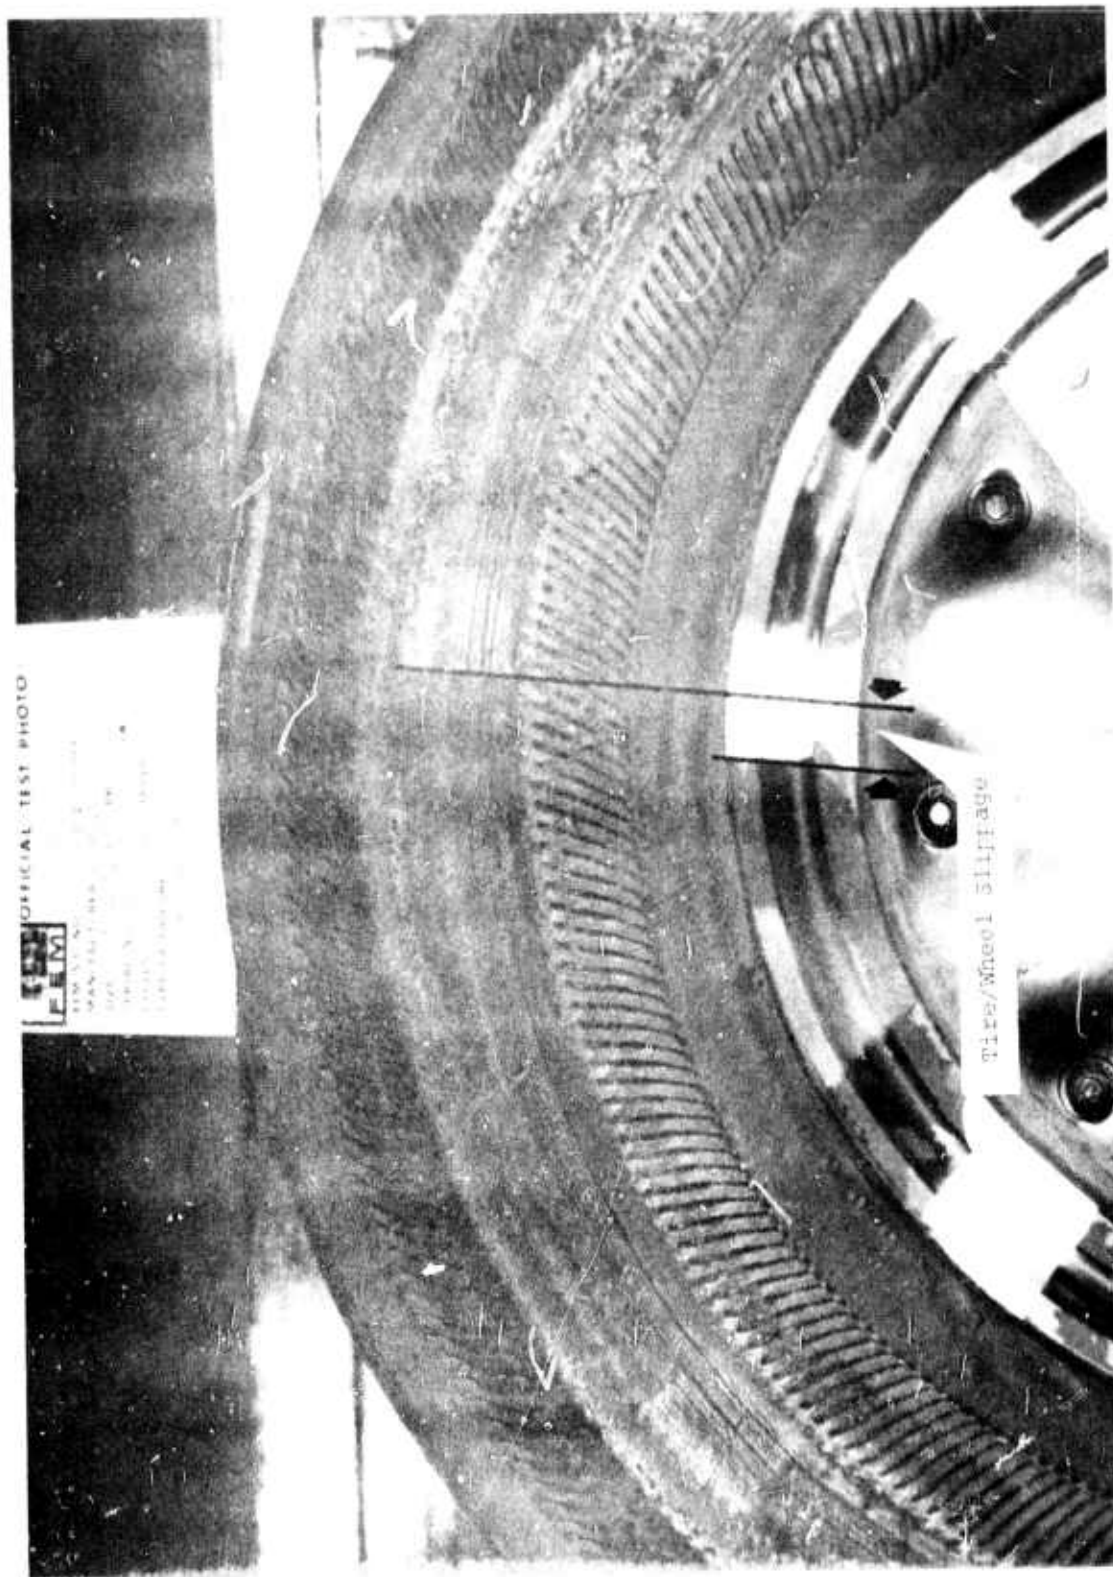
Figure 17. Close-up Of Outboard Sidewall Of Tire No N51-0035-17 After a High Speed Run-flat Pollout. Tire Is Inflated.

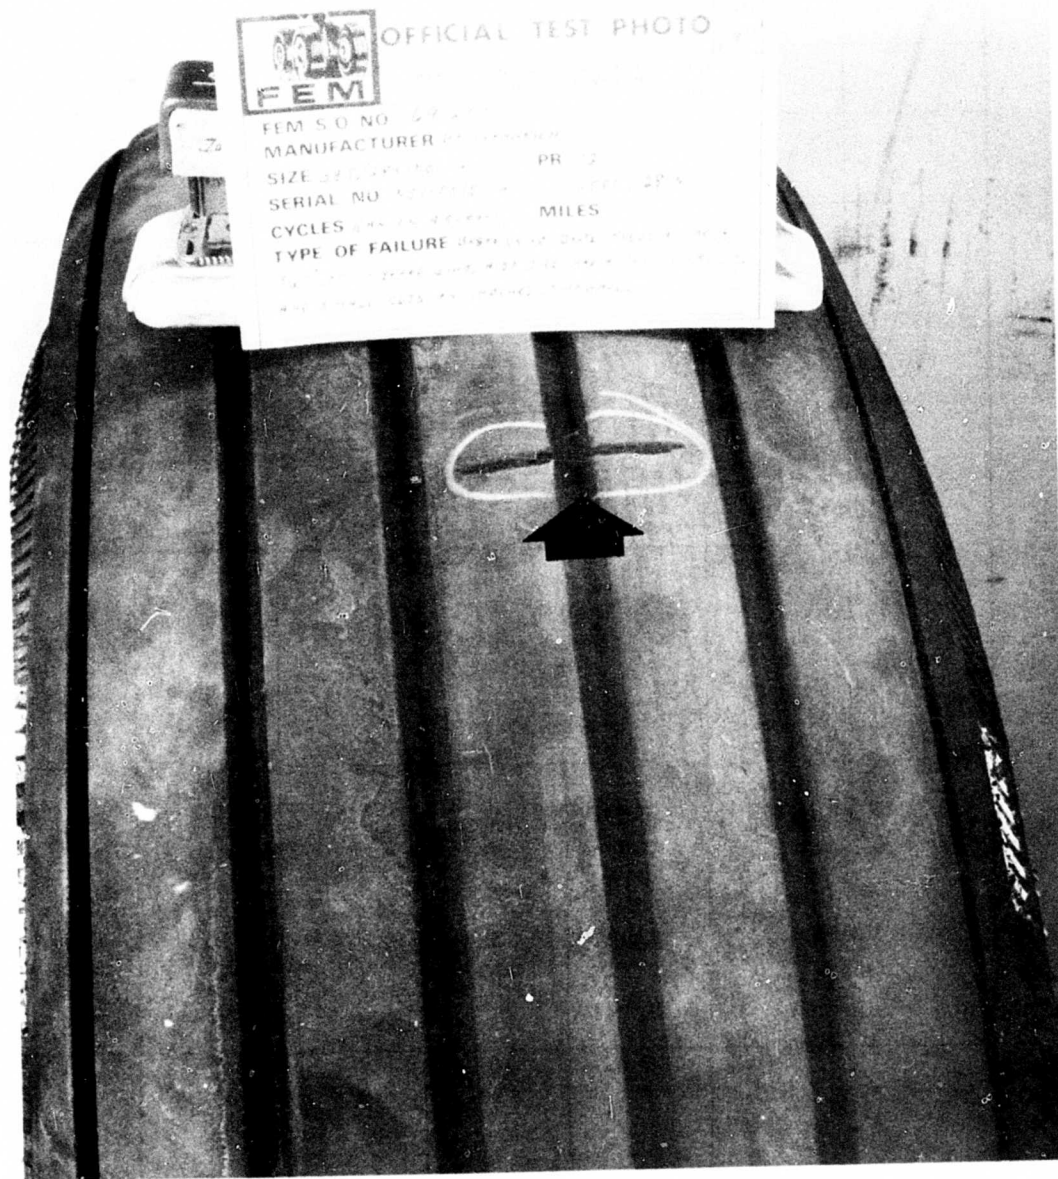
Figure 24. Tread Cut On Tire No N51-0035-16.
