SILICON NITRIDE IN ROLLING CONTACT BEARINGS

NORTON Co.

PREPARED FOR  
NAVAL AIR SYSTEMS COMMAND

OCTOBER 1973

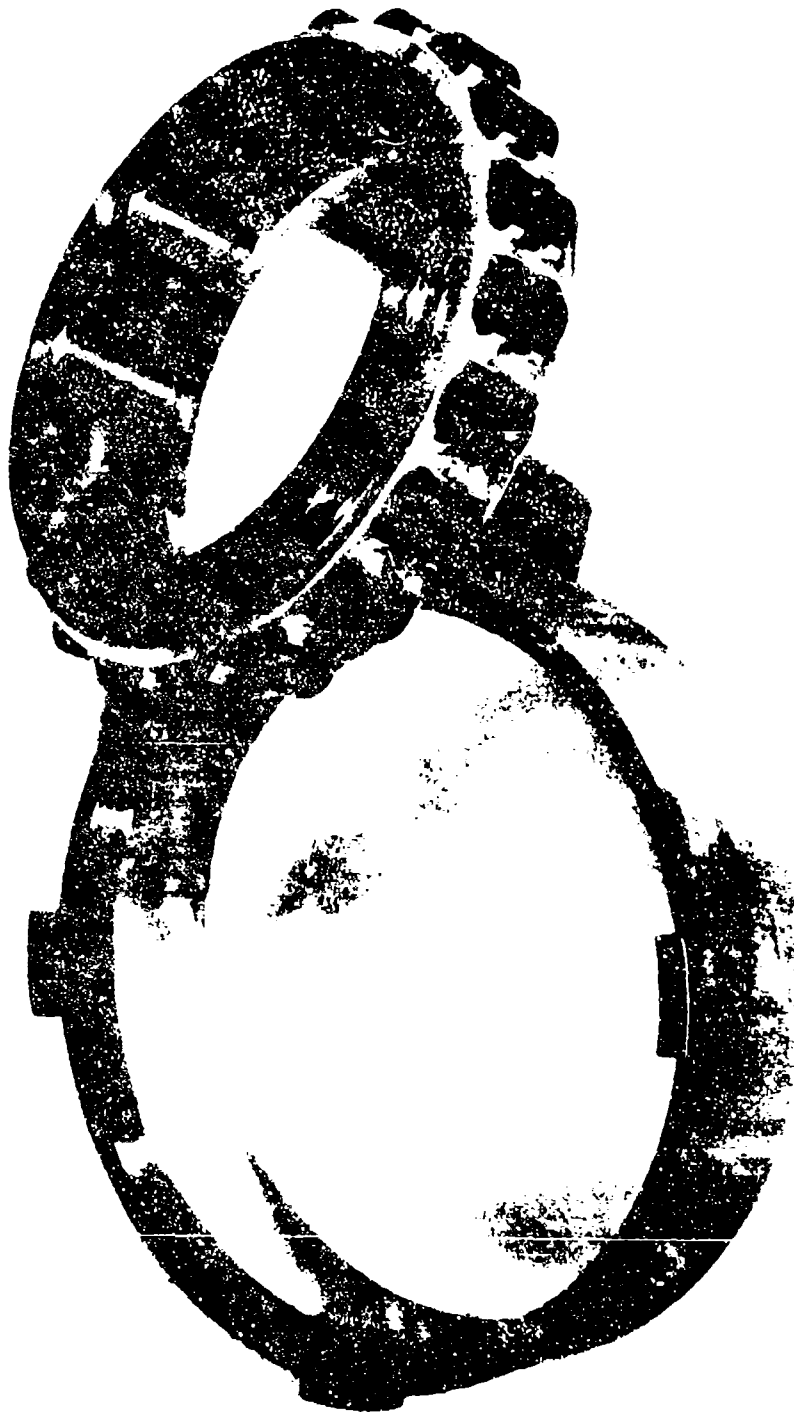
FIGURE 26 - Bearing Containing Silicon Nitride Rollers  
and Steel Races.

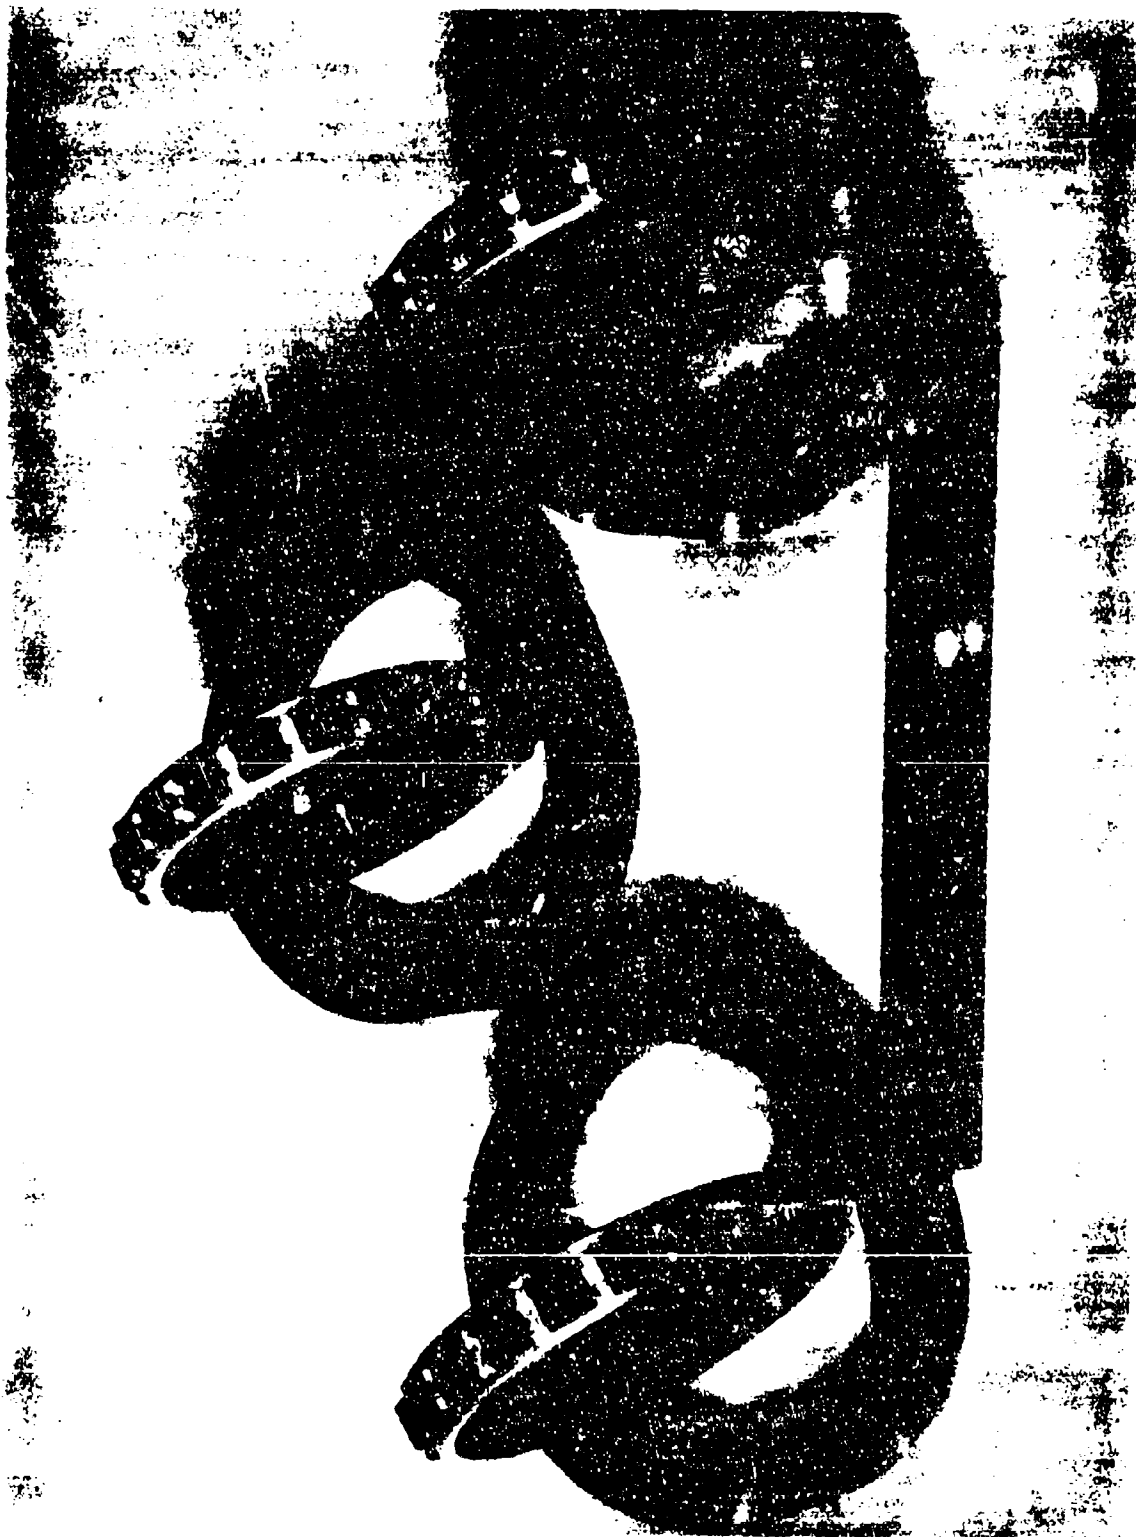
FIGURE 29 - Bearings with Silicon Nitride Rollers and Races

Three bearings with silicon nitride races and rollers were fabricated with AISI 4340 steel retainers and are shown in Figure 29. A close-up is shown in Figure 30. The bearings are serialized 1, 2 and 3. The measured diametral clearances of the three were within the tolerance range of 0.001 to 0.002 inch.

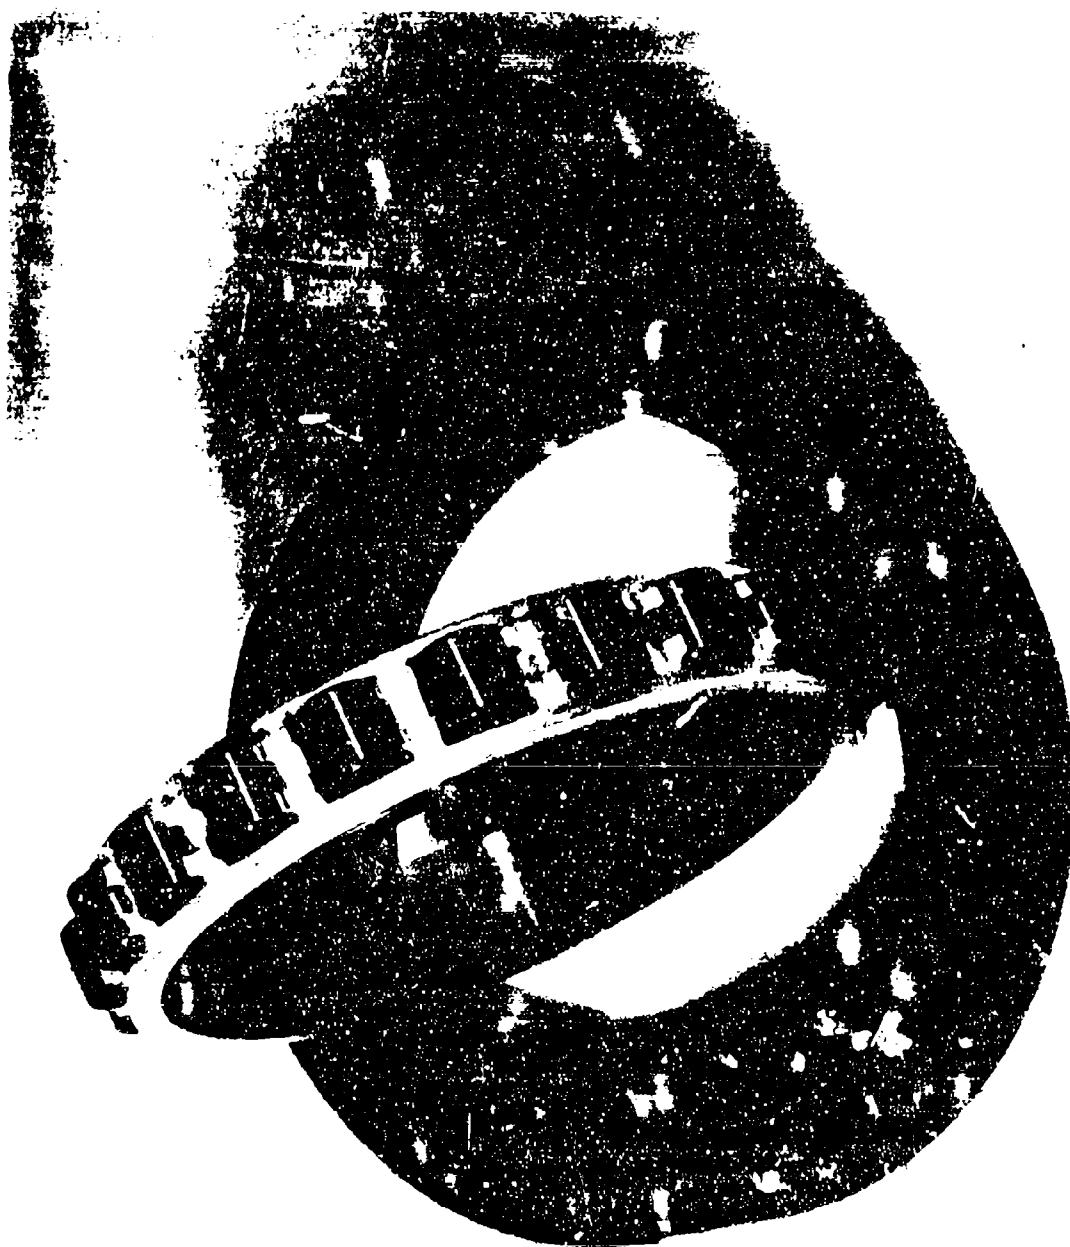
FIGURE 30 - Bearing with Silicon Nitride Rollers and Races
