HEAT EXCHANGER CORROSION TESTS. PHASE
II

HEAT EXCHANGER CORROSION TESTS
PHASE II

PREPARED BY
OSCAR OLDBERG
ENVIRONMENTAL EQUIPMENT DIVISION
MECHANICAL TECHNOLOGY DEPARTMENT
U.S. ARMY MOBILITY EQUIPMENT RESEARCH AND DEVELOPMENT CENTER

JULY 1973

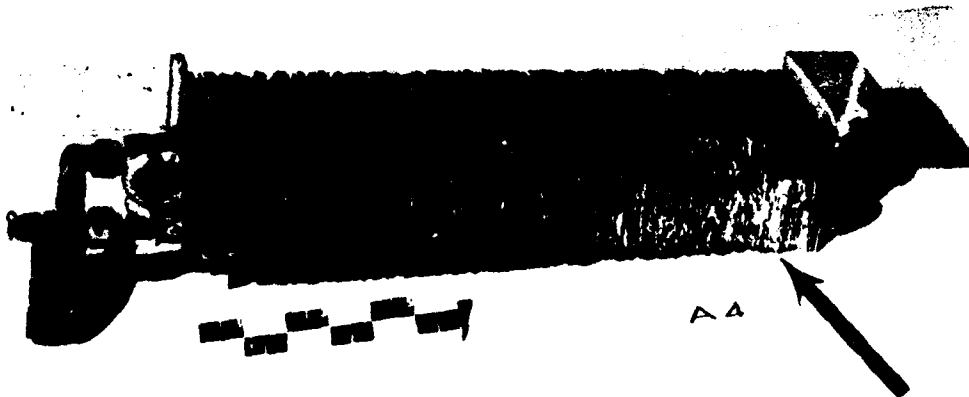
Figure 3. Condenser A4 Showing White Oxide Coating

The general appearance and degree of corrosion attack after exposure to about two years or more on the test console was taken as a measure of the corrosion resistance of the various constructions and coatings. These results are shown on page 4 and photographs of the six test coils remaining on the console at the completion are shown in figures 2-7.

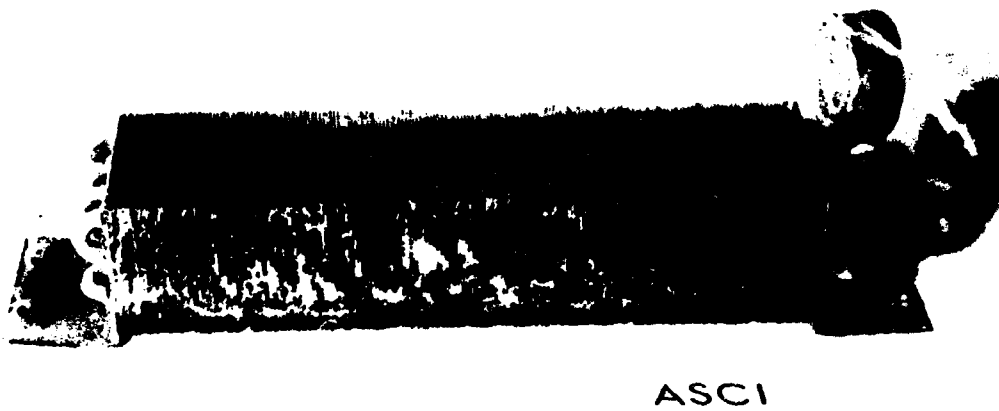
Figure 5. Condenser ASCI Showing Green Deposits of Aluminum Oxide
