IMPROVED TRANSITION RAMPS FOR
McMURDO STATION, ANTARCTICA

Naval Civil Engineering Laboratory
Port Hueneme, California

November 1973

Technical Note N-1317

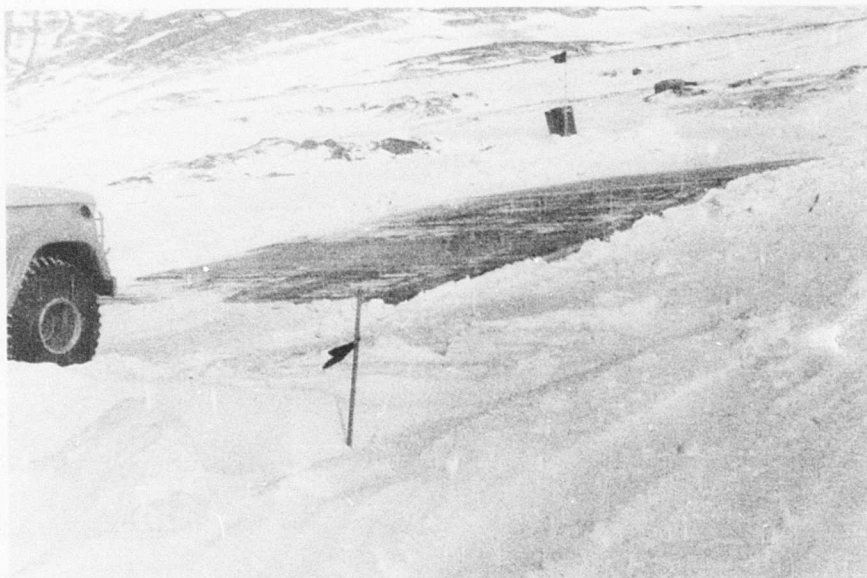
Figure 3. Timber ramp constructed during DF-68 at sea ice to land transition.

During DF-68, the Naval Civil Engineering Laboratory (NCEL) fabricated and installed a 32-foot long timber ramp (Figure 3) over the tide crack at the transition from sea ice to land on the Pass Road between McMurdo Station and Williams Field (Figure 1). The ramp was fabricated with 16-foot long, 6x6 stringers covered with 2x6 decking. The experimental timber ramp, which was tested under NCEL Work Unit YF 53.536.001.01.002, "Vehicle Road Systems on Snow and Ice," improved trafficability, but only slightly. The major shortcoming of the experimental ramp was its limited length. It was also time consuming to construct and required frequent repair.

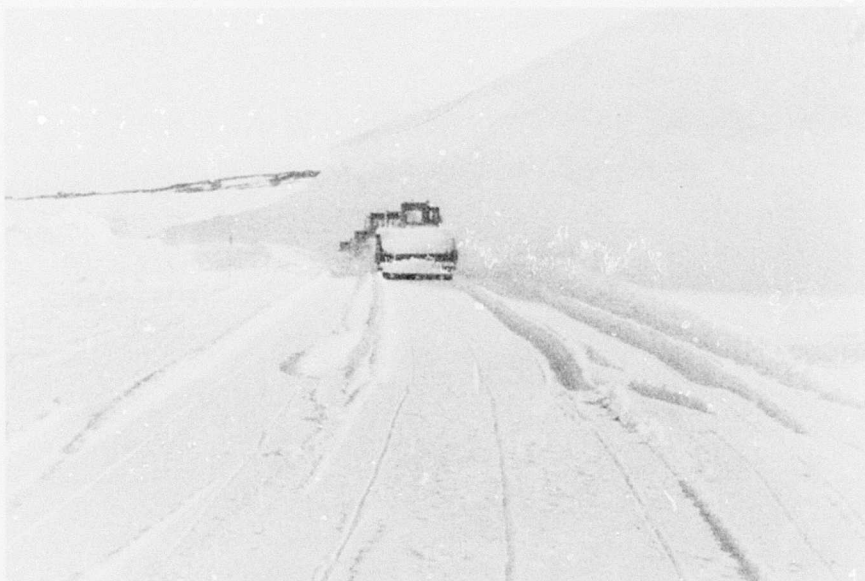
Figure 5. Shaded section of snow road near Scott Base.

At the present time, the end of the earth overlay is adjacent to a cliff which shades about 300 feet of adjacent roadway several hours each day (Figure 5). The shade reduces exposure to solar radiation and decreases deterioration of the snow road. Extension of the earth overlay past its present location will increase deterioration of the snow road and impede vehicular traffic.

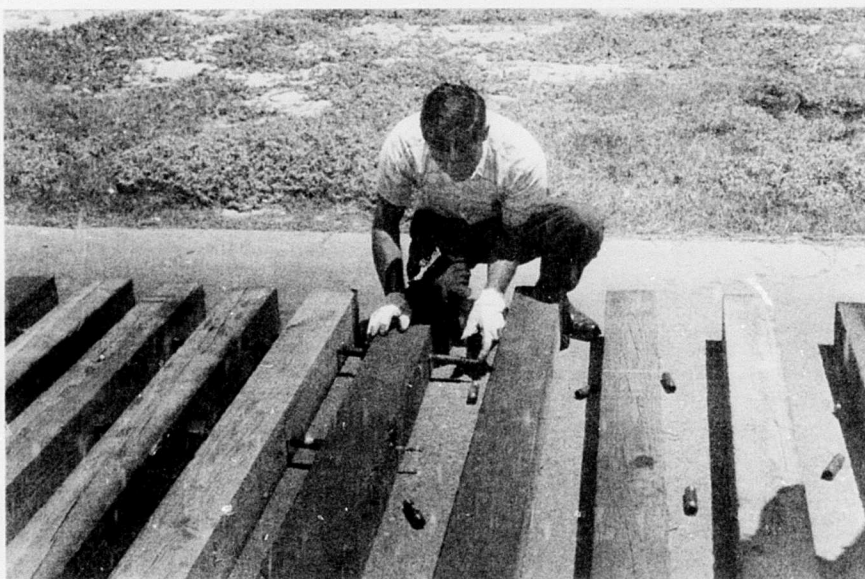
Figure 6. Prototype flexible timber ramp being assembled using 4-inch long pipe nipples as spacers.

A prototype flexible timber ramp similar to NAVFAC Drawing Number 943603 was tested on a level paved road and beach sand in the NCEL compound at Port Hueneme, California, in August 1972. The ramp was composed of two test sections. Test section A used 11-foot long rough cut 6x6 timbers placed transverse to the direction of traffic; test section B used 4-foot and 11-foot long rough cut 6x6 timbers placed transverse to the direction of traffic configured to form two parallel tracks.

Material cost for this type of ramp is reduced by using spacers between the timbers. Measurements of 11.00x15 high-flotation tires indicated that the distance between timbers could be as great as 4 inches. If the spacing is greater than 4 inches, vehicles with this size tire or smaller will experience rough rides when traversing the ramp. A 4-inch space was maintained between the timbers in the prototype flexible ramp by placing 1/2-inch pipe nipples over the 3/8-inch longitudinal cables (Figure 6). A 4-inch space between each timber reduced the cost of prototype ramp by 30 percent per linear foot.

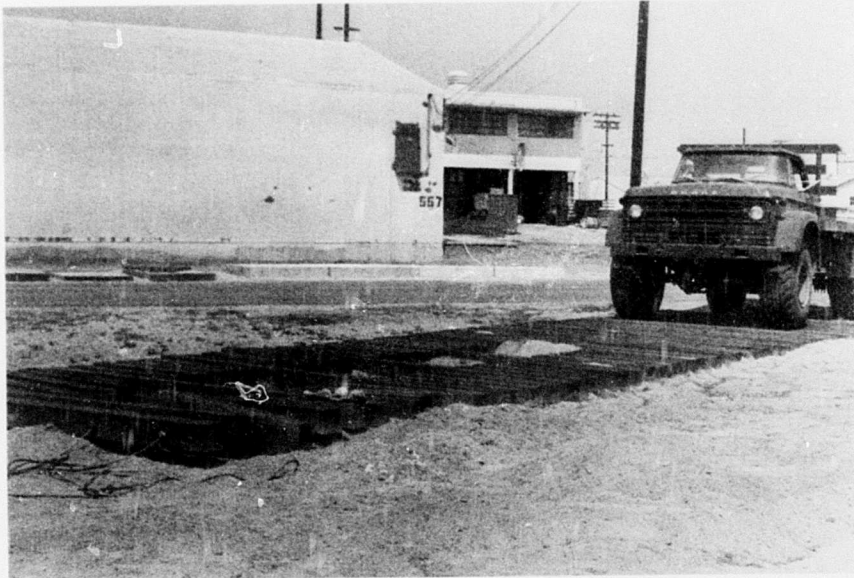
Figure 7. Dodge W-500 traversing prototype timber ramp on beach sand.

A Dodge W-500 equipped with 19.75x20 high-flotation tires was used to traverse the prototype ramp fifty to sixty times (Figure 7). Observations were made to determine the effects of traffic on the durability of the two test sections. When placed on a hard, level road, the Dodge W-500 caused very little movement in the ramp and no damage. However, when placed on beach sand, the timbers in both test sections twisted as the Dodge W-500 traversed the ramp. As the timbers twisted, the pipe spacers cut into the wood. After only a few passes with the Dodge W-500, each timber had a hole worn at each spacer. Inspection of the prototype ramp indicated that except for wear around the pipe spacers, the performance of both test sections was satisfactory.

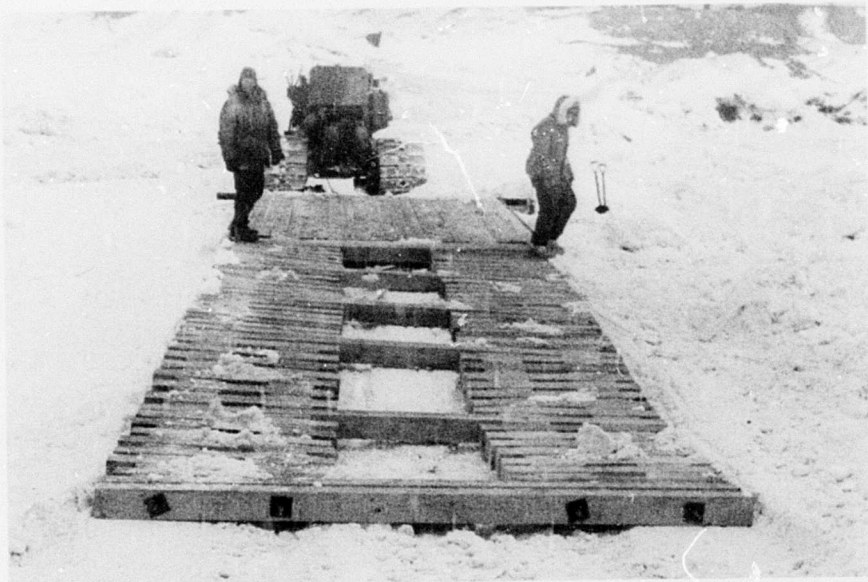
Figure 9. Timber test sections being moved into place.

Test section 2 was a 28-foot long flexible timber surfacing system similar to NAVFAC Drawing Number 943603. The timbers for this test section were cut to size and drilled to accommodate 3/8-inch wire rope ties in the builders shop at McMurdo Station. In lieu of pipe spacers, as used in the Port Hueneme tests, 2x6x12-inch wood spacers were nailed to the 6x6 timbers at each cable (see NAVFAC Drawing No. 943603). The flexible timber section was assembled on the sea ice near the test site in 24 man-hours. All timbers in test section 2 were redrilled in the field during assembly because the holes for the wire rope were plugged with snow and wood shavings. The timbers had been stored in the open and snow had accumulated in the holes. Test sections 1 and 2 were pinned together with 3/4-inch bolts (Figure 8) and towed into position at the test site (Figure 9).

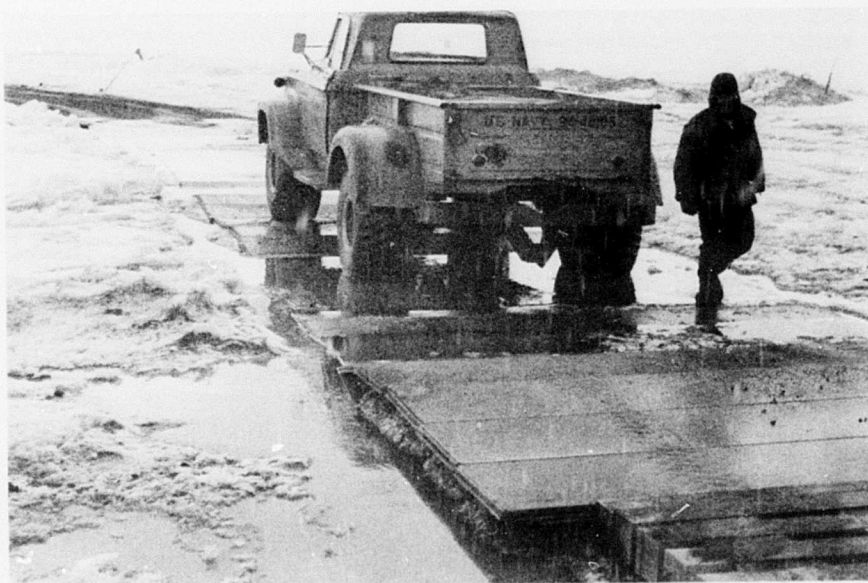
Figure 12. AM_2 aluminum planking after melting occurred.

All tests sections performed satisfactorily until late November when melting was observed under test section 3. All AM₂ planks in test section 3, except those used in the snow ramp to test section 2 (Figure 10), had sunk into the sea ice one inch or more. Melting beneath some planks was as great as 3-inches (Figure 12).
