STRESS WAVE RESPONSE OF CARBON  
COMPOSITE MATERIALS

Floyd R. Tuler, et al

Effects Technology, Incorporated

January 1974

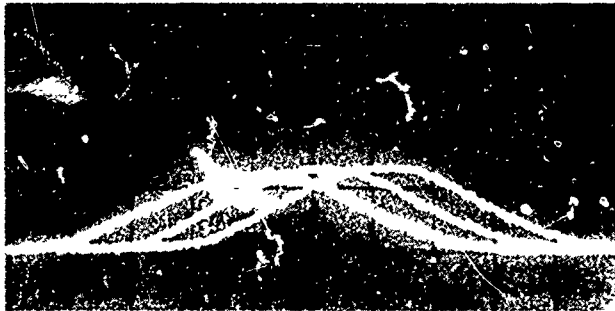
SPECIMEN 2531-1

UPPER TRACE: LOAD  
50 lb/div  
LOWER TRACE: ENERGY  
0.267 ft-lb/div  
TIME: 1 msec/div

LOAD: 20 lb/div  
TIME: 5 msec/div

Figure 3.29. Oscilloscope Traces from Fracture and Compliance Tests on 3D Carbon Phenolic Composite M1 Tensile Wave Damage Specimens.
