INTERACTION OF COPPER-CONTAINING RO-  
TATING BAND METAL WITH GUN BORES AT  
THE ENVIRONMENT PRESENT IN A GUN TUBE

R. S. Montgomery

Watervliet Arsenal  
Watervliet, New York

June 1974

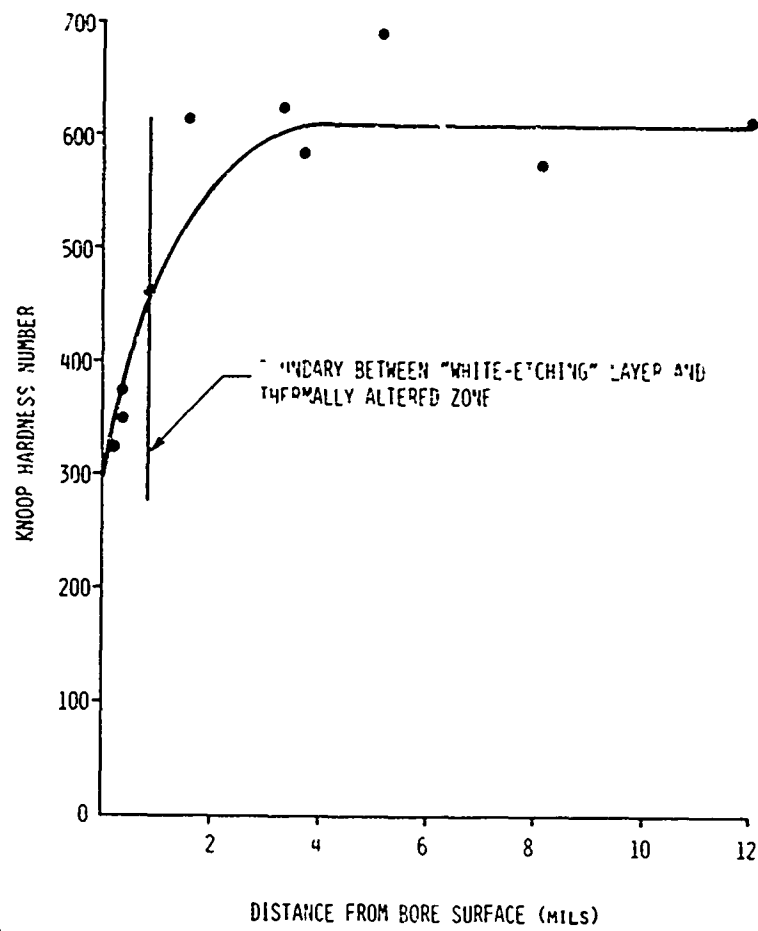
FIG. 20 Hardness through Pyromet X-15 beneath the eroded zone as a function of distance from bore surface.

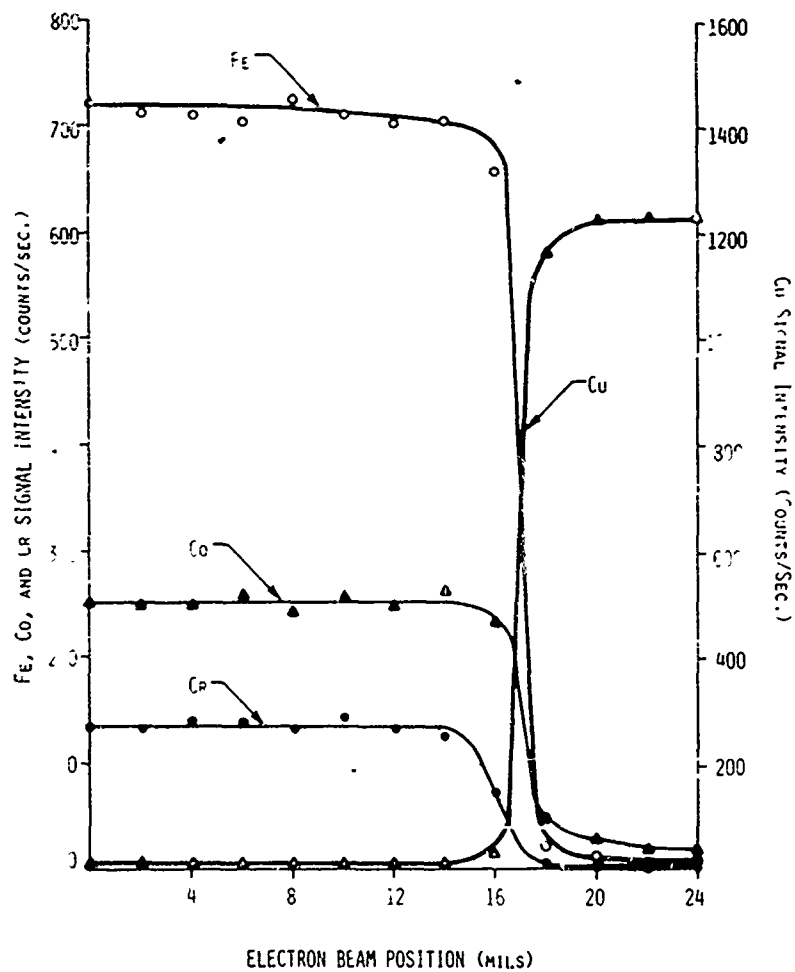
FIG. 22 X-ray intensities characteristic of iron, cobalt, chromium, and copper across a section through the eroded zone of the Pyromet X-15 specimen showing lack of interpenetration.
