INVESTIGATION OF COMPOSITE COATING  
SYSTEMS FOR RAIN-EROSION PROTECTION

Olive G. Engel, et al

Florida Atlantic University

15 July 1974

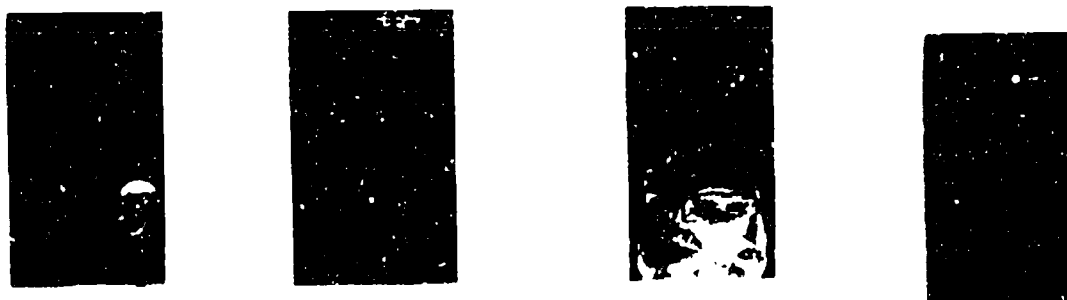
SINGLE-LAYER COATING  $S_2$

TWO-LAYER COMPOSITE COATING  $H_1S_2$

MULTILAYER COMPOSITE COATING  $H_1H_2H_3S_3S_2$

STRESS-BUMPER COMPOSITE COATING  $S_2H_1S_2$

FIGURE 1. FOUR TYPES OF POLYURETHANE COATING AFTER RAIN-EROSION TEST AT BELL AEROSPACE COMPANY. Left to right are Specimens 1 to 4.

During the microscopic inspection of the specimens three modes of failure were monitored; these were hole formation, crack formation, and adhesion loss. The test lifetimes and the extent to which the three modes of failure that were monitored had progressed are given in Table 1 for the condition that the failure criterion of hole through the coating was not reached for six of the specimens. A picture of the specimens of the four coating types that was taken after each of the specimens was tested to the point of formation of a hole through the coating is shown in Figure 1.

Each of the four specimens of the single-layer softcoat, S<sub>2</sub>, was tested to the point of failure as indicated by formation of a hole through the coating (see Table 1). For two of the specimens the hole that formed is large; for the other two it is small.
