ROLLING CONTACT FATIGUE OF SILICON
NITRIDE

Raymond Valori

Naval Air Propulsion Test Center

3. REPORT TITLE Rolling Contact Fatigue Endurance of Silicon Nitride		
4. DESCRIPTIVE NOTES (Type of report and inclusive dates) Final Report		
5. AUTHOR(S) (First name, middle initial, last name) VALORI, Raymond

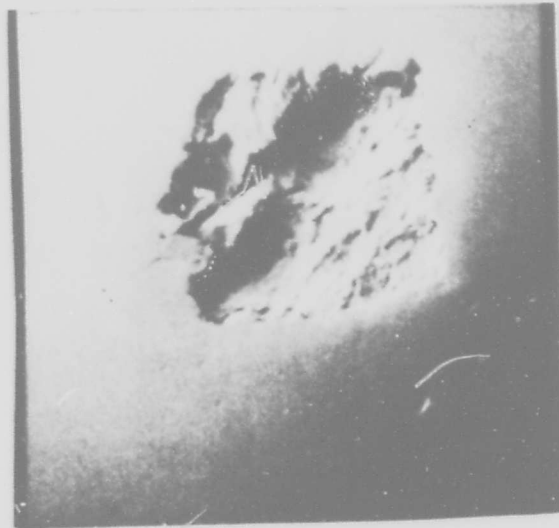
COMPARISON OF SPALLS FOR M-50
STEEL AND SILICON NITRIDE (50X)

SILICON NITRIDE

M-50 STEEL

The number of stress cycles was recorded as a data point for each test. Typical fatigue spalls for M-50 steel and silicon nitride are compared in the photomicrographs in Figure 4.

a. All the spalls include one or both edges of the wear track as shown in Figures 4 and 10. Closer examination of these wear tracks reveals cracking at the edge of the wear track as shown in Figure 11. This cracking is on both edges of the track and extends around the entire circumference of the test rods. Edge cracking remote from the spall is shown in Figure 12. This suggests that the spalls originated at the edge of the wear track and were initiated by the cracking. Figure 11 suggests that the fatigue spalls propagate by a) the formation of cracks transverse to the wear track and b) the flaking out of material between successive transverse cracks.

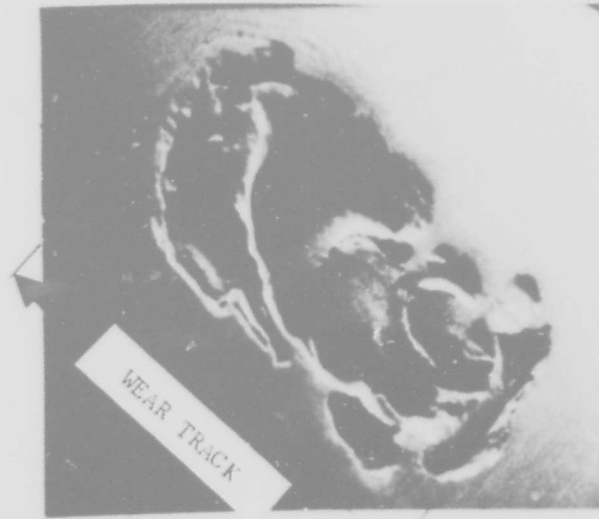
FIGURE 10

FATIGUE SPALLING OF SILICON NITRIDE

TRACK N4 (50X)

TRACK N1 (50X)

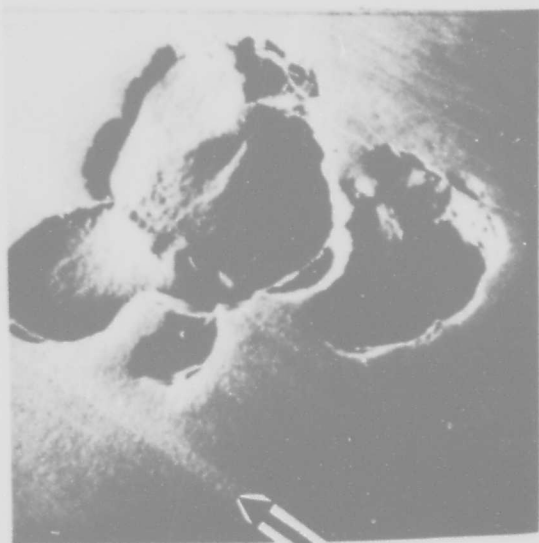
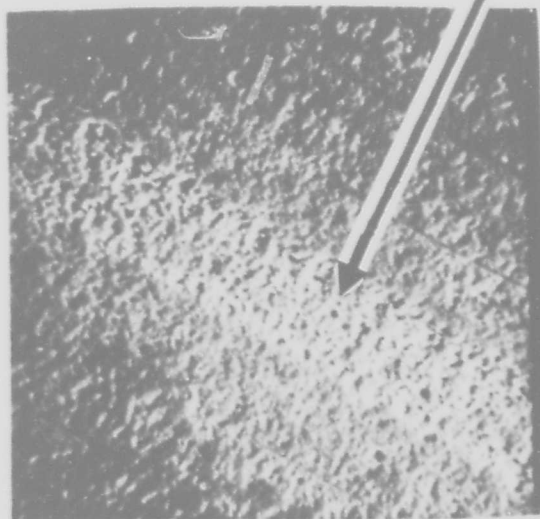
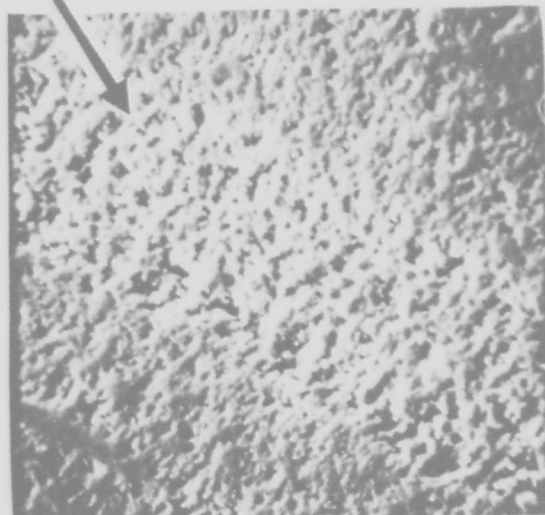
TYPICAL GROOVES IN SILICON NITRIDE WEAR TRACK
FROM TESTS PERFORMED BY THE NORTON COMPANY (TRACK N1)

SAME GROOVE

d. All the Norton run wear tracks, exhibited several grooves within the wear track as shown in Figure 14. None of the NAPTC wear tracks exhibited grooves. One of the grooves in Figure 14 is shown at successively higher magnifications. The surface within the groove appears to contain a higher density of surface pits than the area outside the groove. Surface traces of the wear tracks of test rod 73-23 were made. The traces for tracks N1, N2 and N3 are shown in Figure 15. The deepest grooving occurs in track N1 which was run at the highest Hertz stress (800,000 psi) and was the only run which experienced a fatigue spall. The largest groove (track N1) is about 0.008 inches wide and 0.00016 inches deep. For comparison, traces on NAPTC produced tracks (P2 to P5) are shown in Figure 16. All testing on these tracks was conducted at 800,000 psi Hertz stress. No grooves are apparent in the NAPTC tracks. In addition, no fatigue spalls were obtained in NAPTC tracks at this Hertz stress even though tests were run up to almost 10 times the number of stress cycles to which the failed Norton Company tests were run as shown in Table III. It is possible that the grooving in the Norton run tests played some role in the failure mechanism to accelerate fatigue. Such surface imperfections are known to initiate fatigue spalling in steel bearings. It is speculated that the grooves may have been caused by a combination of slight slipping (or skidding) between the test rod and the loading disks and poor surface finishing of the crown of the loading disks.
