AD 804975

This report presents the results of visual and photographic underwater surveys from the shoreline to a depth of 600 feet along selected routes off the eastern coast of Andros Island, Bahamas. Additional oceanographic and meteorological data are included which were obtained during previous surveys. This is the U. S. Naval Oceanographic Office's first survey utilizing SCUBA equipped divers and submersibles and represents a further expansion of our data collection and survey capabilities to provide a more lucid presentation of ocean environmental characteristics.

The survey was performed to provide information applicable to the installation of submarine cables in support of the U. S. Navy's Atlantic Undersea Test and Evaluation Center.

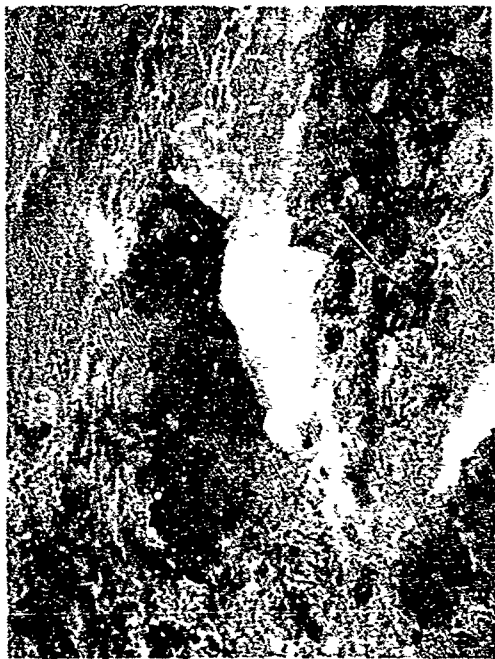
PLATE 12. GOLDING CAY (A) & (B) EASTERN SHORELINE, (C) & (D) DETAILED VIEW OF CAY ROCK. KNIFE IS 8 IN. LONG.

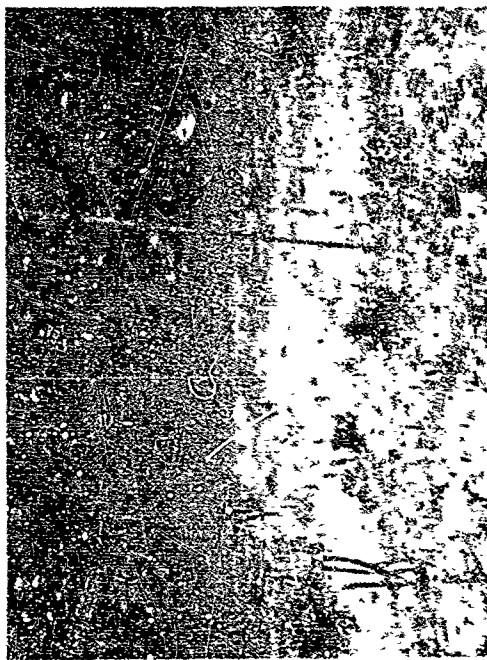
PLATE 20. HIGH POINT CAY (A) & (B) BUOY 3. DEPTH 12 FEET. CORAL IN (B) IS DIPLORIA LABRYNTHIFORMIS. (C) & (D) BUOY 4, DEPTH 15 FEET.

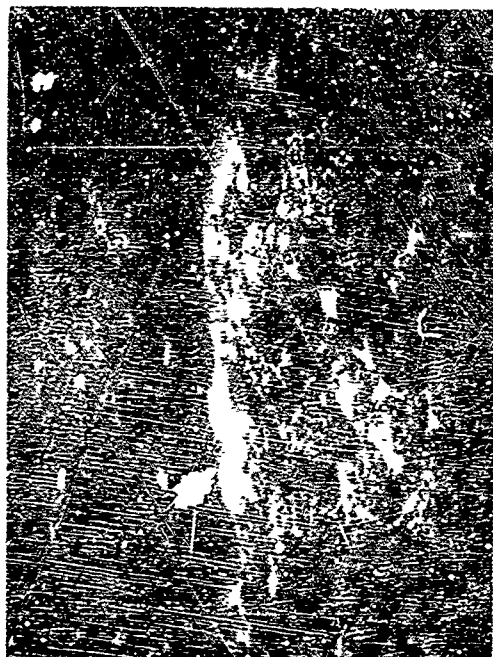
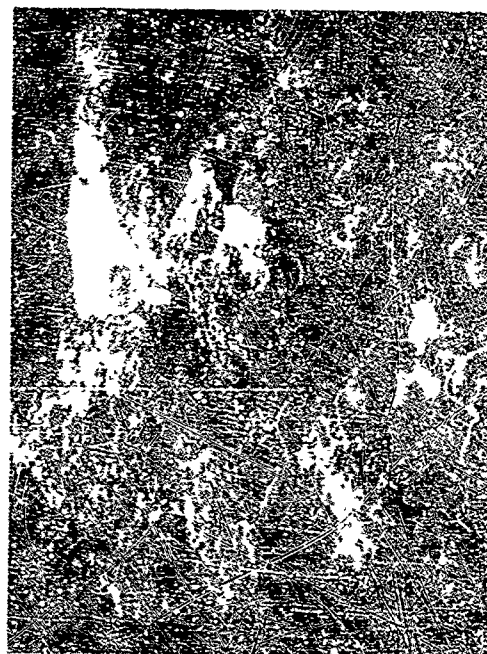
PLATE 26. REPRESENTATIVE PHOTOGRAPHS OF MARGINAL ESCARPMENT OFF GOLDING CAY. (A) 210 FEET. (B) 270 FEET. (C) 270 FEET. (D) 312 FEET.
