AIRCRAFT GROUND-FLOTATION INVESTIGATION

PART IX — DATA REPORT ON TEST SECTION 8

TECHNICAL REPORT AFFDL-TR-68-43, PART IX

SEPTEMBER 1968

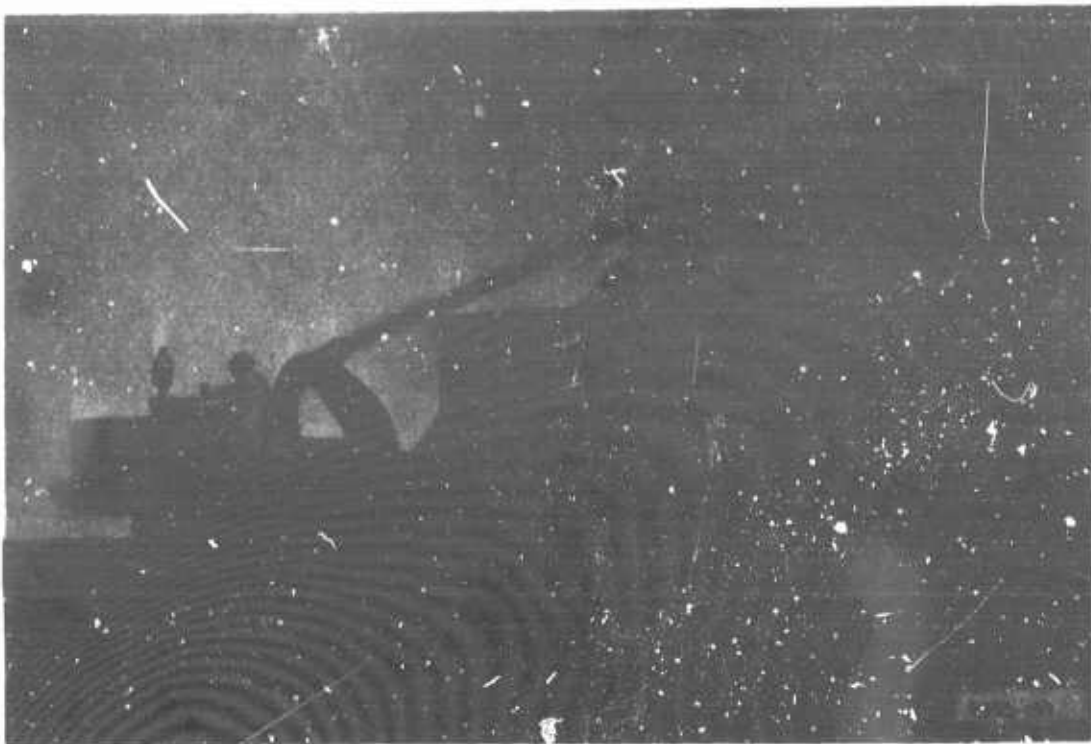
Figure 1. Test load vehicle

The load vehicle used for trafficking test lanes in Section 8 is shown in figure 1. Load cart construction, details of linkage between the load compartment and prime mover, and method of applying load are explained in Part I. For trafficking lanes 17, 17A, 18, 19, and 20, a 25,000-lb single-wheel load was used with the tracking tire inflated to 25, 100, 60, 40, and 80 psi, respectively. A 25.00x28, 30-ply aircraft tire was used on the assembly. Tire-print dimensions and pertinent tire characteristics are shown in figure 12.
